May 8, 2023

HIR-23-06

# Wrong-Way Driving Crash between Service Truck and Motorcoach on Interstate 20

Big Spring, Texas  
November 19, 2021

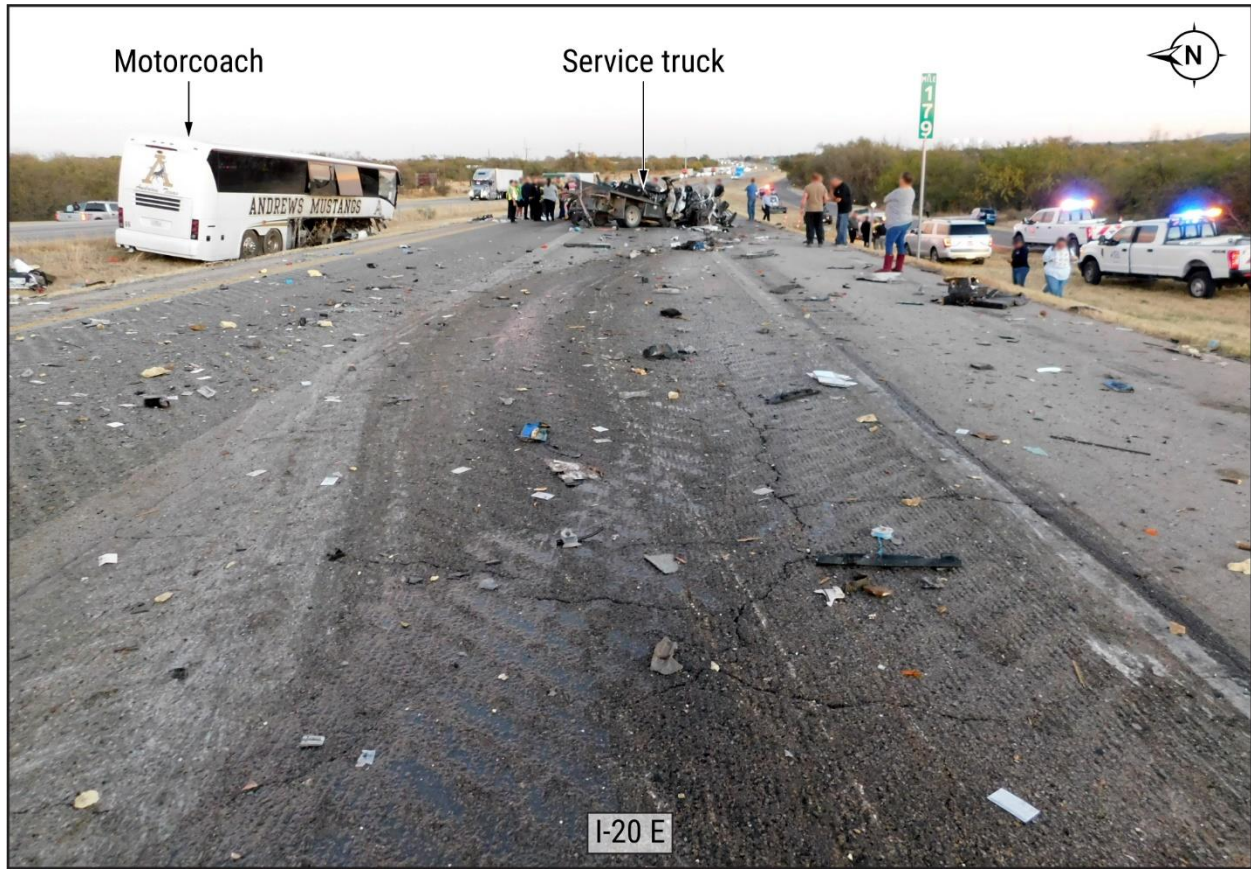
**Figure 1.** Impact area, with motorcoach in median and service truck in right-hand eastbound traffic lane, both at final rest. Freightliner bus, not pictured, is farther east on the right shoulder of I-20. (Source: Texas Department of Public Safety)

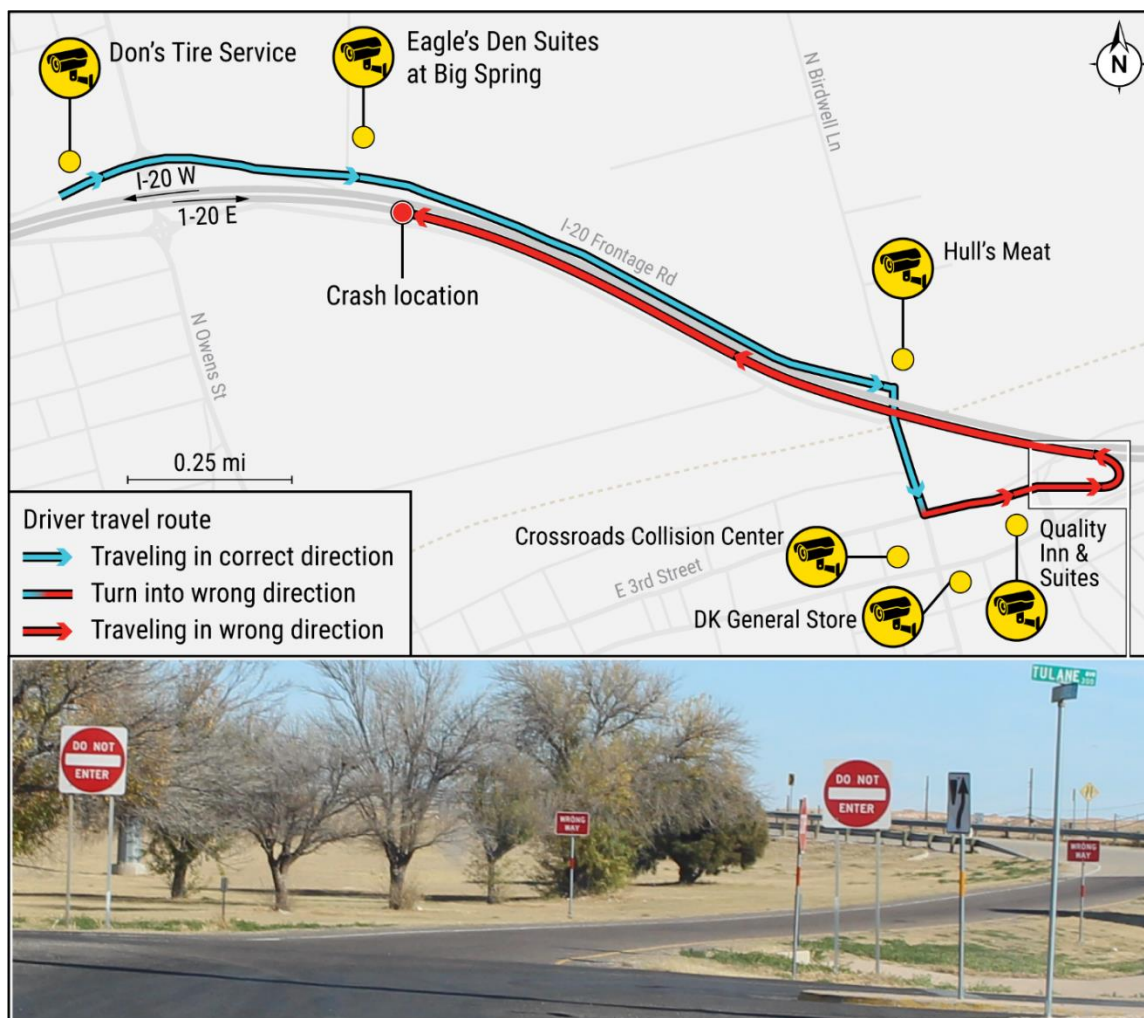
**Figure 3.** Service truck driver’s path of travel as determined by surveillance video and witness testimony. Blue arrows show travel in the correct direction, and red arrows show travel in the wrong direction. (Map Source: Google Maps; annotated by NTSB)

Video showed the driver at the signalized intersection of Birdwell Lane and East 3rd Street, which is a one-way street for westbound traffic. The driver made a left turn onto East 3rd Street and began traveling in the eastbound direction. The intersection had a one-way sign posted on the mast arm of the signalized light on East 3rd Street. After turning left, the driver continued for 30 feet and passed a second one-way sign on East 3rd Street indicating that he was traveling in the wrong direction.<sup>3</sup> About 90 feet after he passed the second one-way sign, he passed a wrong-way sign on East 3rd Street.<sup>4</sup>

He continued traveling the wrong way on East 3rd Street and entered the exit 179 off-ramp for eastbound I-20 (refer to the lower image in figure 3). Two do-not-enter signs and two wrong-way signs were posted on either side of the ramp's base; the wrong-way signs were located 150 feet behind the do-not-enter signs. In total, from the point of initial wrong-way travel to his entering the exit ramp, the driver passed seven traffic signs indicating that he was traveling in the wrong direction (see figure 4).

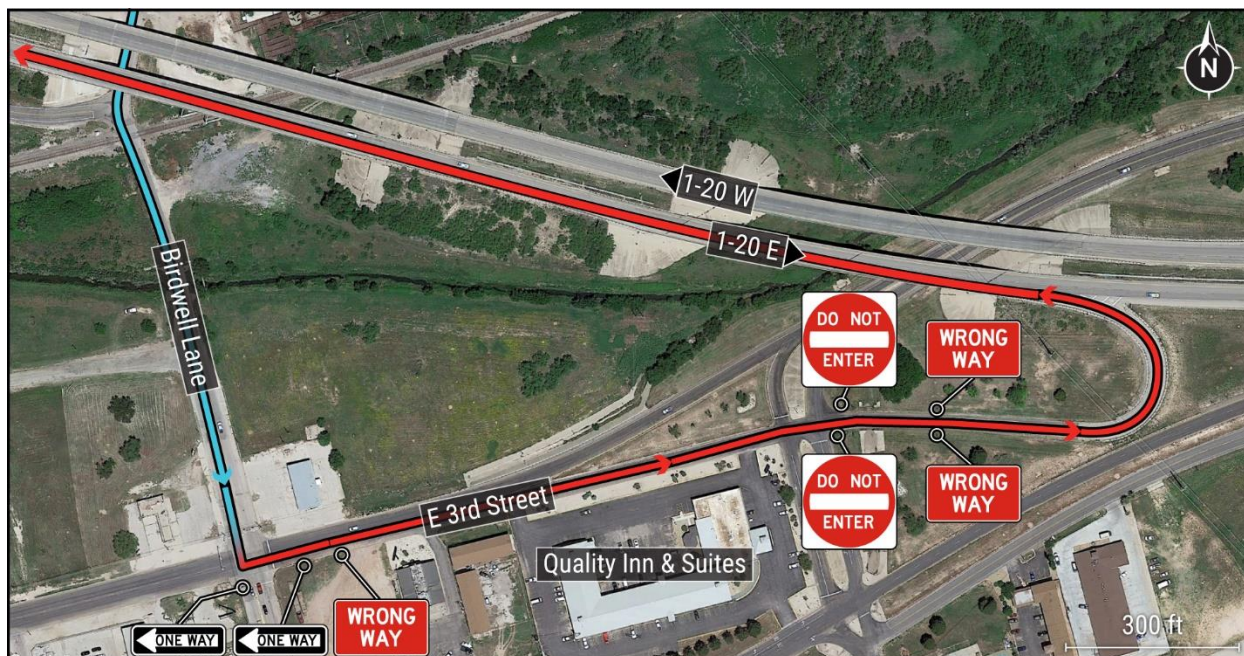
**Figure 4.** Traffic signs encountered by service truck driver indicating wrong-way travel from Birdwell Lane until he entered the exit ramp onto I-20. (Source: Google Maps; annotated by NTSB).

Traffic signage was not a factor in the service truck driver's error leading to his travel in the wrong direction. He was presented with multiple traffic signs to guide him to travel in the correct direction. From the initial wrong turn onto a one-way street at the intersection of East 3rd Street and Birdwell Lane until the crash event, the driver encountered seven traffic signs indicating wrong-way travel, as follows:

- One-way sign above the signalized traffic light at 3rd Street and Birdwell Lane
- One-way sign on East 3rd Street
- Wrong-way sign on East 3rd Street
- Two do-not-enter signs at the base of the exit ramp
- Two wrong-way signs 150 feet behind the do-not-enter signs at the base of the exit ramp

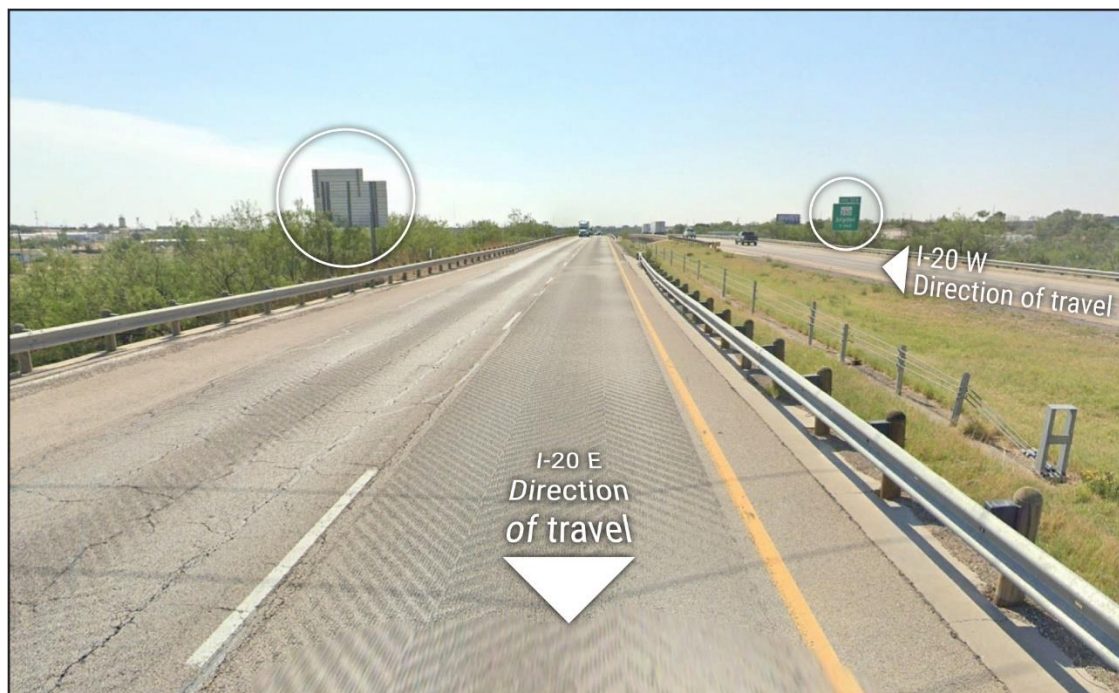
After entering the highway, the driver encountered additional cues indicating that he was driving in the wrong direction (see figure 6). Before the crash, at least four vehicles that were traveling east on eastbound I-20 approached and passed him as he continued to travel west. Further, a driver traveling in the wrong direction would face the backs of highway traffic signs. Although subtle, the white pavement line on a highway is located on a driver's right, and the yellow pavement line is located on the left; for a driver traveling the wrong way, these colored lines would appear on the opposite sides.

**Figure 6.** Examples of cues indicating wrong-way travel: facing oncoming traffic and the backs of traffic signs and having the yellow pavement line on the right (incorrect) side. (Source: Google Maps; annotated by NTSB)
