HIR-23-10

Grade Crossing Collision Between Commuter Train and Box Truck

Clarendon Hills, Illinois
May 11, 2022

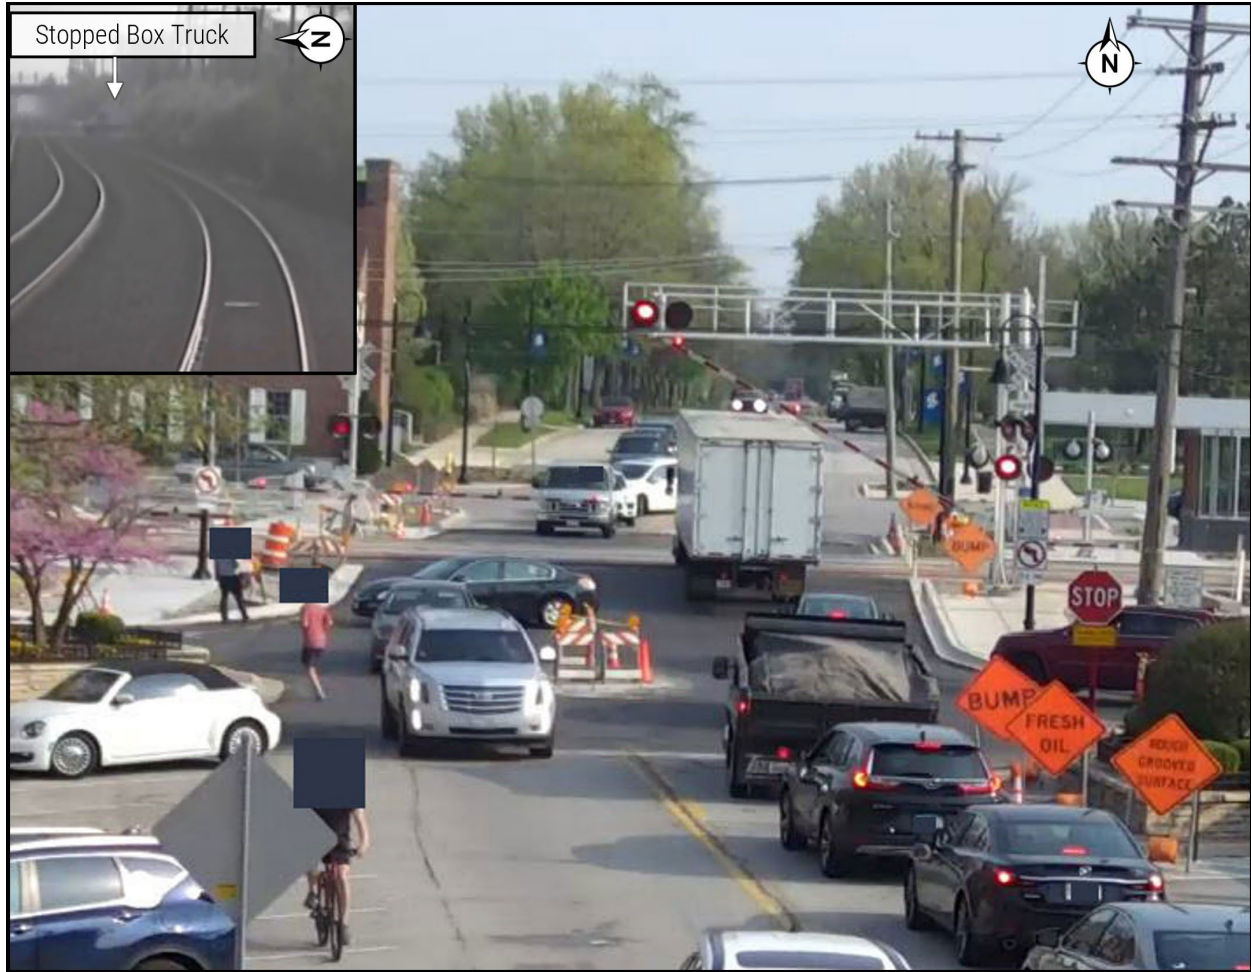
Figure 1. Synchronized images from the north-facing security camera at the Prospect Avenue grade crossing (Source: Village of Clarendon Hills, redacted by NTSB), and the forward camera from the eastbound commuter train on track #3 (Inset, Source: METRA, annotation by NTSB). At the time of these images, the box truck was stopped on the tracks with the occupants still inside the truck. The active crossing warning system was activated, and the gate arm struck the top of the box truck. As shown in the inset, traffic in front of the box truck was clear of the tracks.

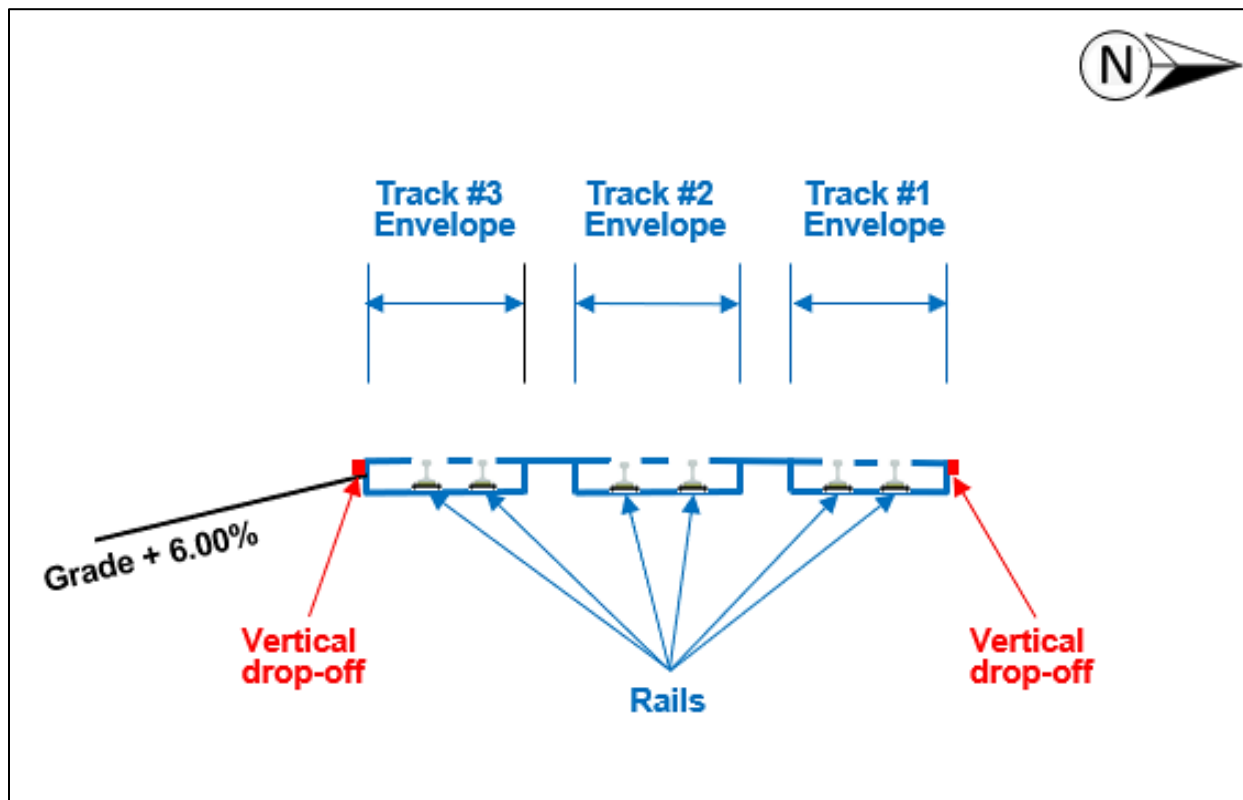
drop-off between the track envelope and the road surface.³ A temporary tapered joint was in the design plans but had not been installed at the time of the collision. However, the vertical drop-off was within recommended highway design guidance for road construction.⁴

Figure 4. Diagram of the grade crossing with the location of vertical drop-offs on each side of the track envelope annotated along with the grade increase on the south side of the crossing. Track envelope and rail locations are also noted.

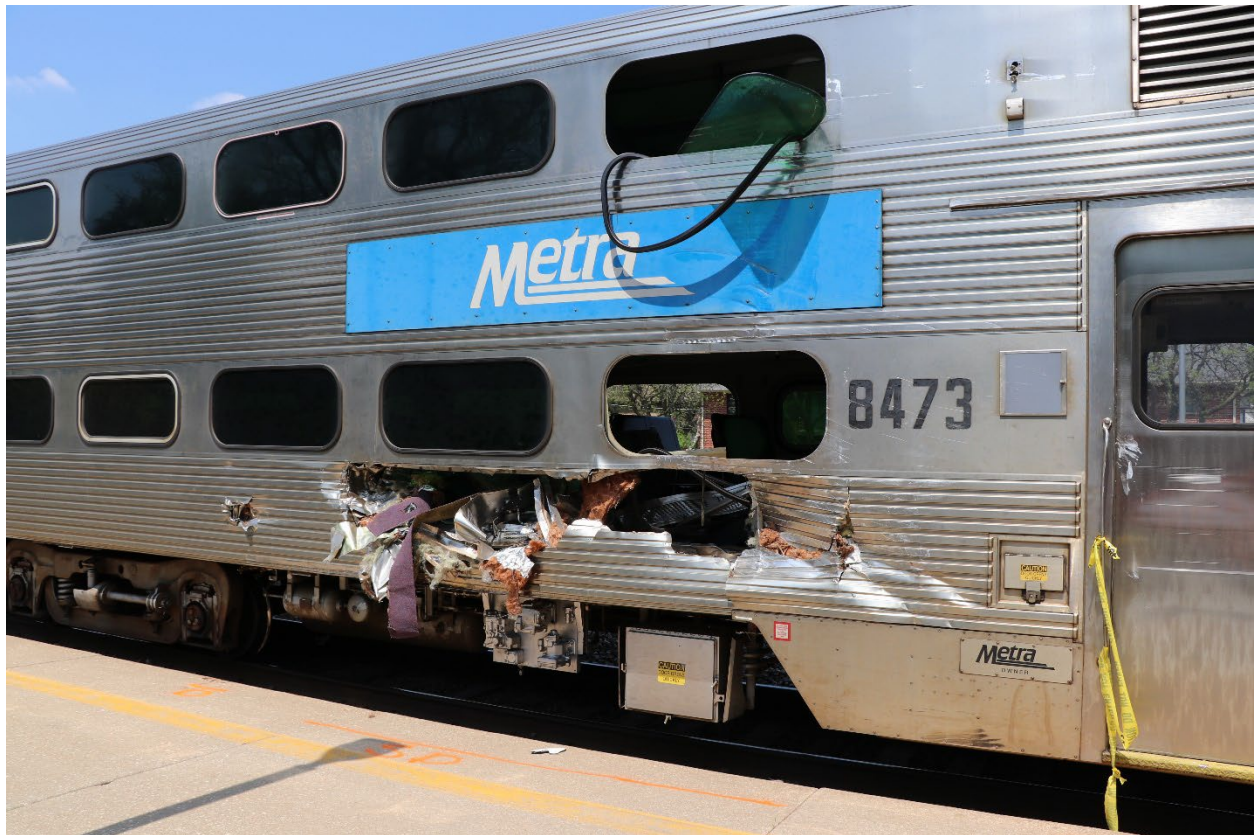
When the commuter train struck the box truck, the truck was pushed against the crossing arm supports, which broke away from the concrete support pedestals on the ground. The truck then rotated clockwise and struck the right side of the train's lead cab car, below the windows. The train did not derail and came to a full stop at 8:16:38, about 1,106 feet east of the crash location. As shown in figure 5, the secondary impact resulted in exterior gouging of the cab car, with intrusion damage to the lower-level seating compartment of the two-level commuter train passenger car, as well as window damage on the upper level.

Figure 5. Exterior damage to the lower-level seating area of the right side of the commuter train's lead cab car. The upper level also sustained window damage.

Window retention was not a factor in the fatal injury sustained by one commuter train passenger. The evidence indicates that the fatal injury was sustained by the impact force of the rear of the box truck with the cab car sidewall near the passenger's seating location, and not as a result of the ejection itself. The impact forces from the box truck likely exceeded the cab car side wall strength requirement in 49 *CFR* 238. The NTSB has previously recommended that the Federal Railroad Administration develop side-impact crashworthiness standards for passenger railcars and then update federal regulations to reflect these new standards. Safety Recommendations [R-12-39](#) and [-40](#) are currently classified Open–Acceptable Response.

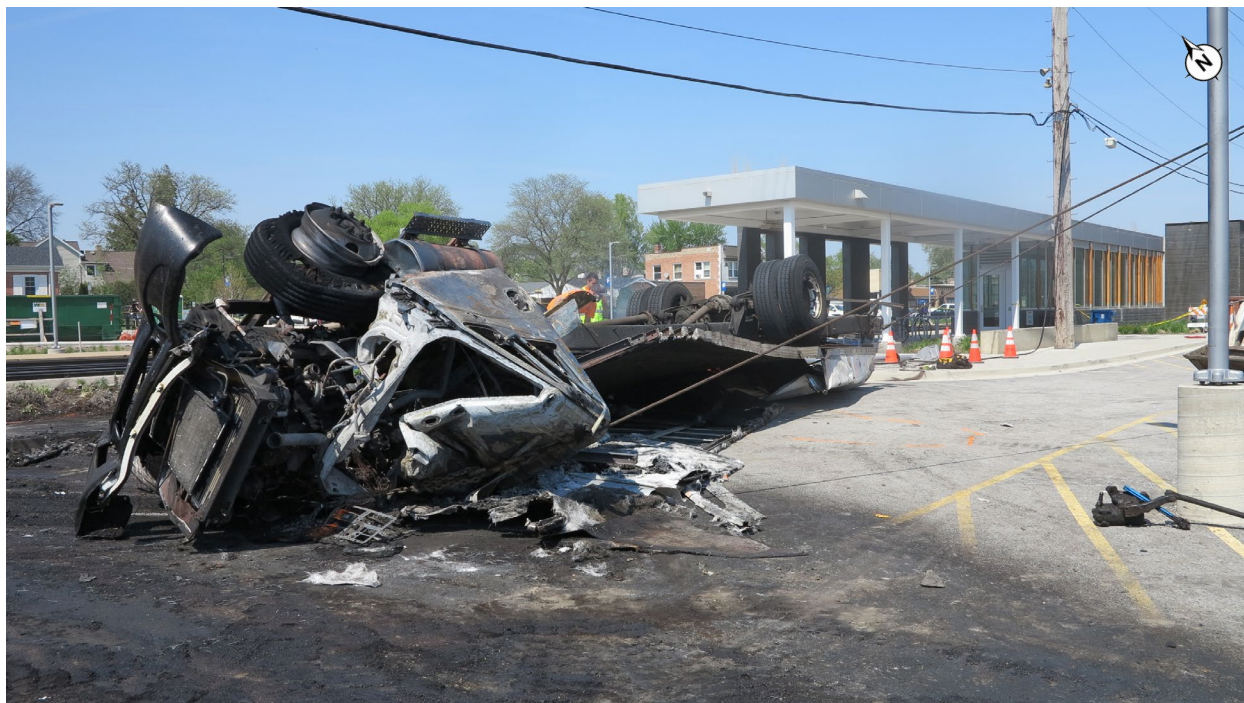
The truck came to rest in a parking area near the grade crossing and was then engulfed in a postcrash fire. The fire consumed the electrical system of the truck, including the engine control module (ECM). Figure 6 shows the box truck at final rest.

Figure 6. View, facing to the northeast, of the box truck at final rest.

The truck sustained significant damage from the crash and the resulting fire. All combustible material from the front bumper to the rear of the cab was consumed by the fire, including the vehicle batteries, wiring, and electrical system. Therefore, investigators were unable to evaluate the electrical system for shorts, blown fuses, or tripped circuit breakers. The ECM was also consumed by fire, and it was not possible to recover its data.

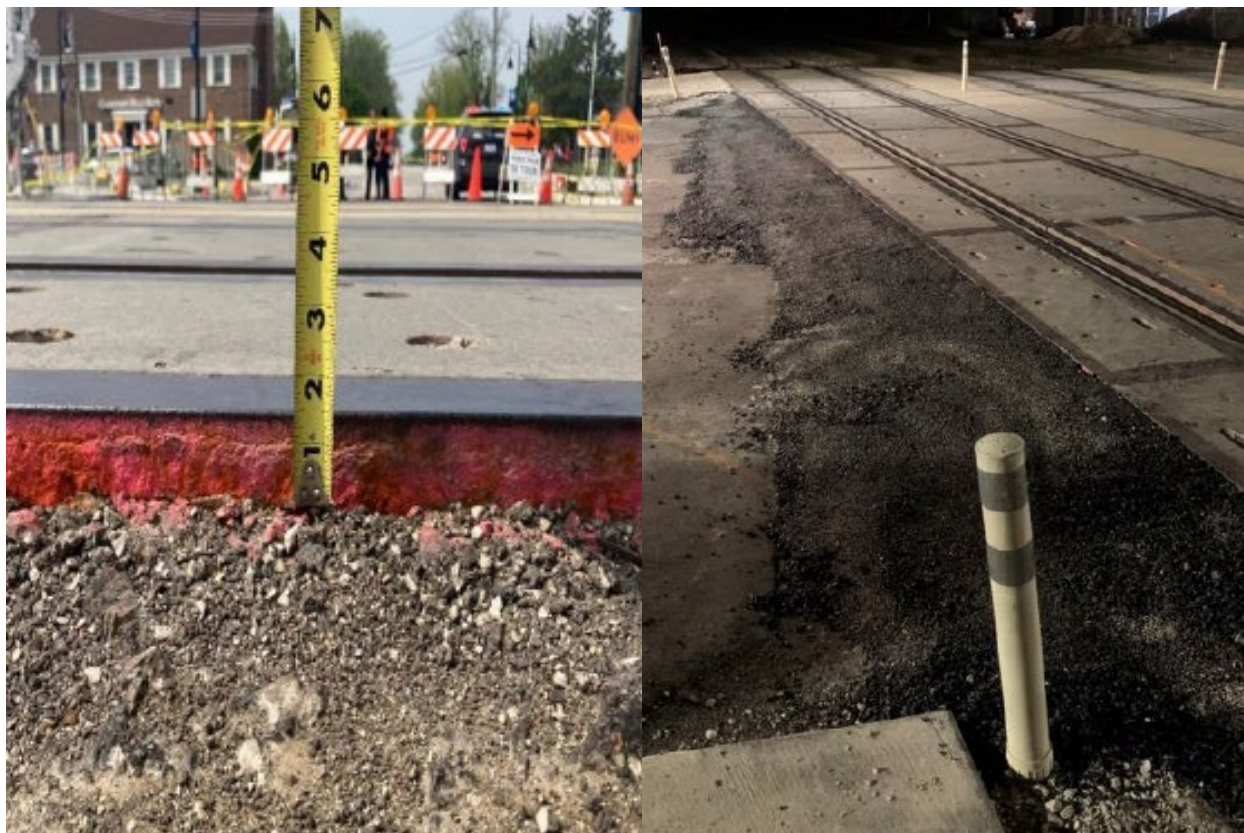
Figure 7. Image of the drop-off at the south end of the grade crossing before the crash with tape measure (left; source: Illinois Commerce Commission) and a temporary tapered joint installed on May 13, 2022 (right).

On May 13, 2022, the Village of Clarendon Hills performed temporary repairs to the vertical drop-off at the grade crossing until the remainder of the streetscape repairs could be completed. Figure 7 shows an image of the drop-off before the crash (left) and a tapered joint installed along the south end of the grade crossing (right). The streetscape and paving improvements were completed on June 26, 2022, and provided a new asphalt surface flush with the grade crossing surface at the south and north ends.
