HIR-24-07

High-Speed Vehicle Collision with Workers in a Highway Work Zone

Woodlawn, MD
March 22, 2023

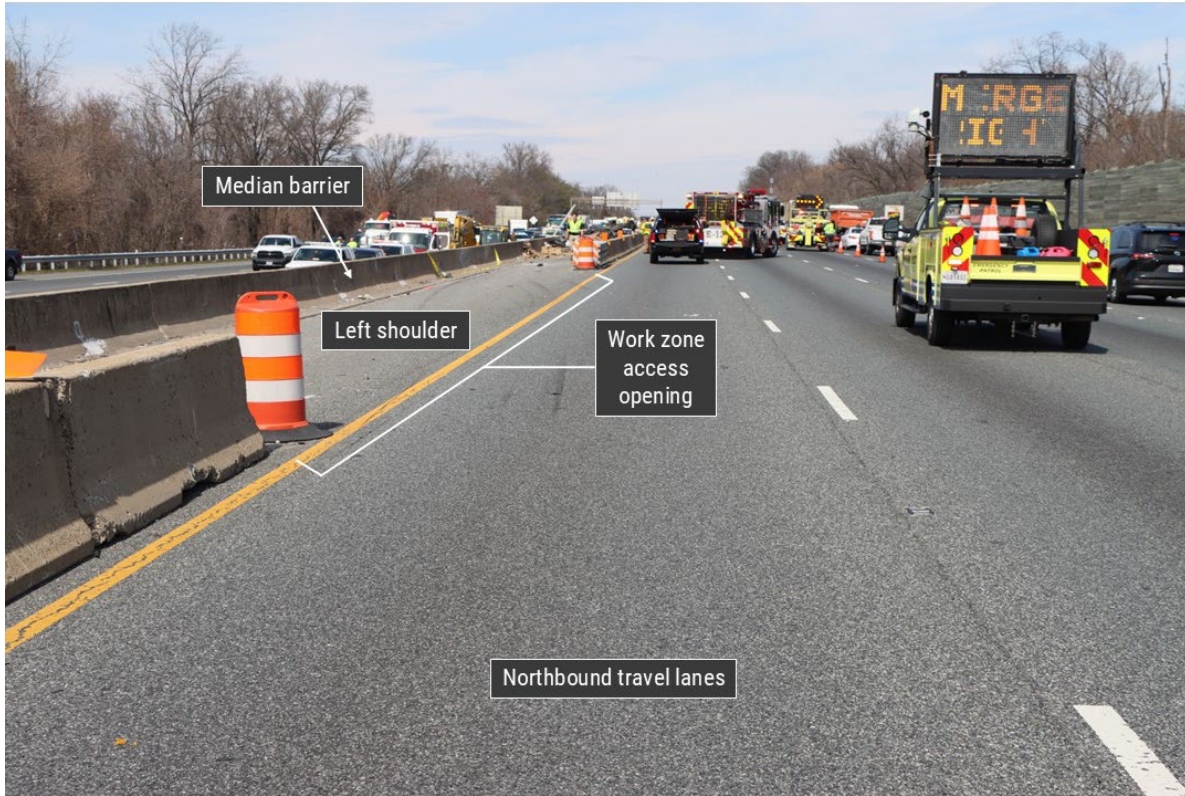
Figure 1. Postcrash view of the work zone and the opening in the concrete barriers through which the Acura entered. (Source: Maryland State Police; annotations by NTSB)

Although the opening in the concrete barriers allowed the Acura to enter the work zone after losing control, the Acura's excessive speed was the key factor that determined how far the vehicle traveled into the work zone as it overturned, resulting in the worker fatalities. In addition, the Acura's loss of control was initiated by the driver's unsafe high-speed lane change across three lanes and collision with the high-speed Volkswagen. Since the crash, MDSHA planned several changes to the work zone, including closing the adjacent lane when work is taking place and blocking the work zone opening with a protection vehicle.

- Close additional lanes next to the median when workers are present;
- Block access areas with a protection vehicle when the adjacent lane is closed and work is taking place;
- Reduce the speed limit when workers are present by using variable speed limits; and
- Increase the use of ASE systems.

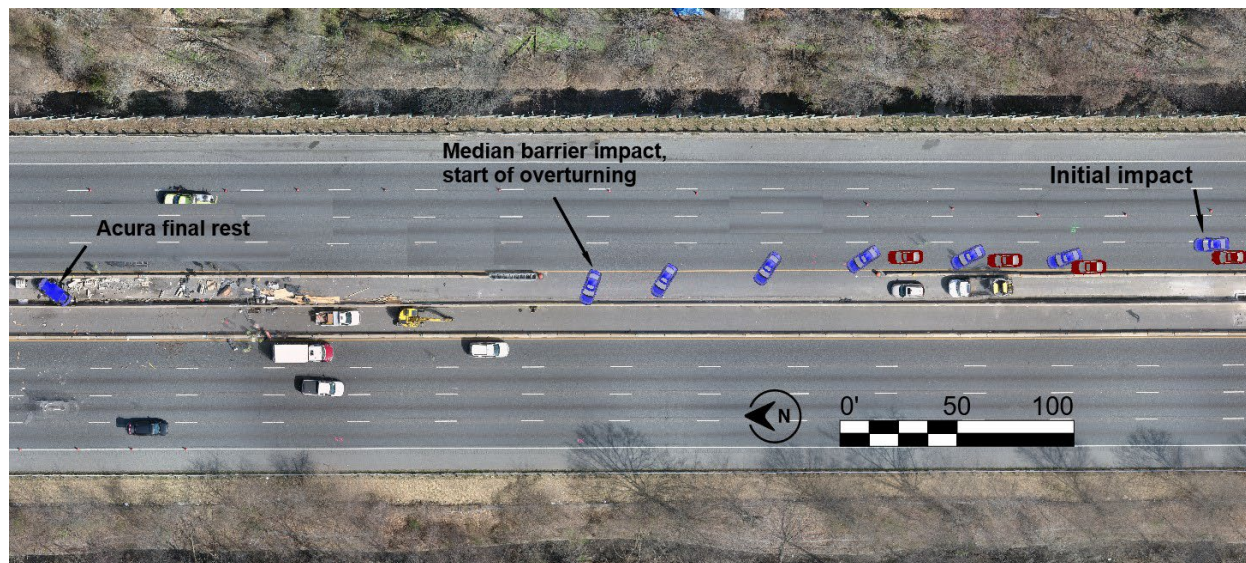
As the Acura transitioned into the left lane, the vehicle's left rear struck the Volkswagen's right front. That contact redirected the Volkswagen to the left, where the vehicle's left-front tire and lower left-front corner contacted the concrete barrier protecting the work zone. As the Volkswagen engaged with the barrier, the Acura began an impact-induced counterclockwise rotation around the front of the Volkswagen. The Acura lost control, began to rotate, and entered the work zone through the opening in the concrete barrier. The Volkswagen continued north in the left lane and made a controlled stop. Figure 3 depicts the crash sequence and postcrash path of travel.

Figure 3. Postimpact travel path for the Acura (shown as the blue vehicle) relative to the physical evidence as overlaid on an orthomosaic image of the scene. (Source image: Maryland State Police; annotations by NTSB)

The front of the Acura struck the center median barrier; the vehicle then began to overturn. As the Acura continued through the work zone, it struck a large metal toolbox and three pallets of prefabricated polymer concrete trench drain, each weighing about 2,240 pounds and spaced about 35 feet apart. Each pallet contained eight sections of drain. The Acura's movement through the work zone broke and displaced the eight sections on the first two pallets and four of the sections on the third pallet. The vehicle's final rest position was about 525 feet from the point of impact with the Volkswagen.

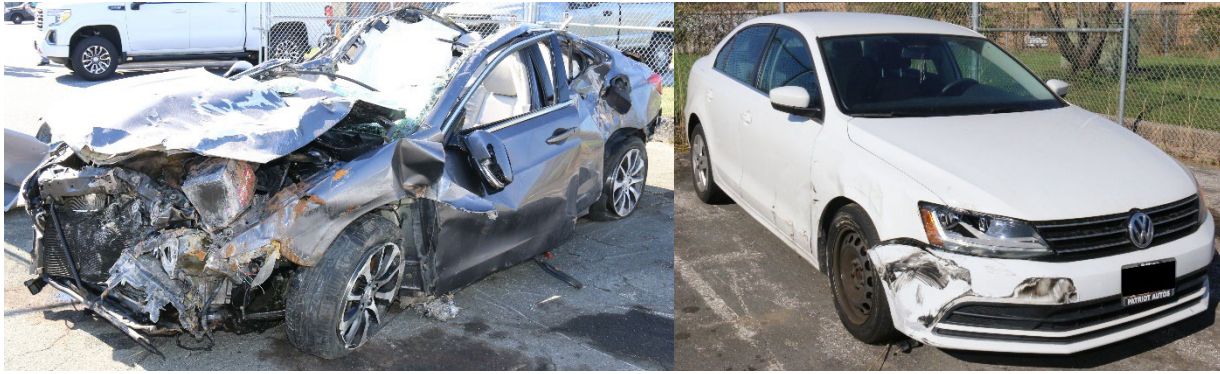
Figure 4. Postcrash damage to the 2017 Acura TLX (left) and the 2017 Volkswagen Jetta (right).
