Preliminary Report HMD24LR001

# BNSF Railway Derailment and Hazardous Materials Release

Manuelito, New Mexico  
April 26, 2024

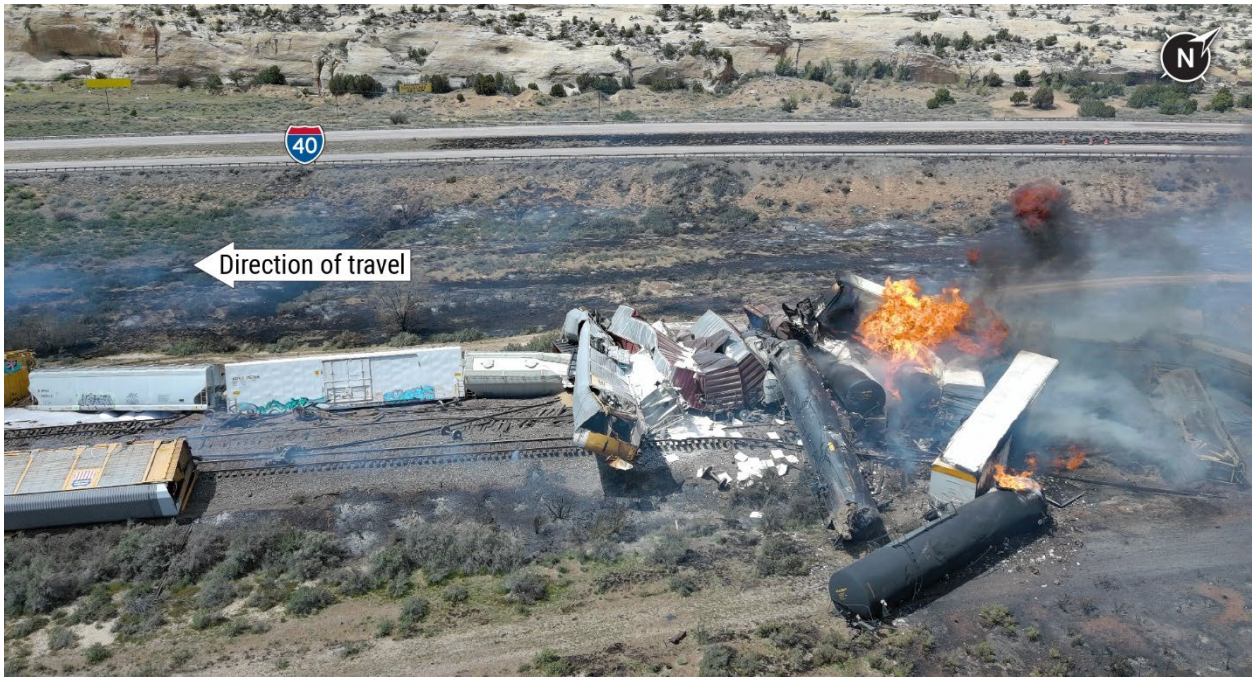
On April 26, 2024, about 12:37 p.m. local time, westbound BNSF Railway (BNSF) mixed-freight train H-BELPHX1-25 derailed 35 railcars at milepost 178.6 on the Southwest Division near Manuelito, New Mexico. (See figure.) The derailed equipment included six tank cars containing propane—a type of liquefied petroleum gas (LPG) and hazardous material transported under pressure.<sup>1</sup> Four of these tank cars were breached and released their contents, which ignited. A fifth LPG tank car was exposed to the fire and released vapor through its pressure relief device.<sup>2</sup> The local fire department ordered a 2-mile evacuation; 52 people were evacuated, and Interstate 40 was closed in both directions. The local fire department chose to allow the LPG tank cars to burn overnight, and the fires were extinguished on April 27. The evacuation and road closure were lifted on April 28. No injuries were reported. Visibility conditions at the time of the derailment were daylight and clear; weather conditions were 61°F with a 20-mph wind and no precipitation.

**Figure.** Aerial view of the derailment. (Courtesy of McKinley County Office of Emergency Management.)
