Group Chairman's Factual Report of the Investigation

**Watco Dock & Rail, LLC Employee Fatality at
Musket/Gemini Facility at Greensport Industrial Park**

Houston, Texas

RRD22LR002

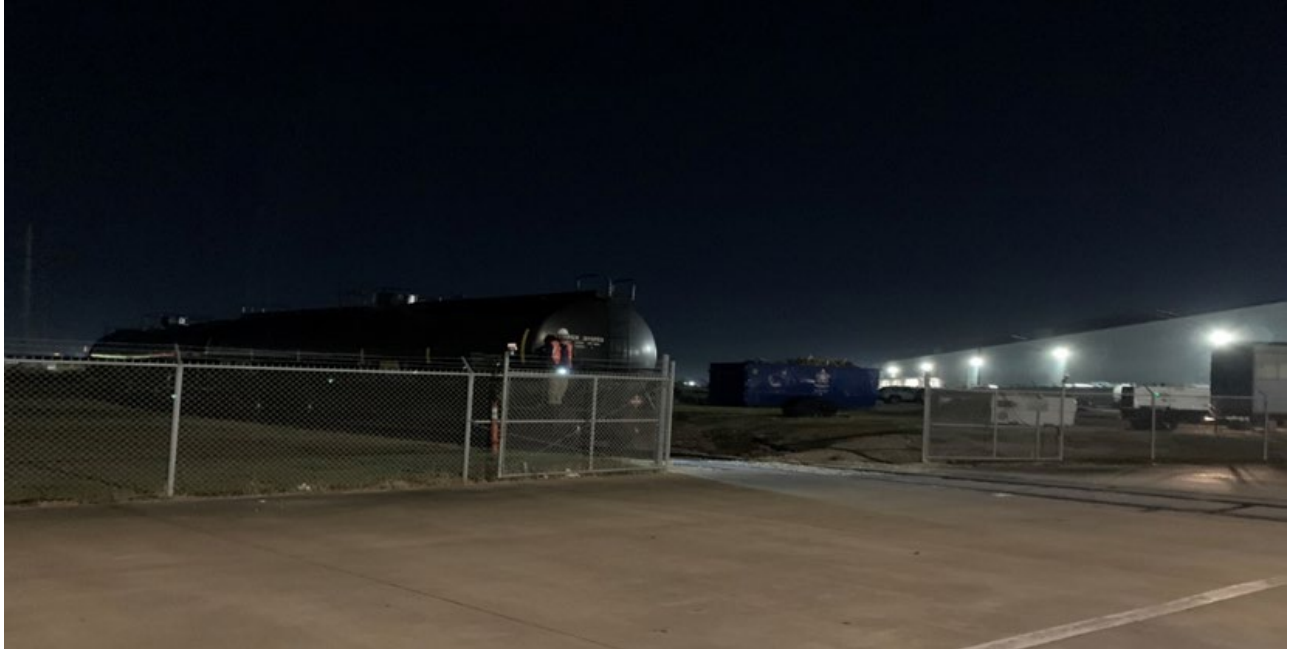
In addition, puck lights are positioned at the inner and outer tops of the right and left gates that cross the railroad tracks on both sides of the road. These gates are open and the puck lights are flashing when a Consist is expected to travel across the road at the grade crossing. Investigators observed that the gates on both sides of the road and all four puck lights functioned and were visible. Figure 1 shows the north side of the grade crossing with the Consist on the left

side of the photograph. The Consist is stopped inside the chain-linked fencing that borders the entry driveway, prior to the incident location.

Figure 1: NTSB photograph taken during the site distance test conducted at 4:00 a.m. (the incident time) showing the incident Consist on the left, behind the open fencing gates. A NTSB investigator is standing on the Consist platform wearing an orange vest and white helmet and holding a lighted conductor's lantern. The white light on the rear of the Consist is a reflection of the building lights seen on the right side of the photograph.

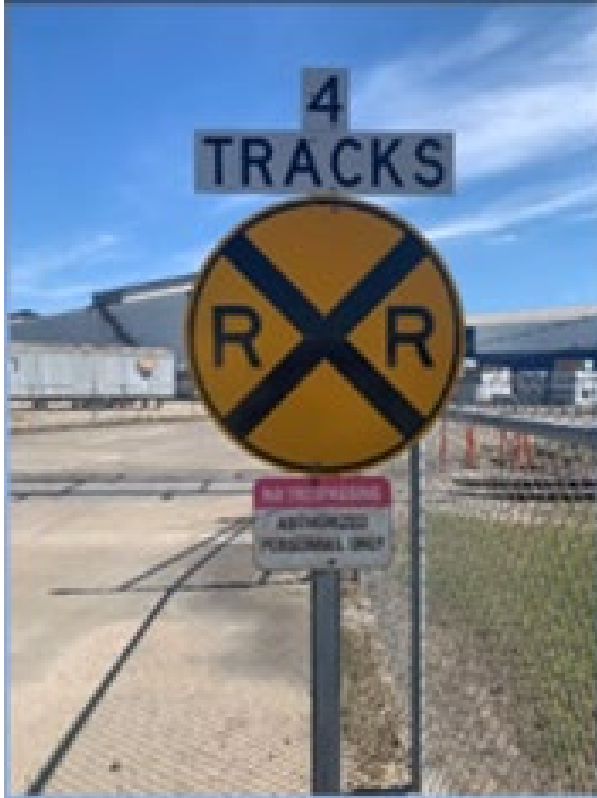
A rail crossing warning sign is located at the entrance to the Musket/Gemini facility, warning road vehicle drivers and pedestrians of four rail grade crossings (Figure 2).

Figure 2: Grade crossing sign located at the entrance to the Musket/Gemini facility, prior to the incident grade crossing.
