# National Transportation Safety Board

RRD23FR013, ELLISTON, VA

## **HUMAN PERFORMANCE**

## **A. NORFOLK SOUTHERN (NS) TRAIN DERAILMENT**

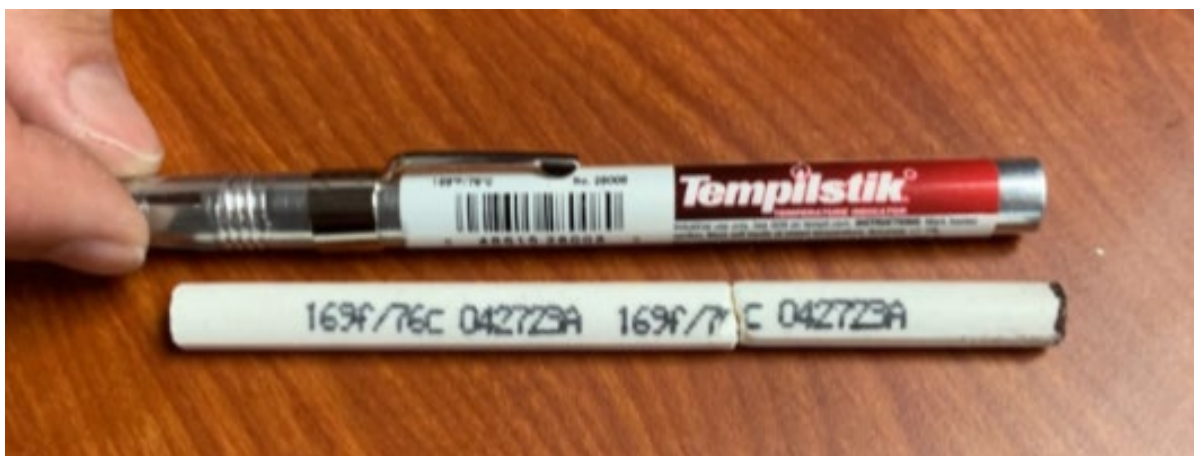
NS Train Crews are issued Tempilstiks, with a wax-based, push-up replaceable inner “crayon” that melts at 169°. (Mid-February 2023 NS lowered the standard of the Tempilstik melting point from 200° to 169°.) These are used to gauge the wheel bearing temperature when an alert or alarm is set off by the HBD (see Figure 4).

**Figure 1:** Exemplar Tempilstik issued to Train Crews. This will melt at hot wheel bearing temperatures of 169° or above. The inner wax-based, push-up crayon that will melt is removed and set below the pen in this photograph.
