Summary Report

BNSF Railway Company (BNSF) Derailment

FRA Accident No. HQ-2020-1401

Custer, Washington

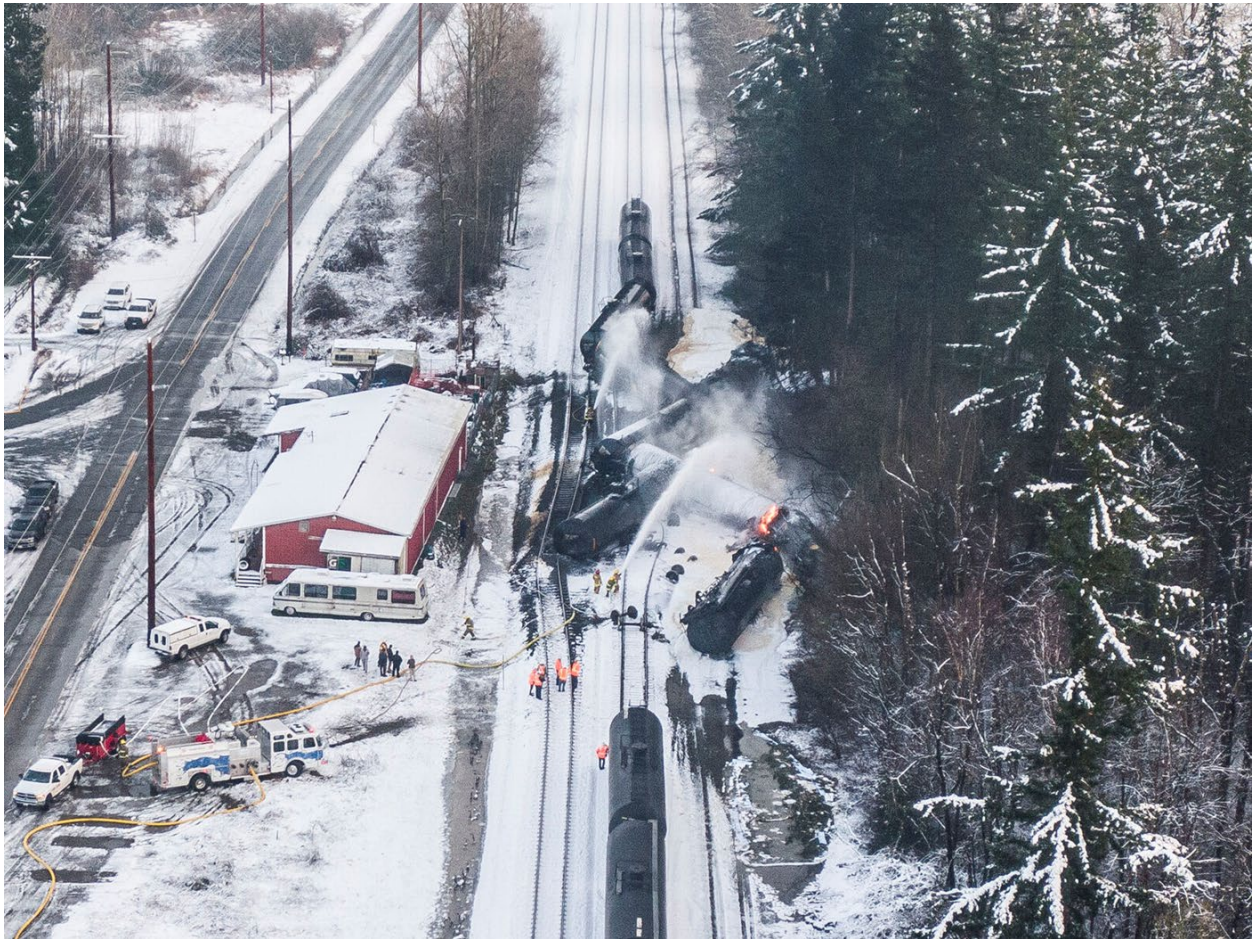
BNSF Derailment, Custer, WA December 22, 2020

The 10 derailed tank cars were located at positions 59 through 68 from the head-end of the train. Train 1 had separated in two parts and derailed when the rear end section of the train (lines 63-108 plus two Distributed Power Unit [DPU] locomotives) traveling at a recorded speed of 21 miles per hour (mph) collided with the head-end section (lines 1-62 plus two head end locomotives) of the train traveling at a recorded speed of 7 mph. The derailment site is located on BNSF's Bellingham Subdivision approximately 104 miles north of Seattle, Washington, and nine miles south of the Canadian Border.

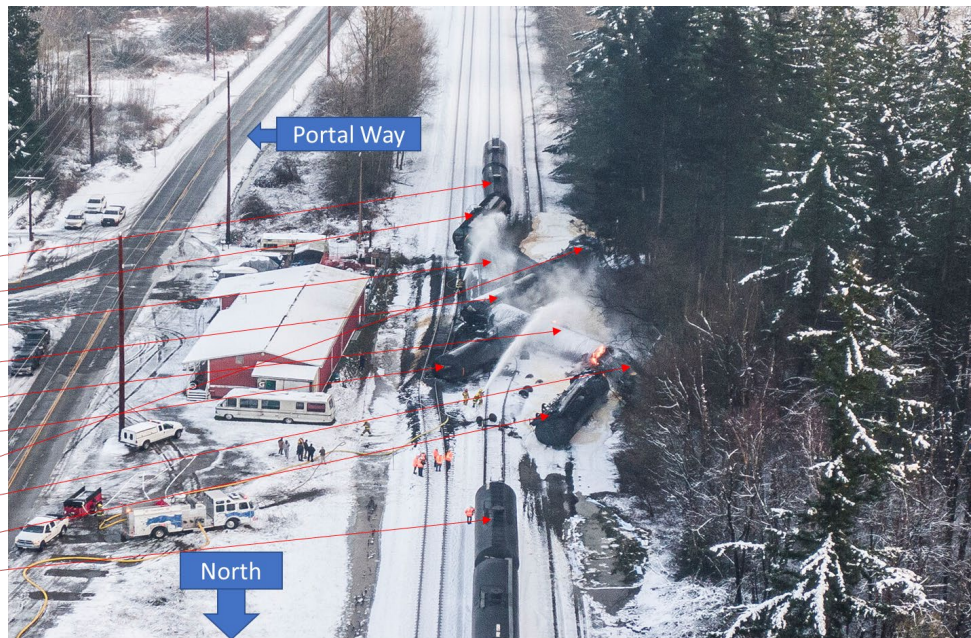
**BNSF
Derailment
Scene at Custer
MP 111.7
Bellingham sub**

Angle cock found on B end (north) of line 60, PPRX 172350. Its coupler was broken and still attached to line 59, PPRX 171143. Train separation as seen by BPA video was between line 62, PPRX 172745 and line 63, TILX 360655.

Two angle cocks that appeared to be tampered with were found during the on-site investigation, one partially closed and the other fully closed. The first angle cock was found, sheared off from a rail car and laying on the ground approximately 15 feet from the closest derailed tank car in a completely closed position. Due to the extensive damage from the forces of the derailment, FRA could not determine which rail car the sheared off angle cock came from. When the FBI opened the accident scene on December 23rd, FRA and WUTC inspectors found a second angle cock partially closed on the B end of rail car PPRX 172350.

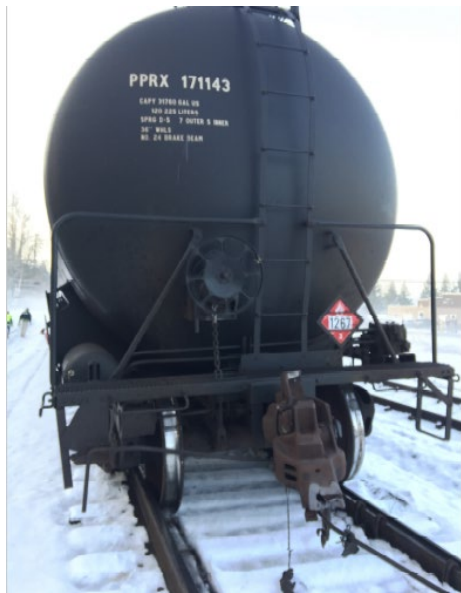
Train consist lines 56-69: On December 23, 2020, starting at 8:00 a.m. PST, a complete inspection was performed on all railcars at the derailment site. Rail car PPRX 171143 was found with part of a broken coupler from the B-end of PPRX 172350 still attached to the B-end of PPRX 171143. It was determined that the broken coupler was caused by the action of the derailment and not a contributing factor of the derailment. This determination was based on the

“new” condition of the break in the coupler as there was no prior rust or corrosion showing on the exposed metal. On the B-end of rail car PPRX 172350, a partly closed train line end angle cock was found, and it did not appear that the angle cock became partly closed from the action of the derailment. This partially closed angle cock on PPRX 172350 together with another found on scene but not attached to a car (refer to Analysis and Conclusions – Train Separation and Angle Cocks) were analyzed as contributing factors of the derailment. No other defects were noted during the investigation on the remaining pieces of equipment at the derailment site.

Broken coupler from car PPRX172350 attached to PPRX 171143.
