NATIONAL TRANSPORTATION SAFETY BOARD
Vehicle Recorder Division
Washington, DC 20594

Onboard Image Recorder

Group Chairman's Factual Report By Sean Payne

Location: Boise, Idaho
Date: July 16, 2018
Vehicle: 2017 Volvo Truck
Operator: Krujex Freight Transport
NTSB Number: HWY18FH015

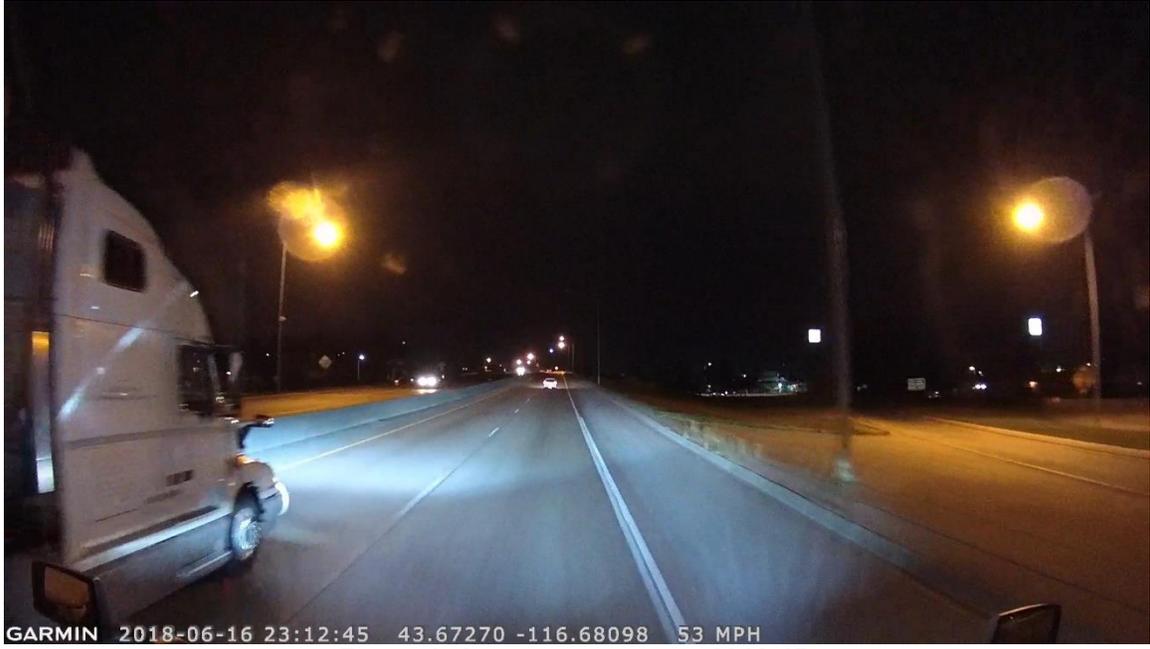
Figure 1. A screen capture at 2312:45.

2312:45 A white truck passed in the left lane. Figure 1 is a screen capture at this time.

2312:53 After the white truck passed and was clear, the subject truck flashed its high beams.

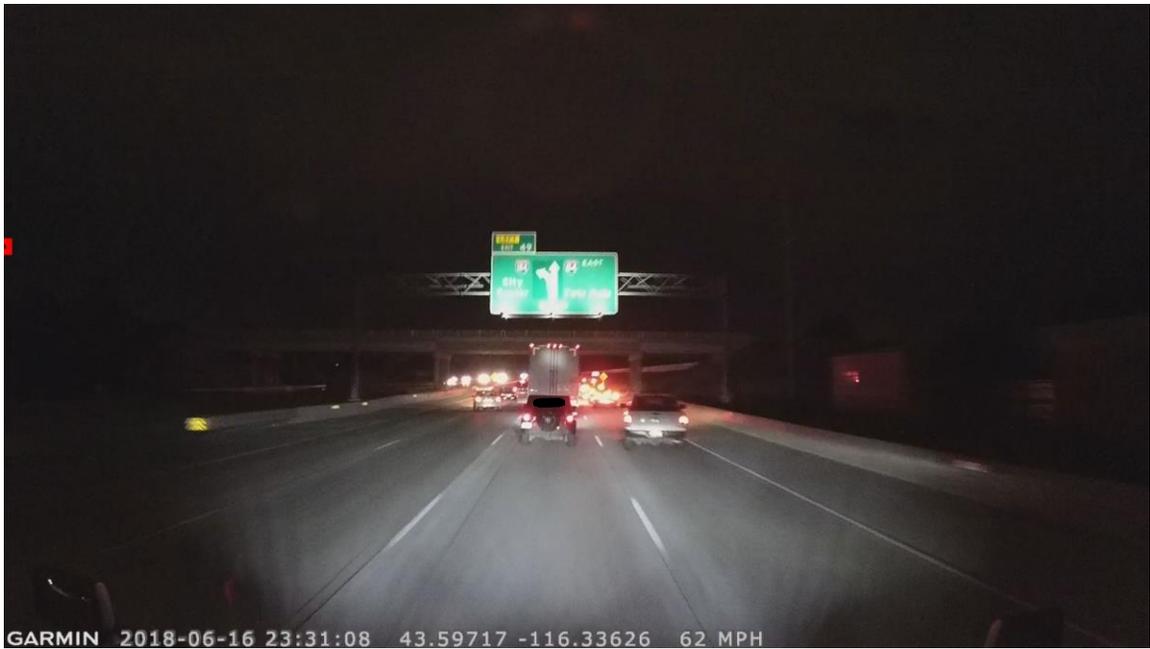
Figure 2. A screen capture at 2331:08. The occupants of the Jeep have been redacted.

2331:07 The white pickup truck completed its lane change when the striking truck was about 150 feet from the impact area. The white pickup truck was clear of lane three. A Jeep was visible ahead in lane three and a truck was visible ahead of the Jeep. The vehicle in lane two had its left turn signal on and was beginning to change to lane one. Reflections continued to be visible from left and right guard rails approaching the impact area.

2331:08 The Jeep brake lights activated. Figure 2 is a screen capture at this time. The occupants of the Jeep have been redacted.

2331:09 The truck impacted the Jeep at an indicated GPS speed of 62 mph.
