## INVESTIGATIVE UPDATE

### **Collapse of Pedestrian Bridge Under Construction Miami, Florida (HWY18MH009)**

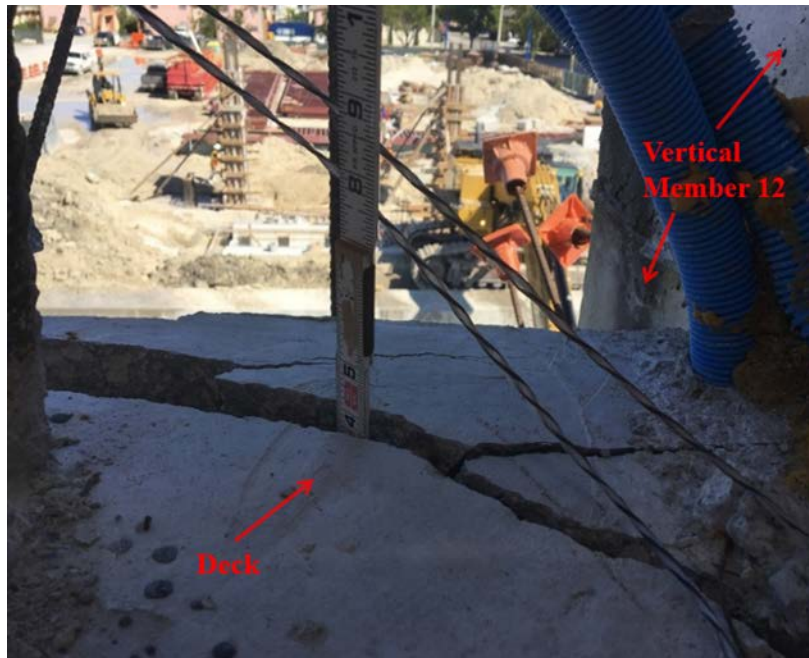
**Figure 1.** Location: Diaphragm II, west side directly adjacent to vertical member 12, top deck view of crack, looking to the north. Time stamp: March 13, 2018, at 11:16:50 a.m., labels added by the NTSB. (Source: Munilla Construction Management)

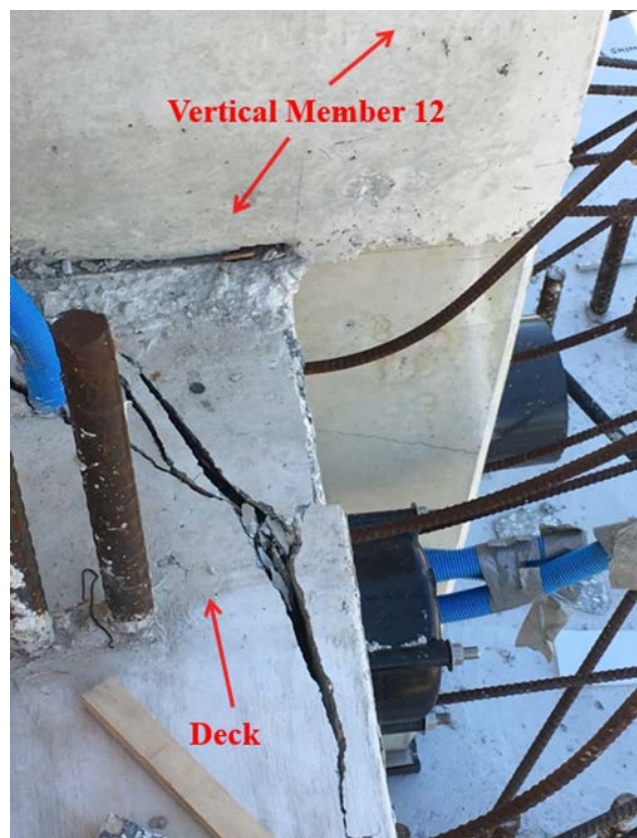
**Figure 2.** Location: Diaphragm II, east side directly adjacent to vertical member 12, top of deck looking down view of crack. Time stamp: March 14, 2018, at 1:50 p.m., labels added by the NTSB. (Source: Bolton, Perez & Associates Consulting Engineers)

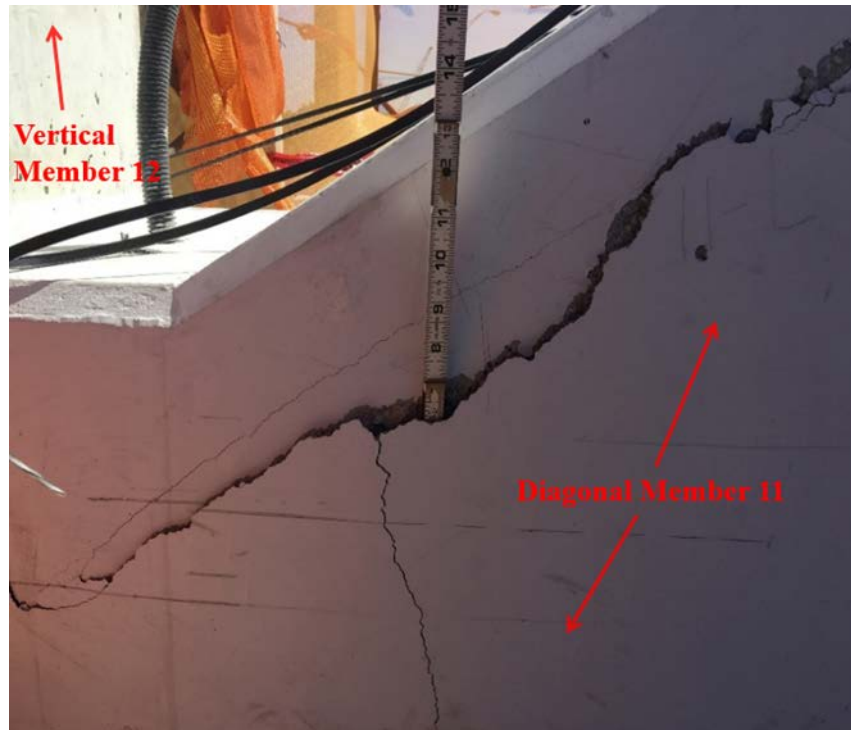
**Figure 3.** Location: Bottom of diagonal member 11 west face, looking to the east. Time stamp: March 13, 2018, at 11:18:50 a.m., labels added by the NTSB. (Source: Munilla Construction Management)

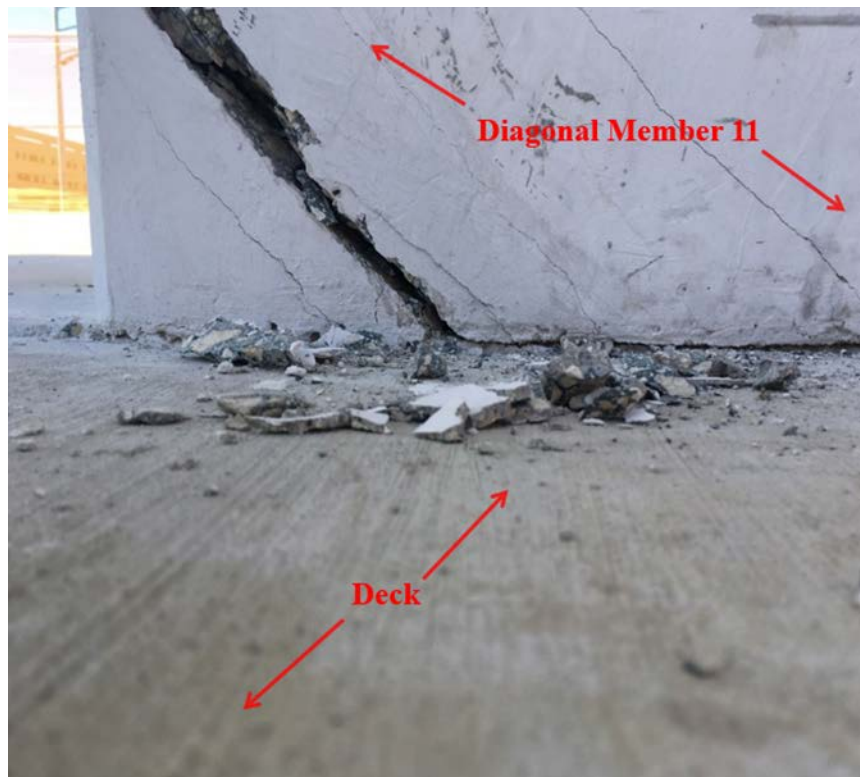
**Figure 4.** Location: Bottom of diagonal member 11 east face, looking to the west. Time stamp: March 13, 2018, at 1:29:15 p.m., labels added by the NTSB. (Source: Munilla Construction Management)
