PRELIMINARY REPORT

HIGHWAY

Collapse of Pedestrian Bridge Under Construction Miami, Florida (HWY18MH009)

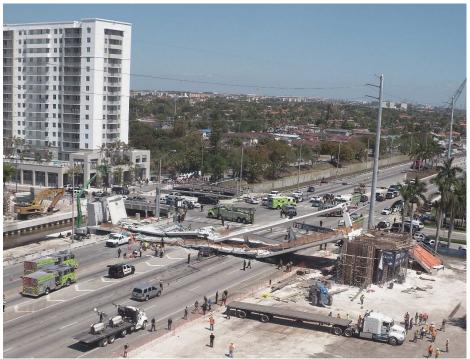
On Thursday, March 15, 2018, about 1:47 p.m. eastern daylight time, a partially constructed pedestrian bridge crossing SW 8th Street—an eight-lane roadway—in Miami, Florida, experienced a structural failure. As a result, the 174-foot-long bridge fell about 18.5 feet onto SW 8th Street (figure 1). Eight vehicles that were stopped below the bridge at the time of the collapse were fully or partially crushed; seven of those vehicles were occupied. As a result of the bridge collapse, one bridge worker and five vehicle occupants died. Four bridge workers and four other people were injured.

Figure 1. View of collapsed pedestrian bridge. (Source: Florida International University)

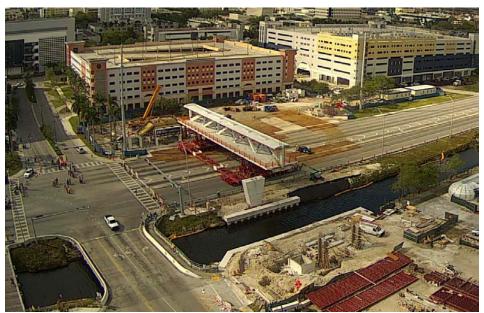
Figure 2. View of transporters moving the pedestrian bridge into place on the bridge piers. (Source: Florida International University)

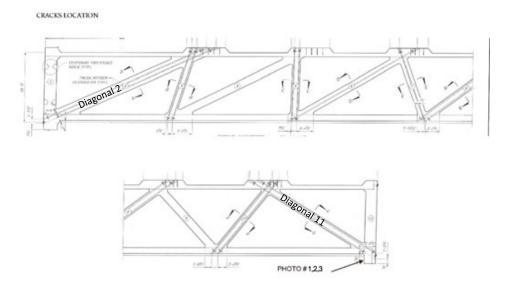
The NTSB is evaluating the bridge design, the construction process, and the construction materials. In addition, the NTSB is evaluating the emergence of cracks in the region of diagonal members 2 (south end of the bridge) and 11 (north end of bridge), see figure 3, and the propagation of cracks in the region of diagonal member 11. Photographic documentation from February 24, 2018 shows cracks in the region of diagonal member 11 (figure 4).

Figure 3. Elevation view of the pedestrian bridge. (Source: Bolton-Perez and Associates Consulting Engineers)

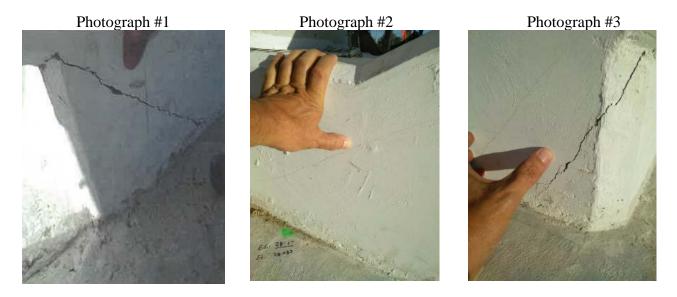
Figure 4. Photographic documentation of the crack in the region of bridge diagonal 11. (Source: Bolton-Perez and Associates Consulting Engineers)
