NATIONAL TRANSPORTATION SAFETY BOARD
Vehicle Recorder Division
Washington, DC 20594

Security Video Factual Report

1. EVENT

Location: Miami, Florida
Date: March 15, 2018
NTSB Number: HWY18MH009

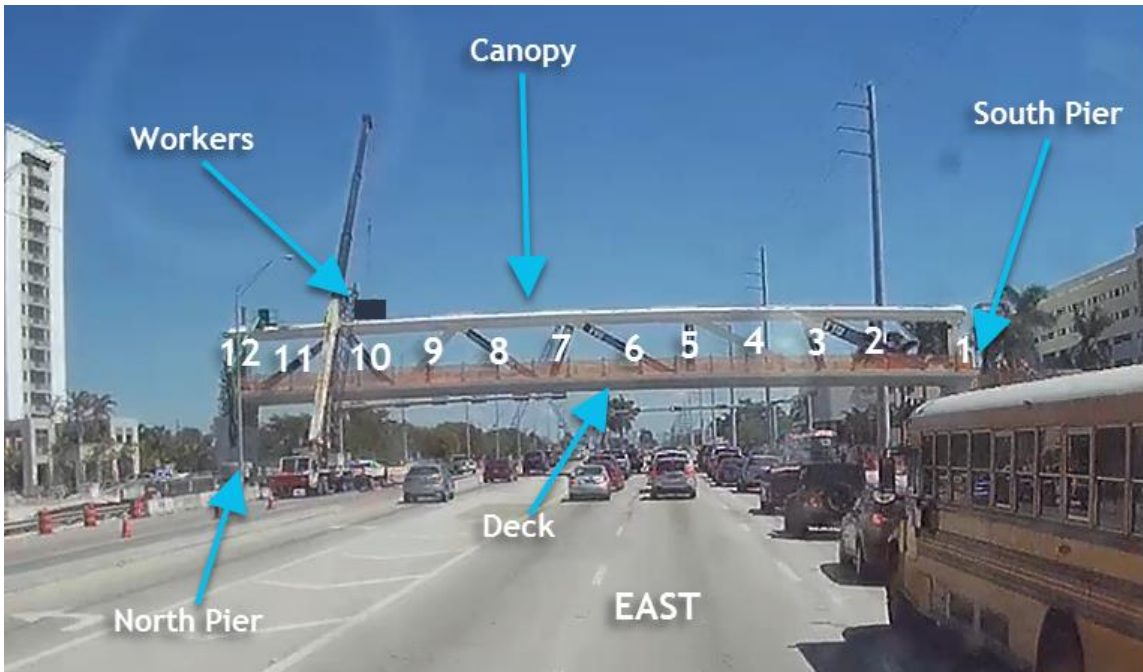
Figure 2. GoPro recording at frame 18 - 13:46:43.815

Frame 18 - Figure 2 - The main-span is shown in pre-collapse condition. No deformation or evidence of collapse or pre-collapse was visible at this time. Workers were visible on the canopy of the main-span in the vicinity of node 10/11. There is eastbound traffic stopped underneath the bridge, but from this vantage it is not clear which cars are directly beneath the mainspan.

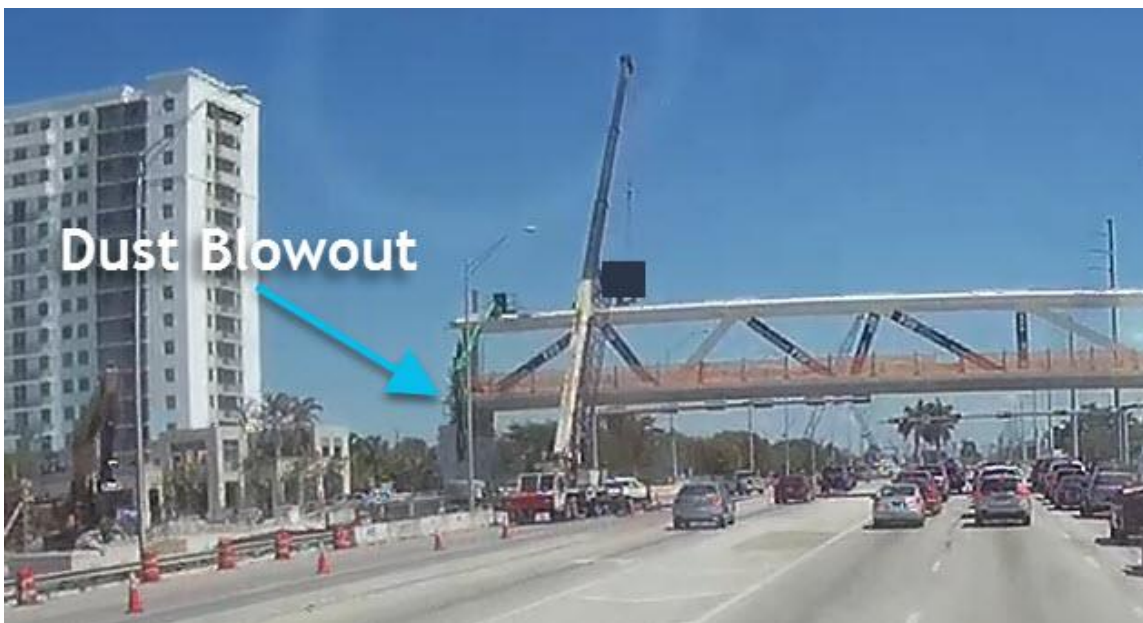
Figure 3. GoPro recording at frame 19 - 13:46:43.815

Frame 19 - Figure 3 - Debris consistent with concrete dust blowout appeared on the north side of the bridge in the region of node 11/12 at deck level. This occurred at the pylon pier (north end of the main-span). Workers were visible on the canopy of the main-span in the vicinity of node 10/11.

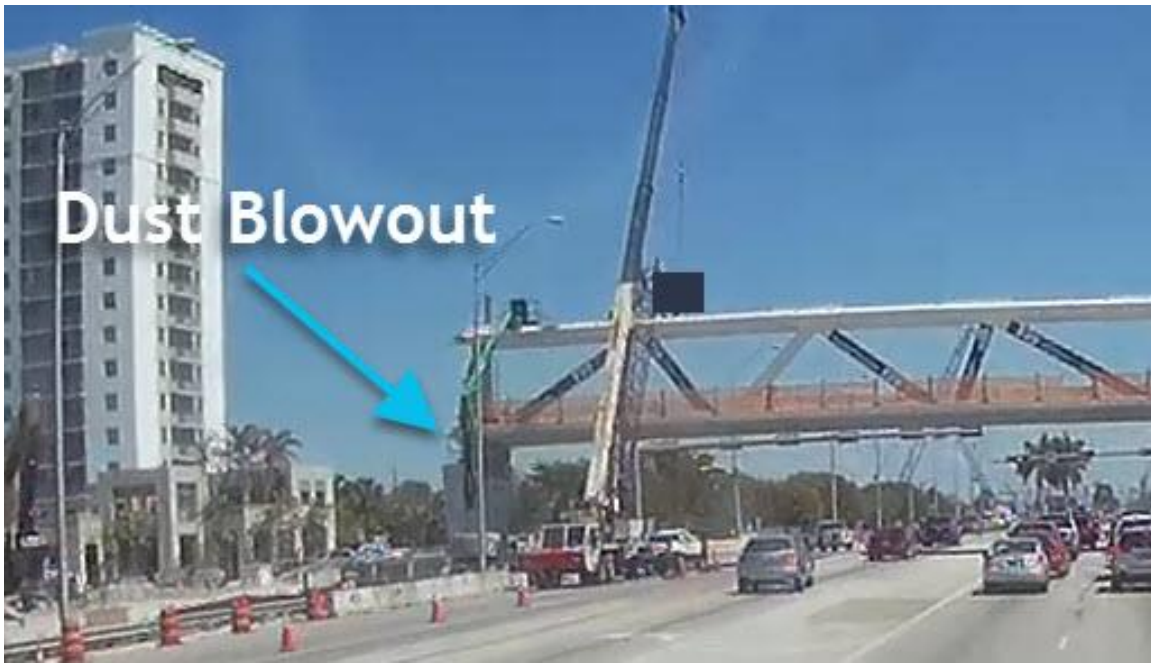
Figure 4. GoPro recording at frame 20 - 13:46:43.848

Figure 20 - Figure 4 - Debris consistent with concrete dust blowout on the north side of the bridge appears larger. Workers were visible on the canopy of the main-span in the vicinity of node 10/11.

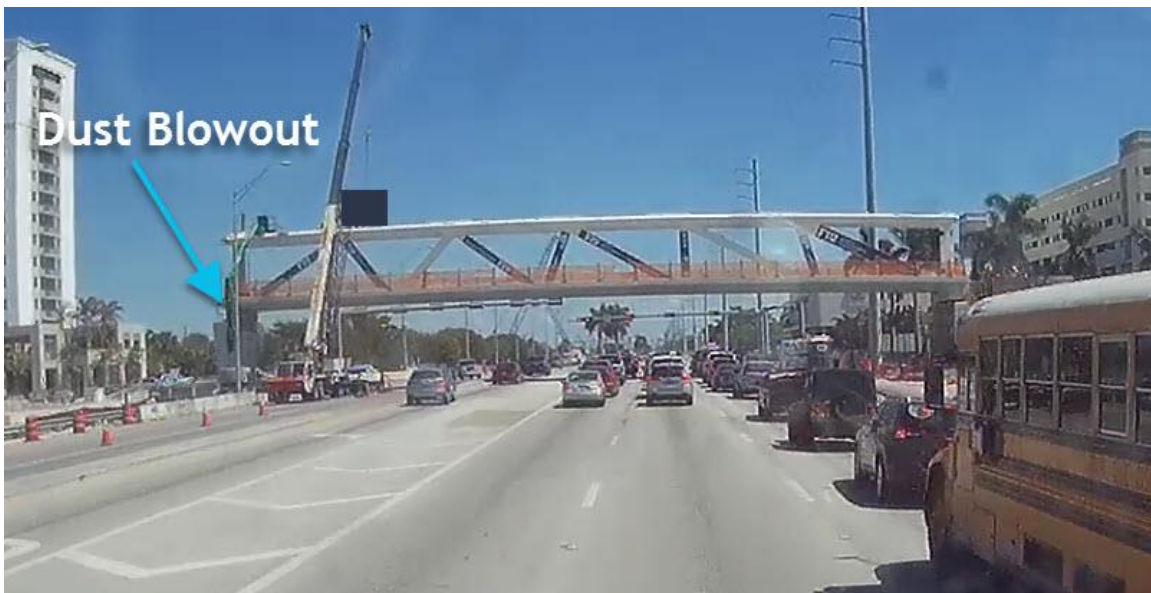
Figure 5. GoPro recording at frame 21 - 13:46:43.881

Frame 21 - Figure 5 - Debris consistent with concrete dust blowout appears larger. It was not conclusive if any deformation of the main-span was visible at this time. Workers were visible on the canopy of the main-span in the vicinity of node 10/11.

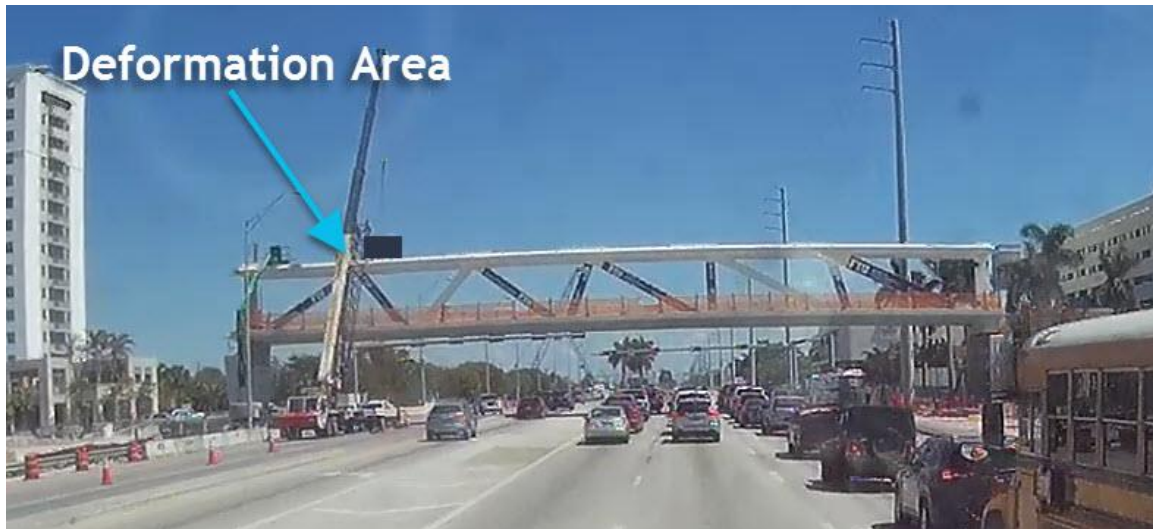
Figure 6. GoPro recording at frame 22 - 13:46:43.914

Frame 22 - Figure 6 - Deformation in the downward direction was conclusively noted as the structure began to hinge at member 10 for the canopy and the deck. Workers were visible on the canopy of the mainspan in the vicinity of node 10/11.

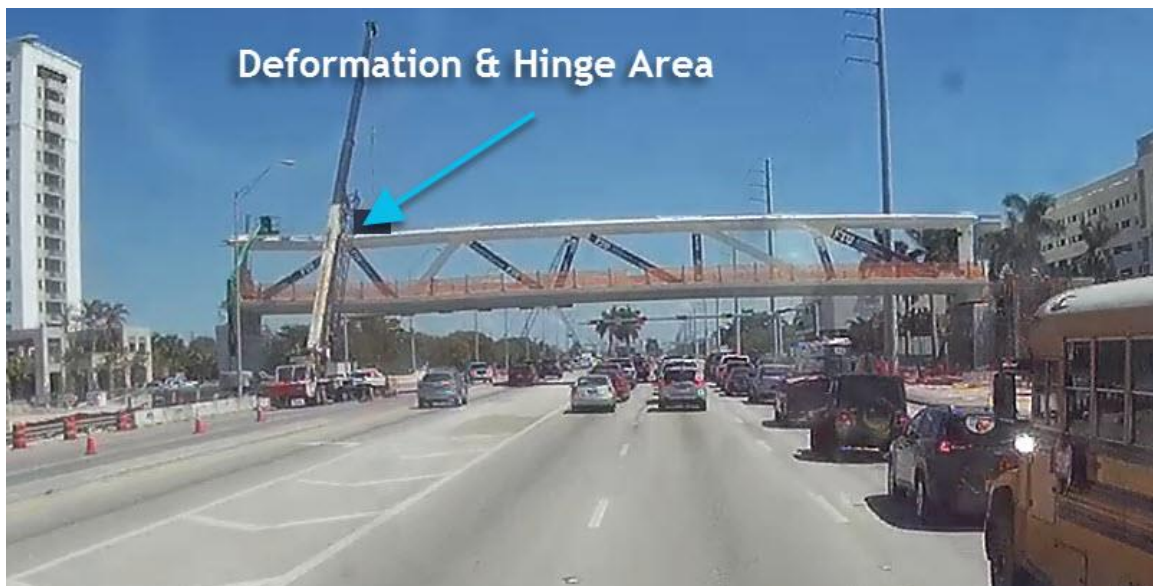
Figure 7. GoPro recording at frame 23 - 13:46:43.947

Frame 23 - Figure 7 - As the structure continues to hinge the deck and canopy south of member 10 can be seen to begin rotating downward as a rigid structure. Workers were visible above the canopy of the main-span in the vicinity of node 10/11.

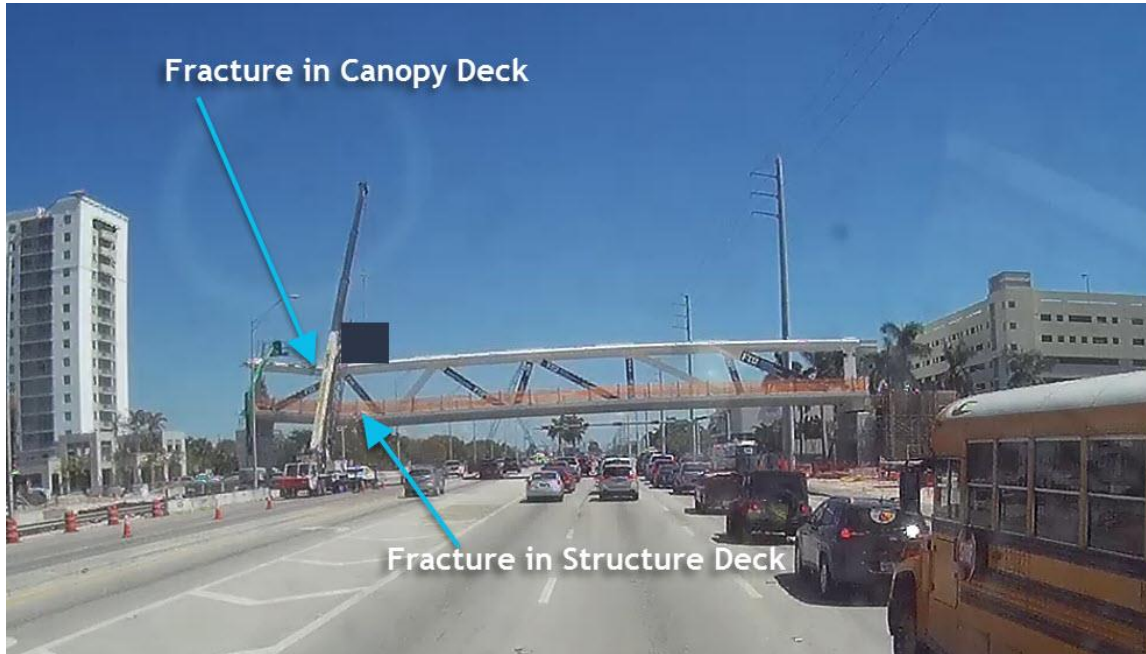
Figure 8. GoPro recording at frame 24 - 13:46:43:980

Frame 24 - Figure 8 - Fracturing in the structure of the canopy was visible north of node 10/11 and in the structure of the deck north of node 9/10. The workers were

still visible in the vicinity of node 10/11 and were moving downward with the structure.

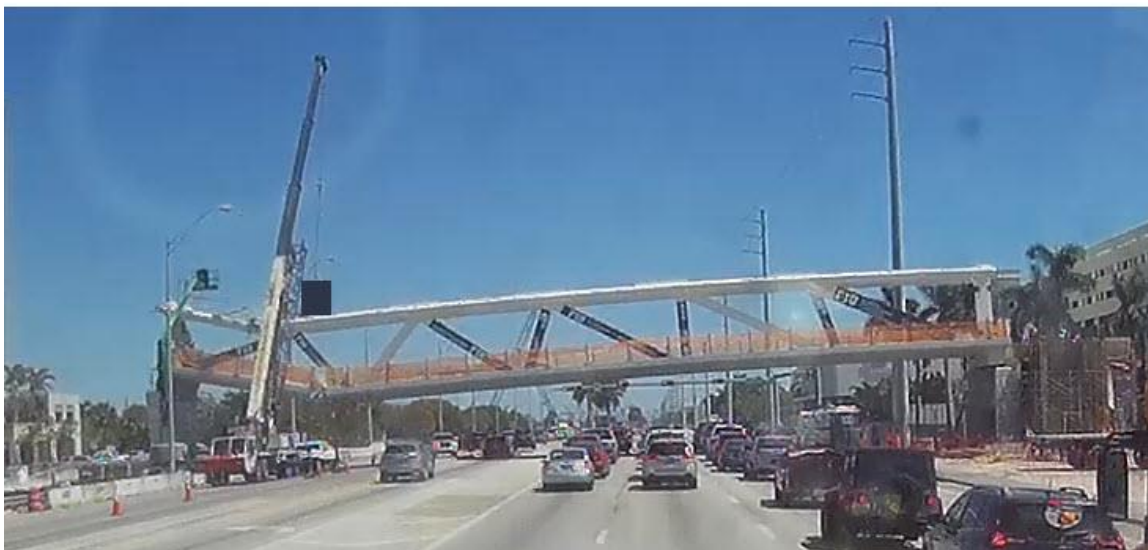
Figure 9. GoPro recording at frame 25 - 13:46:44.013

Frame 25 - Figure 9 - The hinging motion was increasing, the structure south of member 10 appeared to remain rigid and rotated downward about the South Pier. The concrete dust blowout was moving downward with the collapsing main-span. The signal light was green but eastbound traffic remained underneath the main-span. The workers were still visible in the vicinity of node 10/11 and were moving downward with the structure.

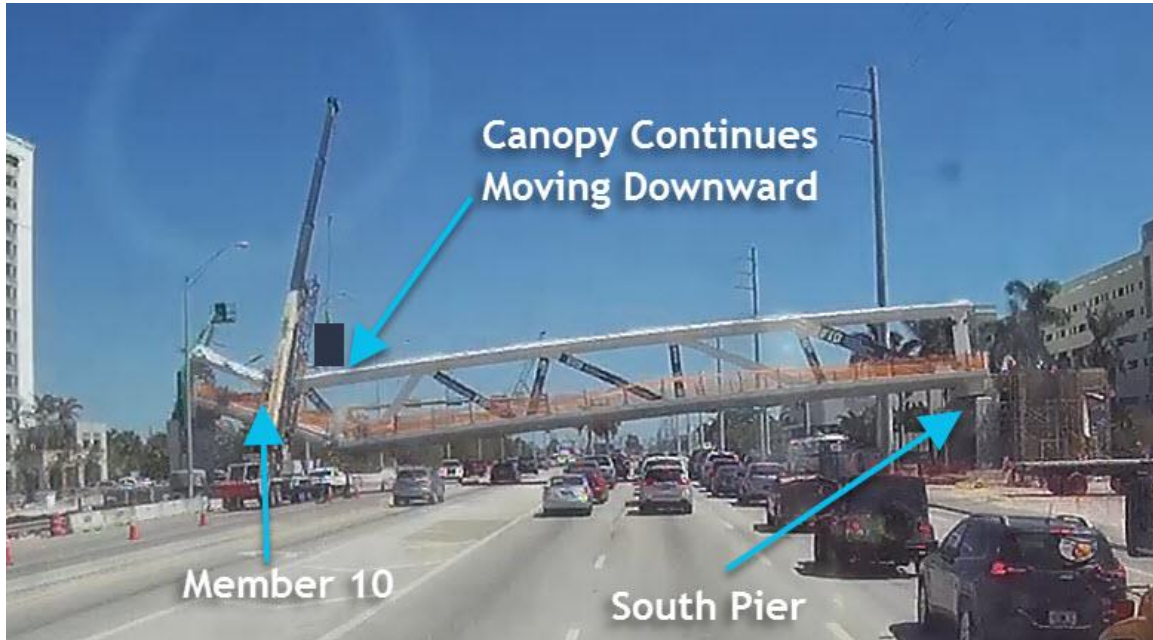
Figure 10. GoPro recording at frame 26 - 13:46:44.046

Frame 26 - Figure 10 - The hinging motion continued north of member 10. The main-span south of member 10 continued to rotate downward rigidly about the South Pier. The canopy was now below the workers in the vicinity of node 10/11 as the workers continued to move downward.

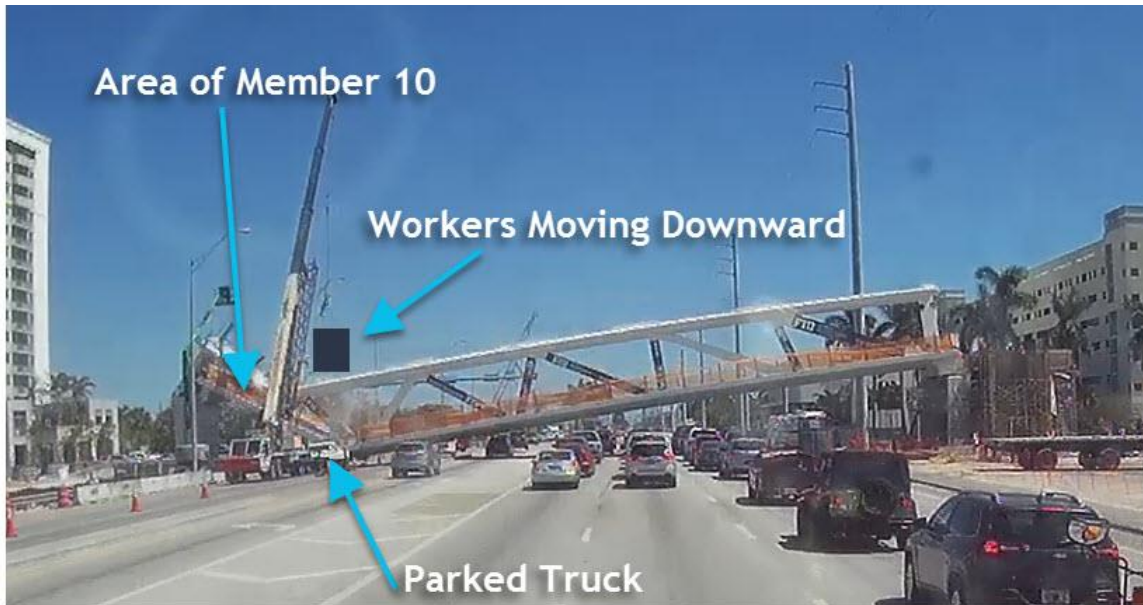
Figure 11. GoPro recording at frame 27 - 13:46:44.079

Frame 27 - Figure 11 - The hinging motion continued north of member 10 as in the previous frame. The hinged area of the deck north of member 10 was making contact with an eastbound facing parked white work truck on the westbound shoulder under the main-span. The workers continued to move downward and were slightly above the canopy. The main-span south of member 10 rotated downward rigidly about the South Pier as in the previous frame.

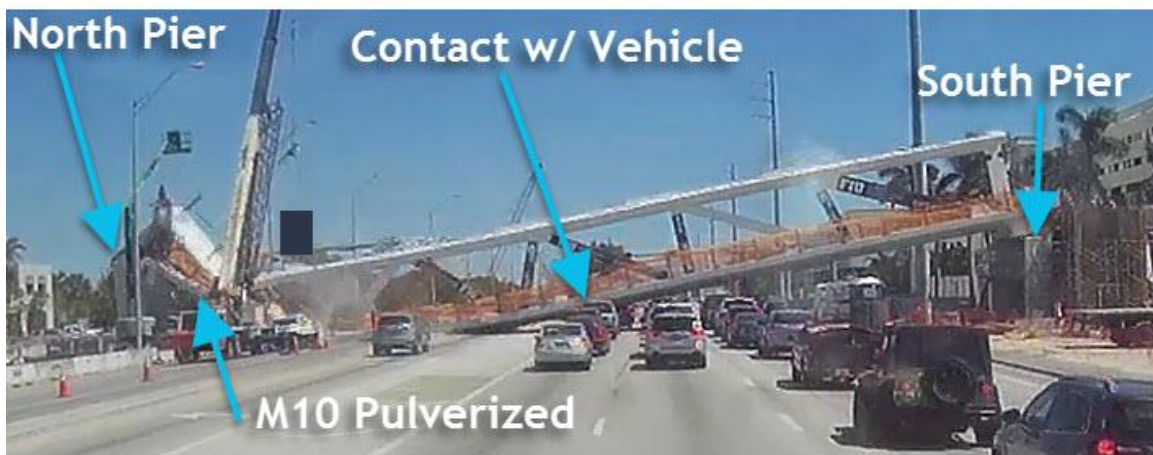
Figure 12. GoPro recording at frame 28 - 13:46:44.112

Frame 28 - Figure 12 - At the fracture area, the deck and canopy made contact. The north end of the deck has slid off the south side of the north pylon pier. The deck region north of node 8/9 made contact with the road. Member 10 and the lower side of member 9 have pulverized in this frame. The deck appeared to make contact with a vehicle in the left-most eastbound through-lane. The southern side of the main-span continued to rotate around the South Pier. The workers continued to move downward and were slightly above the canopy. Workers can be seen on the south side grand staircase.

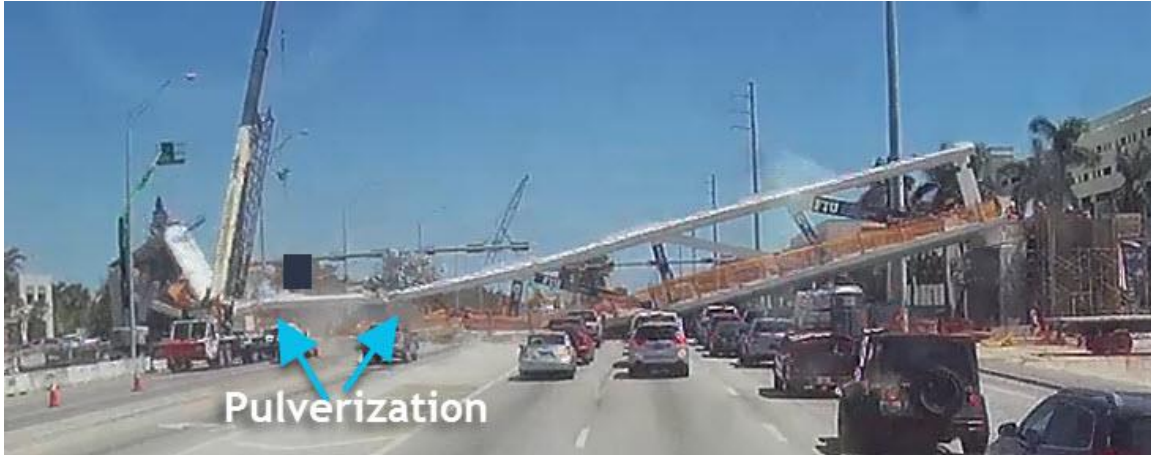
Figure 13. GoPro recording at frame 29 - 13:46:44.145

Frame 29 - Figure 13 - The diagonal members between the deck and canopy begin to pulverize as the deck continued to make contact with the road. The deck remained outside the leftmost through-lane, however, the clearance between the deck and the roadway is small enough to continue contact with the vehicle in the

leftmost through-lane. In the vicinity of the north pylon pier, the deck continued to fall toward the roadway. Member 12 was rotating downward and inward toward the roadway into a horizontal position. The workers continued to move downward and were slightly above the canopy. An expulsion of concrete can be seen above the canopy near node 8/9.

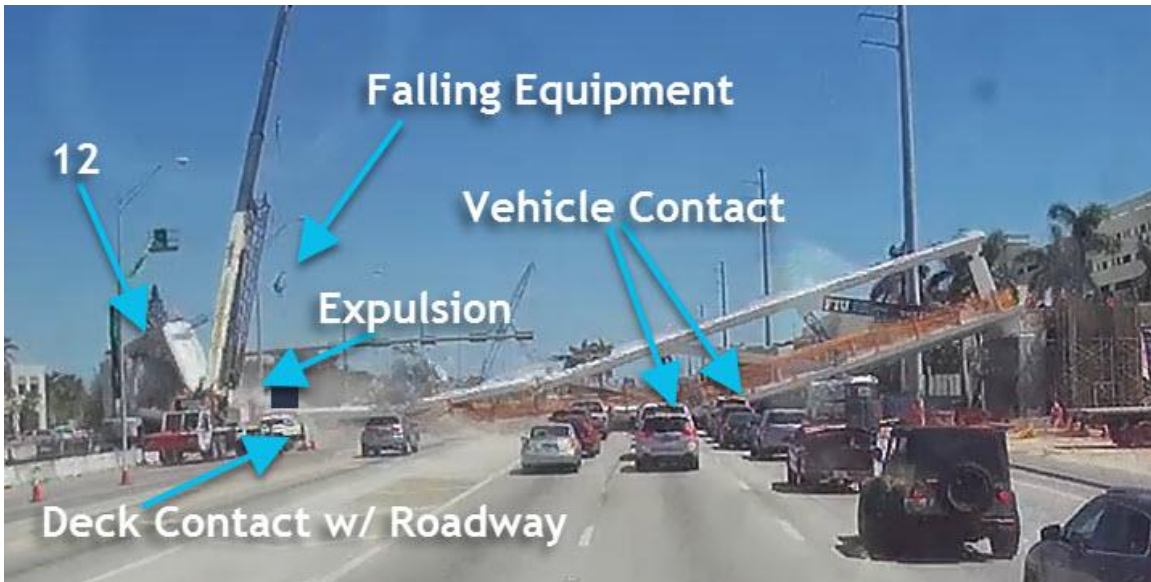
Figure 14. GoPro recording at frame 30 - 13:46:44.178

Frame 30 - Figure 14 - The deck of the main-span has made contact with the leftmost and left center eastbound through-lanes as well as the vehicles occupying those lanes. It was unclear if the deck has made contact with vehicles in the rightmost and right center lane. A piece of equipment was falling from where the workers were originally standing. The north end deck continued to fall inward towards the roadway as member 12 continued to pivot downward and inward. The concrete expulsion in the canopy near node 8/9 was still visible as the canopy continued to fall towards the deck and the roadway. On the north end of the main-span the canopy has made contact with the deck and roadway. One worker was still visible above the canopy.

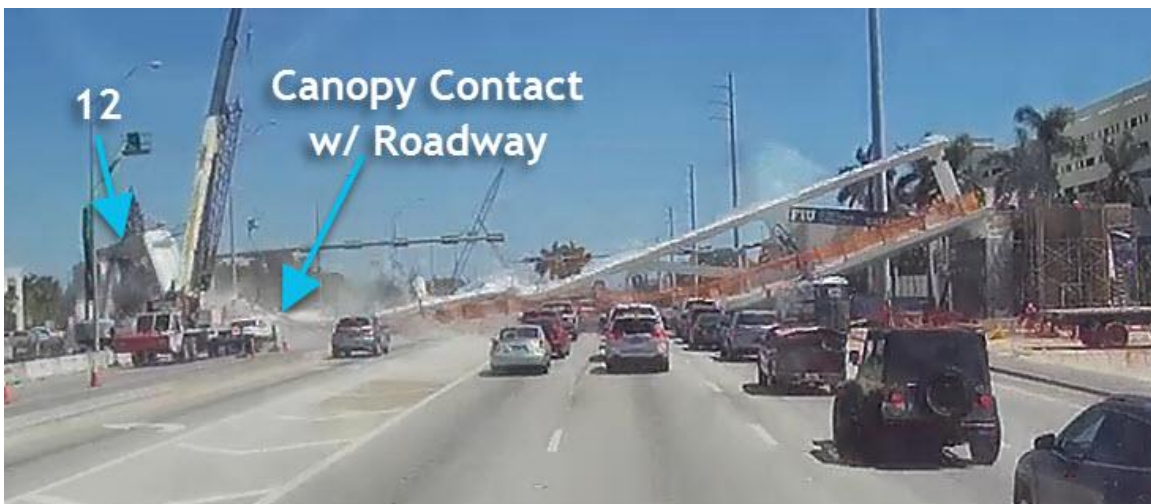
Figure 15. GoPro recording at frame 31 - 13:46:44.211

Frame 31 - Figure 15 - Member 12 was in a near horizontal position as the main-span north of member 10 was beginning to come to a rest. The workers were no longer visible, the piece of equipment continued to fall. The canopy of the main-span had made full contact with the westbound lanes. No vehicles other than the white work truck were visible under the deck of the main-span in the westbound lanes. The concrete expulsion near node 8/9 had begun to settle.

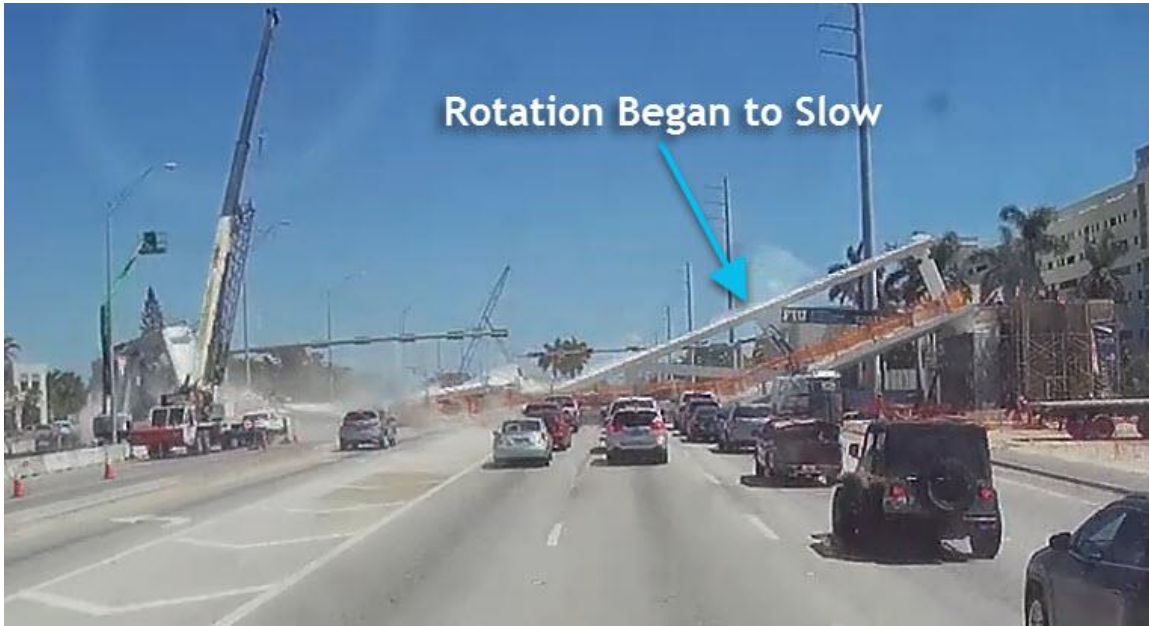
Figure 16. GoPro recording at frame 32 - 13:46:44.244

Frame 32 - Figure 16 - The north side of the main-span occupying the westbound lanes of the roadway had come to rest in this frame. The piece of equipment was still falling. The south side of the main-span continued to pivot about the South Pier as the deck continued to make contact with the eastbound lanes. The rate of deflection of the south side of the main-span was slowing down as more of the deck impacted the roadway.

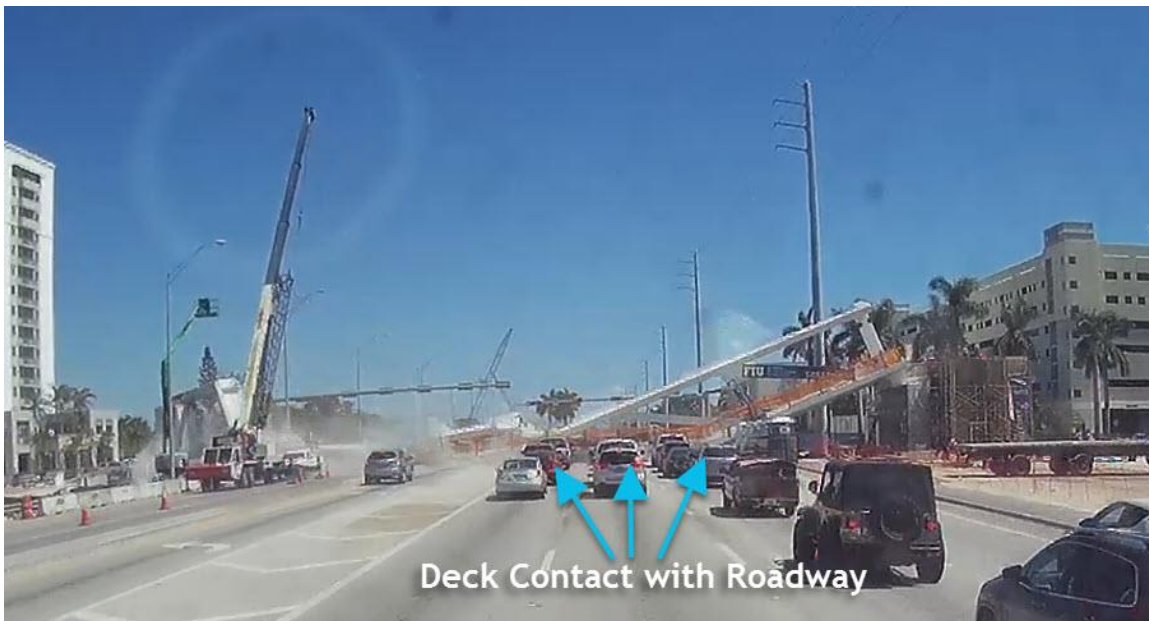
Figure 17. GoPro recording at frame 33 - 13:46:44.277

Frame 33 - Figure 17 - Slight deflection of the south side of the main-span was visible. The deck had made contact with the leftmost, left center, and right center lanes and was very close to the rightmost lane. The falling piece of equipment was no longer visible.

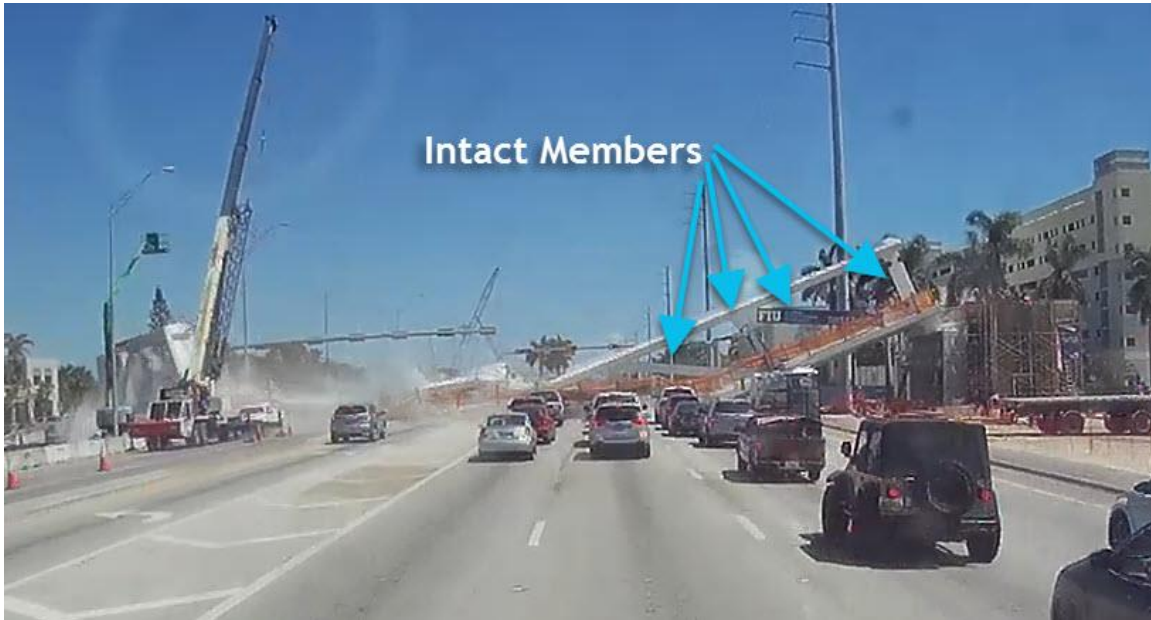
Figure 18. GoPro recording at frame 34 - 13:46:44.310

Frame 34 - Figure 18 - No deflection was visible between frames 33 and 34. The main-span had come to rest on the roadway and made contact with all of the

westbound lanes and the leftmost, left center, and right center lanes of the eastbound side of the roadway. Members 1, 2, 3 and 4 remained intact.

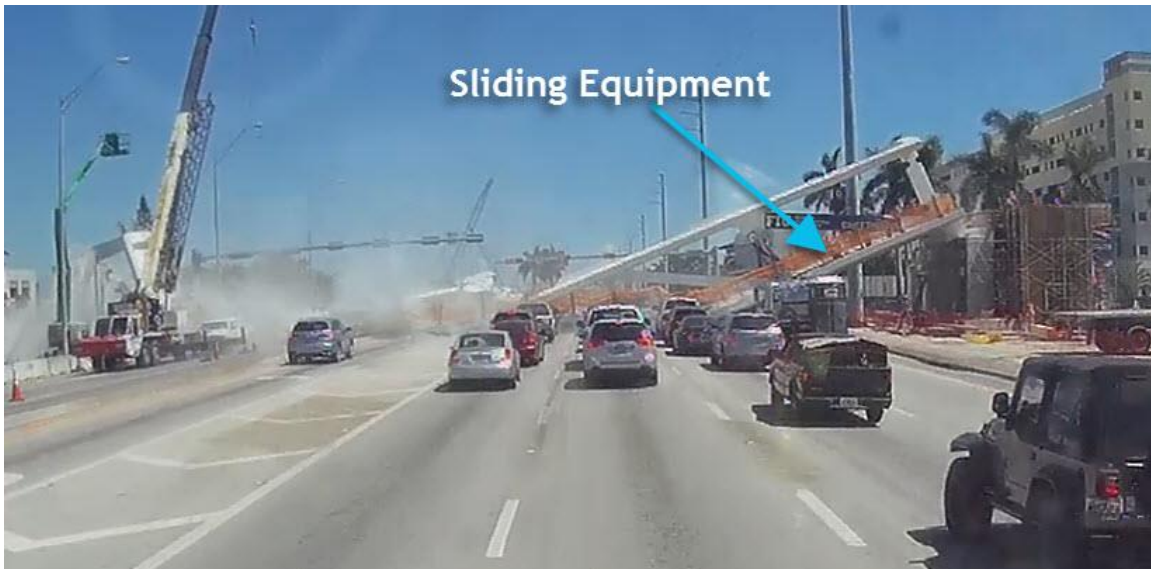
Figure 19. GoPro recording at frame 43 - 13:46:44.610

Frames 34-62 - Figure 19 - In the next 28 frames, unidentified material was visible sliding down the sound end of the now sloped deck. Frame 43 is shown.

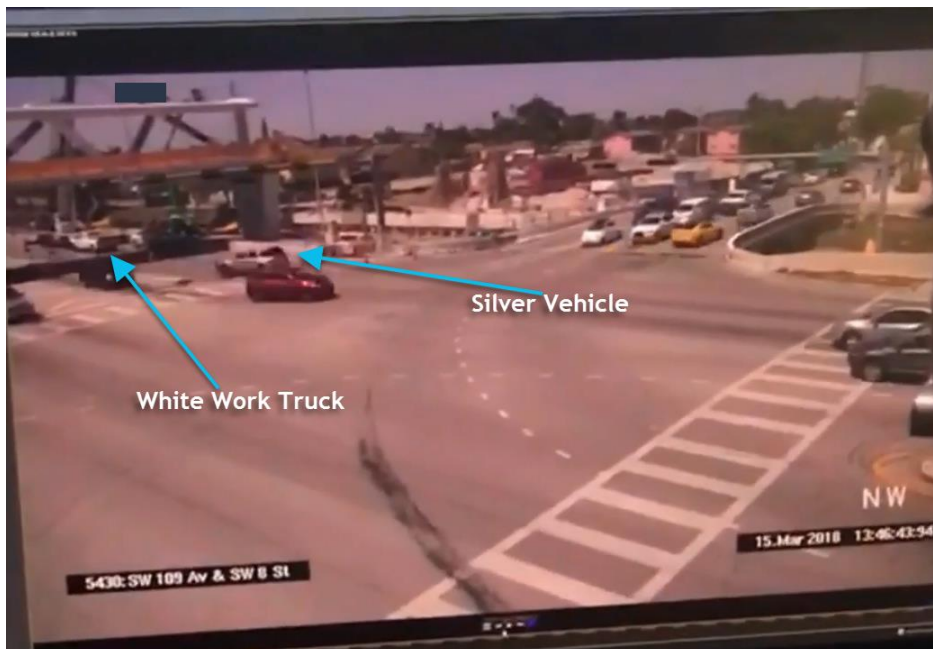
Figure 20. FDOT/Miami Dade camera at 13:46:43:814

Frame 9 - Figure 20 - Main-span was in pre-collapse condition. A white work truck was visible underneath the main-span, on the westbound side, beneath the span. From this viewpoint, one silver vehicle entering the open westbound lane was visible. Workers and equipment were visible on the main-span's canopy level, however, their position was less distinguishable as compared to the GoPro recording.

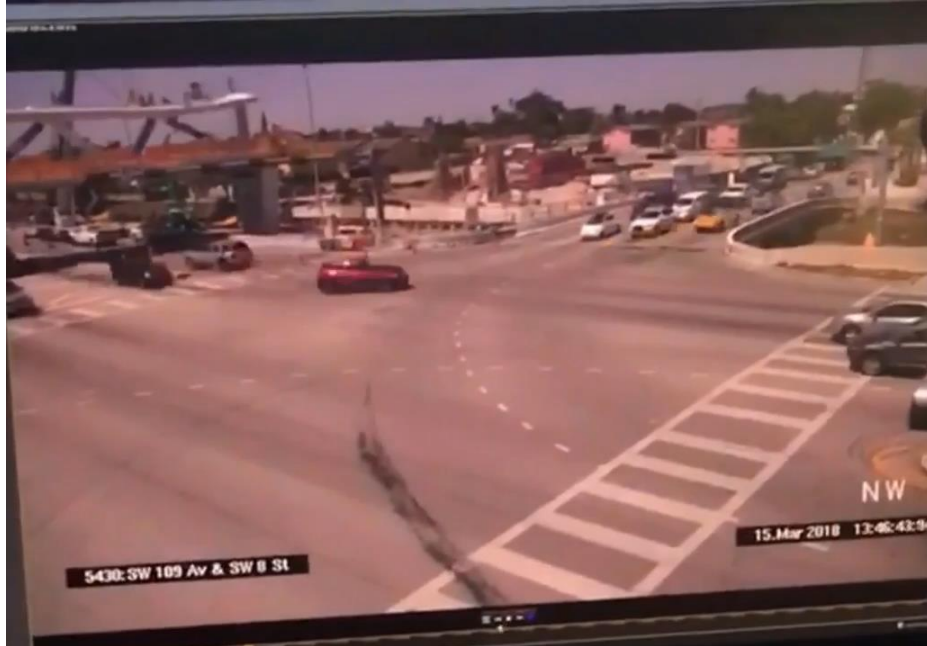
Figure 21. FDOT/Miami Dade camera at frame 13 - 13:46:43.947

Frame 13 - Figure 21 - Significant deformation was distinguishable on the main-span canopy north of member 10.

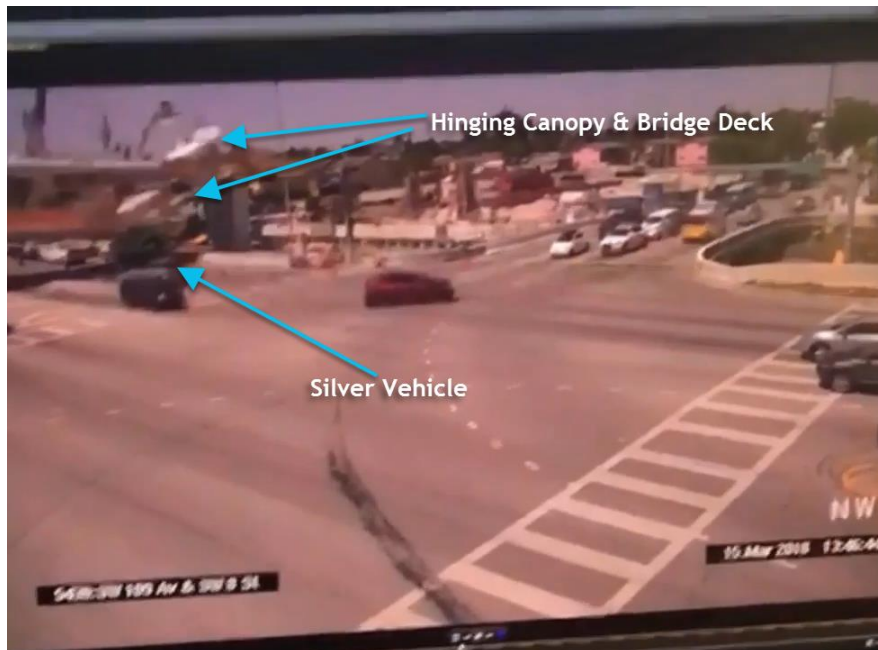
Figure 22. FDOT/Miami Dade camera at frame 25 - 13:46:44.347

Frame 25 - Figure 22 - Significant downward deformation and hinging of the canopy and bridge deck were visible. The silver vehicle entering the westbound lane appeared to have moved closer to the collapsing bridge.

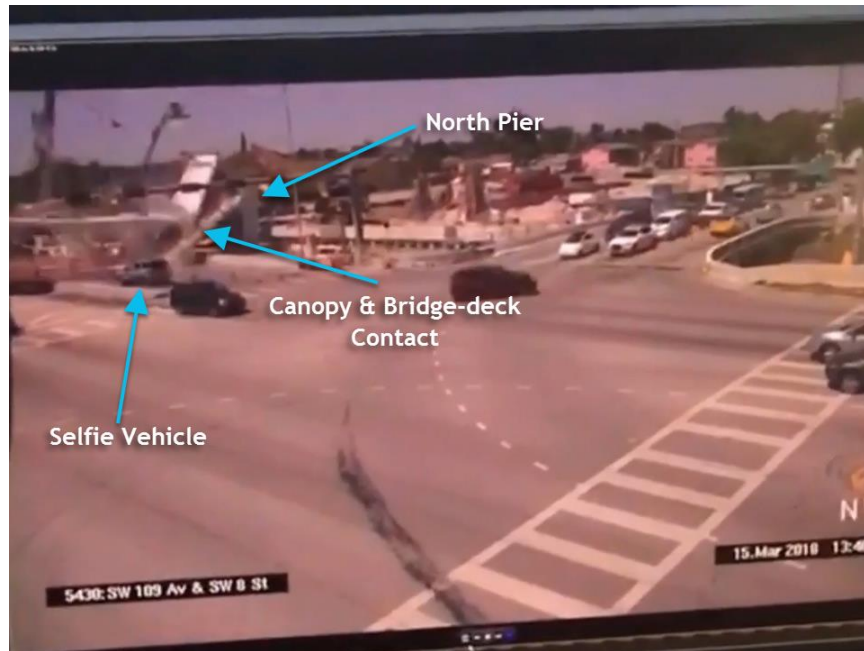
Figure 23. FDOT/Miami Dade camera at frame 39 - 13:46:44.813.

Frame 39 - Figure 23 - The canopy was in contact with the bridge-deck. The deck and diaphragm was dislodged from the pylon pier and was beginning to slide off the pylon pier. The silver vehicle was still occupying the only open westbound lane,

east of the bridge. Structure was collapsed in the immediate frontal vicinity of the vehicle.

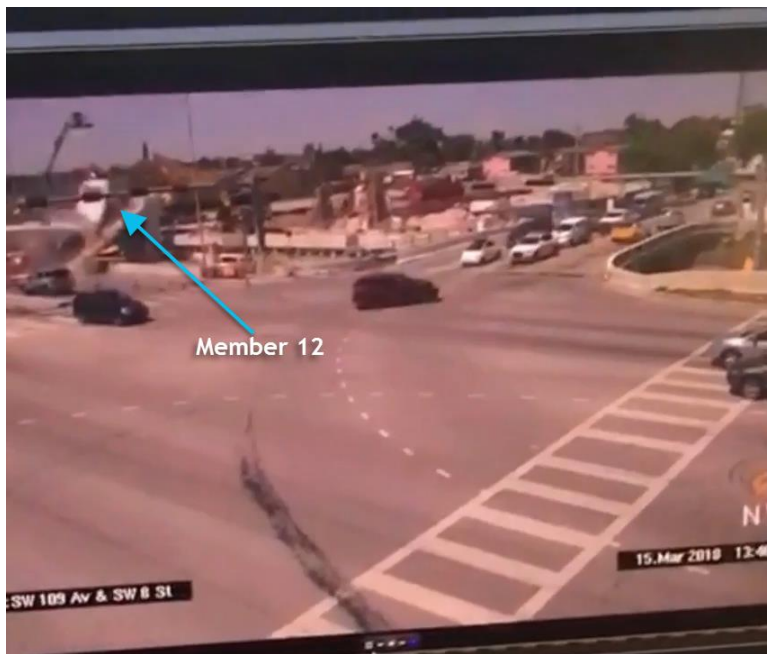
Figure 24. FDOT/Miami Dade camera at frame 50 - 13:46:45.179.

Frame 50 - Figure 24 - Member 12 and the canopy had appeared to rotate inward and downward. A debris cloud was visible forming in front of the silver vehicle in the westbound lane.

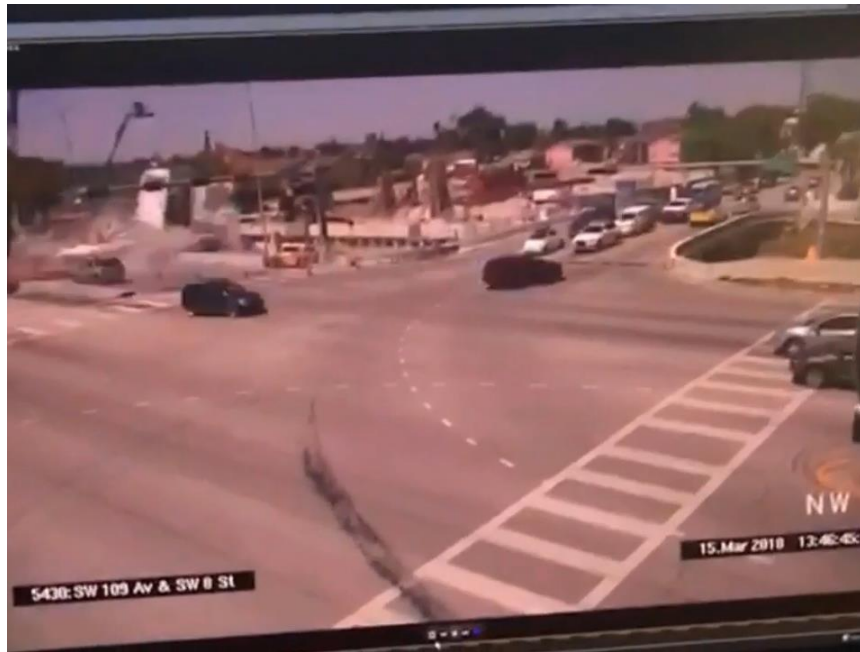
Figure 25. FDOT/Miami Dade camera at frame 60 - 13:46:45.512

Frame 60 - Figure 25 - The deck and diaphragm was fully dislodged from the north pylon pier and had fallen to its final resting position on the roadway surface and surrounding earthen surface adjacent to the roadway surface. The canopy came in contact with the deck and the roadway surface and appeared flattened. A debris cloud continued to form and spread in the vicinity of the roadway surface.

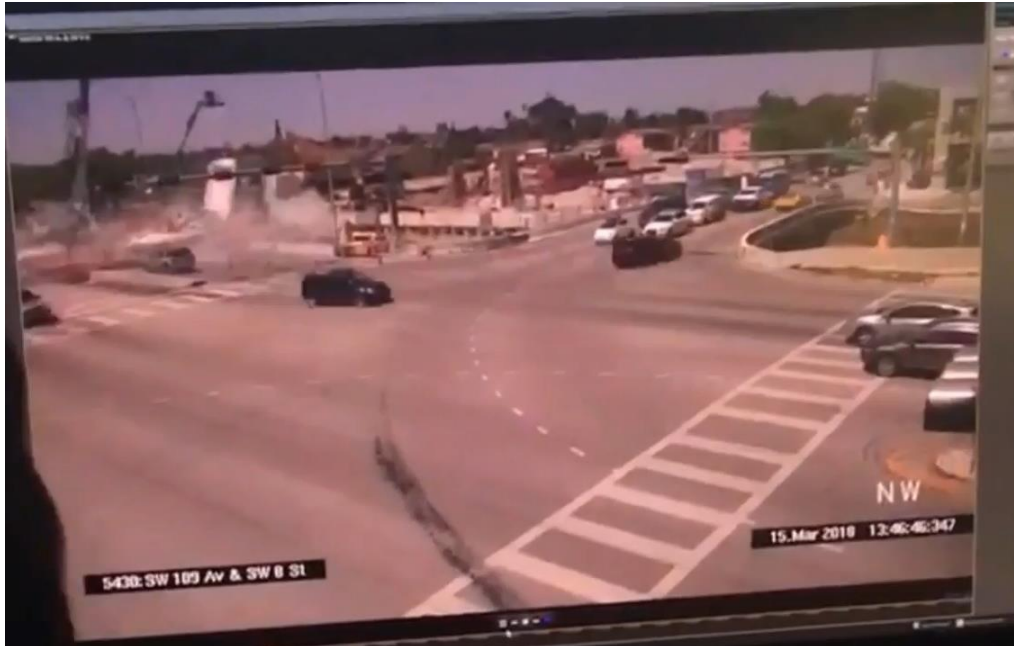
Figure 26. FDOT/Miami Dade camera at frame 74 - 13:46:45.978

Frame 74 - Figure 26 - The debris cloud continued to grow larger. It appeared that all visible main-span surfaces had come to rest and no other remarkable evidence was noted in the remaining frames associated with this camera.

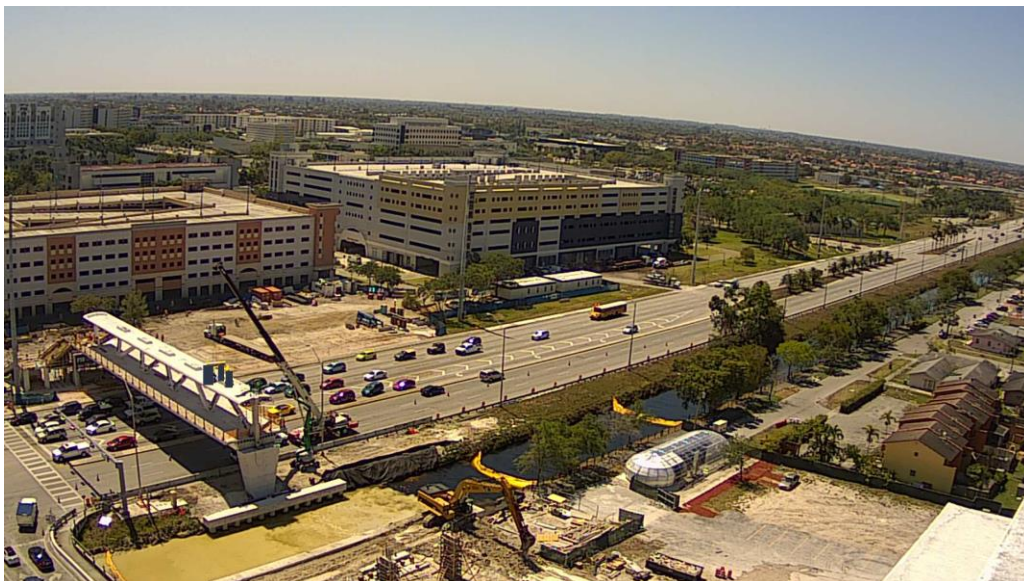
Figure 27. 109 Tower camera at 13:46:42.715

Frame 1 - Figure 27 - 13:46:42.715 -The bridge in a pre-collapse state.

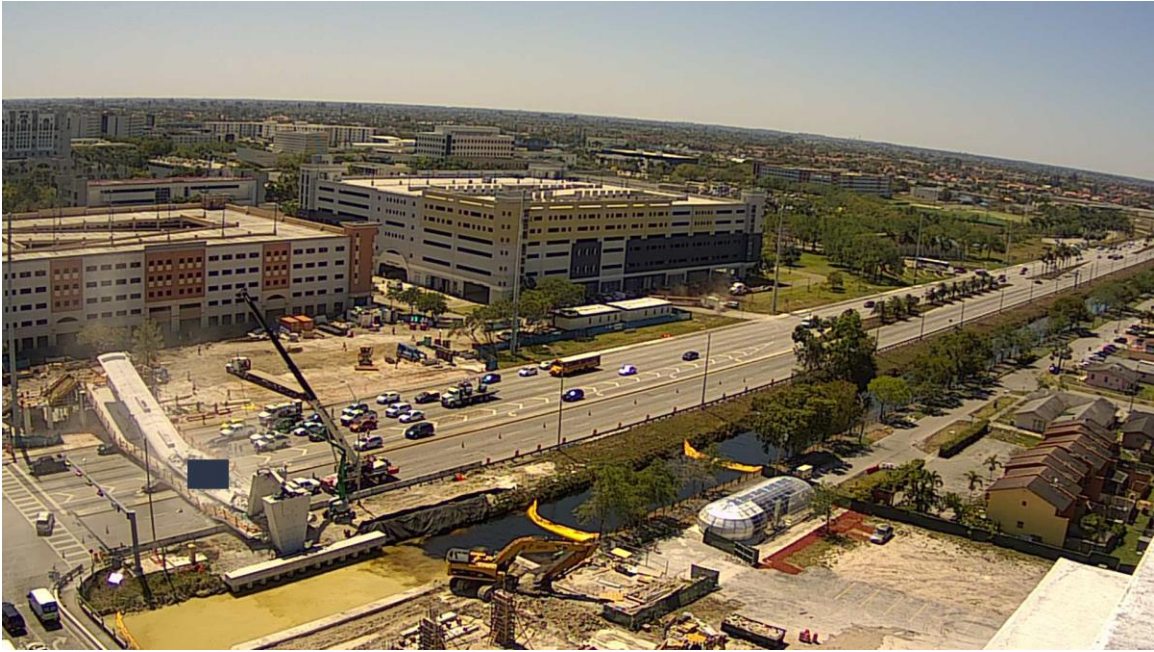
Figure 28. 109 Tower camera at 13:47:39.715

Frame 2 - Figure 28 - 13:46:47:39.715 - The bridge post collapse.
