NATIONAL TRANSPORTATION SAFETY BOARD
Vehicle Recorder Division
Washington, DC 20594

Digital Video Recorder (DVR)

Specialist's Factual Report By Sean Payne

Location: Delray Beach, Florida
Date: March 1, 2019
Vehicle: Tesla Model 3, 5YJ3E1EB2JF0XXXXX¹
Operator: Private
NTSB Number: HWY19FH008

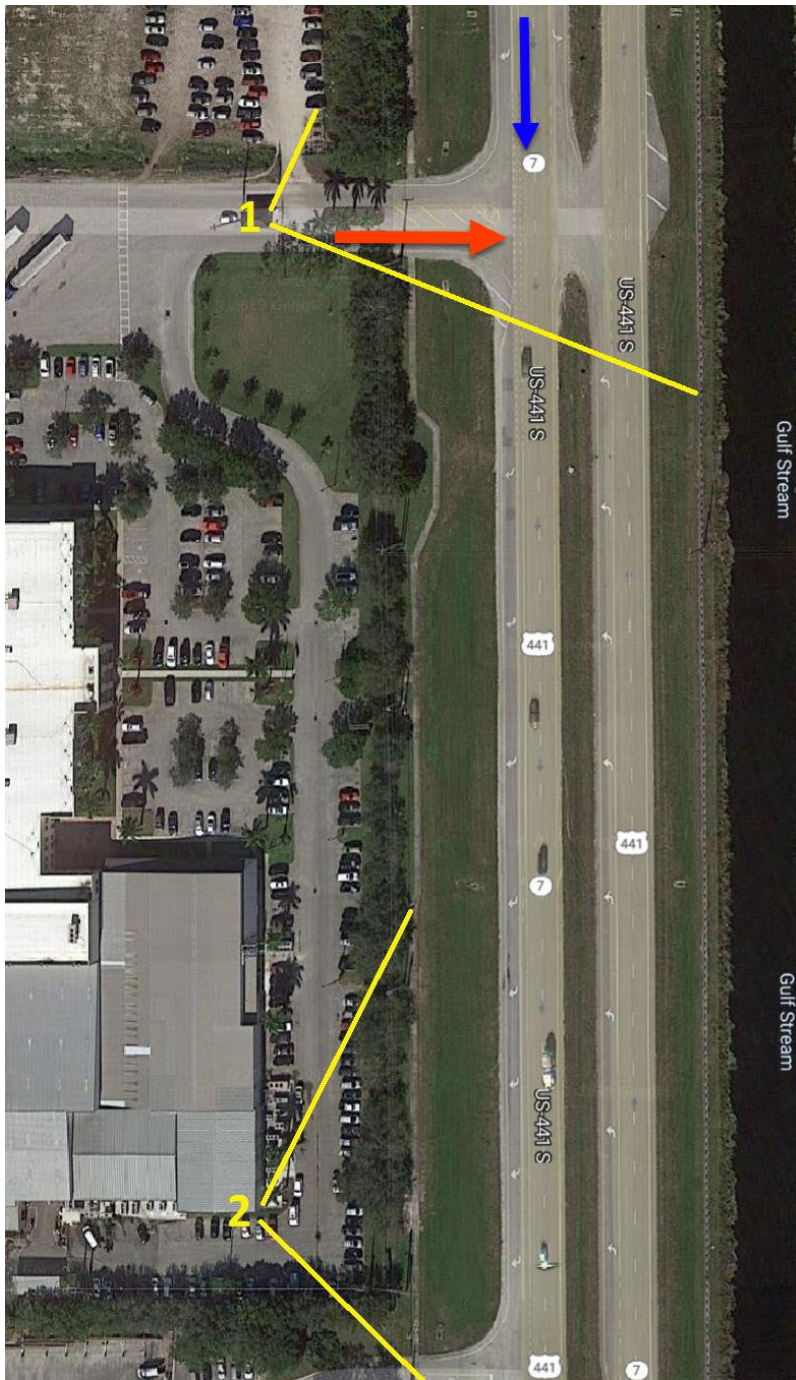
Figure 1. Security camera locations and general vehicle movement.

Figure 1 is a diagram of the security camera locations and vehicle movements involved in the accident. The yellow numbers and lines represent the security cameras that captured the accident and their respective field of view. The red arrow denotes the location and direction of travel of the tractor-trailer combination at the start of the recording. The blue arrow represents the direction of travel of the Tesla vehicle.
