**NATIONAL TRANSPORTATION SAFETY BOARD**  
Vehicle Recorder Division

## Security Video

### Specialist's Factual Report By Nicholas Swann

Location: Spring, Texas  
Date: April 17, 2021  
Time: 2325 central daylight time (CDT)  
NTSB Number: HWY21FH007

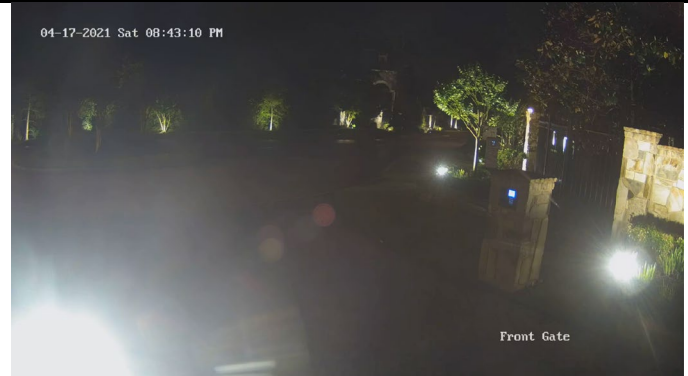
Video Name	Video Length	View from Camera
Front Gate 1	08:11:05

At 09:01:08 the headlights of the accident vehicle came into view. The shadow of the front gate was moving as the gate opened to allow the accident vehicle through. The accident vehicle proceeded down the driveway and braked as it crossed the end of the driveway.

The accident vehicle then continued to slowly enter the cul-de-sac that the driveway was located on.

At 09:01:27, the accident vehicle's brake lights turned off and the vehicle quickly accelerated toward the street.

Approximately 28 seconds later, at 09:01:55, the light from the start of a post-impact fire could be seen over the pillar of a neighboring fence.

The light disappeared between 09:02:09 and 09:03:34. The view of the fire then returned and became noticeably larger at 09:04:50. At this point, the fire began to extend well above the neighboring pillar. The fire continued until the end of the video.
