National Transportation Safety Board

HWY23MH006

ONBOARD RECORDERS

Specialist's Factual Report

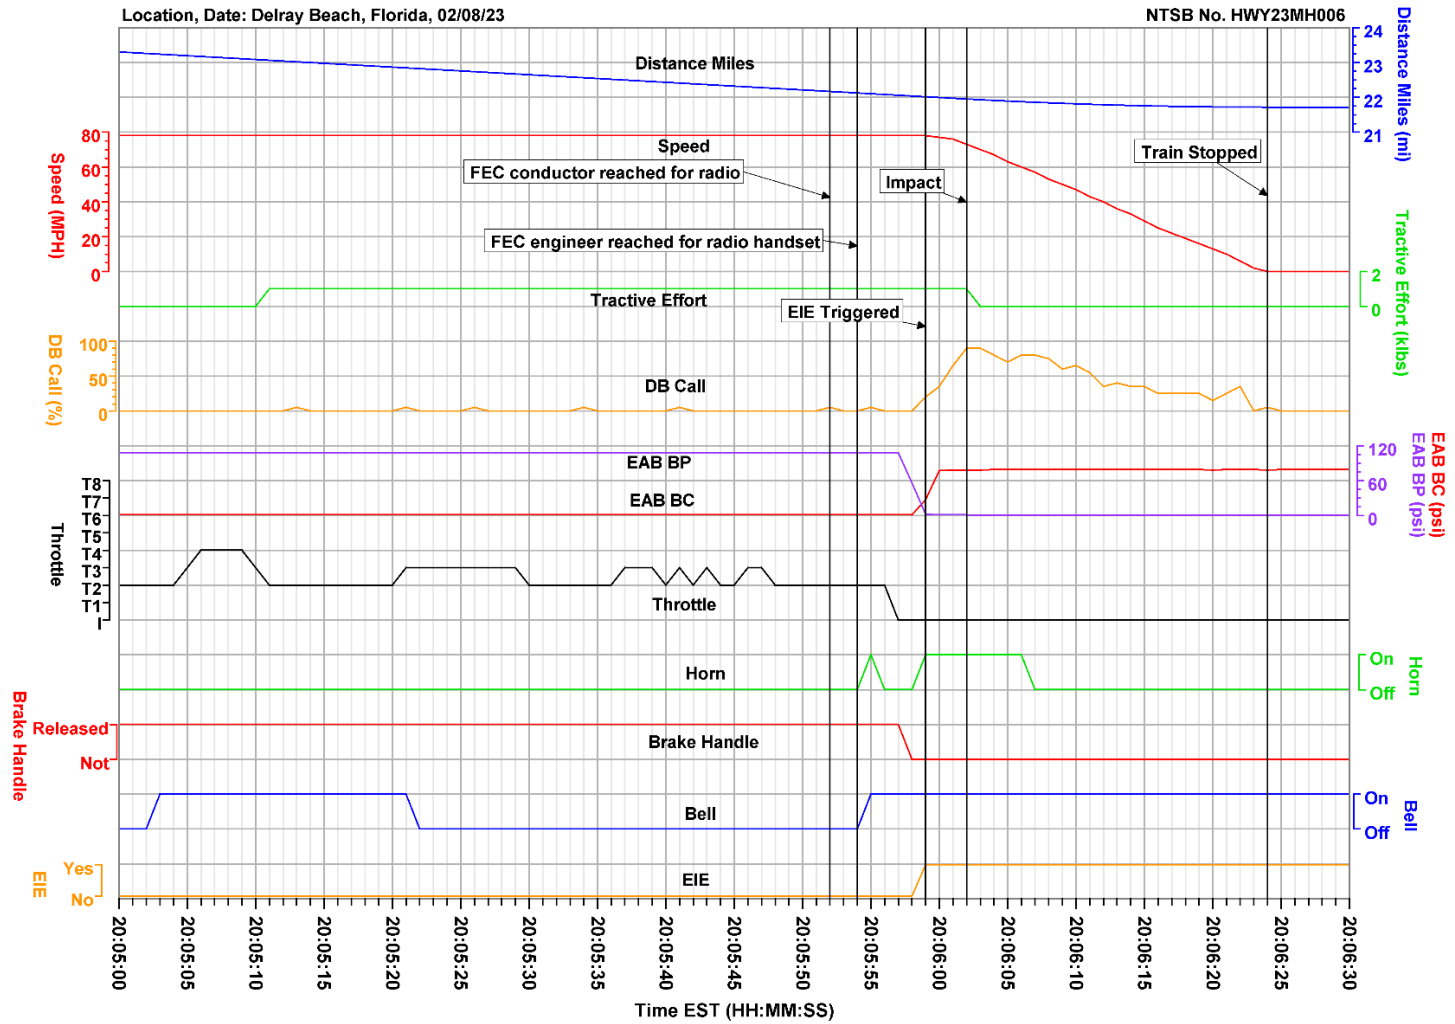
Section D contains a summary of all four videos reviewed. Section E contains screenshots from the head-end videos and a plot of the Brightline locomotive event recorder data. Figure 1 shows a plot of parametric data from the Brightline locomotive event data recorder. The corresponding tabular data used to create figure 1 are provided in electronic comma separated value (CSV) format as attachment 1 to this report.

In summary, at 20:05:52 the FEC crew were noted reaching for their radios. The Brightline train was travelling at 78 miles per hour (mph) at that time. The Brightline train's electronic air brake and throttles were moved five seconds later, at 20:05:57, after having travelled 575 feet (ft). An Engineer Initiated Emergency (EIE) was recorded at 20:05:59, after having travelled 690 ft since the FEC crew were first noted reaching for their radios. Impact occurred three seconds later, at 20:06:02. The Brightline train was travelling at 76 mph at impact and had travelled 343 ft since the EIE was triggered. The train travelled a further 1,353 ft until it stopped 22 seconds later, at 20:06:24.

Figure 1. Plot of recorded data from Brightline train 559.

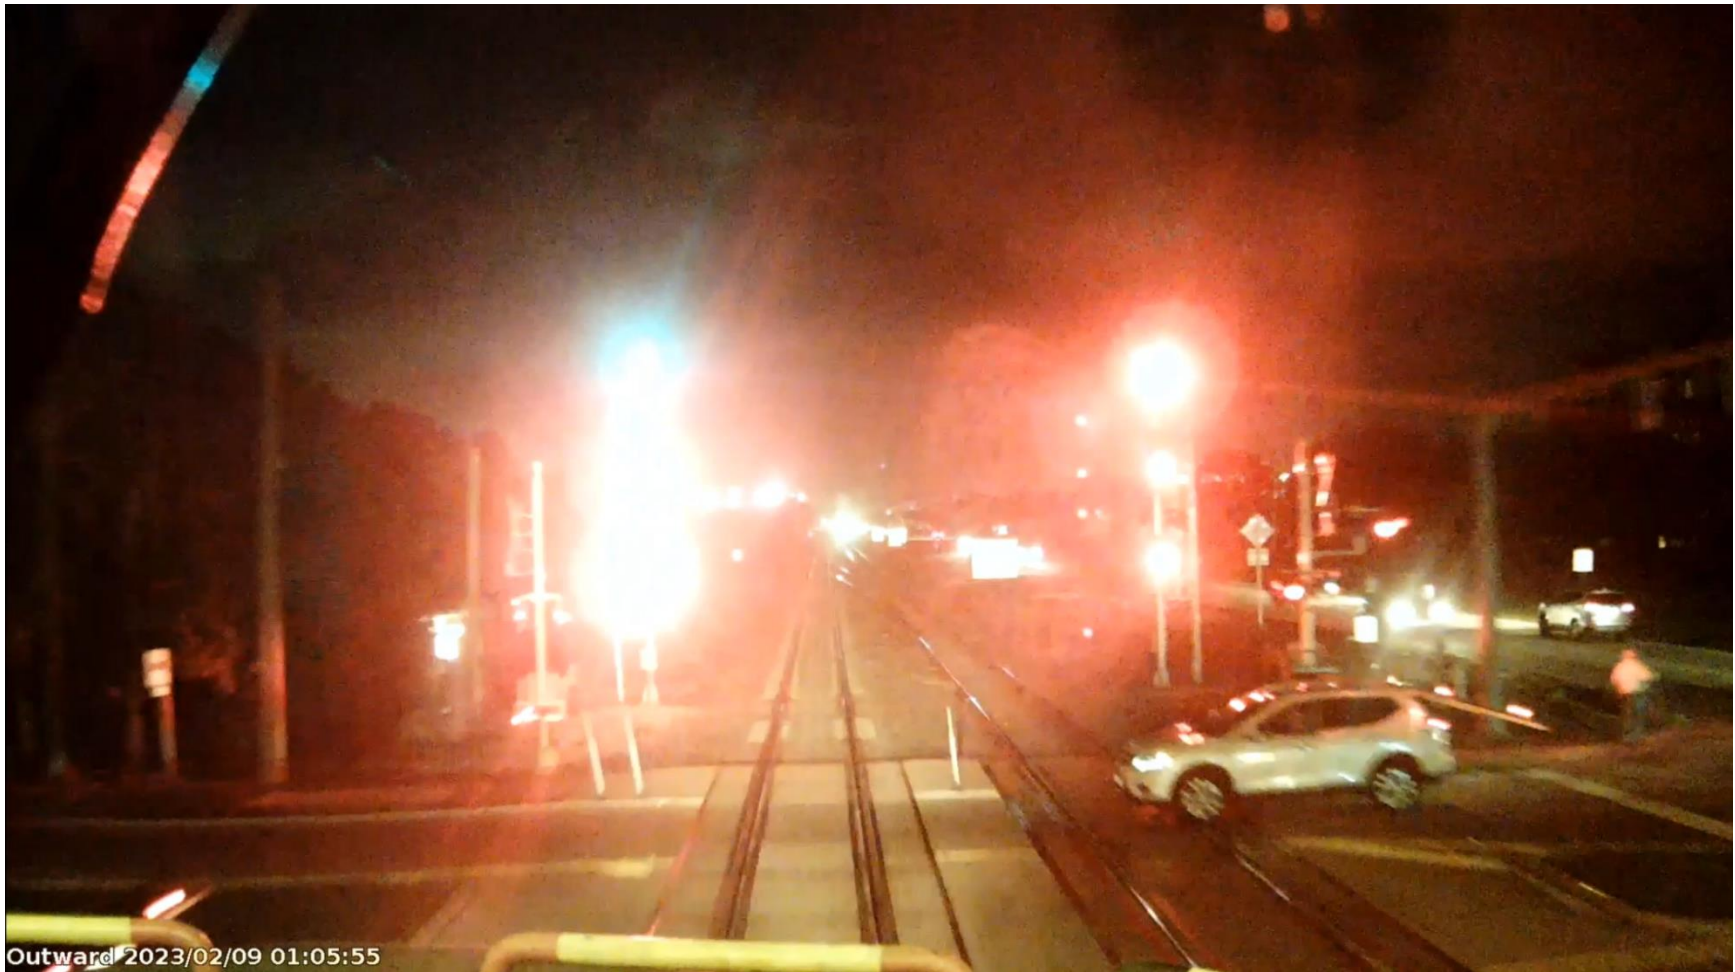
20:05:55	The Brightline headlight and bell were activated.	Brightline Head-End
20:05:55	The FEC locomotive approached the collision grade crossing. Figure 2 shows a view from the FEC head-end as the locomotive passed the stopped vehicle. The crossing guard was flashing and down behind the stopped vehicle. The vehicle's front wheels were stopped approximately in line with the outside rail of the opposite track. A witness was noted behind the vehicle.	FEC Head-End

Figure 2. View from the FEC head-end as the locomotive passed the stopped vehicle at 20:05:55.

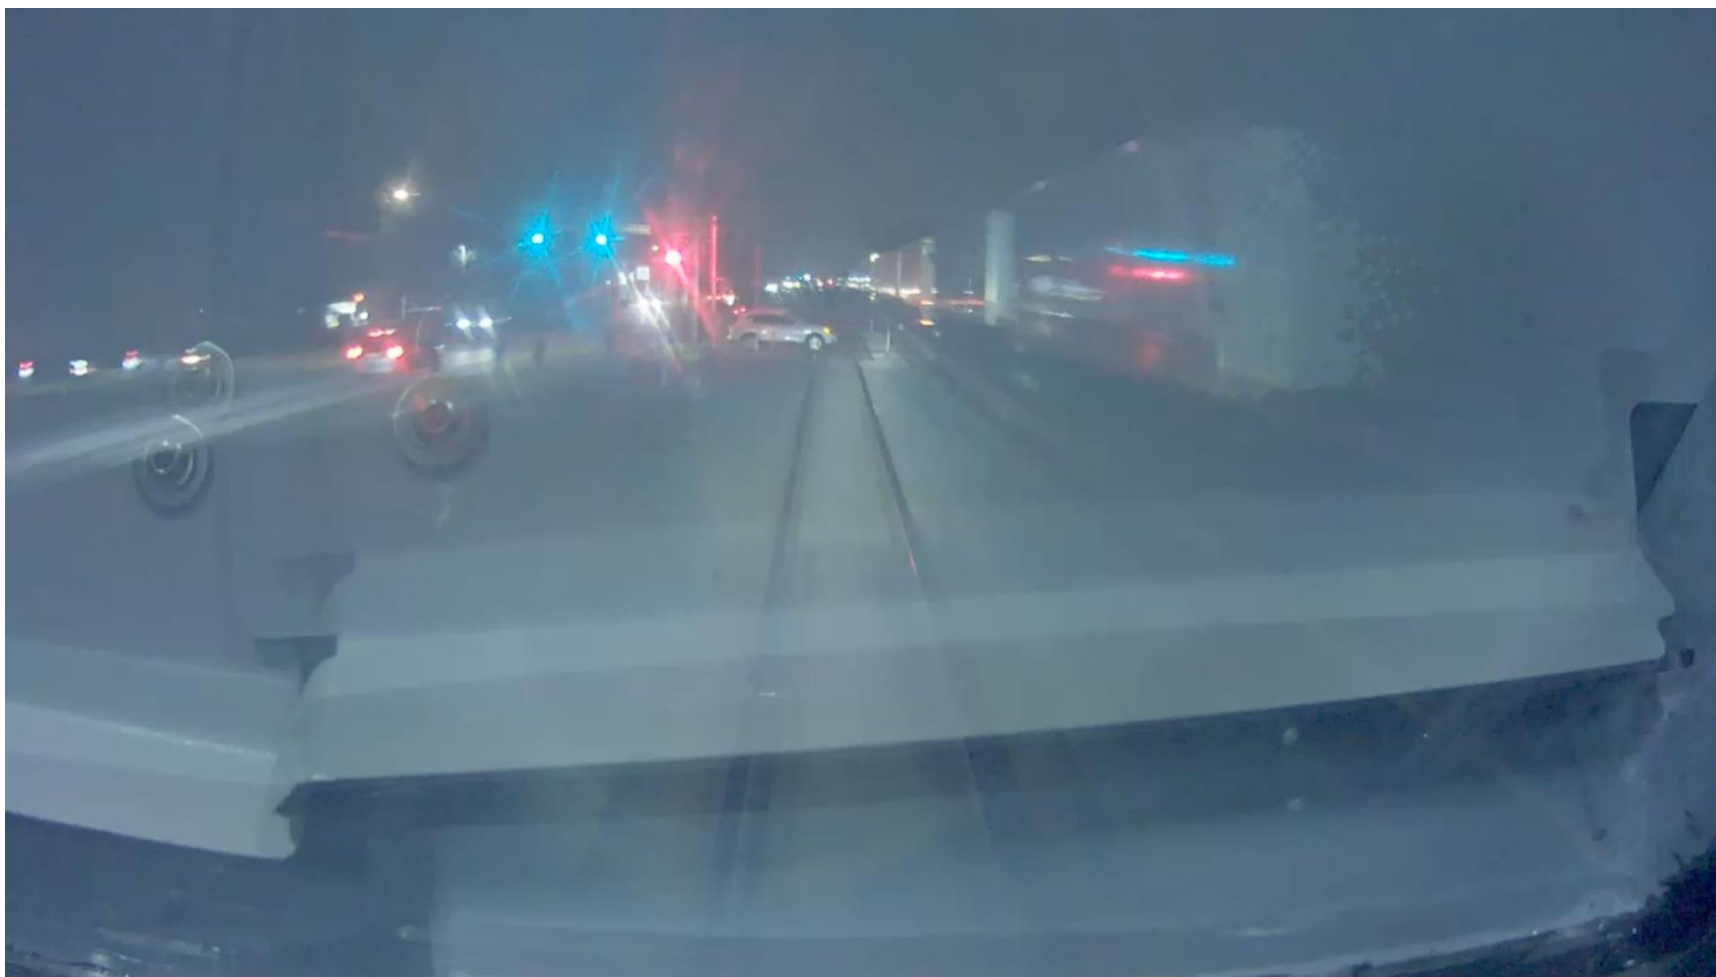
20:06:00	The two locomotives passed one another.	Brightline Head-End FEC Head-End
20:06:01	Figure 3 shows a view from the Brightline head-end as the locomotive approached the stopped vehicle. Figure 4 shows another view from the Brightline head-end shortly thereafter. No lights were noted illuminated on the vehicle, with bright sources determined to be from reflective surfaces.	Brightline Head-End

Figure 3. View from the Brightline head-end as the locomotive approached the stopped vehicle at 20:06:01.

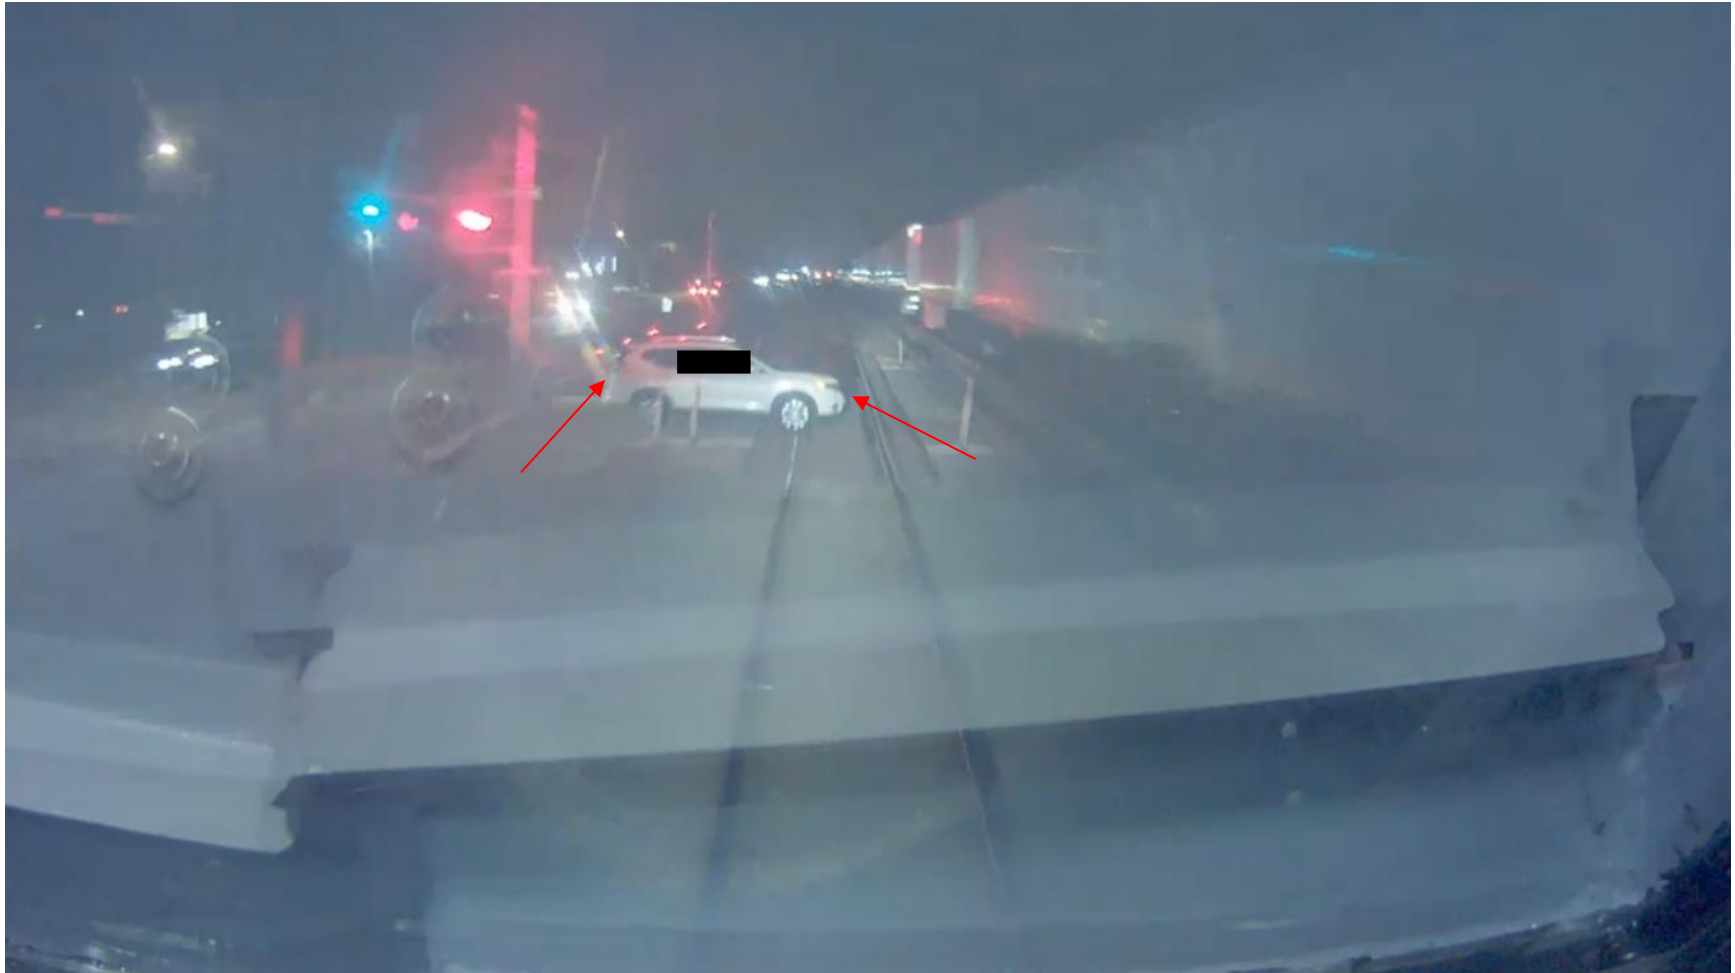
Figure 2 shows the view from the FEC head-end as it passed the stopped vehicle at 20:05:55. Figure 3 shows the view from the Brightline head-end shortly before the collision with the stopped vehicle at 20:06:01. Figure 4 shows a view from the Brightline head-end moments later, detailing the lack of illuminated lights observed on the vehicle with red arrows.

Figure 4. View from the Brightline head-end the stopped vehicle's unilluminated lights (with red arrows) further at 20:06:01.
