National Transportation Safety Board

HWY23MH015

VIDEO FILES

Specialist's Factual Report

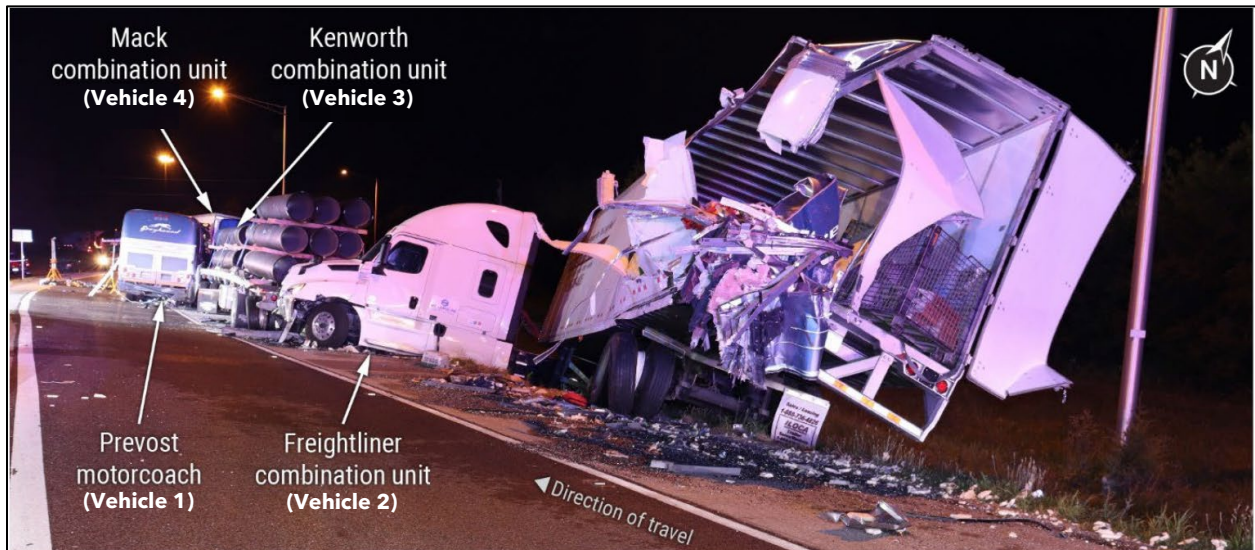
For a summary of this accident, refer to the public docket for this investigation. A post-accident photograph of the four vehicles involved in the accident is provided in Figure 1.

Figure 1. Post-accident photograph of the vehicles involved in the accident. (Source: Illinois State Police, annotated by NTSB).

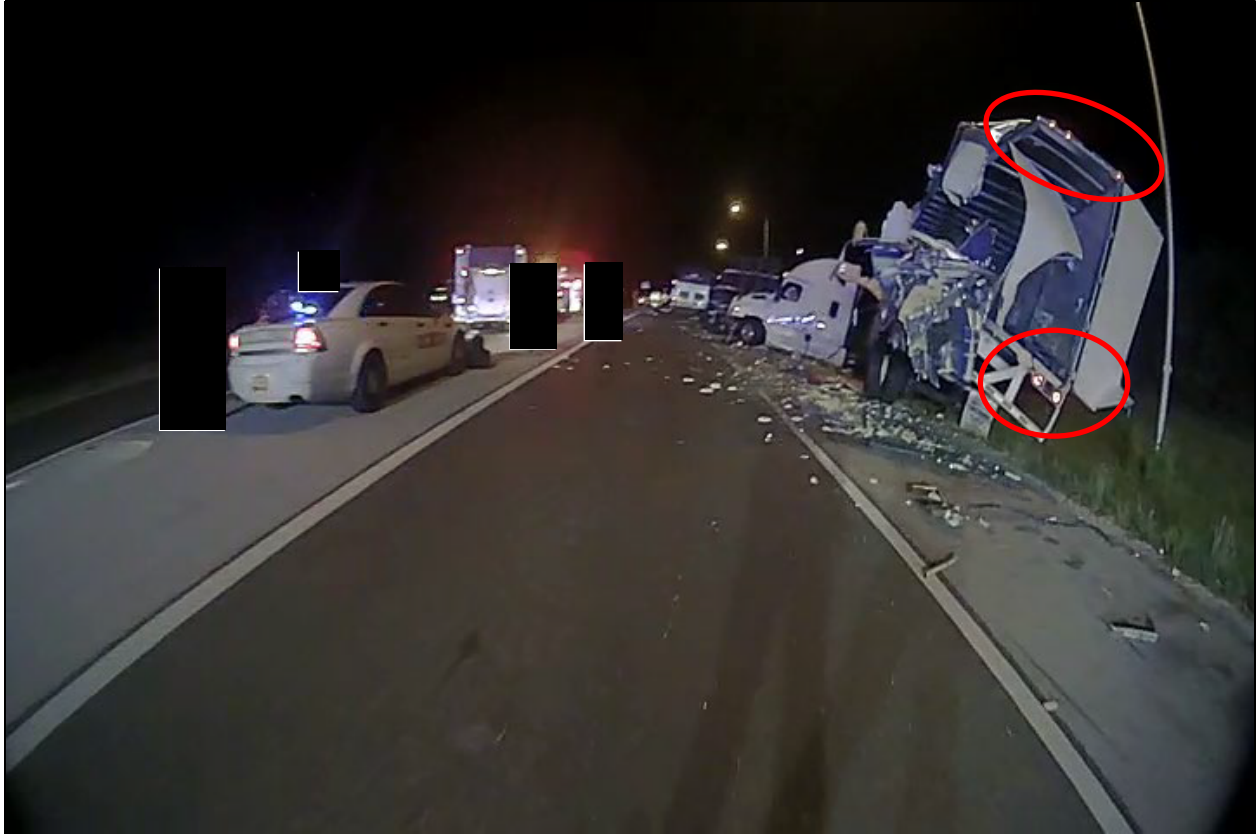
At 05:00 video elapsed time, the officer arrived at the accident scene and exited his vehicle. The road lights on the rest area exit ramp were visible and illuminated. As the officer walked towards the scene, the taillights of the Freightliner combination unit were visible and illuminated, as shown in Figure 2.

Figure 2. Police officer bodycam at video elapsed time 05:19. The Freightliner combination unit's taillights are illuminated (circled in red).

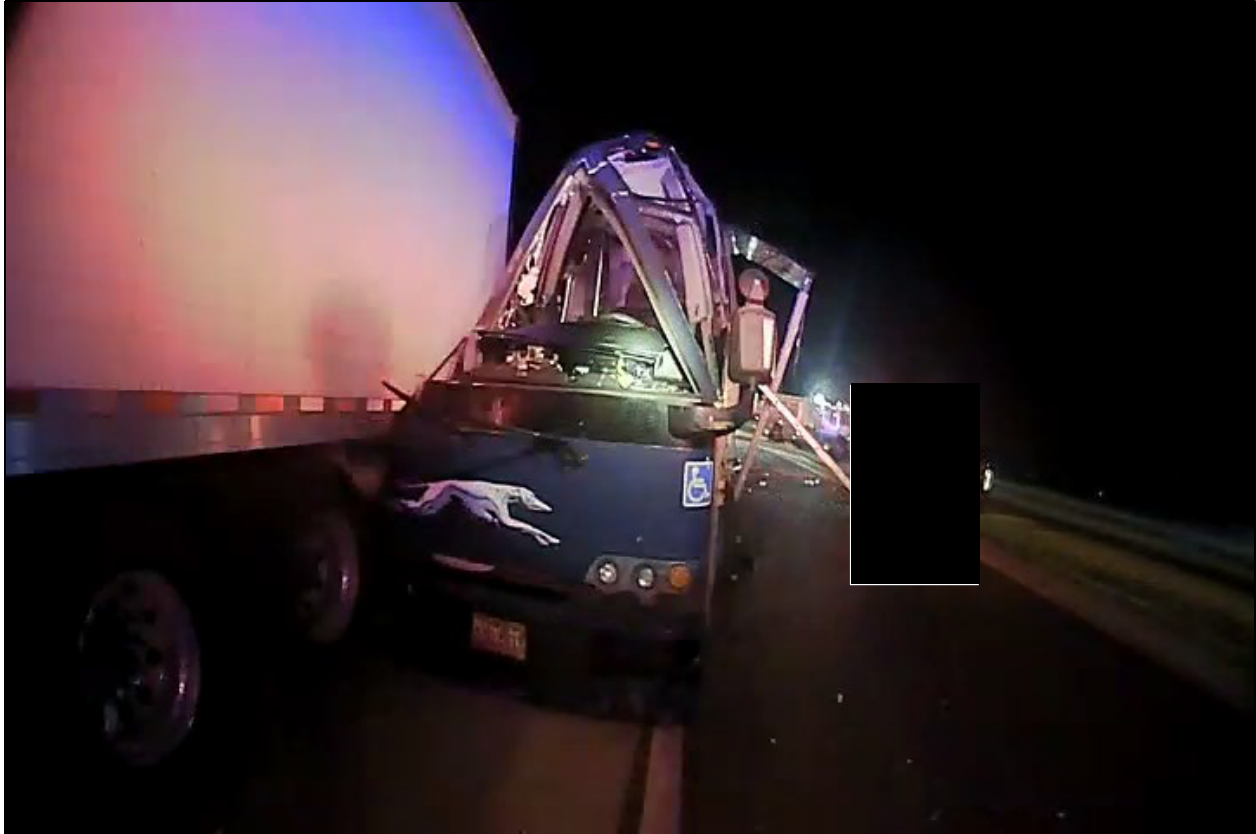
At 08:01, the officer walked towards the front of the motorcoach, as shown in Figure 3.

Figure 3. Police officer bodycam at video elapsed time 08:01 showing the post-accident condition of the front of the motorcoach.

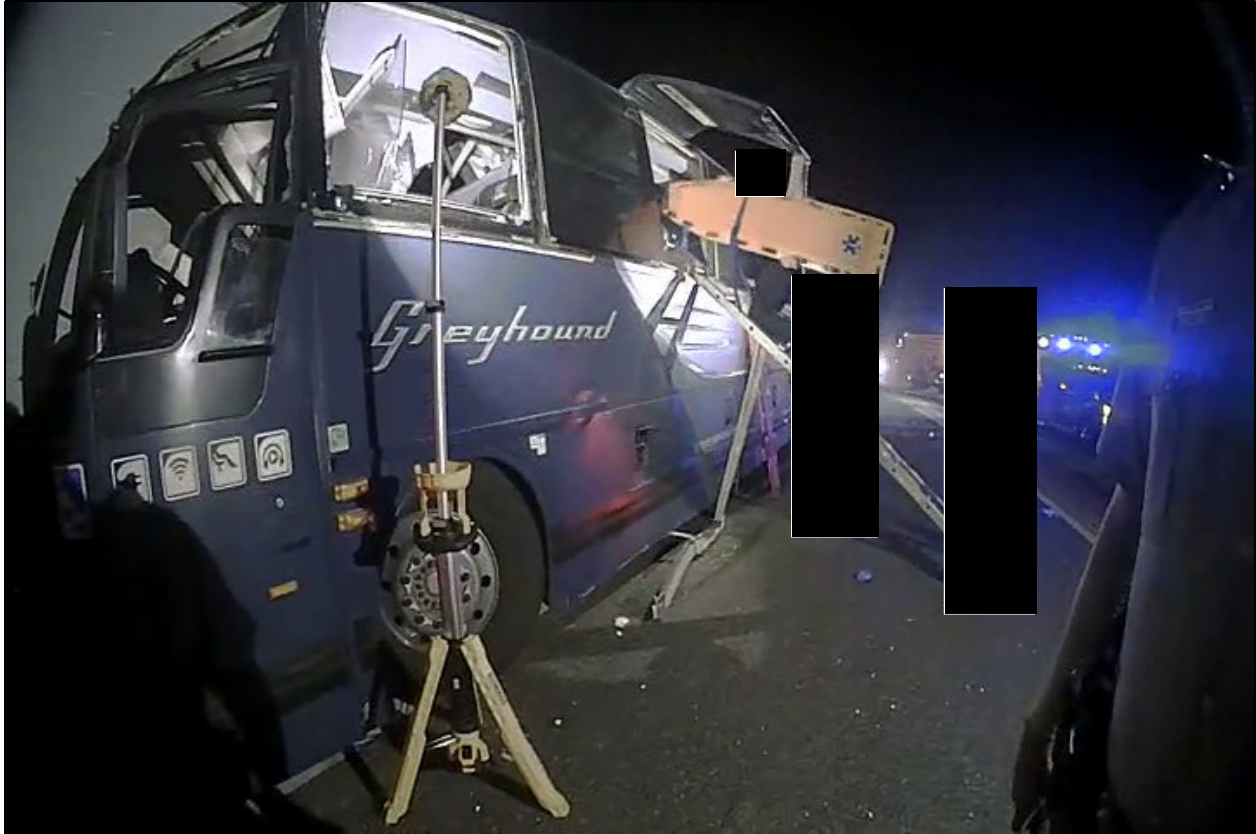
For the remainder of the video, the officer discussed the arrival of medivac helicopters and witnessed the fire department attempting to access the injured passengers of the motorcoach through a window, as shown in Figure 4.

Figure 4. Police officer bodycam at video elapsed time 12:25. A first responder is visible on a ladder carrying a spinal board through a window of the motorcoach.
