Hazardous Materials Investigation Report HZIR-23-01

BNSF Railway Company Derailment and Pool Fire Involving DOT-117J Tank Cars

Oklaunion, Texas
January 8, 2022

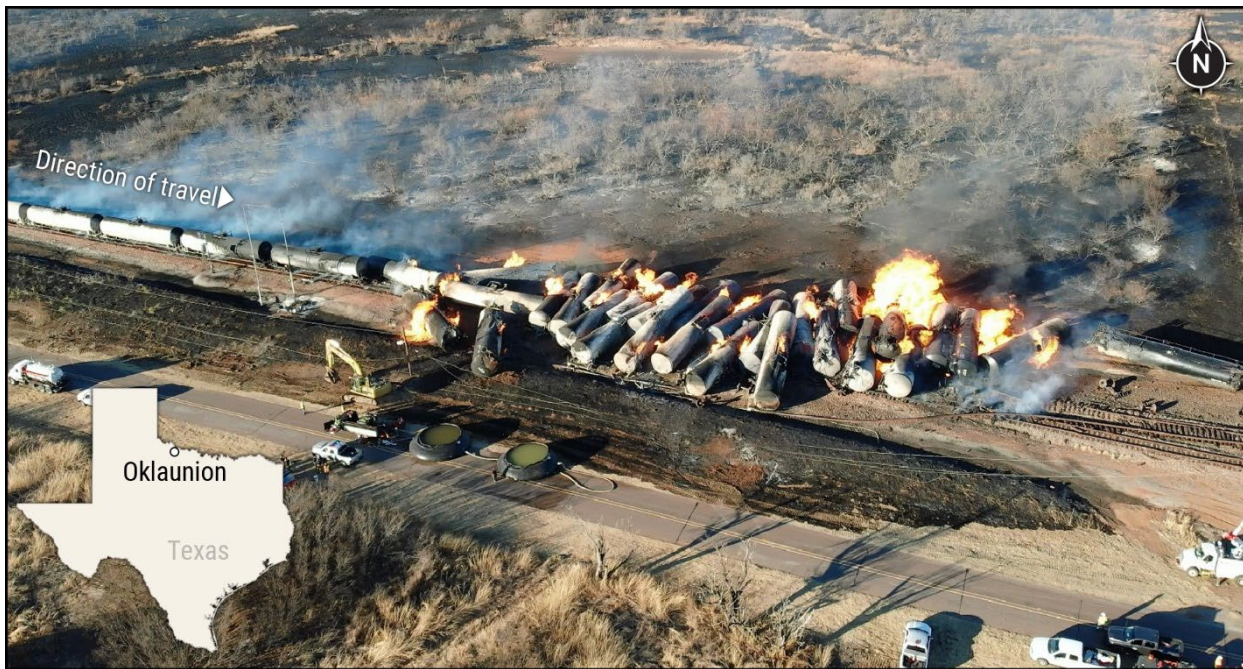
Figure 1. Aerial view of accident scene. (Photo courtesy of BNSF.)

BNSF response teams found five tank cars were burning as part of the pool fire when they first arrived at the scene. Over the next 4 hours, the fire spread to involve 28 of the 37 derailed tank cars. Ten of the derailed tank cars released ethanol primarily because of mechanical damage to their tanks and fittings, while the remaining 18 breached tank cars primarily released product when their service equipment became thermally damaged in the pool fire.⁵

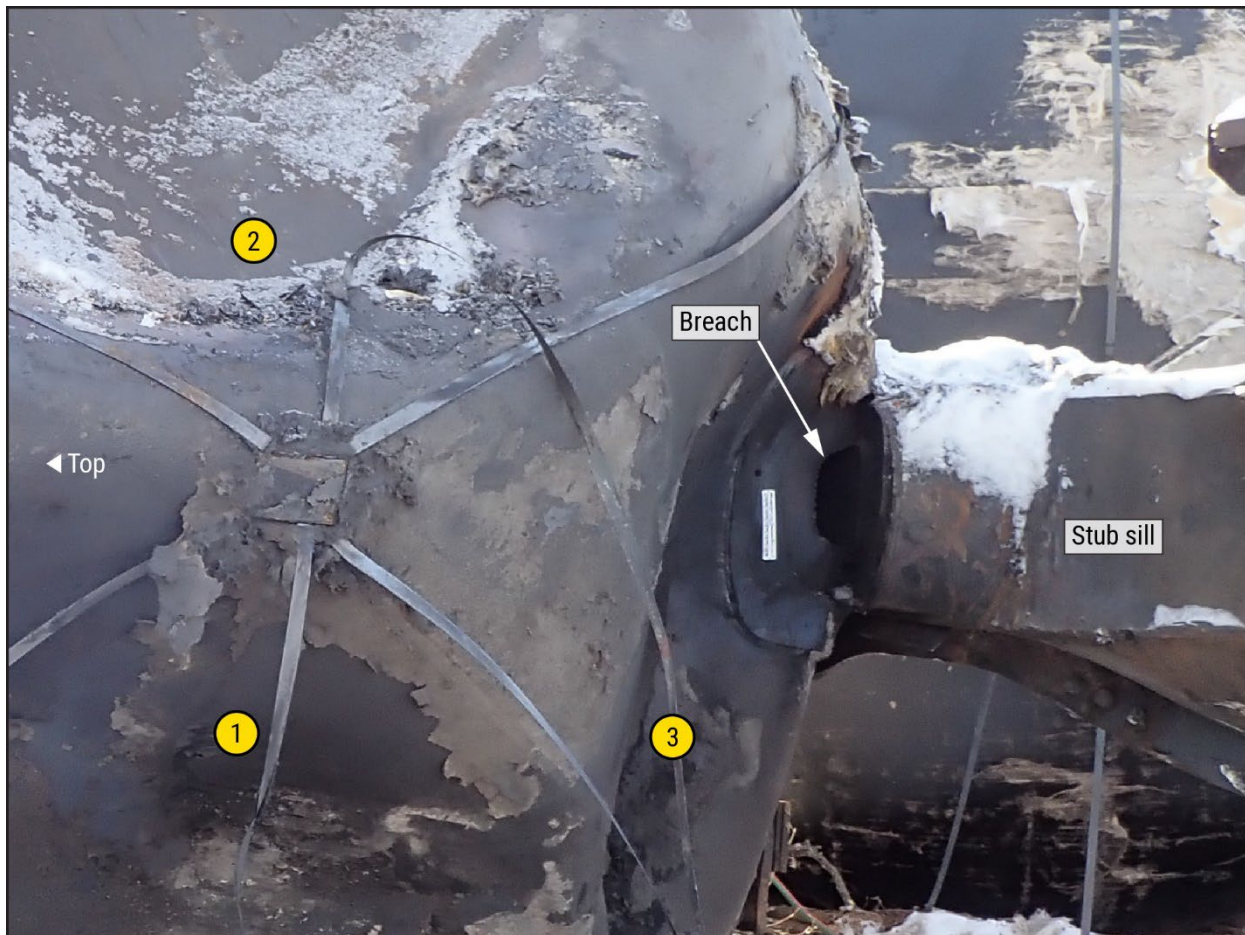
Visual examination of TILX731751, one of the seven tank cars with head or shell breaches, revealed the tank head material fractured near a weld joining the tank to the underframe assembly. (See figure 3.) This tank car was mechanically breached even though it was near the rear of the derailment pileup, where collision forces would have been lowest. The NTSB acquired a section of tank shell, head, and underframe assembly from this tank car for laboratory examination.

Figure 3. The A-end head of tank car TILX731751 postderailment and with the head shield removed for inspection, showing deformation from three impacts.

The fracture and deformation patterns were consistent with bending loads at the fracture locations, including through the front sill pad at the head brace weld toe and through the tank at the window weld in the front sill pad. The head and outboard portion of the front sill pad deformed upward and inboard relative to the stub sill and head brace. Like the visual evidence of larger deformations in the tank head, this deformation is consistent with the tank car sustaining impacts with other tank cars (See figure 3 above.)

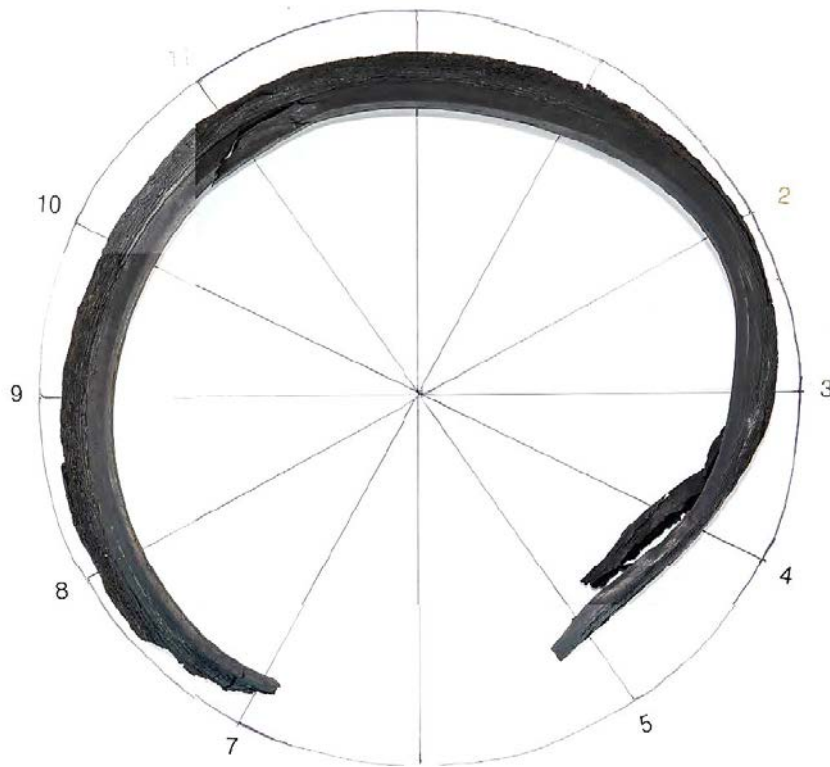
Gaskets sustained different degrees of damage at different locations relative to the pool fire. The manway cover gasket on a tank car near the edge of the pool fire (TILX731758) was cracked, missing material, and textured like alligator skin. (See figure 4 for an image of this gasket taken after the NTSB removed it from the scene.) The manway cover gasket on a tank car near the center of the pool fire (TILX731758) had burned to small fragments and carbon deposits, which were retained by the manway cover gasket groove. (See figure 5.)¹⁸ The NTSB examined service equipment removed from four derailed tank cars that were near the edge of the pool fire and had sustained less thermal damage than tank cars nearer the center. These examinations prompted laboratory tests of gasket material thermal performance.

Figure 4. Manway cover gasket removed from tank car TILX731758.

Work with the Pipeline and Hazardous Materials Safety Administration to develop and publish benchmark service and survival temperatures for gaskets to be used in tank cars used in flammable liquid service that reflect currently available gasket materials. (R-23-12)

Work with the Pipeline and Hazardous Materials Safety Administration to develop and publish thermal performance standards for gaskets used in tank cars in flammable liquid service that address both accident and normal transportation conditions. (R-23-13)

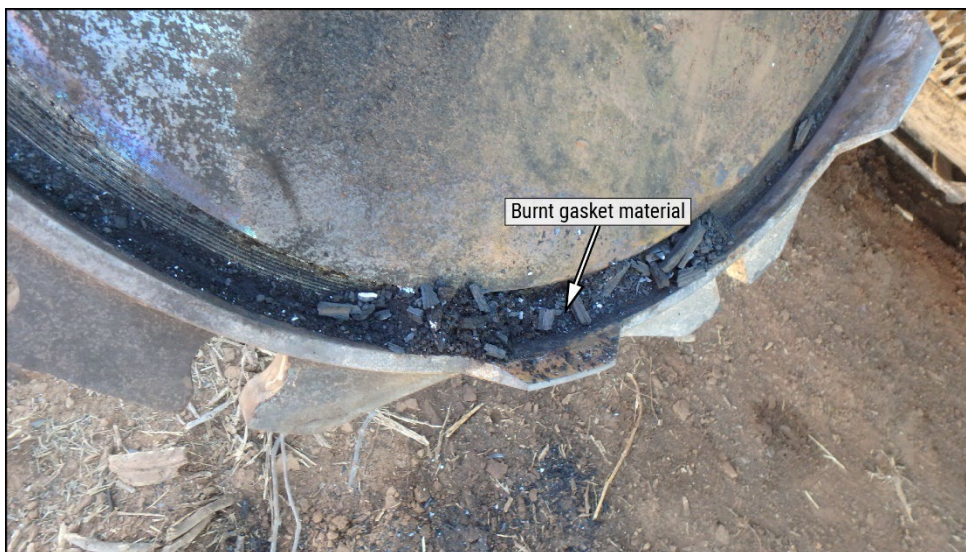
Figure 5. Open manway cover showing burnt gasket material on tank car TILX731739.

Laboratory tests of PRDs from these tank cars found that the internal gaskets had sustained thermal damage such that the PRDs could not retain lading significantly below the pressures at which the PRDs were designed to re-close.

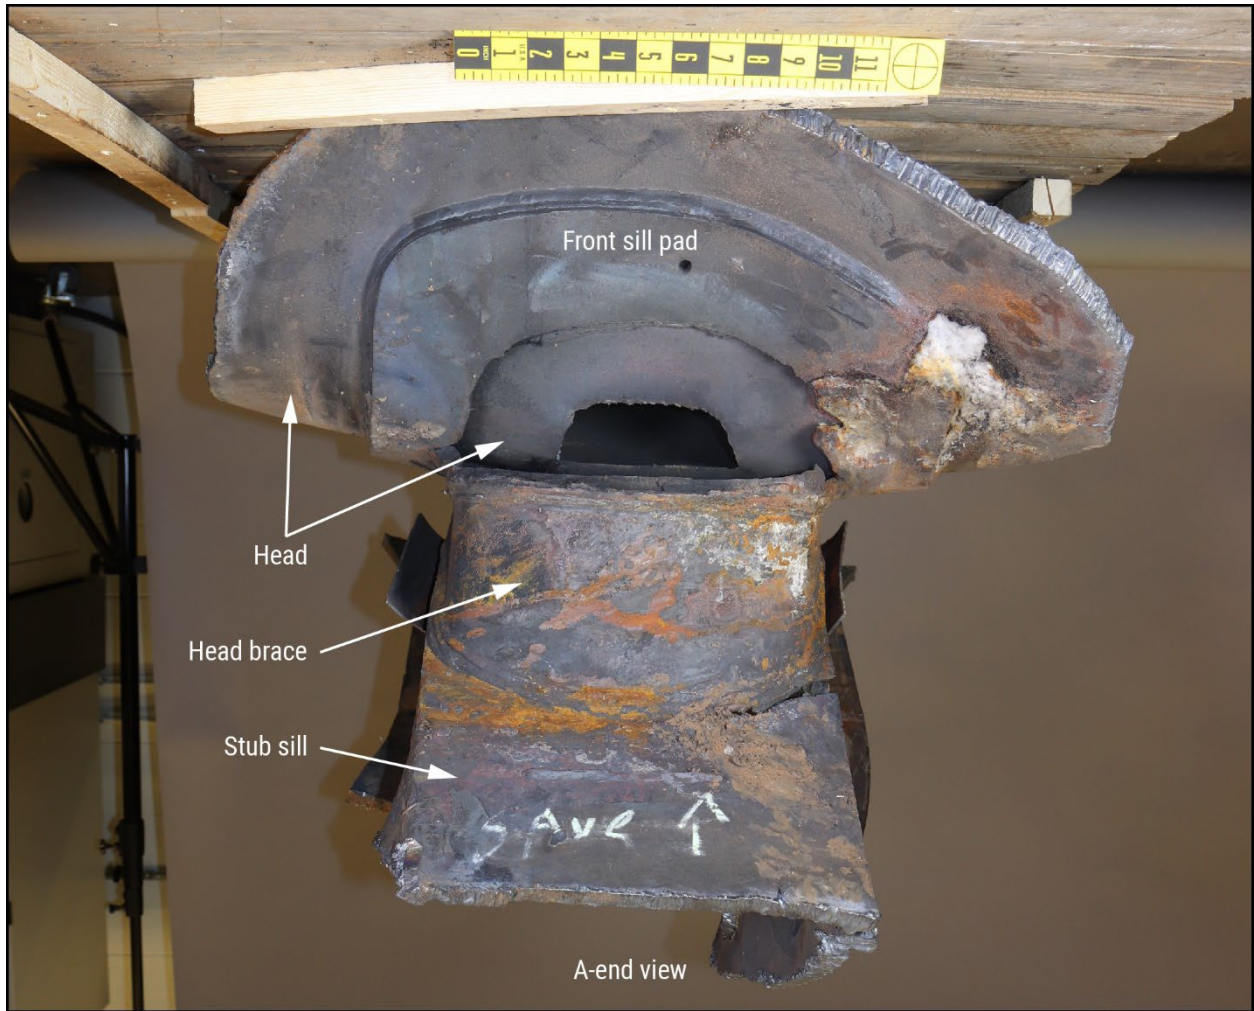
The NTSB sectioned a piece of tank shell, head, front sill pad, head brace, and stub sill from the tank car that was mechanically breached when its head material fractured near a weld. (See figure 7 for a head-on view of the examined piece.) Examination found that the 0.625-inch-thick front sill pad was fractured at the toe of the weld that joined it to the head brace; it had not separated along the weld itself. The tank head wall was fractured at the weld root between the front sill pad window and the tank head (the window weld).²⁰ The head fracture was about 10.25 inches long, and the maximum opening displacement was about 2.5 inches. (See figure 8 for a close-up of the fracture and resulting opening.) The head brace remained attached to the stub sill.

Figure 7. Head-on view of sectioned piece from tank car TILX731751.

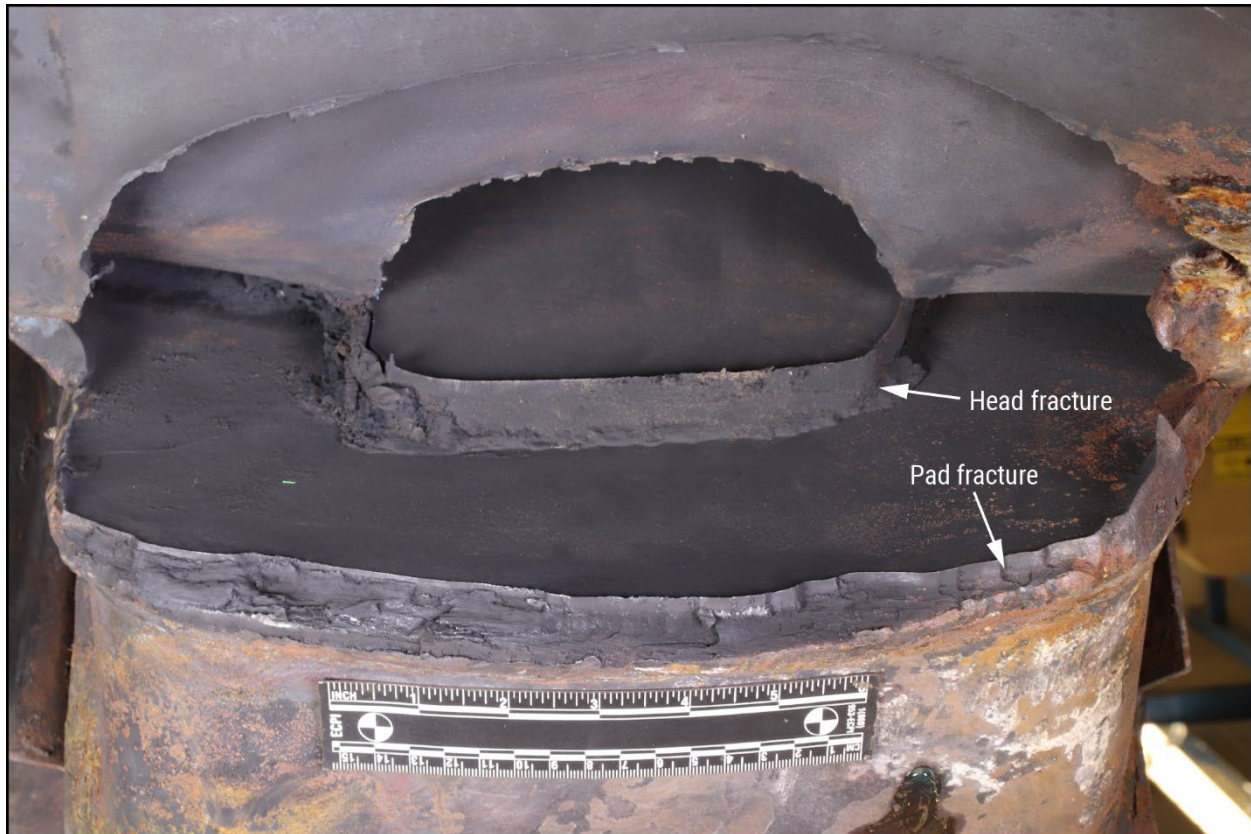
Figure 8. Close-up view of sectioned piece from tank car TILX731751.

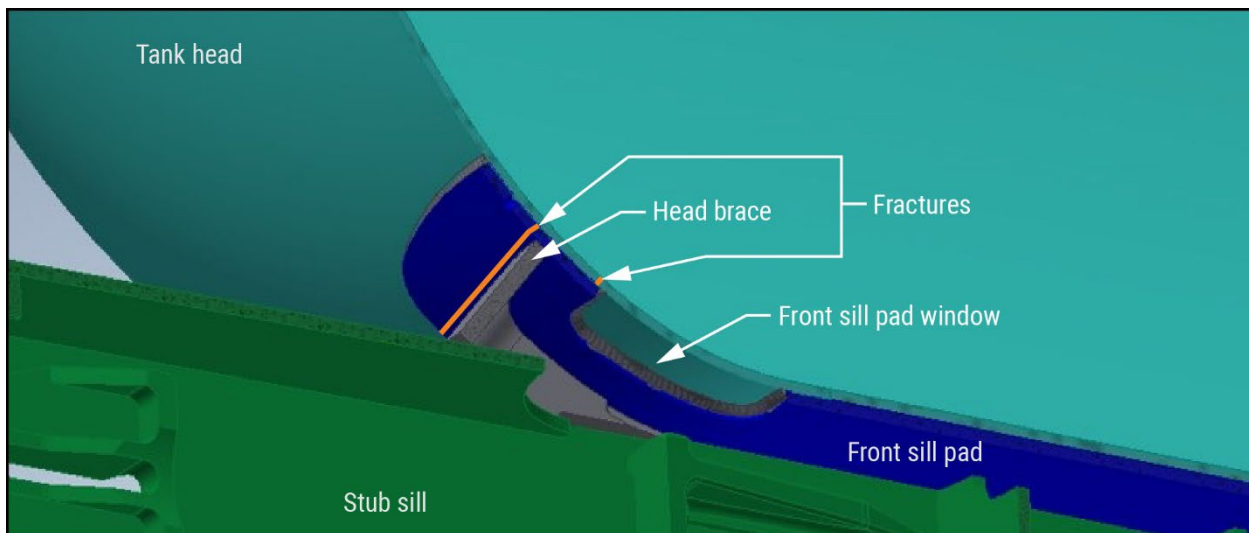
The NTSB's examination of tank car TILX731751 found that the head brace did not separate from the stub sill, and the front sill pad did not separate from the head brace at the weld. Instead, the front sill pad material fractured at a weld joining it to the head brace, and the tank head material subsequently fractured at the window weld root between the front sill pad and the tank head. (See figure 9.) This suggests the window weld between the front sill pad and the tank continued to provide a load path between the tank head and the stub sill, leading to a local stress state that exceeded the strength of the tank head material. This local stress state caused the tank head material to fracture. In other words, when the window weld on the front sill pad was loaded following the front sill pad fracture, the local stress state led to fracture of the tank head material. Therefore, the NTSB concludes that the mechanical breach of tank car TILX731751 between the tank head material and the front sill pad occurred because the window weld between the front sill pad and the tank continued to provide a load path between the tank head and the stub sill while the head brace remained attached to part of the front sill pad, leading to a local stress state that exceeded the strength of the tank head material.

Figure 9. Diagram of fracture locations.

Laboratory examination of a sectioned piece of the damage to tank car TILX731751 showed that oversized welds along this load path contributed to the breach. According to a weld design rule of thumb, maximum weld strength on a T-shaped joint (such as the joint between the front of the head brace and the front sill pad) is achieved when the fillet weld leg on each side of the "T" equals three-quarters of the thickness of the thinner member in the joint (Blodgett 1963). This is equivalent to a theoretical throat of about half the thickness of the thinner member. In the weld between the head brace and front sill pad, the thinner member was the pad, which had a thickness of 0.625 inches. By the weld design rule-of-thumb calculation, maximum weld strength would have been achieved with theoretical throats of about 0.331 inches on the inboard and outboard sides of the head brace. To promote failure at the weld rather than the underlying material (that is, a fracture in the metal of the head brace or stub sill pad), the weld at the joint should have been sized to have less than maximum strength. Thus, the welds attaching the head brace to the pad should have had theoretical throats of less than 0.331 inches.

Similarly, laboratory examinations showed that the window weld exceeded its design size by about 71%, meaning that it also could survive greater loads—and transmit greater loads to the tank head—than the weld specified in the design. The relative strengths of the weld and underlying material caused the window weld to remain intact while the tank head material fractured under load. In other words, because the welds were stronger than the design plan called for, the weakest elements in the load path were the front sill pad and tank head material. While weld design and fabrication practices generally favor creating welds that are at least as strong as the joined elements, tank car design requirements for structural attachments—specifically, the 85 percent rule—are intended to provide specific points of failure by limiting the relative weld strength to protect the underlying components.

5. Because welds between the head brace and front sill pad exceeded their design sizes, the strength of the head brace attachment weld for tank car TILX731751 likely exceeded the load carrying capability of the underlying front sill pad, reducing the probability of the weld failing as intended when placed under high loads, such as the ones that occur during a derailment, and resulting in the tank car being mechanically breached.

Revise the inspection requirements for welds associated with the 85 percent rule contained in the Manual of Standards and Recommended Practices to include a standard for rejecting oversized welds on as-built tank cars. (R-23-18)
