Hazardous Materials Investigation Report HZIR-23-01

BNSF Railway Company Derailment and Pool Fire Involving DOT-117J Tank Cars

Oklaunion, Texas
January 8, 2022

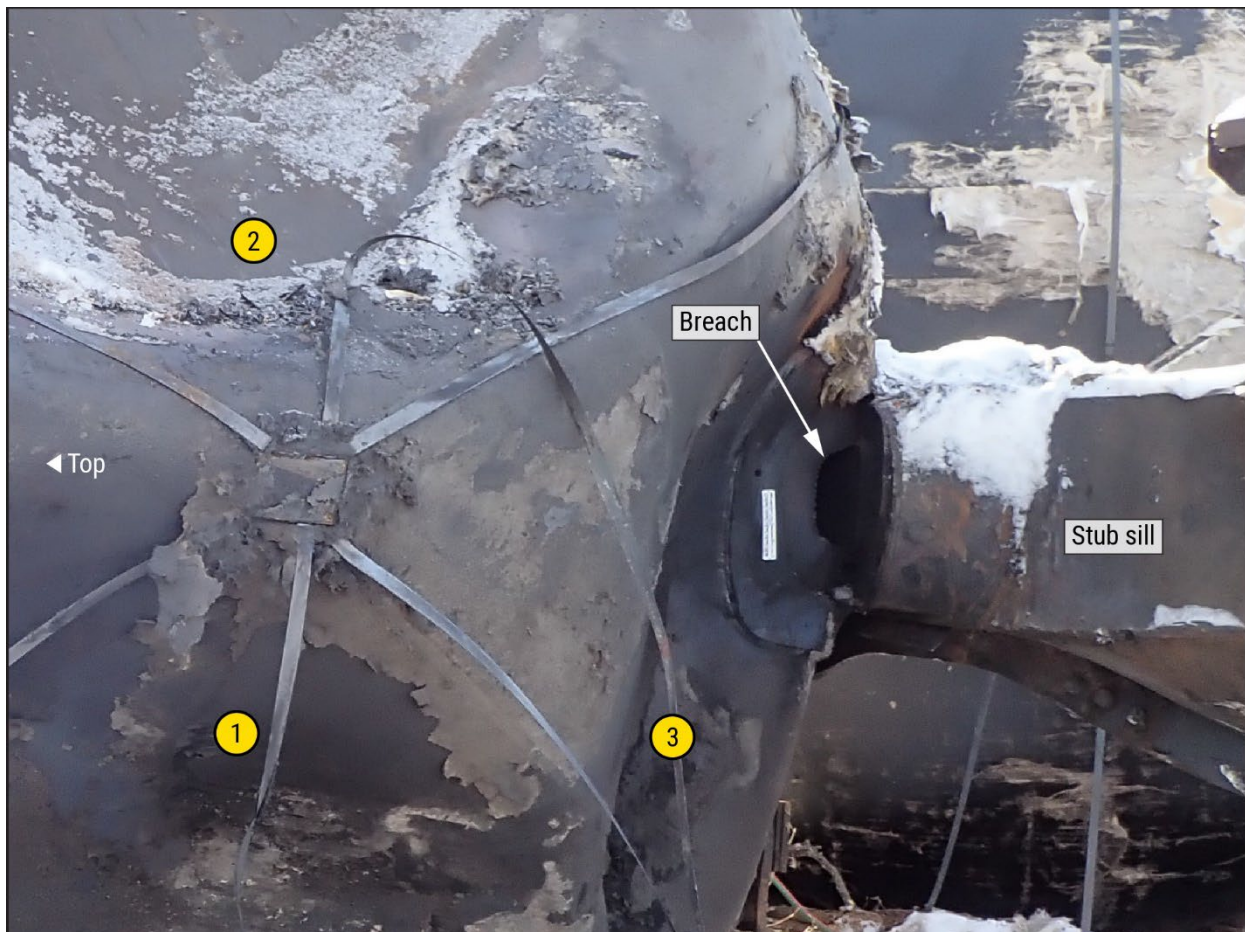
Visual examination of TILX731751, one of the seven tank cars with head or shell breaches, revealed the tank head material fractured near a weld joining the tank to the underframe assembly. (See figure 3.) This tank car was mechanically breached even though it was near the rear of the derailment pileup, where collision forces would have been lowest. The NTSB acquired a section of tank shell, head, and underframe assembly from this tank car for laboratory examination.

Figure 3. The A-end head of tank car TILX731751 postderailment and with the head shield removed for inspection, showing deformation from three impacts.

The fracture and deformation patterns were consistent with bending loads at the fracture locations, including through the front sill pad at the head brace weld toe and through the tank at the window weld in the front sill pad. The head and outboard portion of the front sill pad deformed upward and inboard relative to the stub sill and head brace. Like the visual evidence of larger deformations in the tank head, this deformation is consistent with the tank car sustaining impacts with other tank cars (See figure 3 above.)

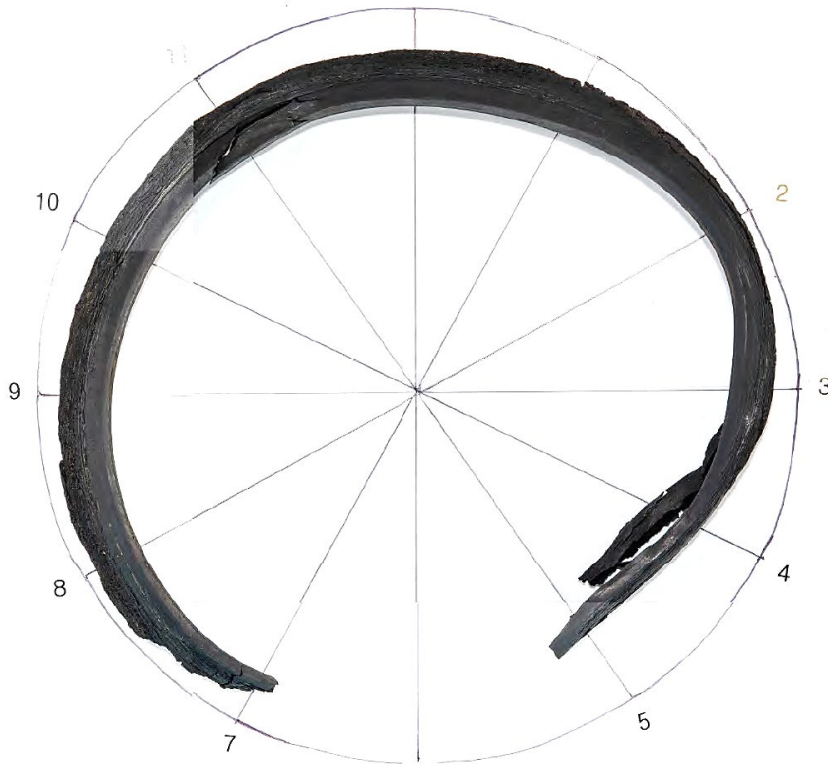
Gaskets sustained different degrees of damage at different locations relative to the pool fire. The manway cover gasket on a tank car near the edge of the pool fire (TILX731758) was cracked, missing material, and textured like alligator skin. (See figure 4 for an image of this gasket taken after the NTSB removed it from the scene.) The manway cover gasket on a tank car near the center of the pool fire (TILX731758) had burned to small fragments and carbon deposits, which were retained by the manway cover gasket groove. (See figure 5.)¹⁸ The NTSB examined service equipment removed from four derailed tank cars that were near the edge of the pool fire and had sustained less thermal damage than tank cars nearer the center. These examinations prompted laboratory tests of gasket material thermal performance.

Figure 4. Manway cover gasket removed from tank car TILX731758.

Work with the Pipeline and Hazardous Materials Safety Administration to develop and publish benchmark service and survival temperatures for gaskets to be used in tank cars used in flammable liquid service that reflect currently available gasket materials. (R-23-12)

Work with the Pipeline and Hazardous Materials Safety Administration to develop and publish thermal performance standards for gaskets used in tank cars in flammable liquid service that address both accident and normal transportation conditions. (R-23-13)

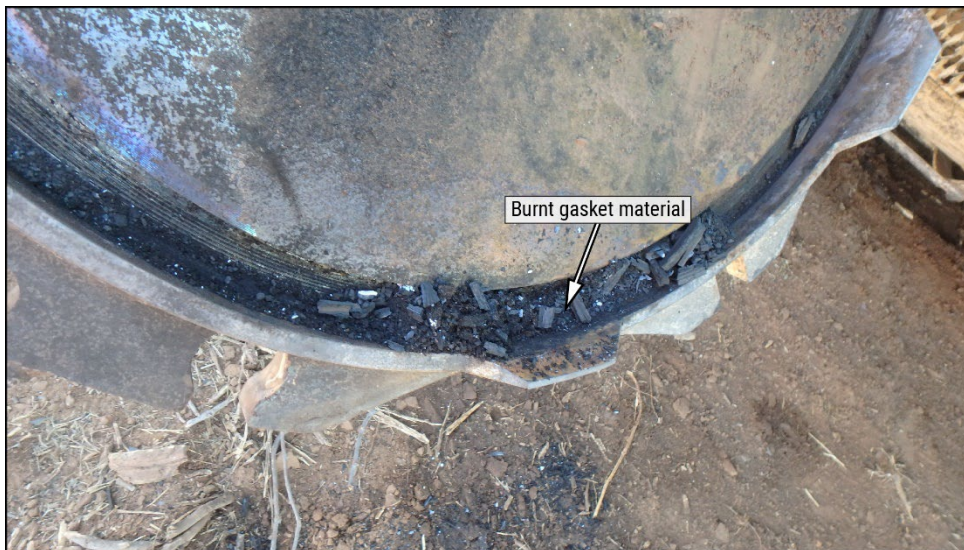
Figure 5. Open manway cover showing burnt gasket material on tank car TILX731739.

Laboratory tests of PRDs from these tank cars found that the internal gaskets had sustained thermal damage such that the PRDs could not retain lading significantly below the pressures at which the PRDs were designed to re-close.
