NTSB File No.: CEN21FA459

Aircraft: Rockwell Commander 690B

PROPELLER EXAMINATION REPORT

Propeller Model: HC-B3TN-5FL with LT10673B blades

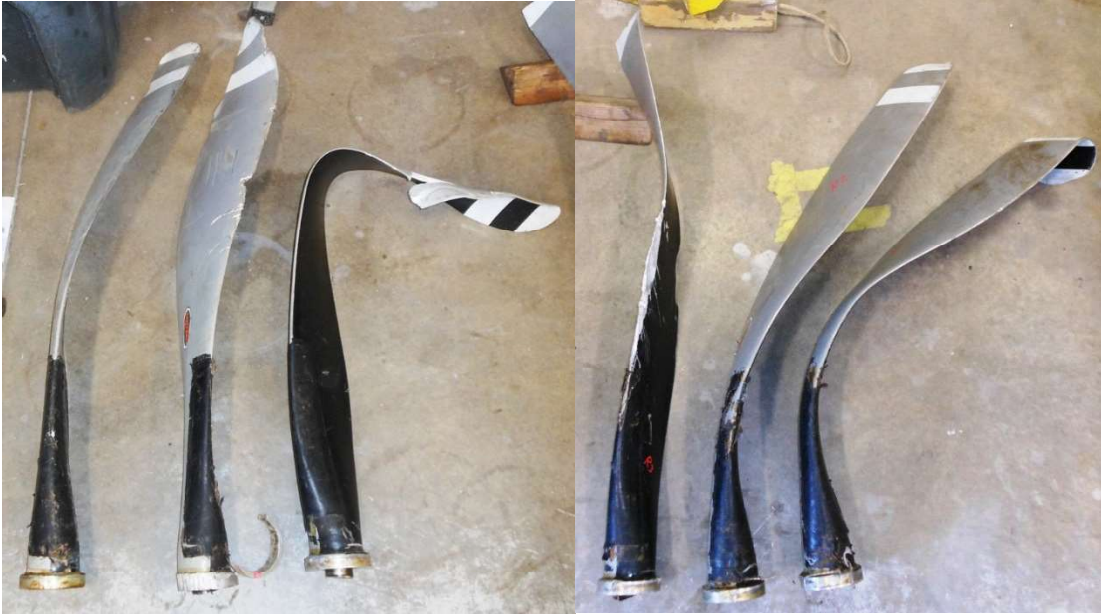
The comparison of bending and twisting between left and right propellers showed similar degrees and some similar characteristics, predominately aft bending and twisting to low pitch (Photo #1). Damage was consistent with rotation under low power at impact and suggested relative power symmetry.

Photo #1 – Relative blade damage

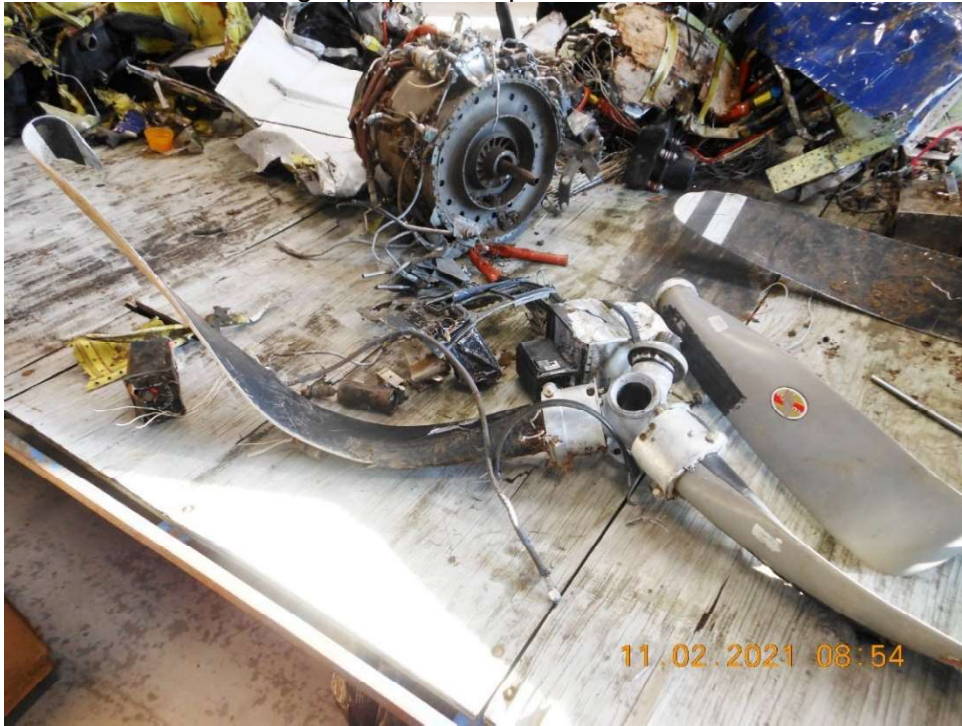
“As Received” Condition: The propeller assembly fracture-separated from the engine propeller shaft flange and was presented for examination as shown on the left side of Photo #2. The propeller was recovered near the main wreckage. One blade fracture-separated from the propeller assembly but was recovered near the main wreckage. The spinner dome, bulkhead and hydraulic unit fracture-separated from the propeller assembly and were not recovered. Blade R3 fractured from the hub and only a portion of the R3 clamp was recovered. The pilot tube for R3 was also fractured. Blades R1 and R2 remained attached to the assembly by their respective clamps. The R2 counterweight arm and slugs were fracture-separated from the clamp and not recovered. Blades R1 and R2 exhibited visual slippage in the clamp toward low pitch. All three link arms were missing and presumed not recovered.

Photo #2 - Right propeller as-presented for examination

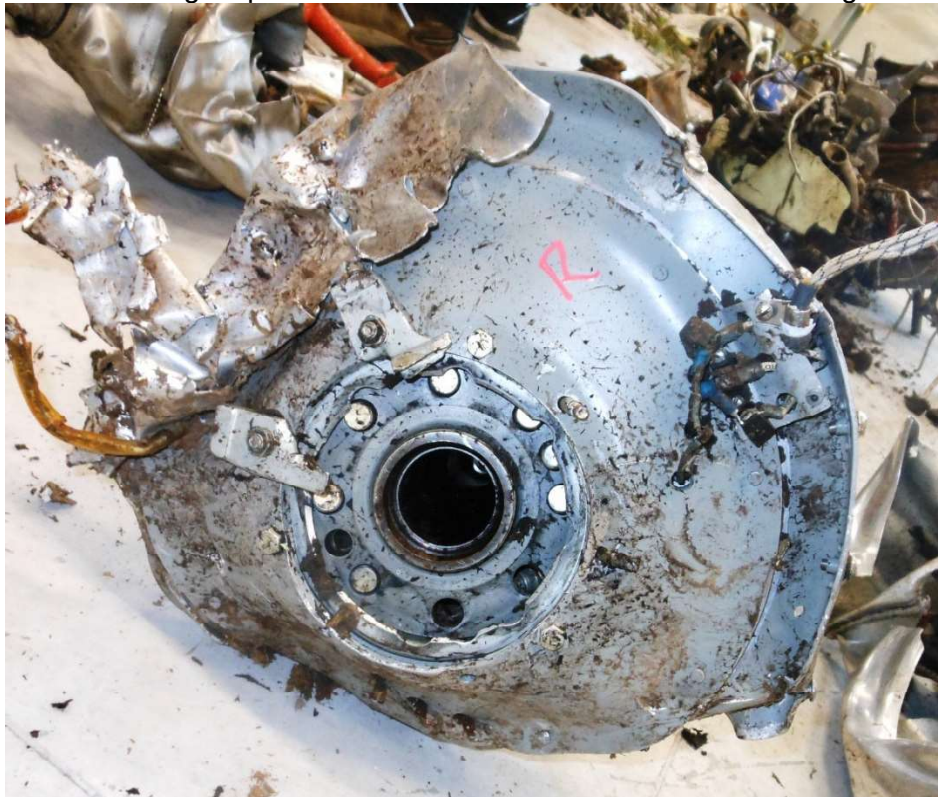
Spinner Dome: The spinner dome was torn from the propeller assembly and only a small fragment remained attached to the spinner bulkhead which was bent around the front of the engine (Photo #3). Various fragments of spinner domes were recovered at the crash scene but it could not be determined from which propeller (left/right) they originated.

Spinner Bulkhead: The spinner bulkhead fracture-separated from the propeller hub, was bent and torn and bent around the front of the engine (Photo #3).

Start Lock: Only fragments of one start lock bracket remained attached to the spinner bulkhead (Photo #3).

Photo #3 - Right spinner bulkhead and one start lock bracket fragments

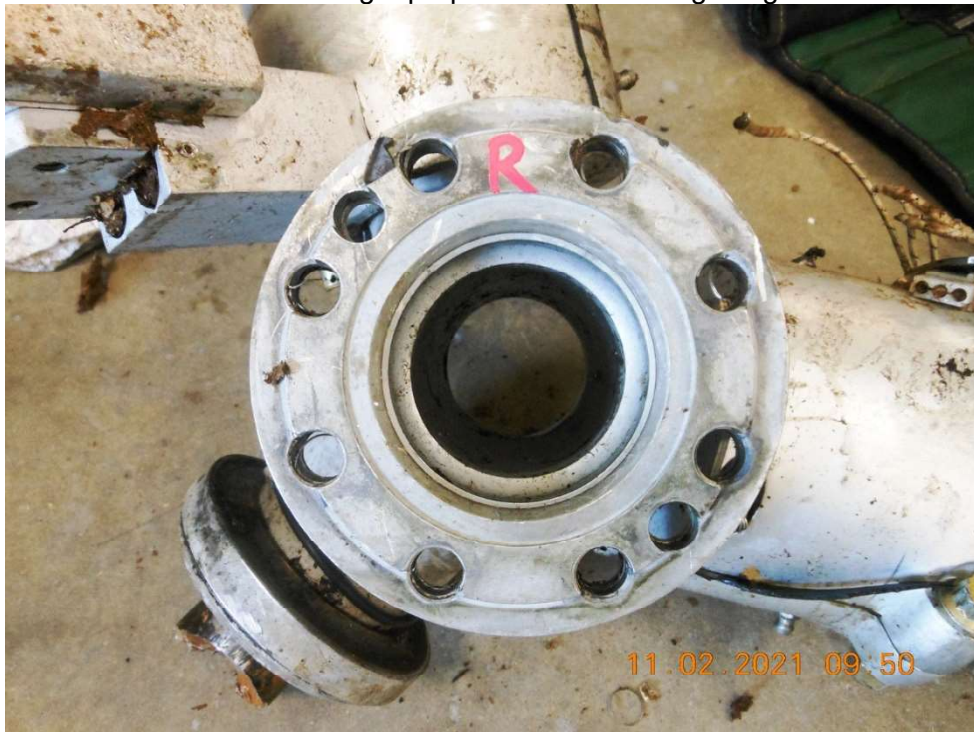
Engine/Propeller Mounting: The propeller hub separated from the engine propeller shaft flange. All eight mounting bolts pulled from the hub (Photo #4) and six bolts were visible in the engine propeller shaft flange.

Photo #4 - Right propeller hub mounting flange

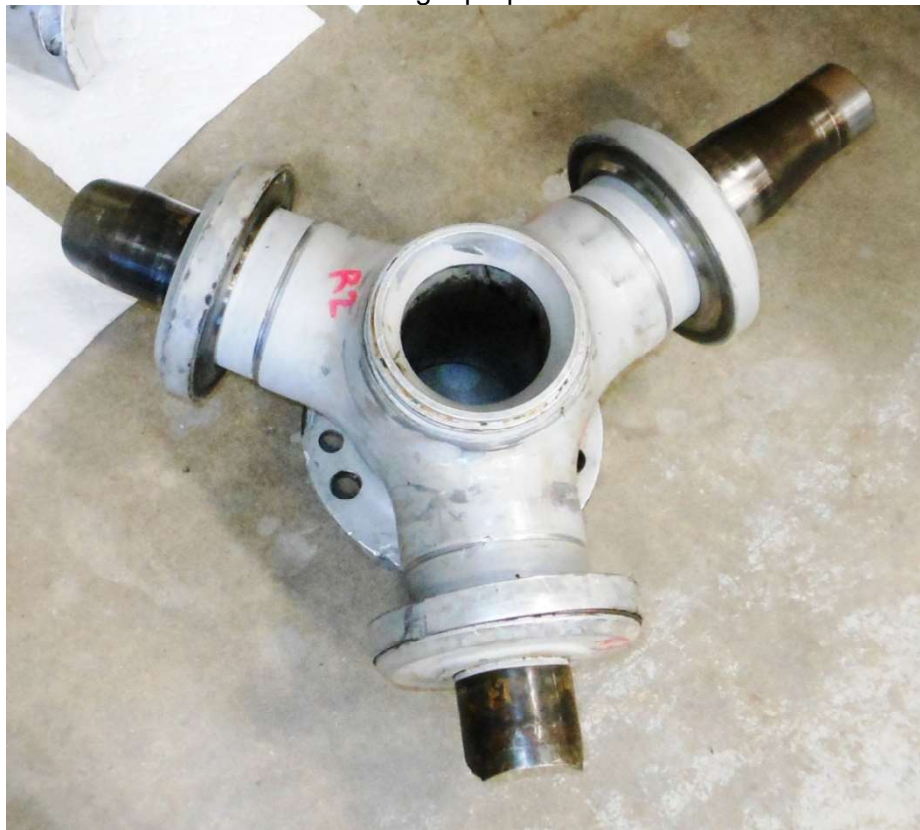
Hub Unit: The hub unit separated from the propeller shaft flange. All eight bolts pulled from the hub and there were some visible thread whiskers in the bolt holes. Six of the mounting bolts were visible in the engine shaft flange. The cylinder attachment boss/thread were intact. There were several clamp-to-hub contact marks on all three blade arms in varying degrees. The R1 pilot tube was intact, the R2 and R3 pilot tubes were fractured (Photo #5). There were blade-to-hub contact marks on two hub arm flanges and are summarized in Table #1.

Photo #5 - Right propeller hub unit

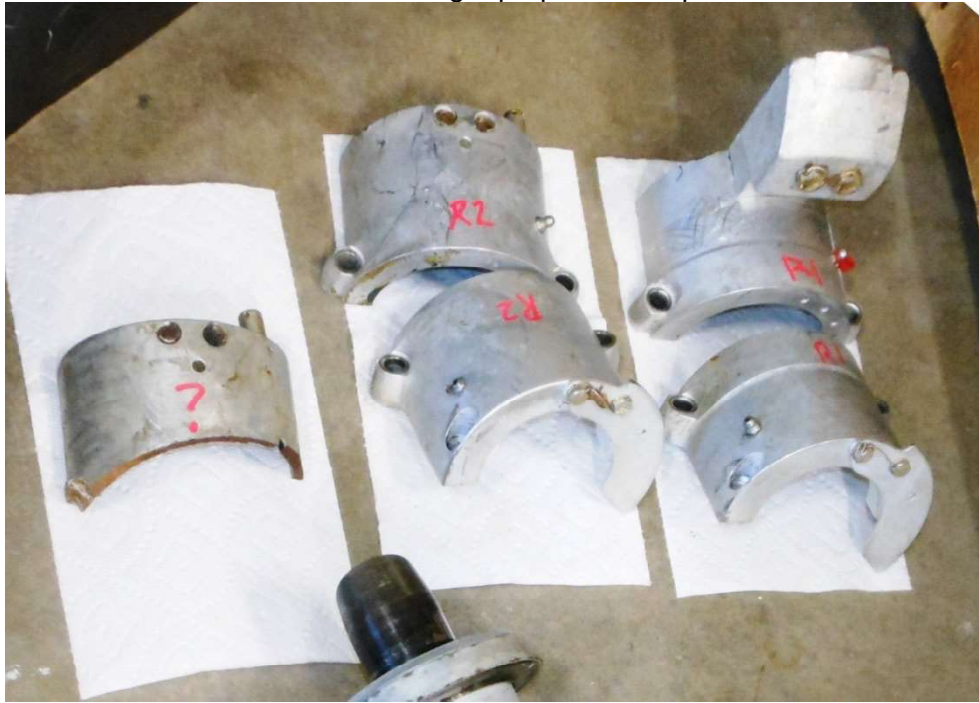
Clamp Pos.	Clamp S/N	Clamp Condition	Counterweight Condition
R1	EM23922	Intact with bolts secure. The link screw was deformed toward low pitch. There was a contact mark on the face side/inboard half. Start lock plate intact.	Intact
R2	DD922	Intact with bolts secure. The link screw was deformed toward low pitch. There was a contact mark on the face side/inboard half. Start lock plate intact.	Fracture-separated and not recovered.
R3		Fractured, only a small fragment of one half recovered.	Fracture-separated and not recovered.

Photo #6 - Right propeller clamps

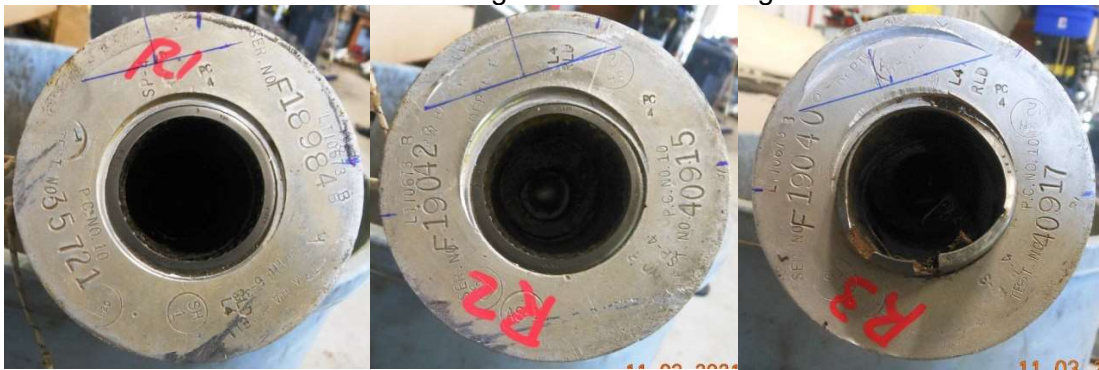
Impact crescent marks on both the left and right propeller blade butts were of similar location and depth, also suggesting some symmetry (Photo #7 vs. Photo #17). The location of the blade butt marks indicated the impact loads were primarily in the aft direction (not helical) suggesting a low blade angle, low power and relatively steep impact angle at moderate airspeed.

Camber side	Chordwise/rotational abrasion with material that appeared like tree sap
Face side	Chordwise/rotational abrasion with material that appeared like tree sap
Bend	5" of tip bent/curled aft. Blade bent aft and opposite rotation.
Twist	Toward low pitch
Lead edge damage	Nicks, wave-like bend in outboard area
Trail edge damage	Localized bending
Blade bearings	Intact and grease appeared normal
Butt/shank impact marks	Pilot tube shoulder impression and impact crescent 82° below trailing edge split line mark. (Photo #7)
De-Ice boot	Torn

Camber side	Chordwise/rotational abrasion
Face	Chordwise/rotational abrasion
Bend	Aft and opposite rotation, tip bent aft
Twist	Toward low pitch
Lead edge damage	Nicks
Trail edge damage	Nicks
Blade bearings	Intact and grease appeared normal
Butt/shank impact marks	Pilot tube fractured. Pilot tube shoulder impression and impact crescent 97.5° below trailing edge split line mark. (Photo #7)
De-Ice boot	Torn

Camber side	Not remarkable
Face side	Random scoring
Bend	S-bend
Twist	Outboard section twisted to low pitch
Lead edge damage	Gouging and chunking, mid-blade exhibited a mechanical shearing surface
Trail edge damage	Chunking
Blade bearings	Not recovered, ball separator remained on hub arm.
Butt/shank impact marks	Pilot tube shoulder impression (bore bearing displaced) and impact crescent 110° below trailing edge split line mark. (Photo #7)
De-Ice boot	Torn

Photo #7 - Right blade butt montage

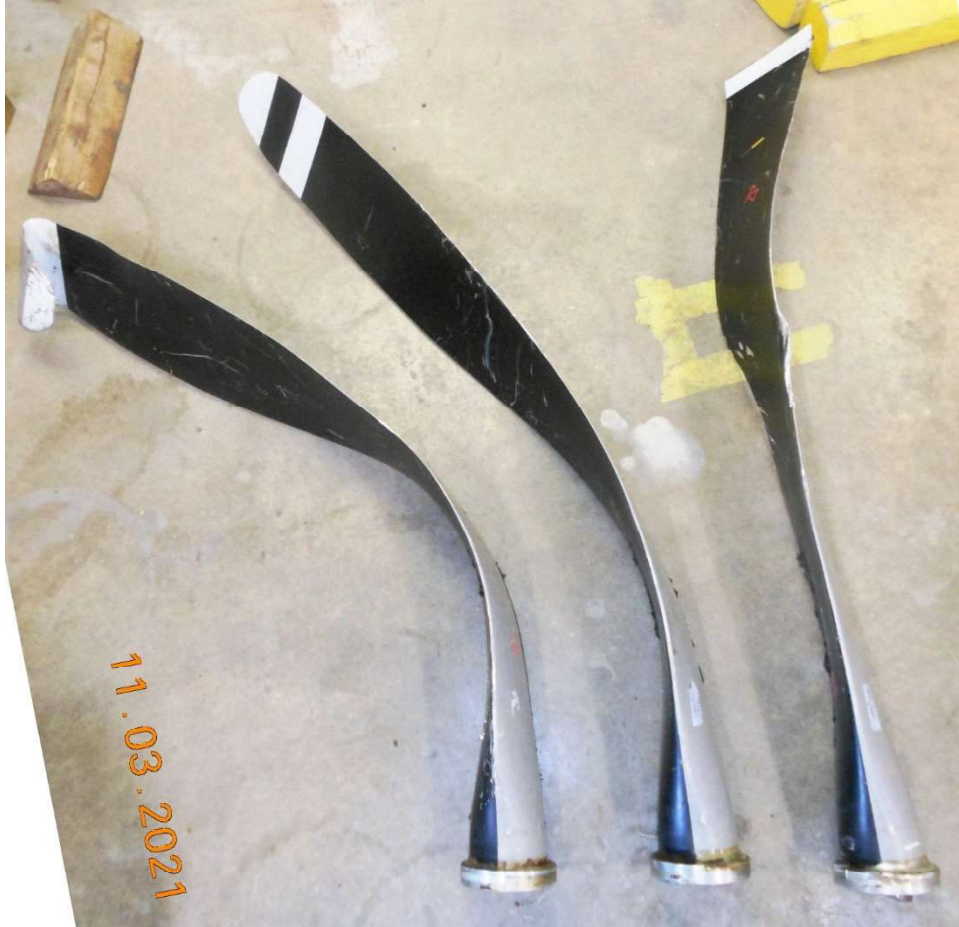
Photo #8 - Right propeller blades trailing edge view (R1, R2, R3 left to right)

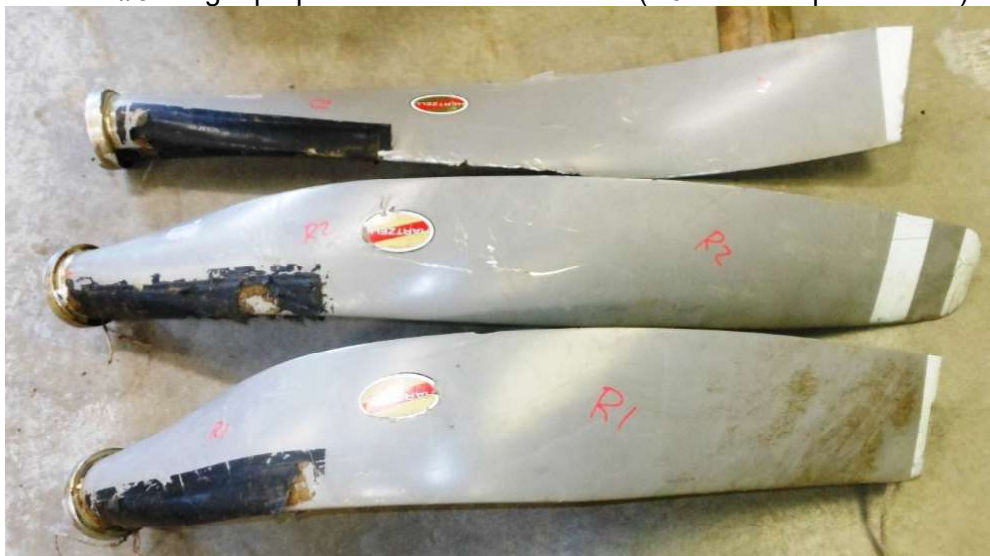
Photo #9 - Right propeller blades camber side (R3-R2-R1 top to bottom)

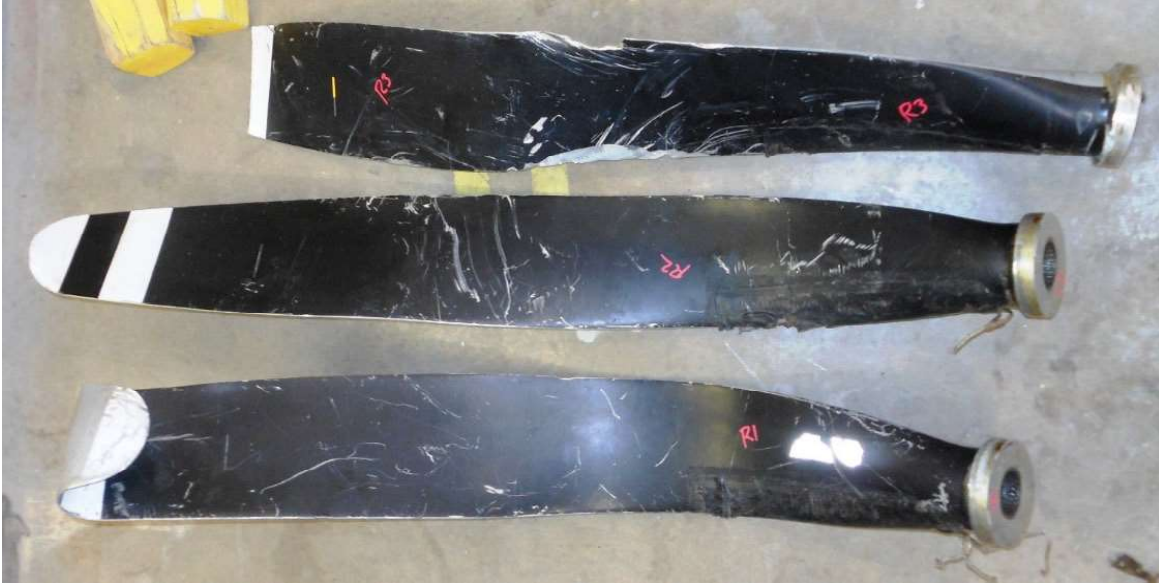
Photo #10 - Right propeller blades face side

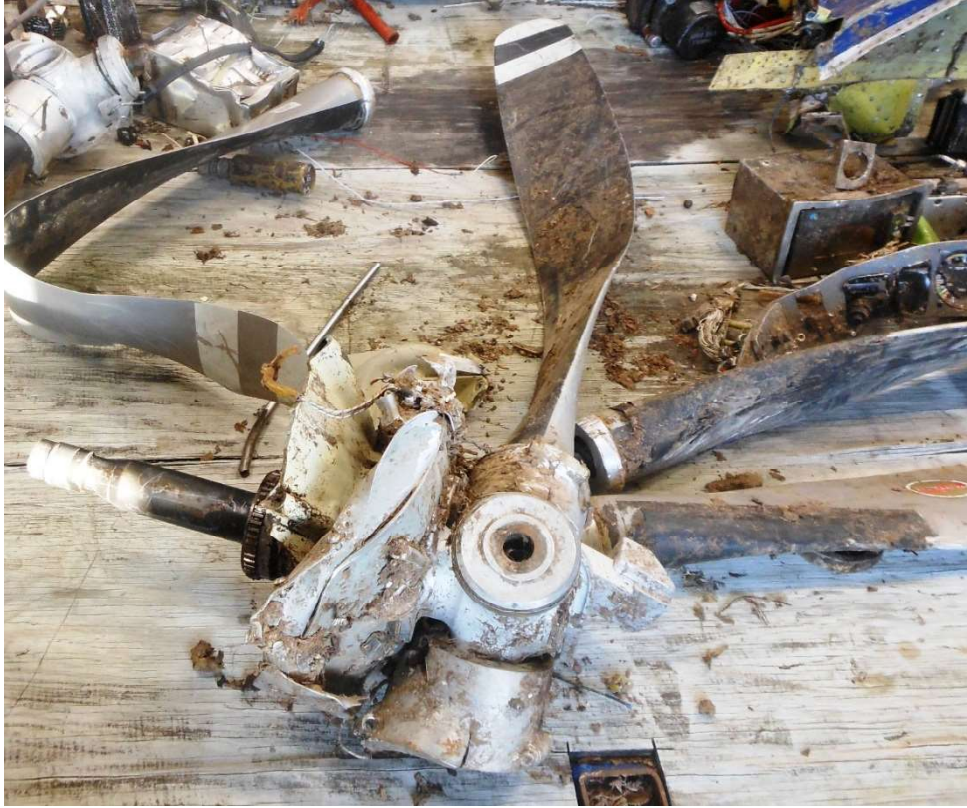
“As Received” Condition: The propeller, engine propeller shaft and forward section of the engine gear housing fractured from the engine during the impact sequence and was presented for examination as shown in Photo #11. The propeller mounting flange appeared intact but the propeller appeared displaced from the engine flange and several propeller mounting bolts appeared fractured. All three blades were recovered near the main wreckage. Blades L1 and L2 fracture-separated from the propeller assembly and the pilot tubes were fractured. The L1 clamp was not recovered. The L2 clamp fractured. The L3 clamp appeared intact. The spinner dome was torn from the assembly. All three blades appeared to be bent aft and twisted to low pitch. The hydraulic unit fracture-separated from the assembly and was not recovered. The L3 link arm was present, L1 and L2 link arms were not recovered.

Photo #11 - Left propeller as-presented for examination

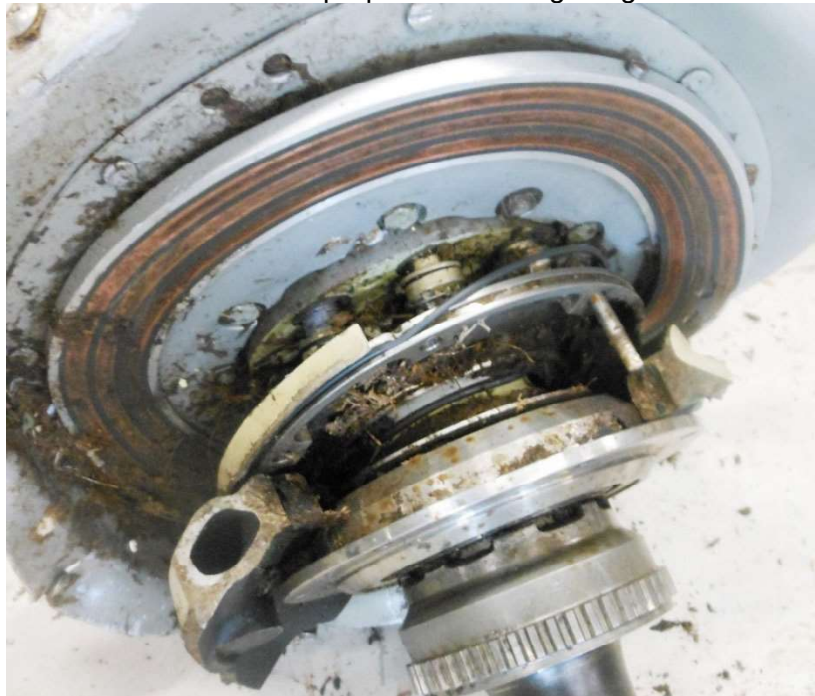
Engine/Propeller Mounting: The propeller mounting flange appeared intact but the propeller appeared displaced and several propeller mounting bolts appeared fractured (Photo #12).

Photo #12 - Left propeller mounting flange area

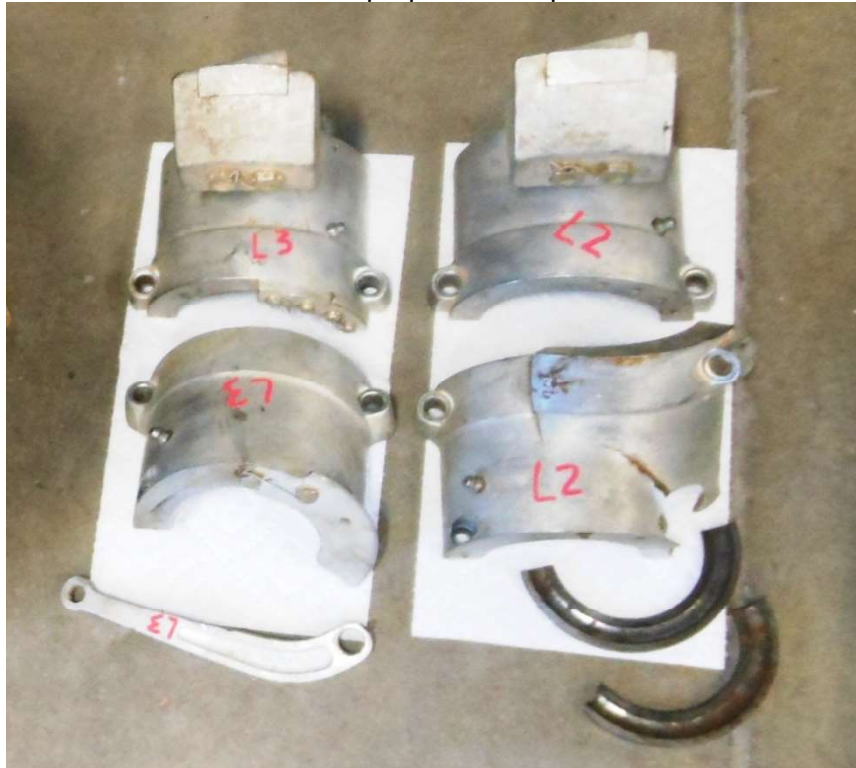
Clamp Pos.	Clamp S/N	Clamp Condition	Counterweight Condition
L1	Not recovered		
L2	EM12458	Fractured on face side/trailing edge quadrant. Inboard and outboard fasteners on trial edge side fractured. Start lock plate fractured from clamp, not recovered. Link screw cotter key sheared, link screw not remarkable.	Intact
L3	EM12460	Clamp intact. Start lock plate intact. Link screw cotter key sheared, link screw not remarkable.	Intact

Photo #13 - Left propeller clamps recovered

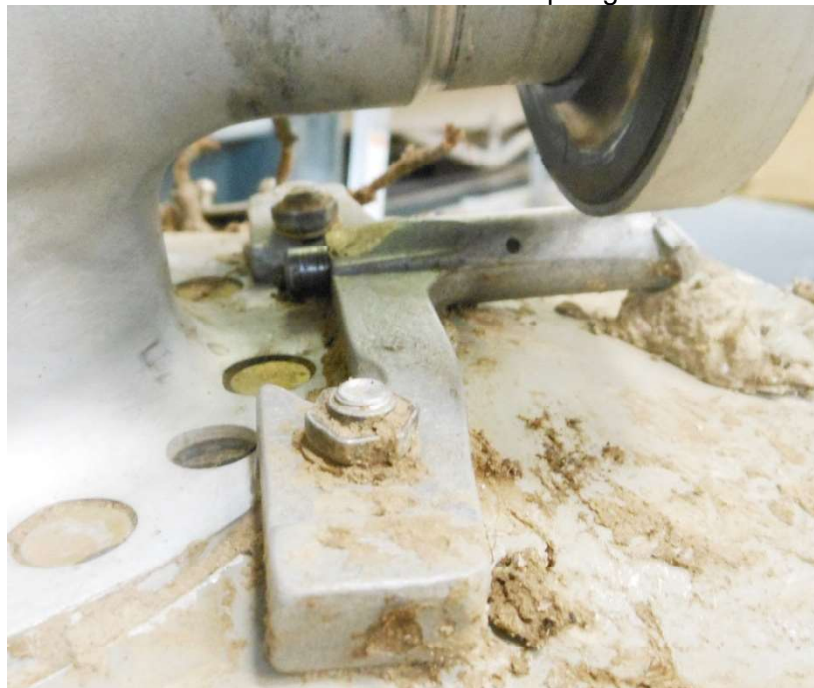
Start Lock: All three start lock brackets were present, bent/fractured and L3 plunger was extended (Photo #14).

Photo #14 - L3 start lock bracket with plunger extended

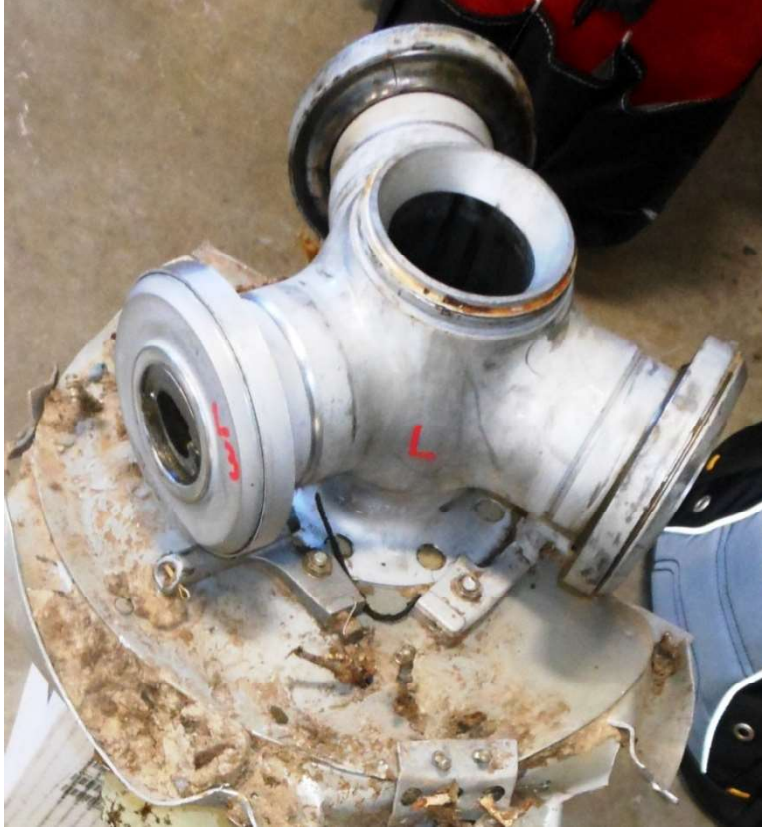
Hub Unit: The hub unit remained attached to the propeller shaft flange. All eight mounting bolts appeared present with some fractured. The cylinder attachment boss was intact with some marring of the threads. There were several clamp-to-hub contact marks on all three blade arms in varying degrees. All three pilot tubes were fractured (Photo #15). There were blade-to-hub contact marks on two hub arm flanges and are summarized in Table #2.

Photo #15 - Left propeller hub unit/spider

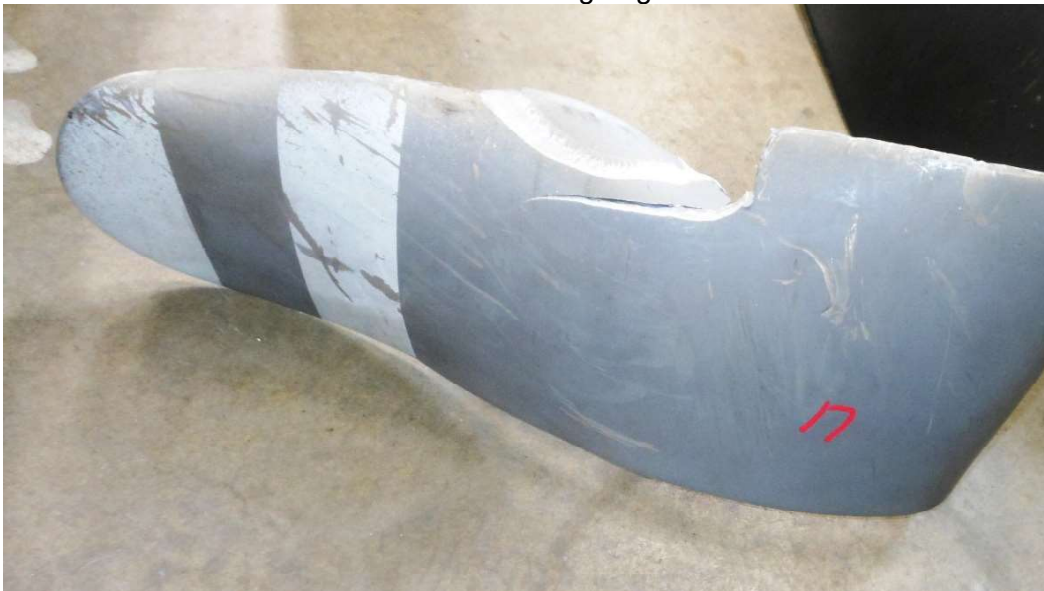
Camber side	Chordwise/rotational scoring and abrasion
Face side	Chordwise/rotational abrasion
Bend	Aft and opposite rotation
Twist	Towards low pitch
Lead edge damage	Wave-type bends consistent with tree strike. Fracture/tear 10" from tip, material deformation to low pitch (Photo #16).
Trail edge damage	Localized, random bending
Blade bearings	Not recovered
Butt/shank impact marks	Pilot tube fractured, fragment jammed in bore. Pilot tube shoulder impression and impact crescent in aft/trailing edge quadrant. (Photo #17)
De-Ice boot	Torn

Photo #16 - L1 blade leading edge fracture/tear

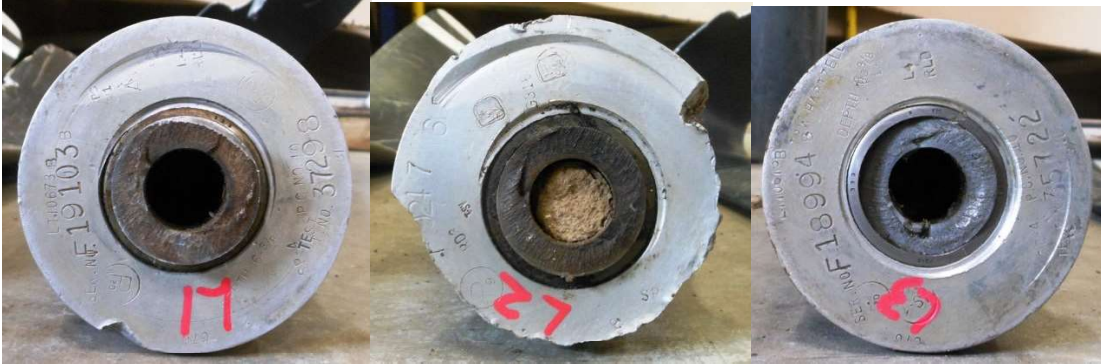
Camber side	Chordwise/rotational scoring and abrasion
Face side	Chordwise/rotational scoring in mid-blade and tip leading edge areas, random spanwise scoring along span
Bend	Aft and opposite rotation
Twist	Towards low pitch
Lead edge damage	Gouging and chunking, material deformation appears neutral
Trail edge damage	Localized bends, kinks and nicks
Blade bearings	Corroded, fractured race, ball imprints
Butt/shank impact marks	Blade retention radius sheared on camber side. Pilot tube fractured, fragment jammed in bore. Pilot tube shoulder impression and impact crescent in aft/trailing edge quadrant. (Photo #17)
De-Ice boot	Torn

Camber side	Chordwise/rotational scoring and abrasion
Face side	Chordwise/rotational scoring and abrasion
Bend	Aft and opposite rotation
Twist	Towards low pitch
Lead edge damage	Nicks and dents
Trail edge damage	Localized bends
Blade bearings	Intact, grease in good condition
Butt/shank impact marks	Pilot tube fractured, fragment jammed in bore. Pilot tube shoulder impression and impact crescent in trailing edge quadrant. (Photo #17)
De-Ice boot	Torn

Photo #17 - Left propeller blade butts

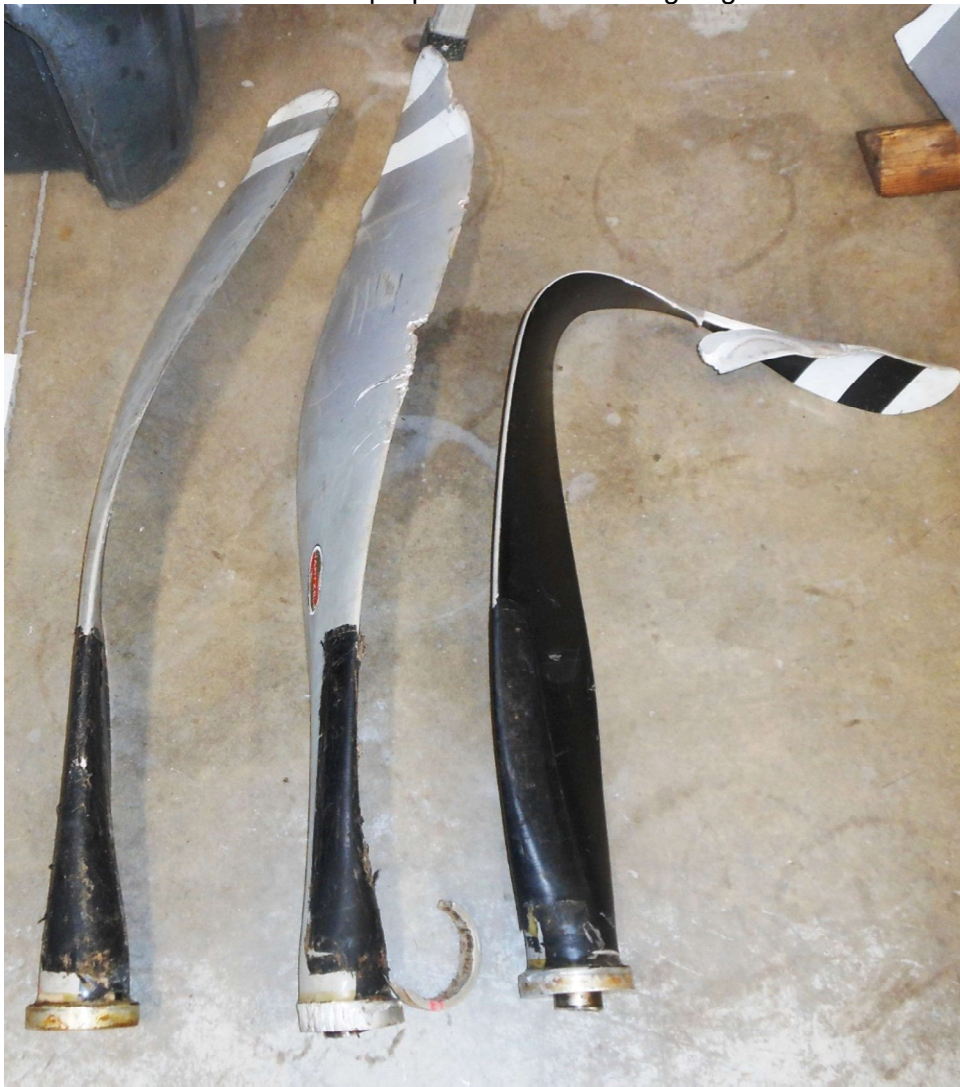
Photo #18 - Left propeller blades leading edge view

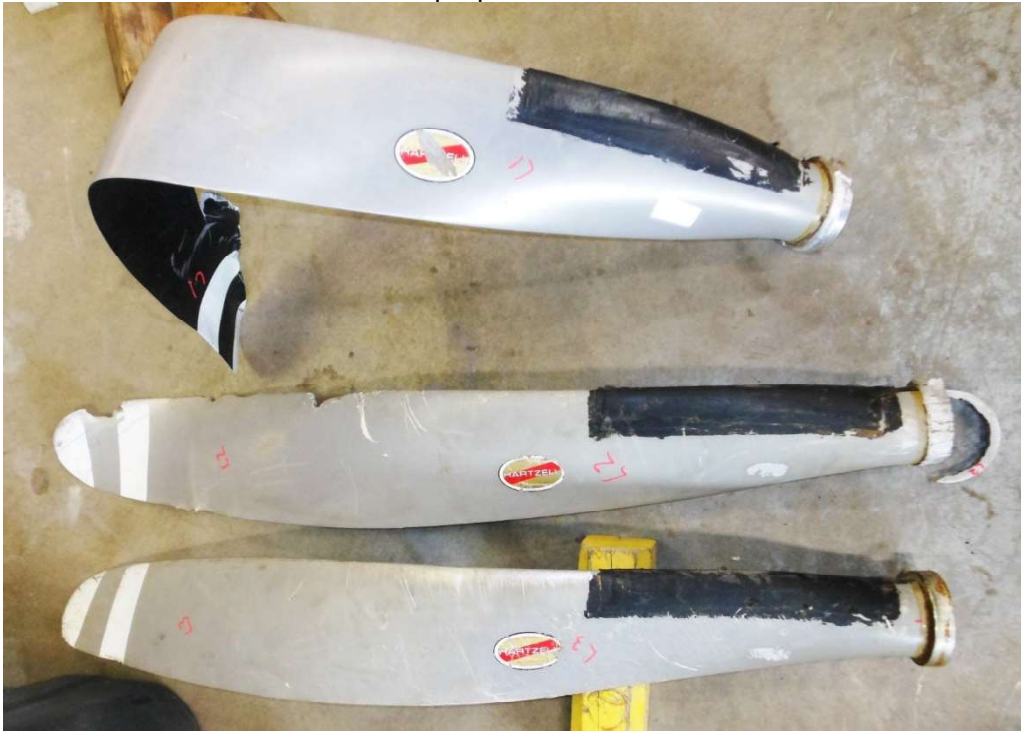
Photo #19 - Left propeller blades camber side

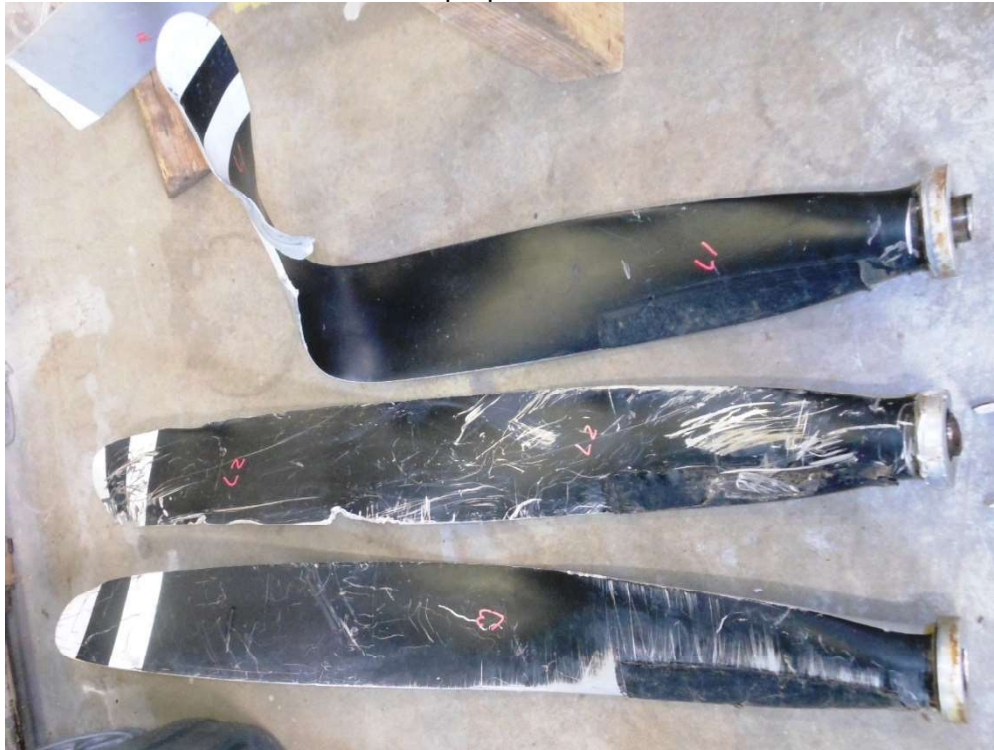
Photo #20 - Left propeller blades face side
