HAZARDOUS MATERIALS GROUP FACTUAL REPORT

**Derailment of Union Pacific Railroad Train UEBLTG 20
on April 24, 2019, with Subsequent Hazardous Materials Release**

Fort Worth, Texas

RRD19FR007

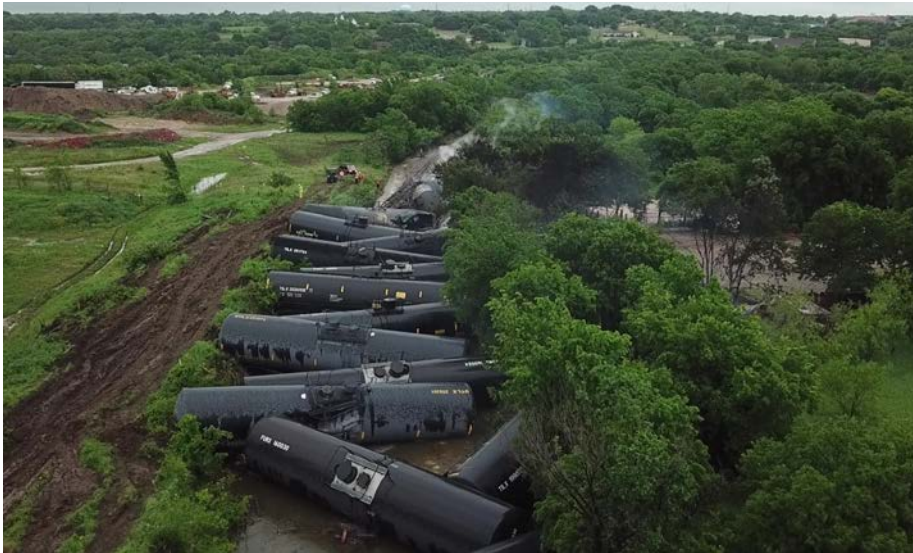
Figure 1: Accident scene, Ft. Worth, Texas.

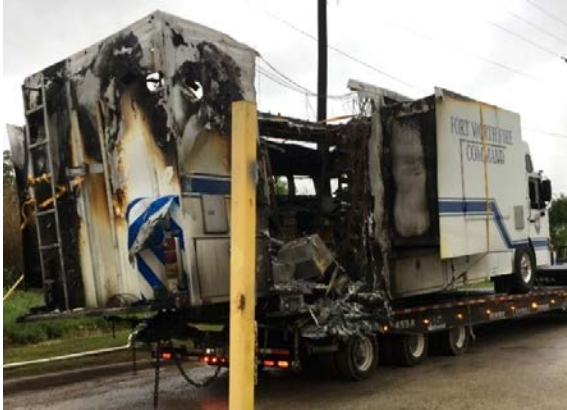
“unpredictable powerline placement,” the camera boom was raised into high-voltage overhead power lines. The command unit “became energized and untenable.” One fire chief reported that he felt a slight electrical shock when attempting to enter the command vehicle. The unit was evacuated before it caught fire and its loss did not ultimately impede the emergency response effort (Figure 2).

Figure 2. Destroyed Fort Worth Fire Department incident command vehicle.

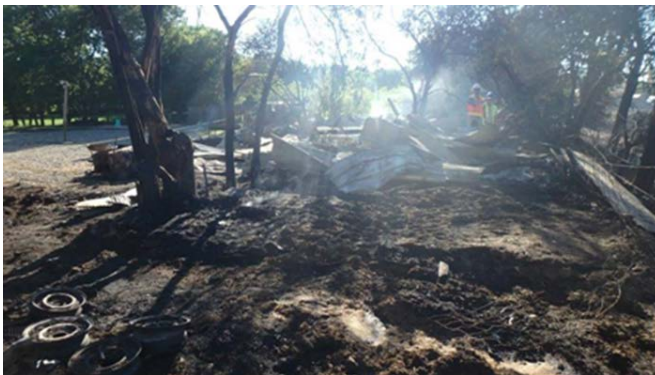
Figure 3. Investigators examine destroyed horse stables next to the derailment scene.

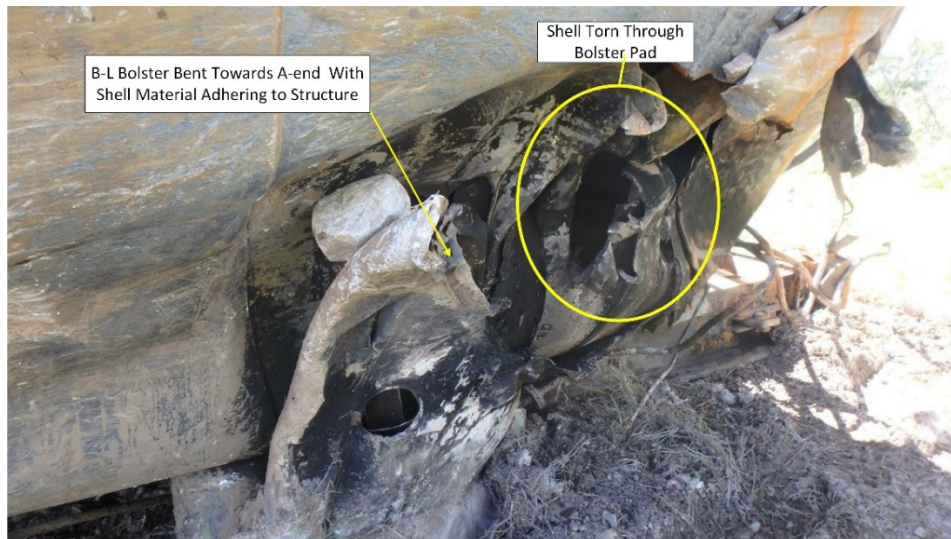
- Shell tear, 6 x 13-inches, across the B-L body bolster pad. The bolster was bent flat to the tank toward the A-end and appears to have shell material adhering to the weld attachment that was torn away from the tank (Figure 4).
- Top fittings multihousing protective cover was sheared from the flange and the liquid, vapor, vacuum relief valves, and a blind flange were broken away leaving four openings into the tank. The flange and surrounding tank jacket showed evidence of thermal damage. Shear pattern on the bolts show the impact came from the B-end direction. A dent and jacket tear also occurred on the opposite, A-end side of the flange (Figure 5).
- UP contractors confirmed that 27,290 gallons of ethanol were released from this tank car, while about 1,489 gallons were recovered.

Figure 4. Shell tear, 6 x 13-inches, B-L bolster pad area

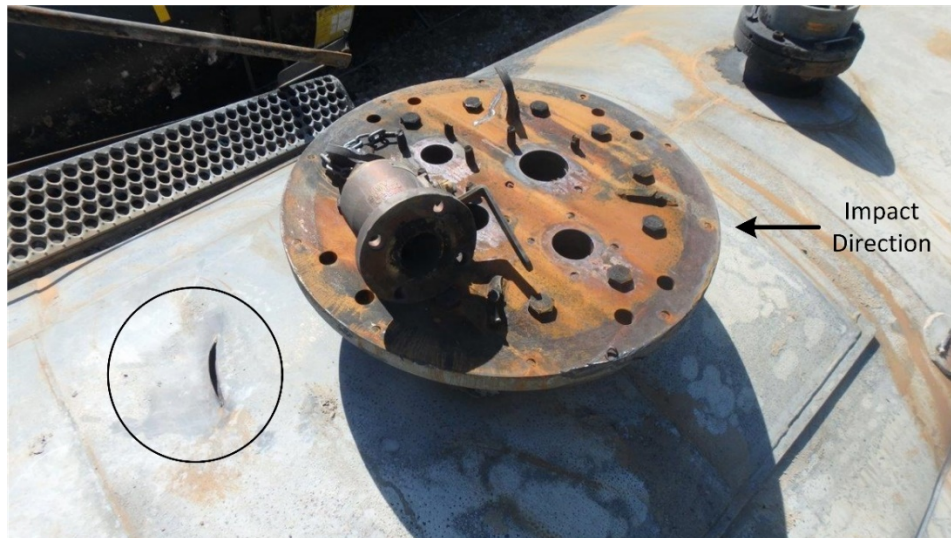
Figure 5. Top fittings flange showing missing multihousing cover, vapor valve, liquid valve, and VRV. A dent and jacket tear occurred on the opposite side of the flange (circled).

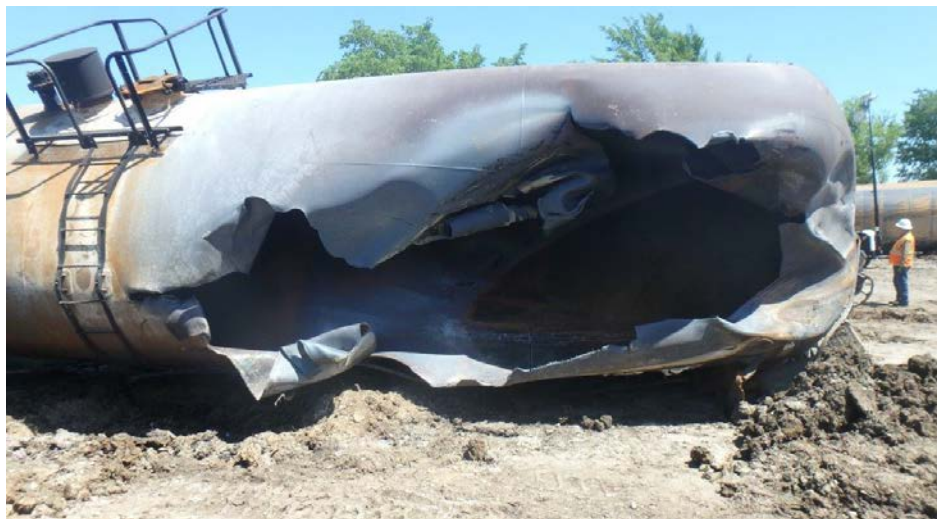
- Left side shell tear, 86 x 255-inches (Figure 6).
- B-end head punctured (Figure 7).
- Bottom outlet ball valve was open, handle was manipulated downward in the derailment.
- The tank car released its total load, about 28,779 gallons of ethanol.

Figure 6. TCBX 194145, left side shell tear.

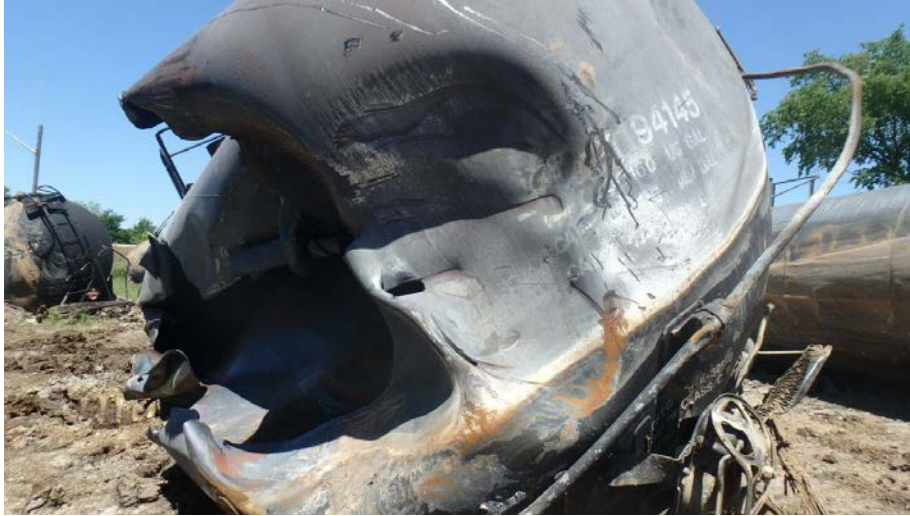
Figure 7. TCBX 194145, B-end head punctures and dents.

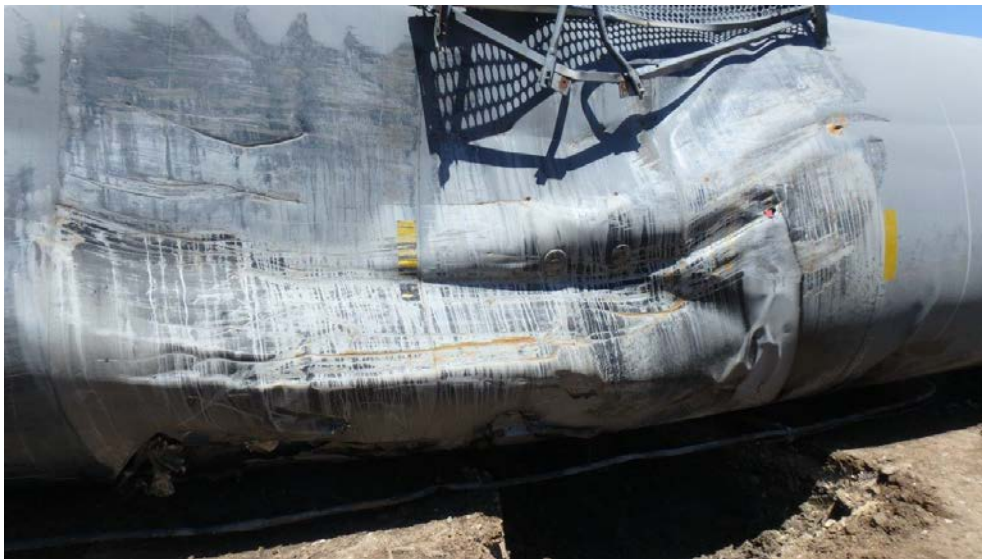
- The left side of the car was impacted near center, resulting in a 2-inch diameter hole. The jacket was gouged about 19-inches wide toward the A-end about 13-feet (Figures 8 and 9).
- The tank had 44-inches of outage and released about 9,112 gallons of ethanol.

Figure 8. Dent and jacket damage to left of tank puncture.

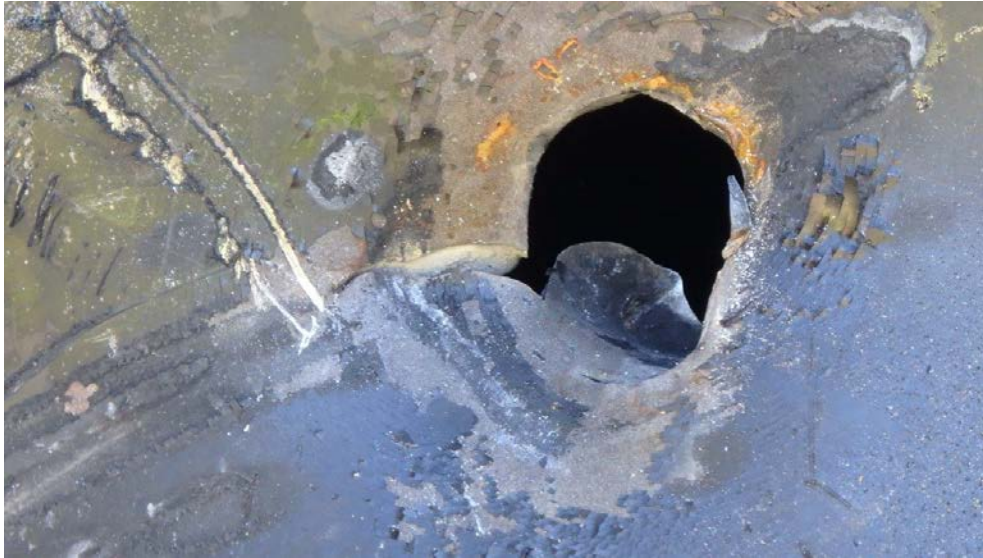
Figure 9. UTLX 209301, 2-inch diameter hole in tank shell.

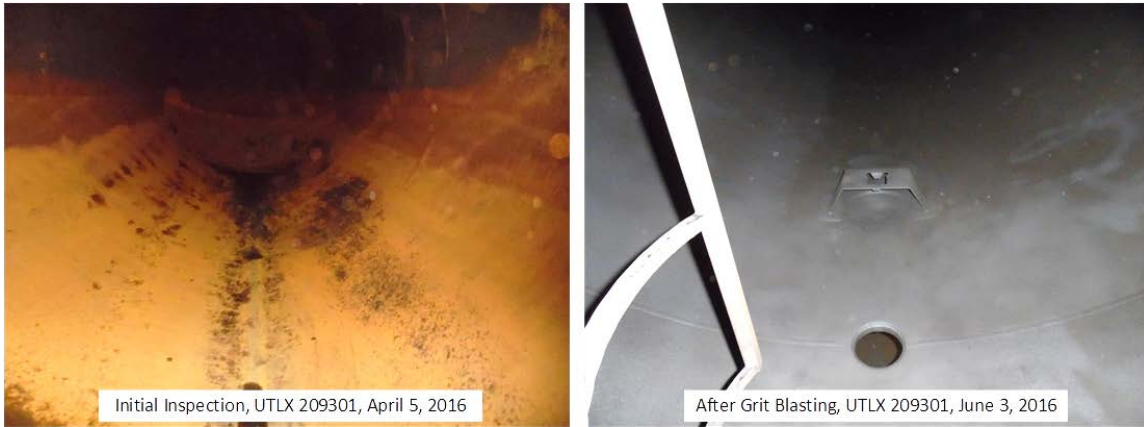
The tank corrosion inspection reports for both tank cars indicated the interior tank surfaces were uniformly “roughened” by corrosion. For both tanks, the tank inspector commented “rust bloom throughout.” However, the inspector reported there were no areas below the minimum corrosion allowance thickness that Union Tank Car determined was appropriate for these cars in accordance with 49 CFR Part 180.509(f) and (g) (Figure 10). Measured shell thickness at 3 o’clock and 6 o’clock (middle and bottom near each circumferential tank ring butt weld) for UTLX 209301 were no less than 0.450-inch and for UTLX 209403 no less than 0.446 inch.¹⁴

Figure 11. Before and after grit blasting. Views of the interior surface of UTLX 209301 during the 2016 shopping for qualification inspection, courtesy of Union Tank Car Company.

After the inspections were completed and prior to returning the cars to service, Union Tank Car grit-blasted the rust scale from interior surfaces of the tanks (Figure 11). Cargill leased these tank cars and placed them in ethanol service immediately following their qualification inspections and conversions to DOT-117R.

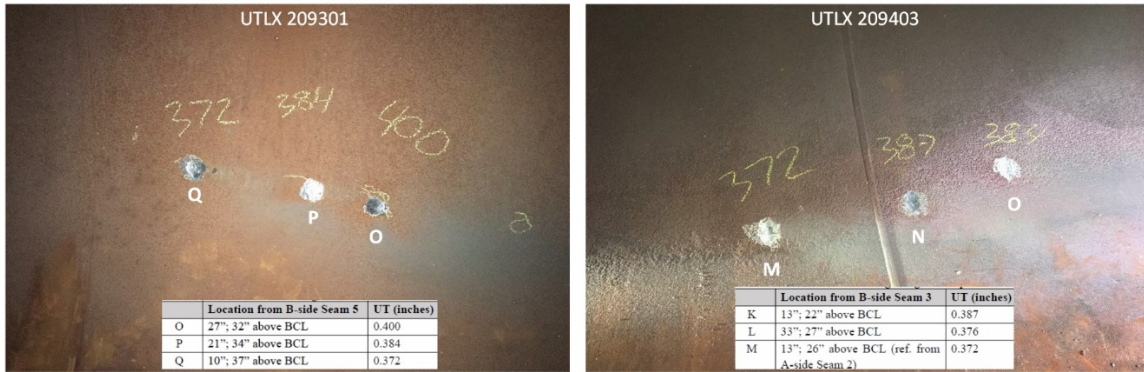
Figure 12. Minimum shell thickness locations and examples of corrosion observed in tank cars UTLX 209301 and UTLX 209403 during the June 18, 2019, ultrasonic thickness inspections.

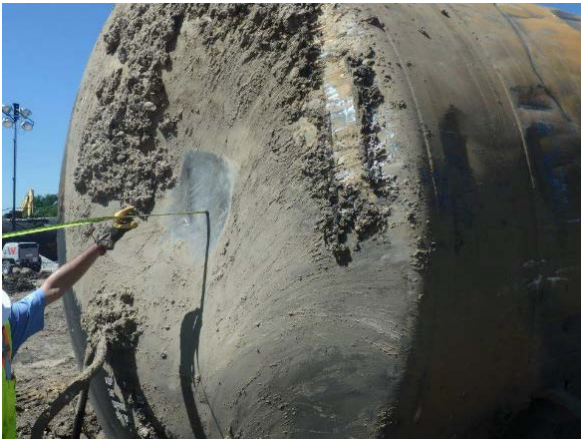
1(a) A-end head dent, 3' x4'

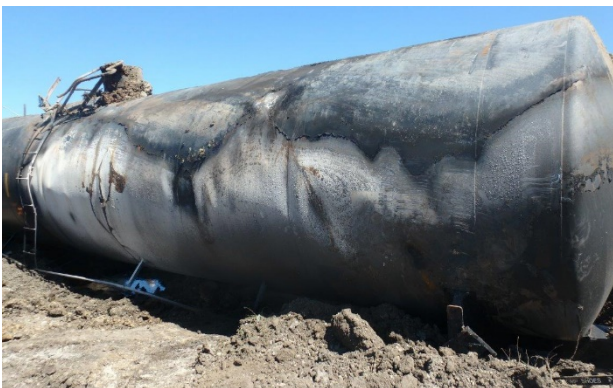
1(c) Thermal damage right side, center to A-end.

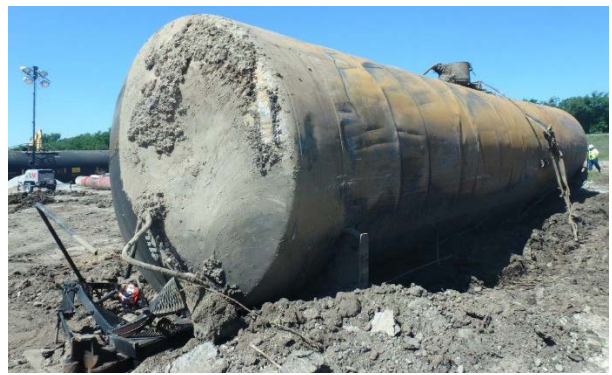
2(d) Left side ground surface contact area.

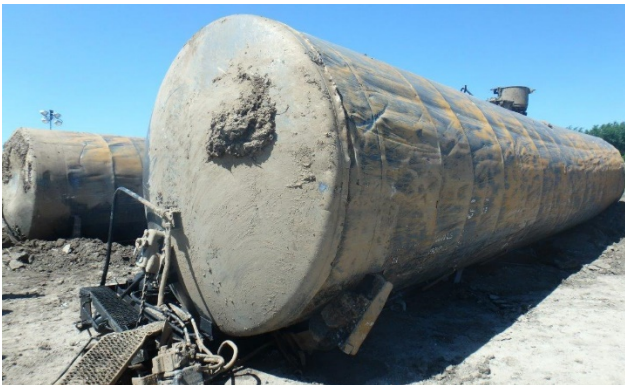
2(a) B-end head bent stub sill, right side shell with wrinkled jacket and scrapes.

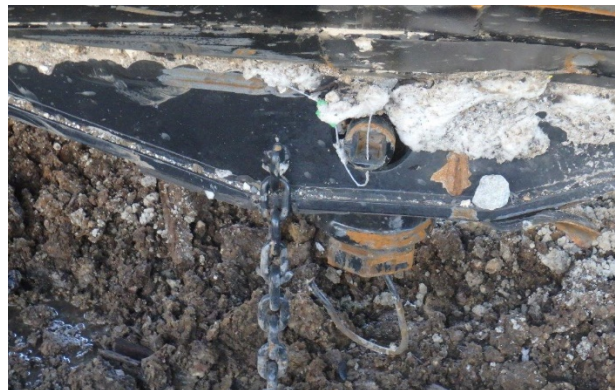
3(d) BOV missing operating handle and undamaged nozzle.

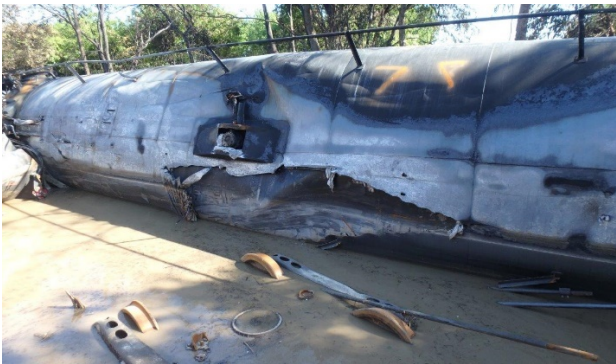
4(a) Tank bottom as found in the accident scene, showing thermal damage, with jacket tear and dent on B-L bottom.

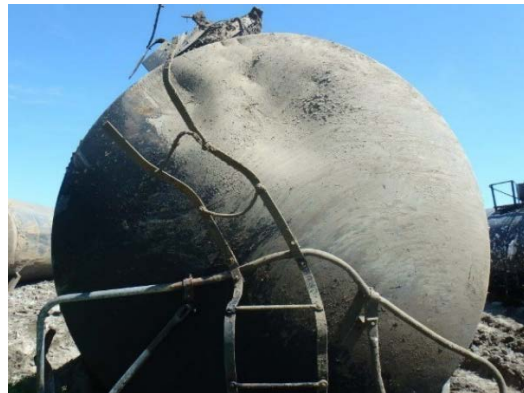
4(b) A-end head shield dents at 11 and 12 o'clock

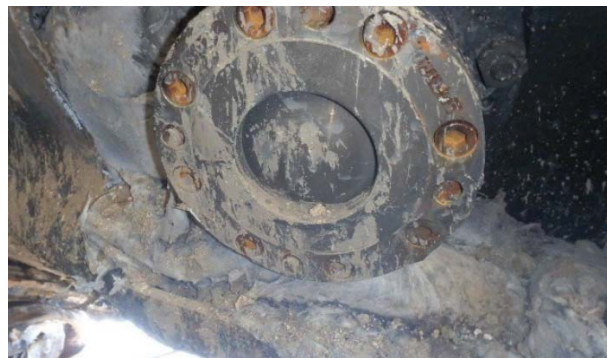
6(d) Thermally damaged BOV with missing nozzle.

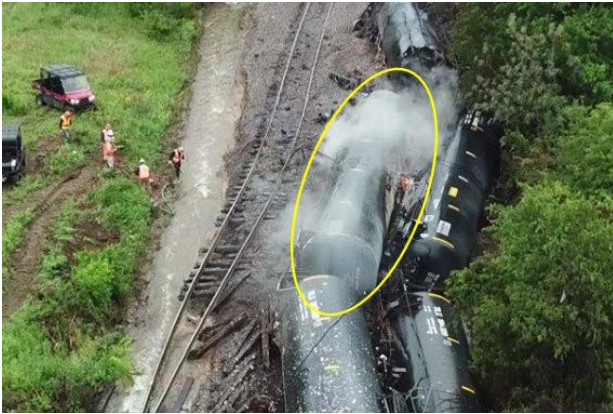
5(a) Car in the derailment scene on its left side with fire from top fittings impinging on adjacent car TILX 198946.

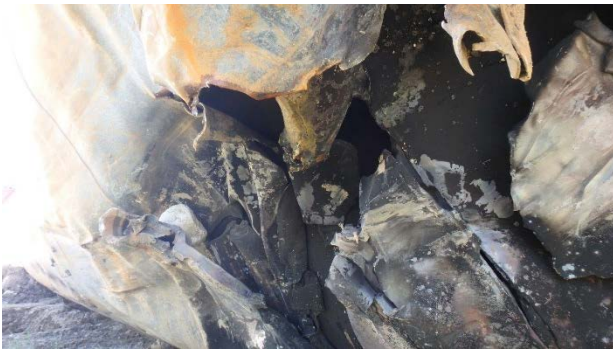
5(c) Fractured tank shell in B-R bolster region.

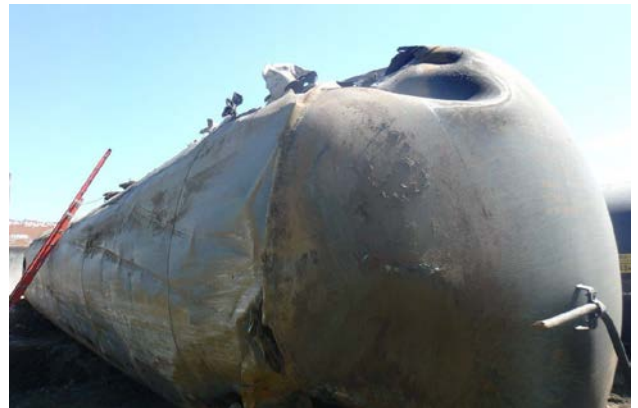
5(d) Deep B-end head dents at 11 – 12 o'clock.

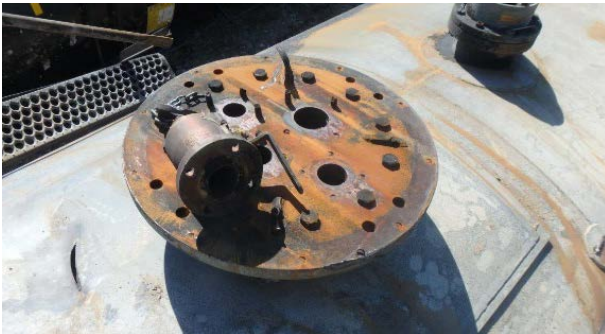
5(e) Top fittings flange with missing protective housing, liquid, vapor, and vacuum relief valves.

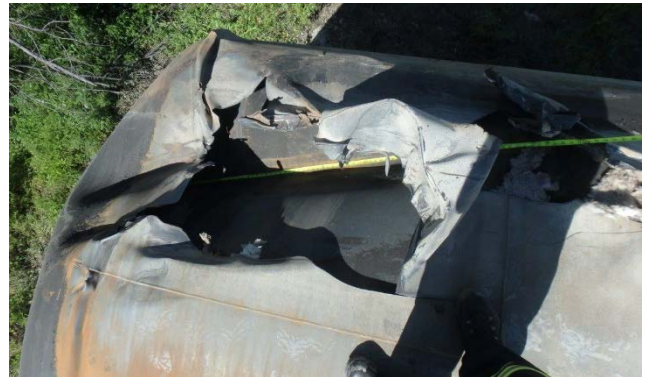
5(f) B-top jacket tear and dent 27" deep x 42" wide x 72 long.

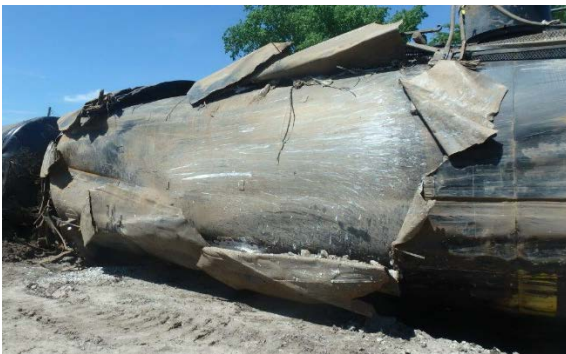
8(a) B-R side jacket tear and gouge. The gouge continued over jacket down the center left side.

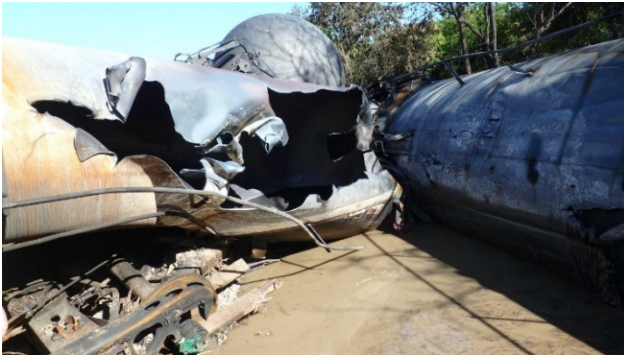
7(a) Car in the derailment scene showing the B-L irregular-shaped shell tear.

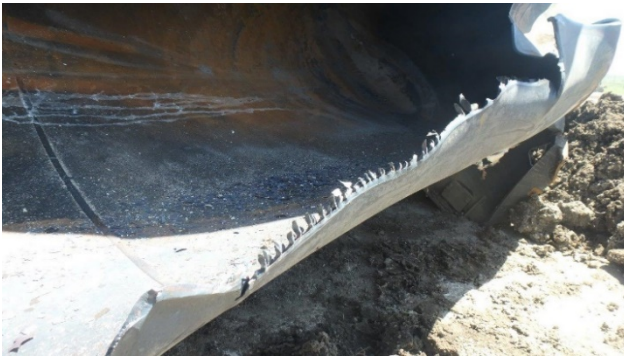
7(c) Bottom B-end shell breach with high-rate tearing fracture (sawtooth burrs) on bottom fracture surface.

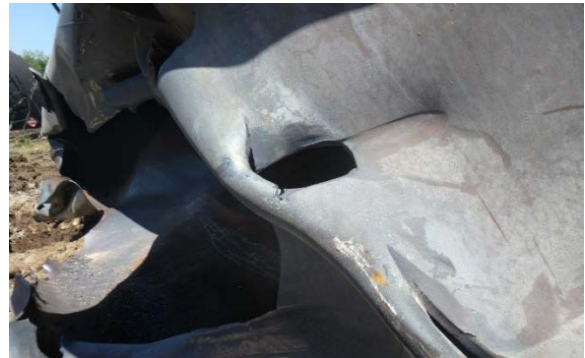
7(d) B-end head rectangular puncture and tear.

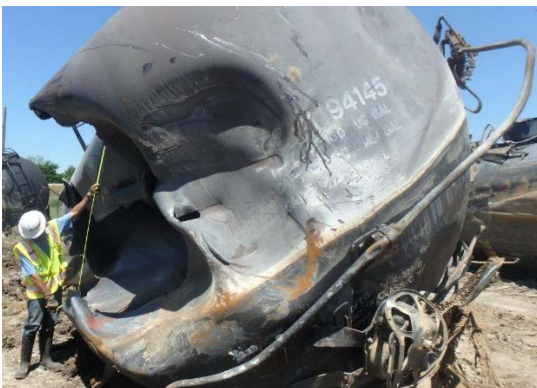
7(e) B-end head breaching damage.

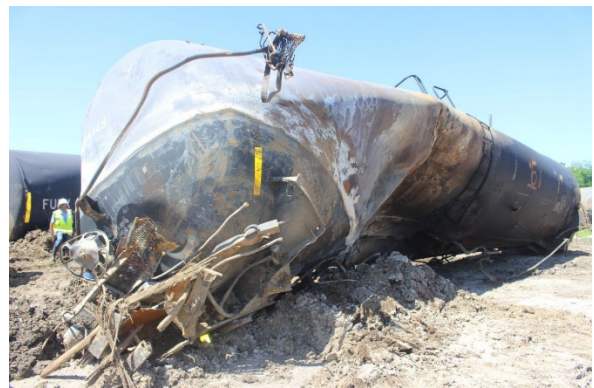
7(f) Buckled B-R side and thermal damage.

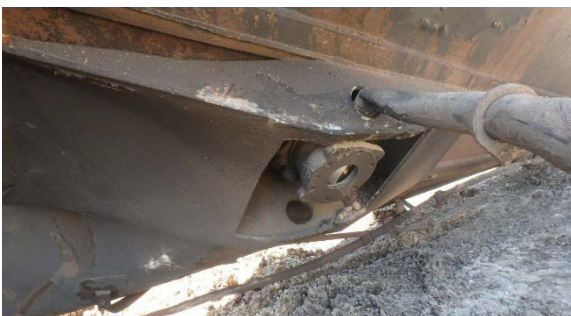
7(g) Open BOV ball valve, bent operating handle and fractured skid weld.

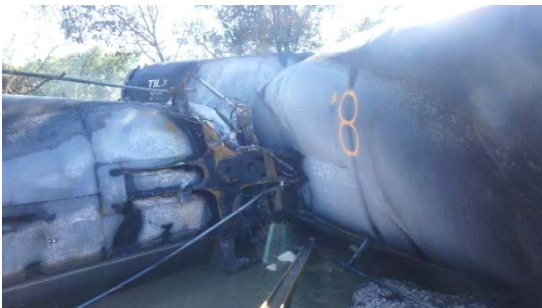
8(a) A-end stub sill of TILX 351873 wedged into the A-L shell as found in the derailment site.

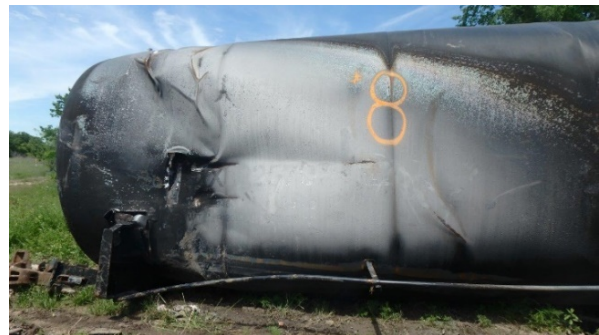
8(b) A-end impact location as seen in the staging area. Thermal damage to jacket paint.

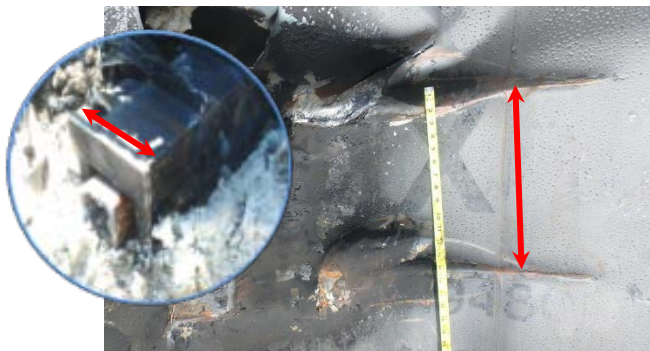
8(c) Stub sill 14” impact mark in A-L shell. The tank jacket is still in place. Inset photo is the stub sill of TILX 351873 showing relationship of impact mark to contact surface.

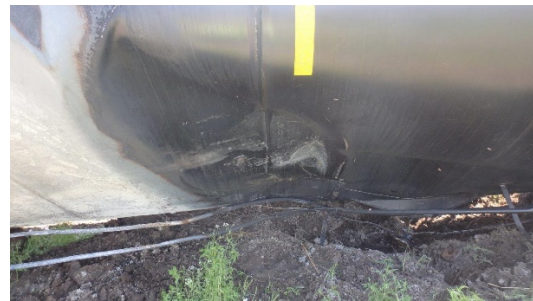
9(b) Buckled A-L shell and thermal damage to jacket.

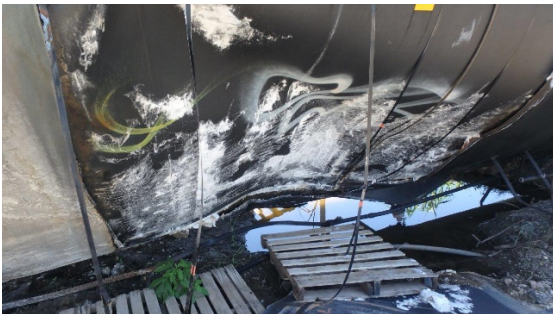
9(c) Buckled A-L shell after jacket removal, no crack found.

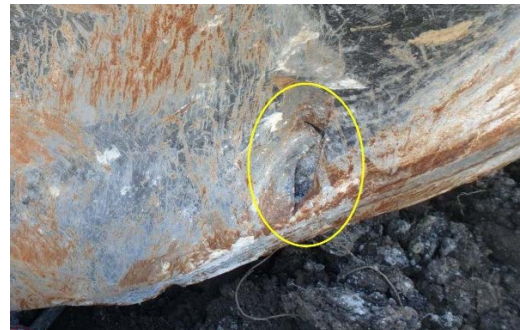
9(d) A-end head shield with 2" x 8" puncture.

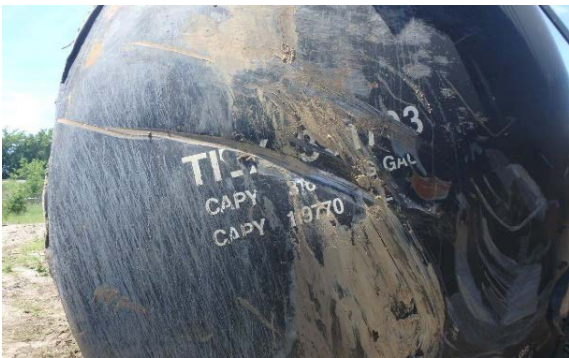
10(a) A-end head shield gouges about 10 o'clock.

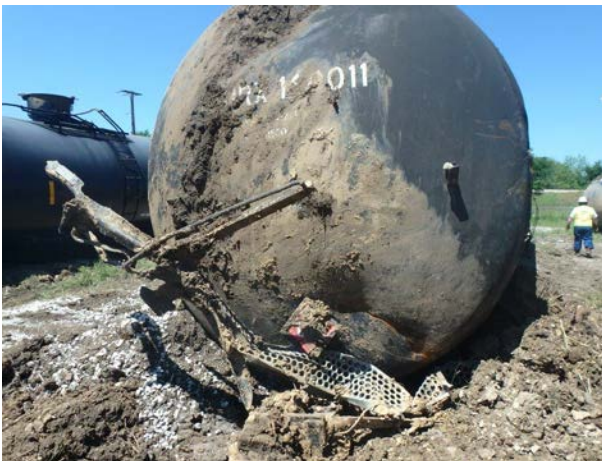
11(a) A-end head shield and gouge at 5-6 o’clock.

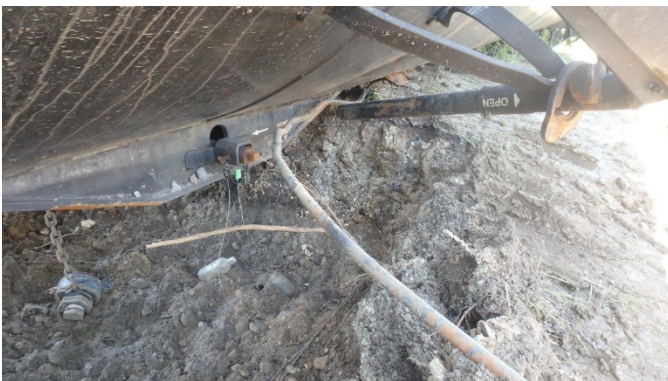
11(c) BOV operating handle separated from the ball valve extension shaft.

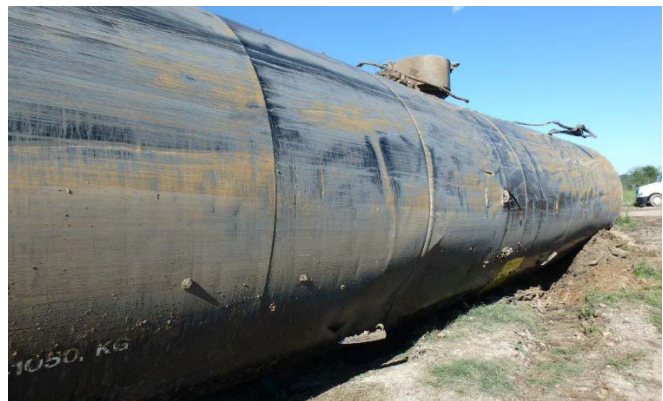
13(b) Right side, jacket wrinkles and scratches.

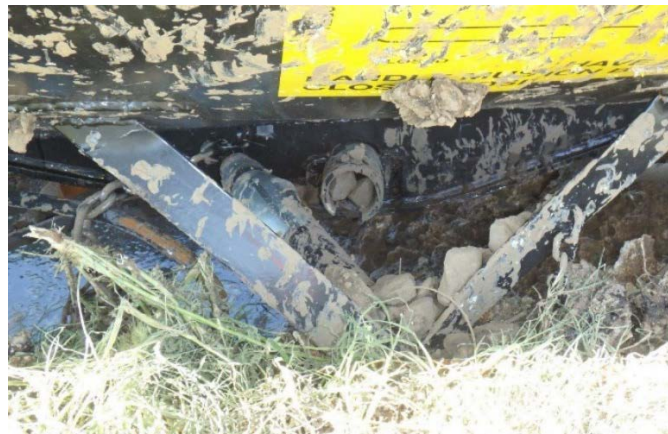
13(d) The BOV operating handle sleeve bent away from ball valve extension.

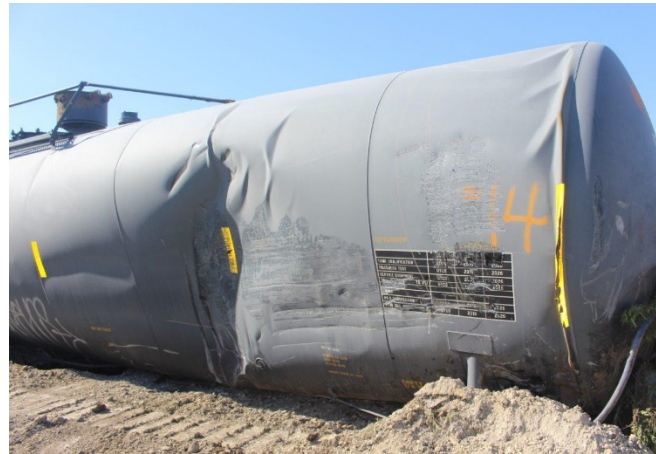
14(b) B-L dent/buckle, 5' x 8', adjacent gouge and scrape marks.

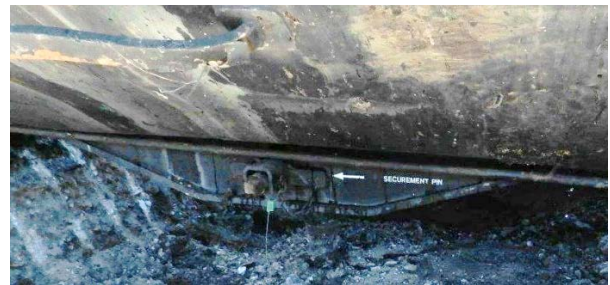
15(d) Missing BOV operating handle and undamaged nozzle extension. The ball valve extension shaft securement pin was in place.

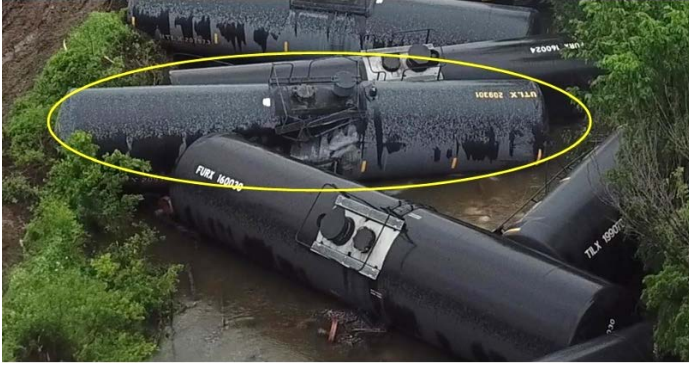
16(a) UTLX 209301 as found in the derailment scene, showing position of impacting car FURX 160030.

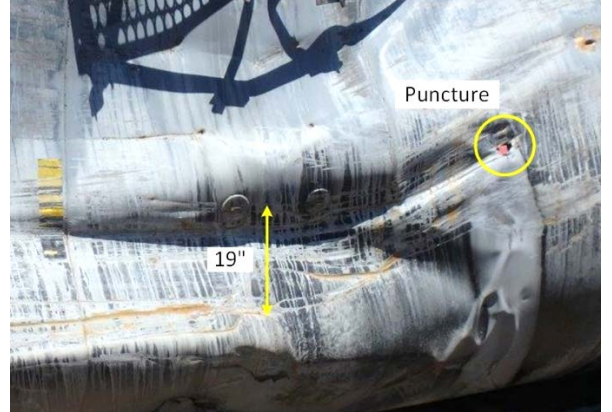
16(b) Puncture location and 19" wide gouge marks.

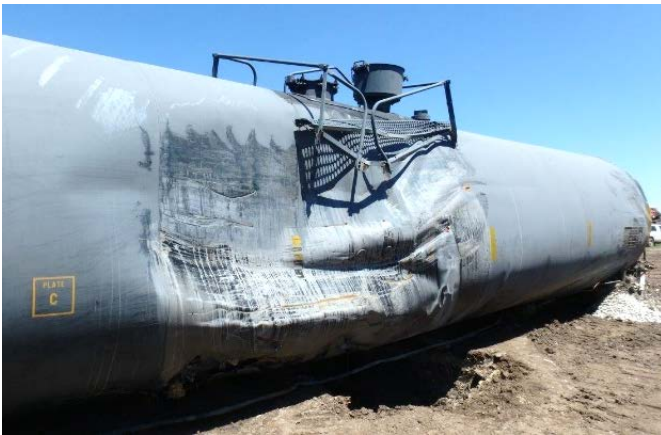
16(c) Left side overall impact damage.

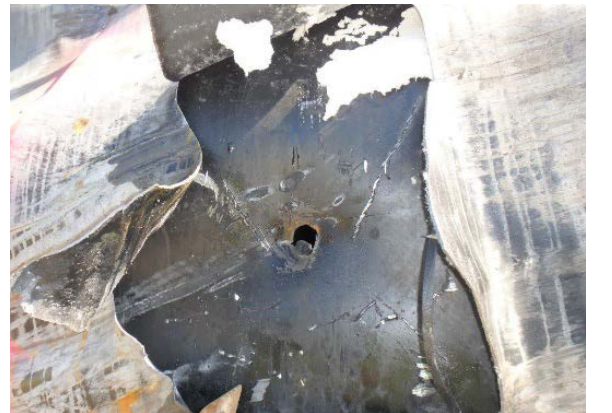
16(d) Tank jacket peeled away from the puncture location.

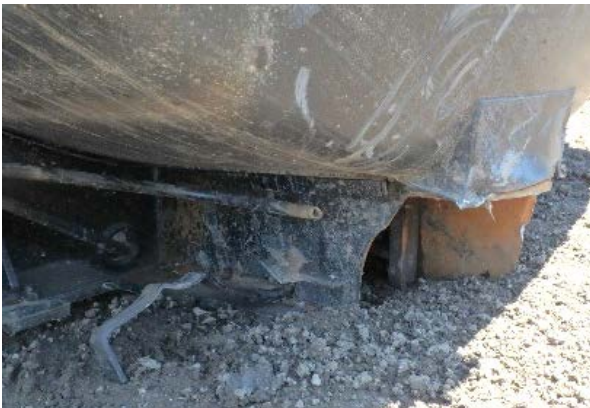
17(c) The B-end stub sill was fractured at the head brace.

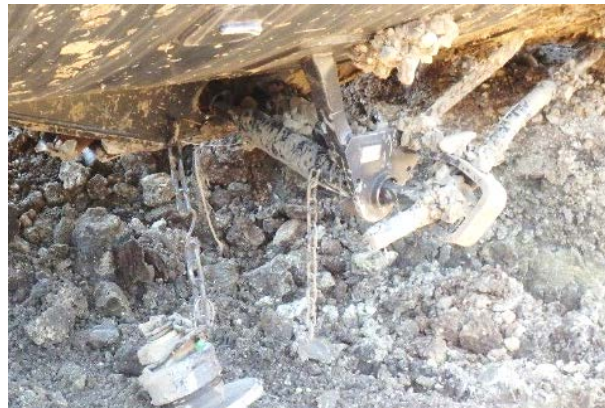
17(d) The BOV operating handle was bent, with extension sleeve disengaged from the valve stem.

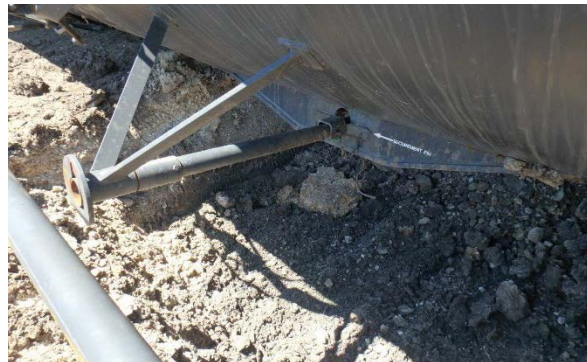
18(d) BOV operating handle and nozzle were missing, securement pin was in place.

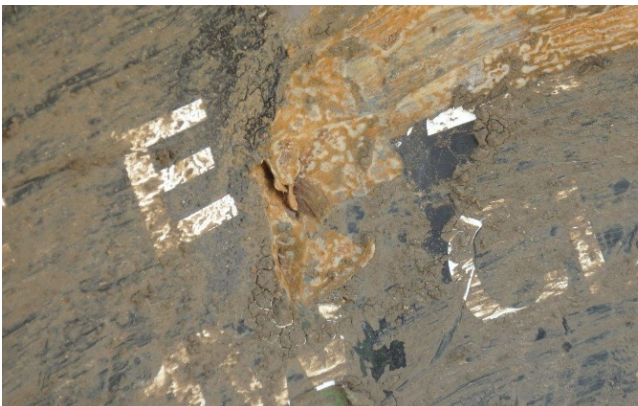
19(c) Gouge in the center of the dent noted in Figure 19(b).

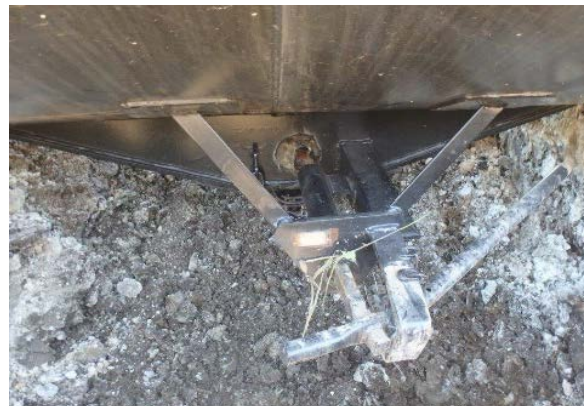
19(d) BOV operating handle was bent, the nozzle was not damaged

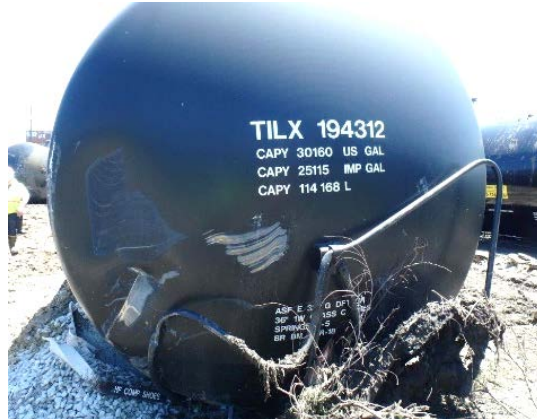
20(b) A-end head 2'x3' head shield dent at 8 o'clock.

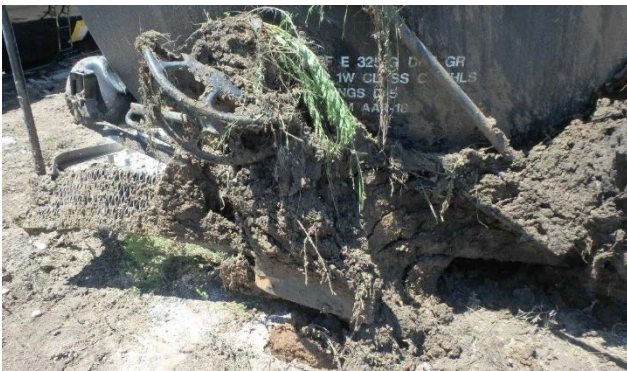
20(c) Fractured B-end stub sill and missing coupler.

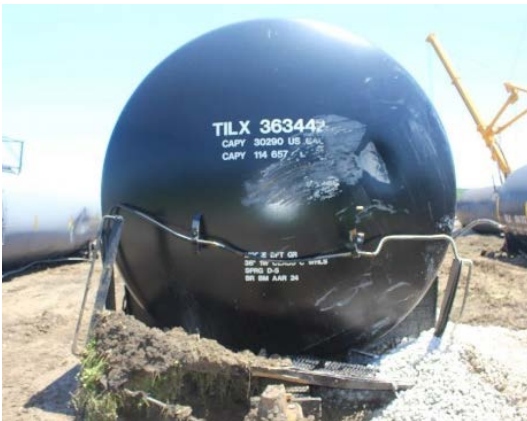
21(a) A-end head shield dent about 2 o'clock..

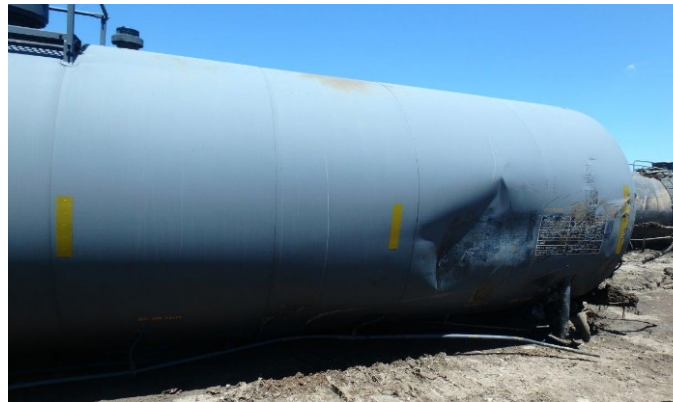
22(b) Left side jacket dent.
