**HAZARDOUS MATERIALS GROUP  
FACTUAL REPORT ADDENDUM**

**Derailment of Union Pacific Railroad Train UEBLTG 20  
on April 24, 2019, with Subsequent Hazardous Materials Release**

**Fort Worth, Texas**

**Report Date: November 14, 2019**

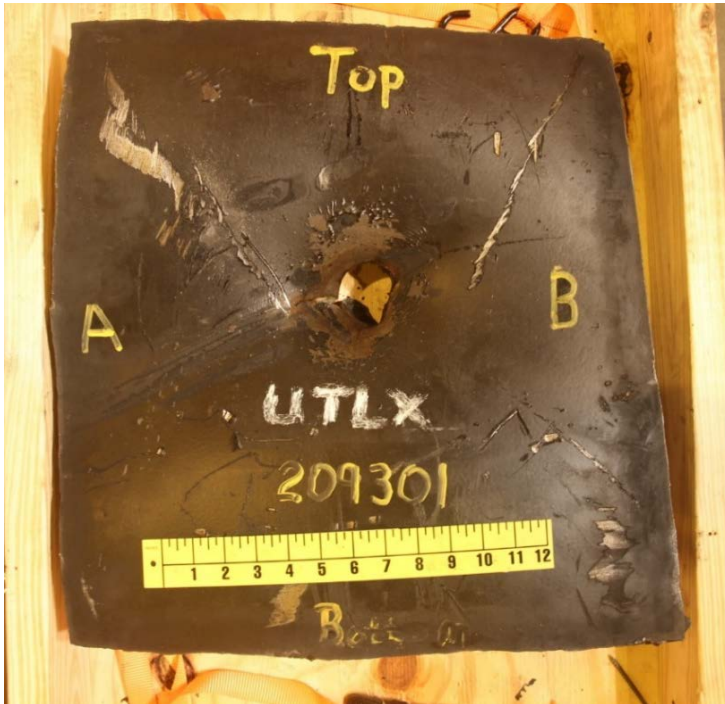
- UTLX 209301, approximately 18-inch square tank shell coupon with score, dent, and puncture features taken from left side of the car in Ring 2 (Figure 1).
- FURX 160030, approximately 28-inch square head-shield coupon with impact-damaged hand brake (Figures 2 and 3).
- UTLX 209403, approximately 24 x 36-inch breached shell plate with B-L body bolster pad (Figures 4 and 5).

Figure 1. UTLX 209301 shell coupon with puncture, left side Ring 2.

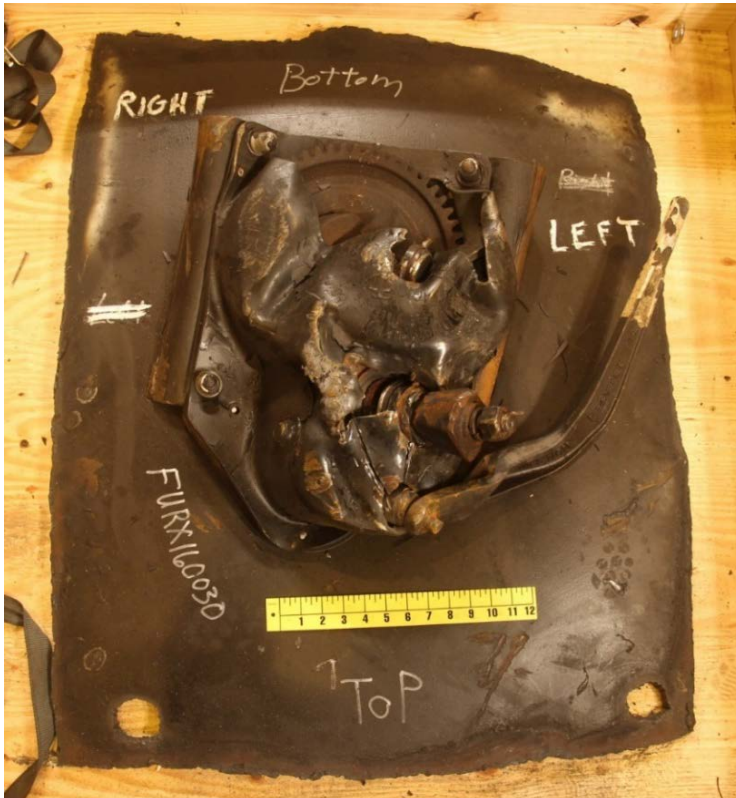
Figure 2. FURX160030 head shield coupon with hand brake assembly (missing hand wheel).

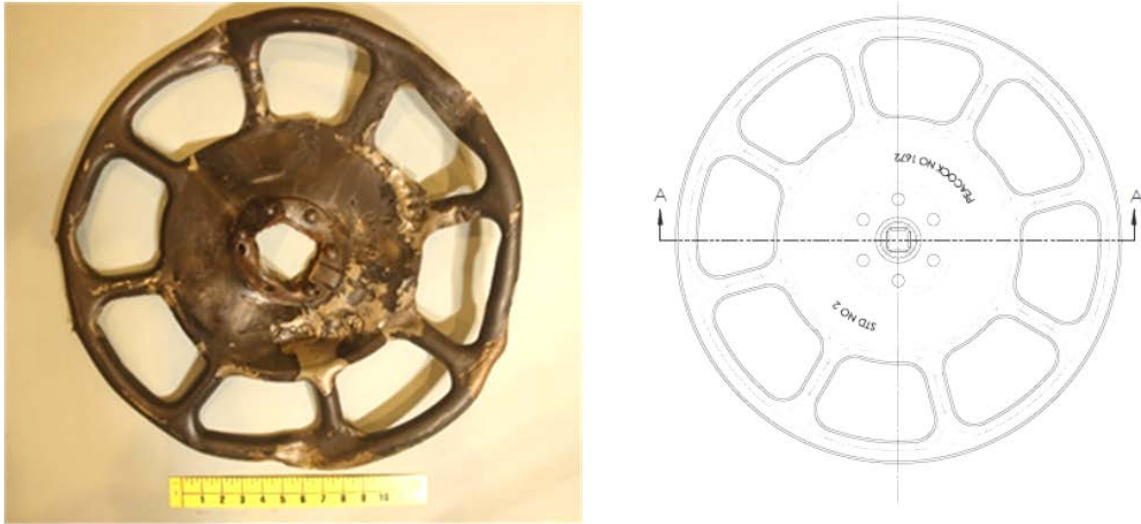
- The center hole of the FURX 160030 hand brake wheel hub was deformed such that the wheel detached from the rest of the hand brake assembly (Figure 3).

Figure 3. FURX 160030 brake wheel separated from hand brake nut and trunnion, and excerpt from Amsted Rail 22-inch diameter hand wheel drawing.

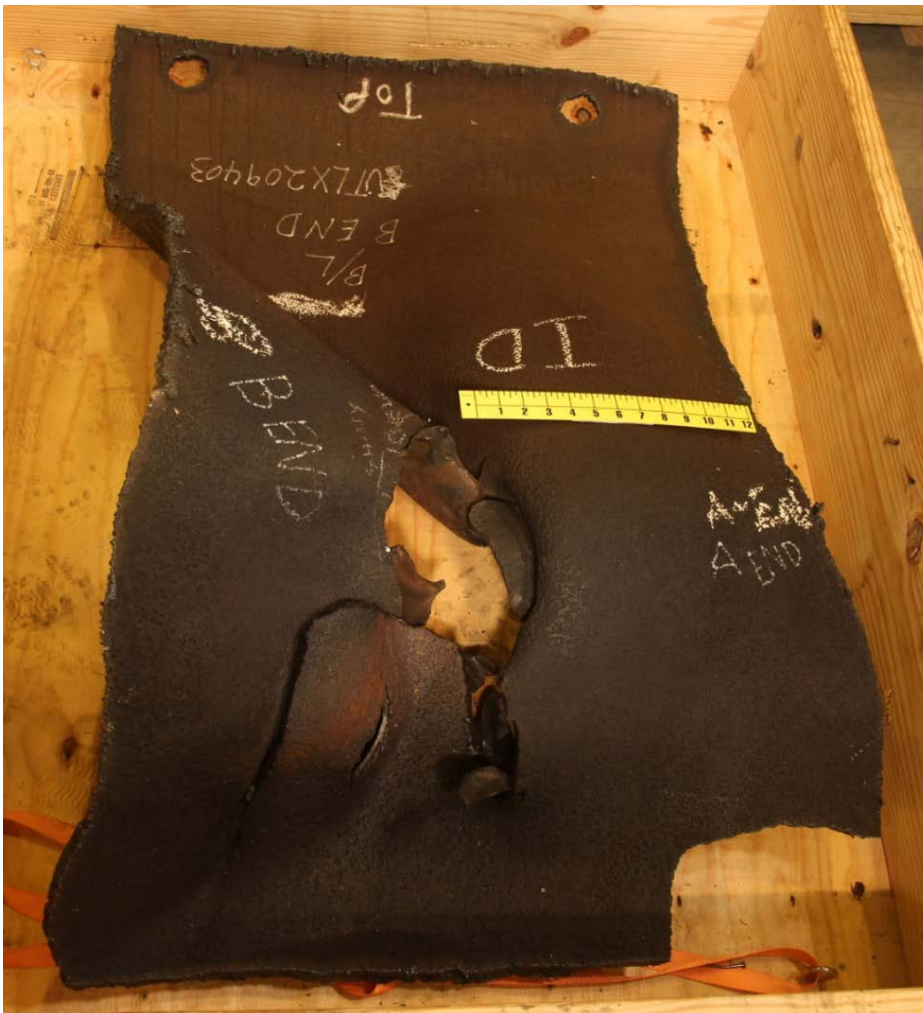
Figure 4. UTLX 209403 breached B-L shell plate interior surface.

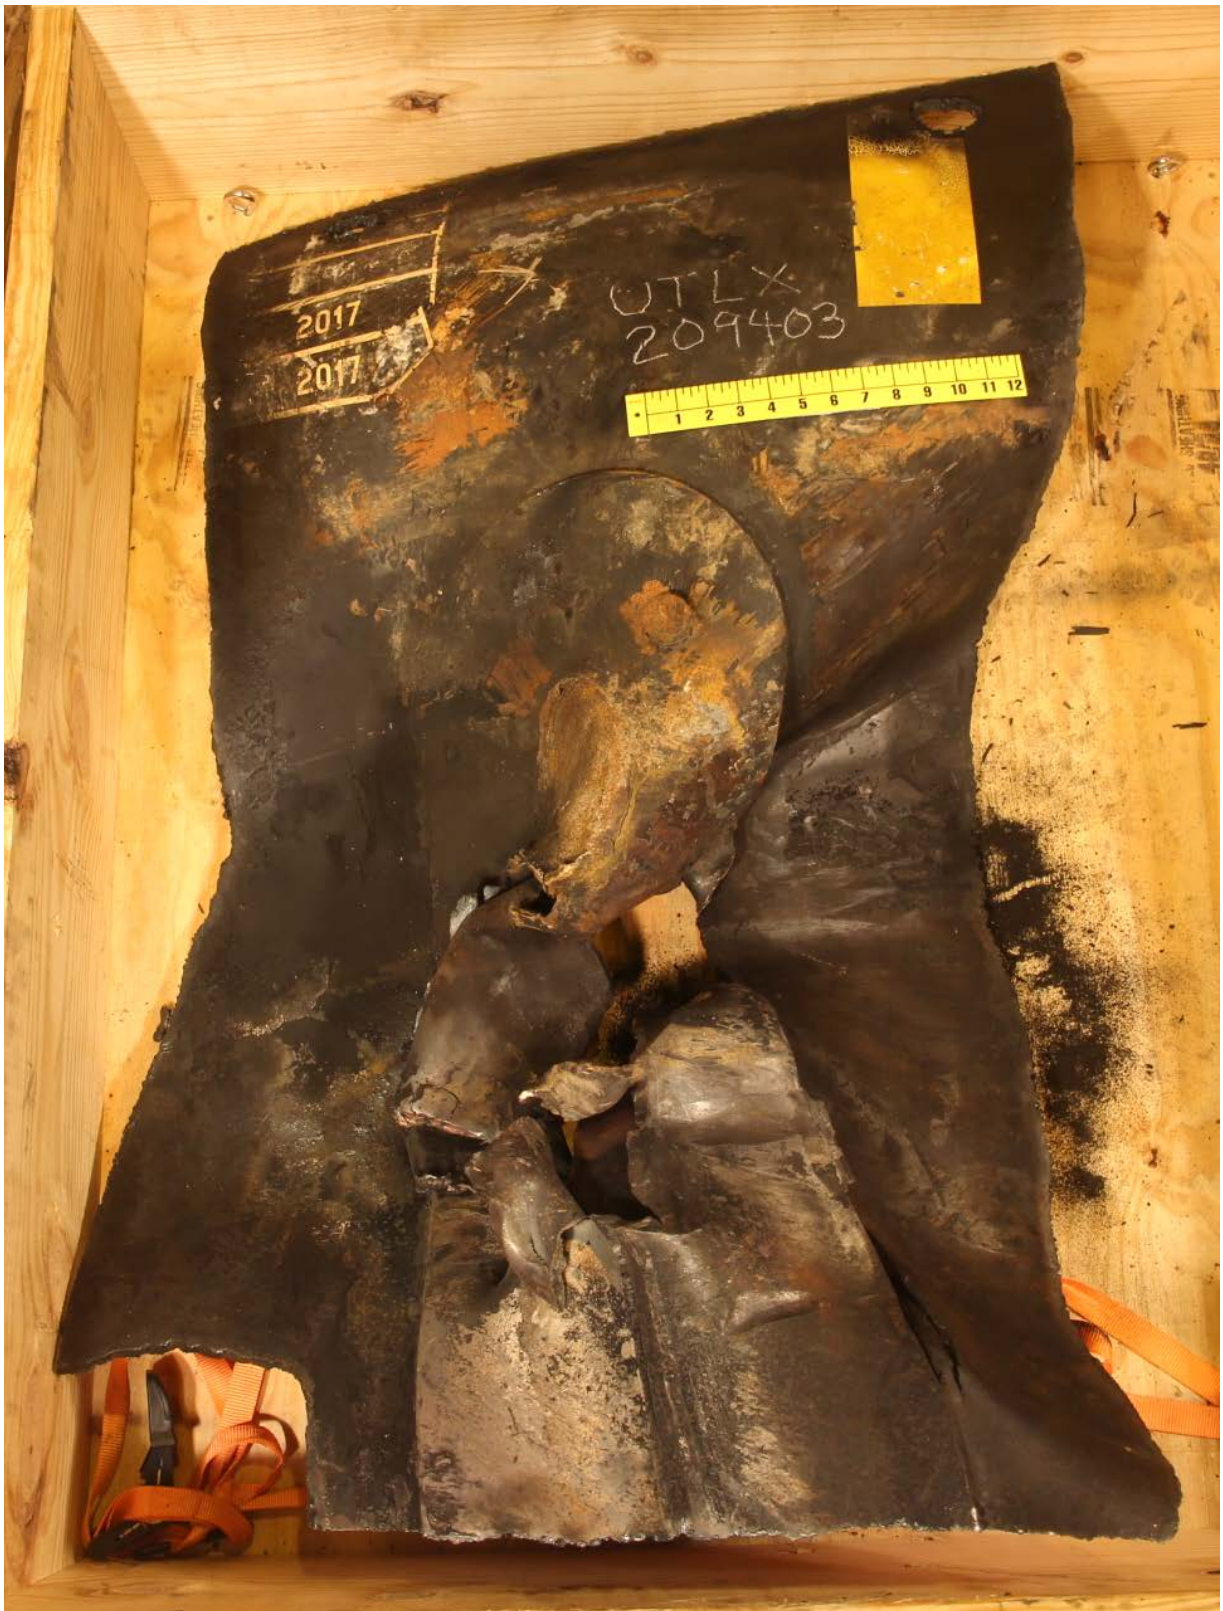
Figure 5. UTLX209403 breached shell plate with B-L body bolster pad, exterior surface.

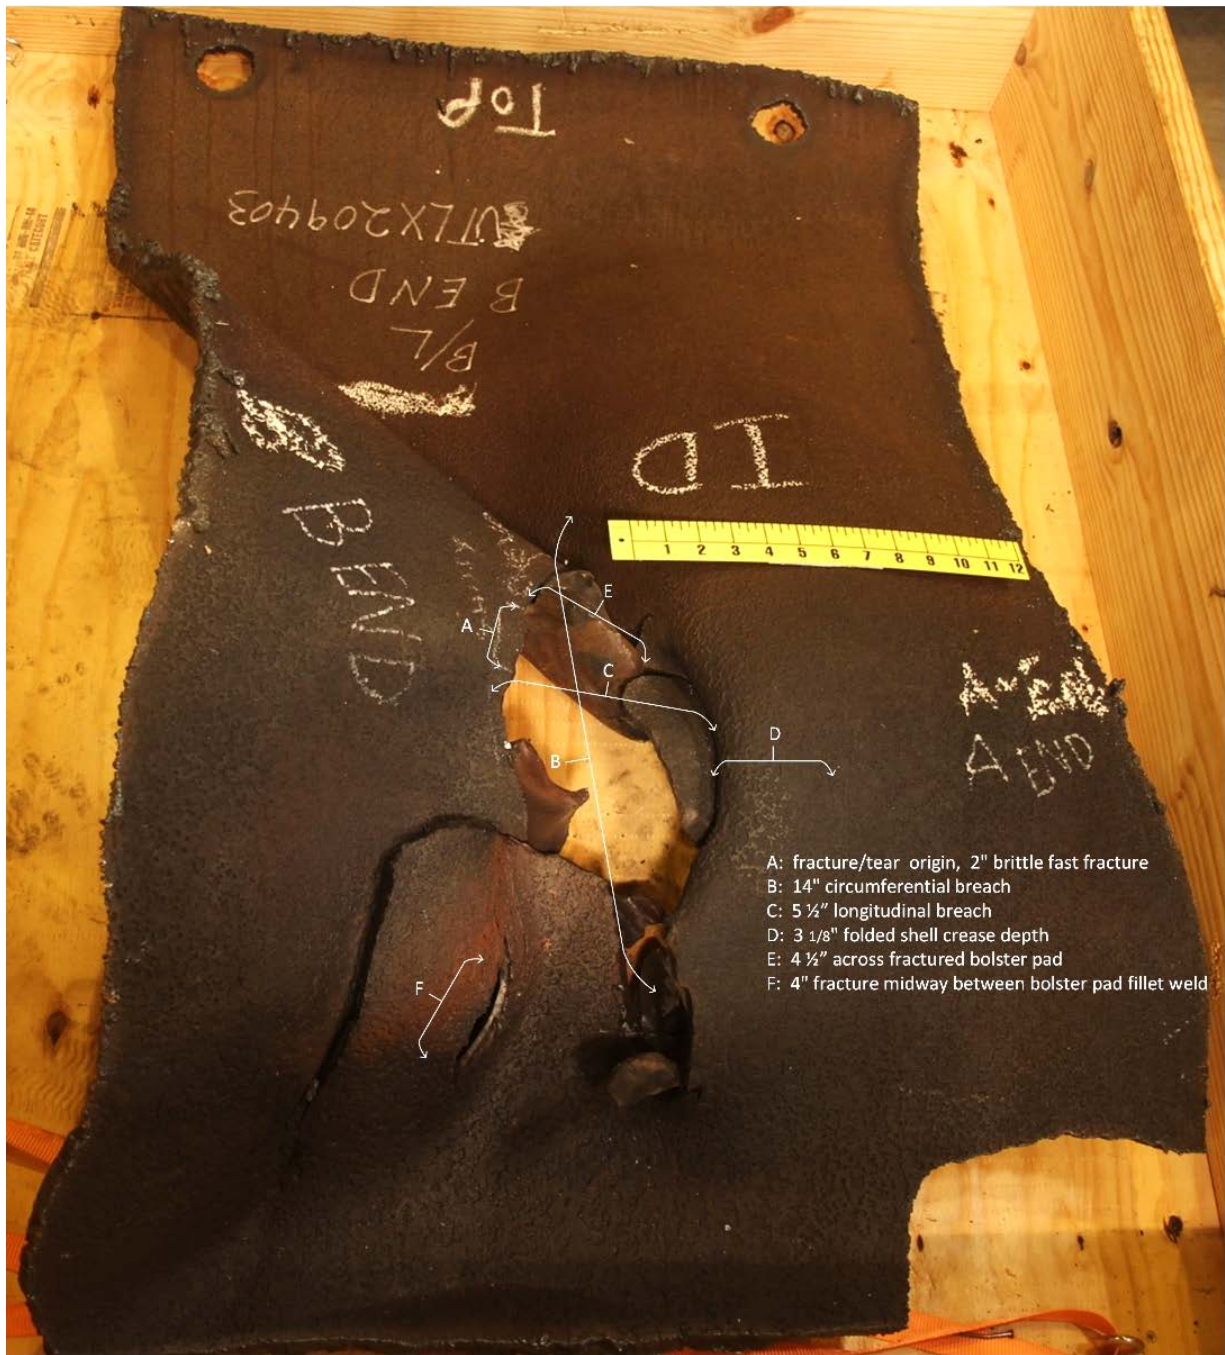
- The shell fracture origin, as determined by fracture face indications, was a 2-inch wide brittle/fast fracture region parallel to a fractured B-side bolster pad fillet weld (Figure 6, location A).

- The shell fracture followed the edge of the fractured bolster pad fillet weld 14-inches in a circumferential direction along the A-side of the bolster pad (Figure 6, location B).

- The width of shell breach was 5 ½-inches longitudinally (Figure 6, location C).
- Folded shell material at A-end side of breach 14-inches longitudinally formed a 3 1/8-inch-deep crease (Figure 6, location D).

- Fractured bolster pad produced a 4 ½-inch opening above the breached shell (Figure 6, location E).
- A separate 4-inch fracture was located midway between bolster pad fillet welds, within region of inward deformation (Figure 6, location F). Visible cracks in the corrosion layer within this bulged area produced a crumbling appearance.

Figure 6. UTLX209403 tank coupon interior surface with noted measurements and fracture/tear features.

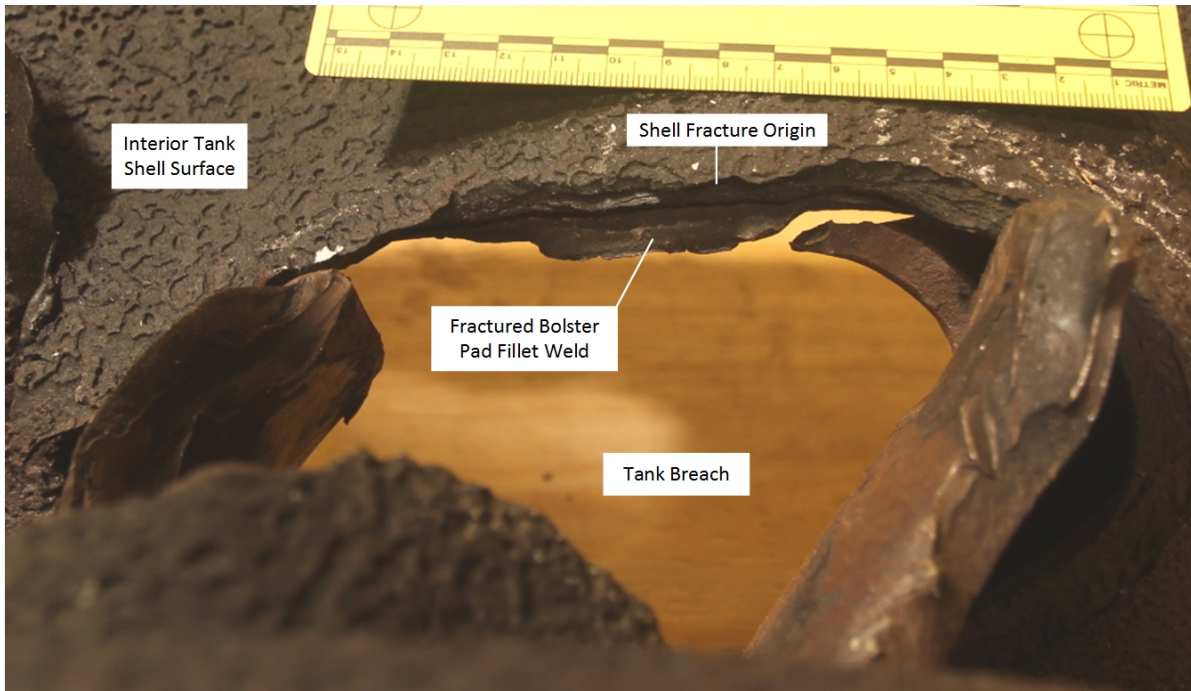
- The origin of the shell fracture and the tank breach are shown in Figure 7.

Figure 7. UTLX 209403 shell plate coupon showing the tank breach created by fractured shell material. The origin of the shell fracture is indicated adjacent to fractured bolster pad fillet weld material.

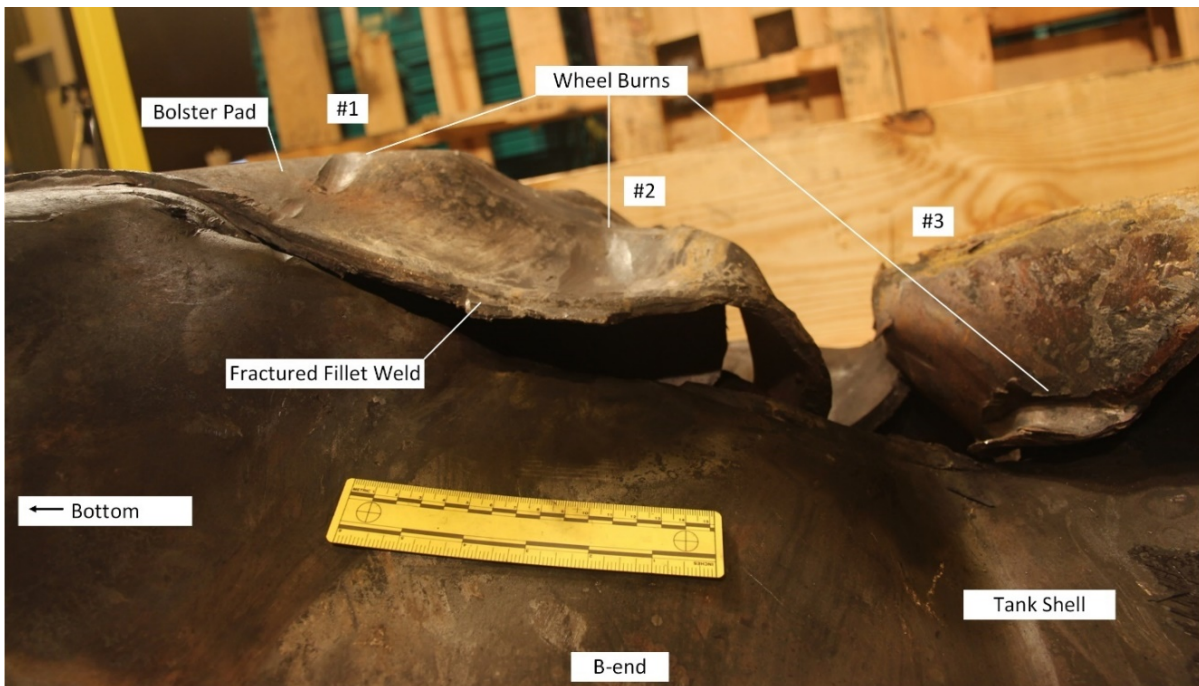
- The bolster pad surface was marked with three scores or wheel burns, having characteristic features of circular cuttings, striations, and metal flow (Figures 8-11).

Figure 8. UTLX 209403 shell plate coupon side view showing three gouges, or wheel burns in the bolster pad. Wheel burn #3 was situated next to the origin of the shell fracture.

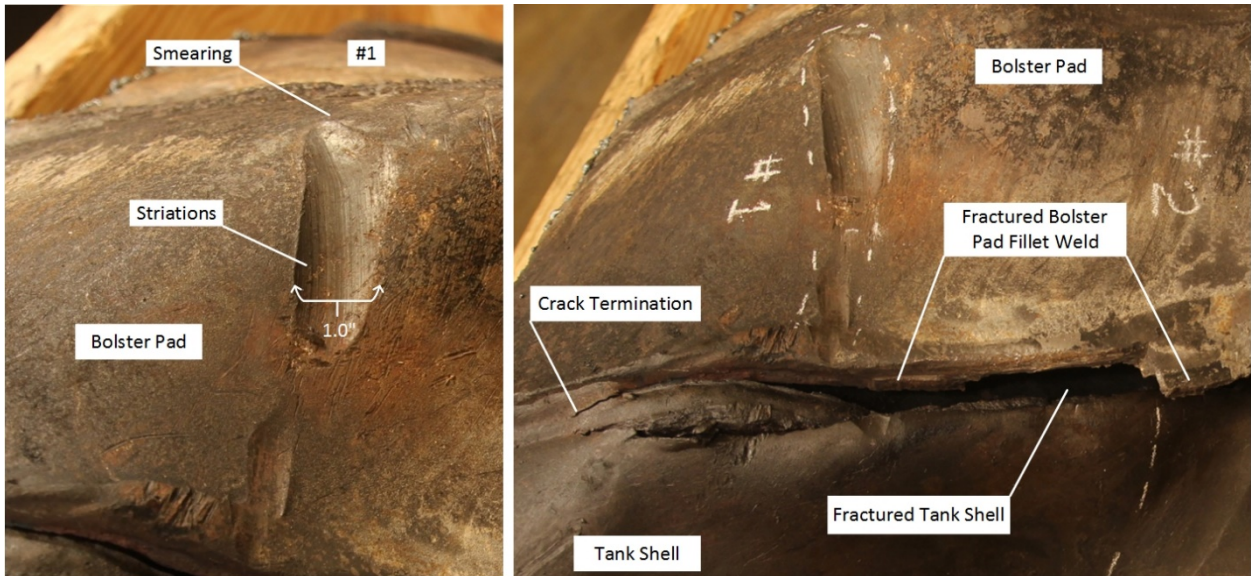
- Wheel burn #1 at the lowest point on the bolster pad was 1-inch wide.
- Wheel burn #2, located above #1 and below the breached area was about 1 1/8 to 1 1/2-inch wide. The wheel burn mark extended across the bolster pad and onto the tank shell, but these marks were offset by the bolster pad buckling.

Figure 9. UTLX 209403 close view of gouge or wheel burn #1 across the lower portion of the bolster pad showing striations and metal flow (smearing) toward the A-end (left). The lower B-side termination of the shell crack is shown in the right photograph.

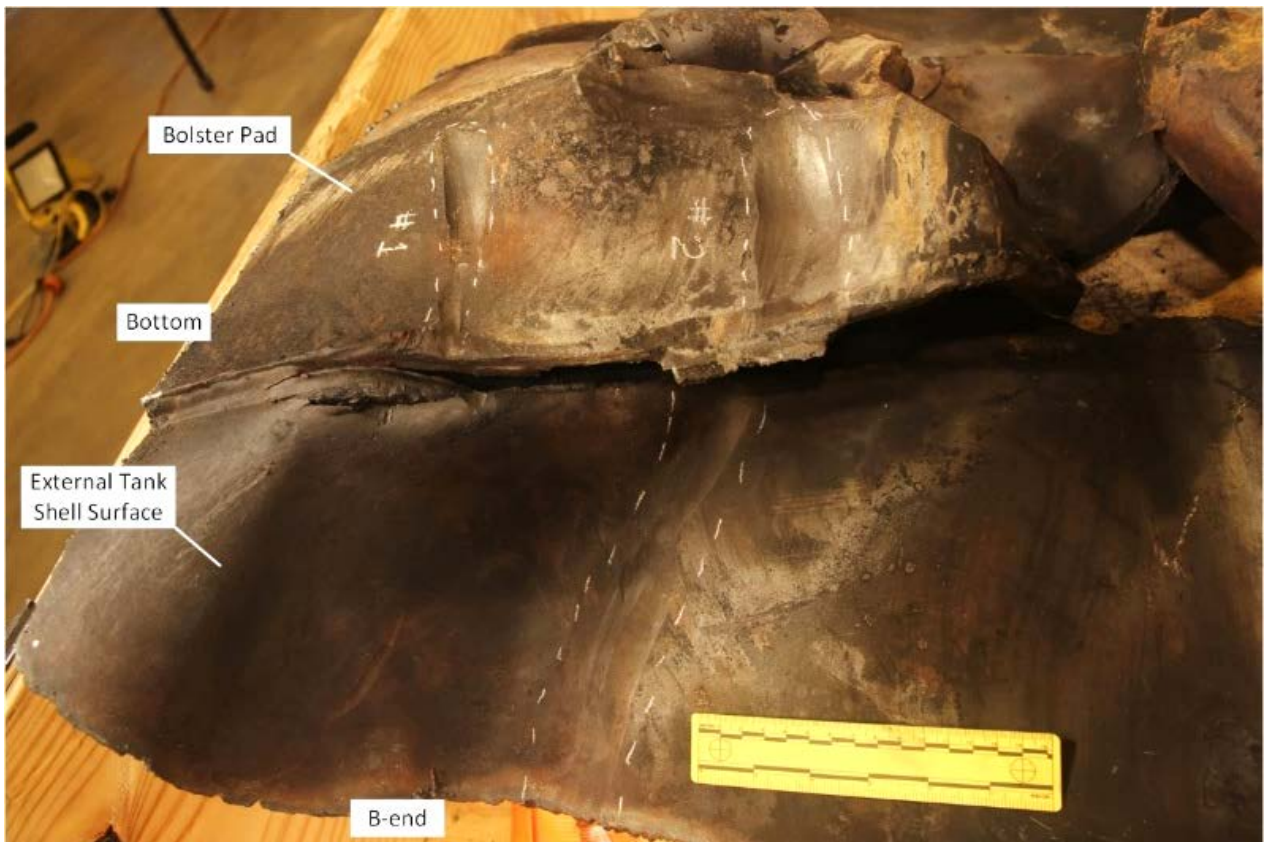
Figure 10. UTLX 209403 tank shell coupon from B-L bolster region showing outlined extent of wheel bum marks at locations #1 and #2.

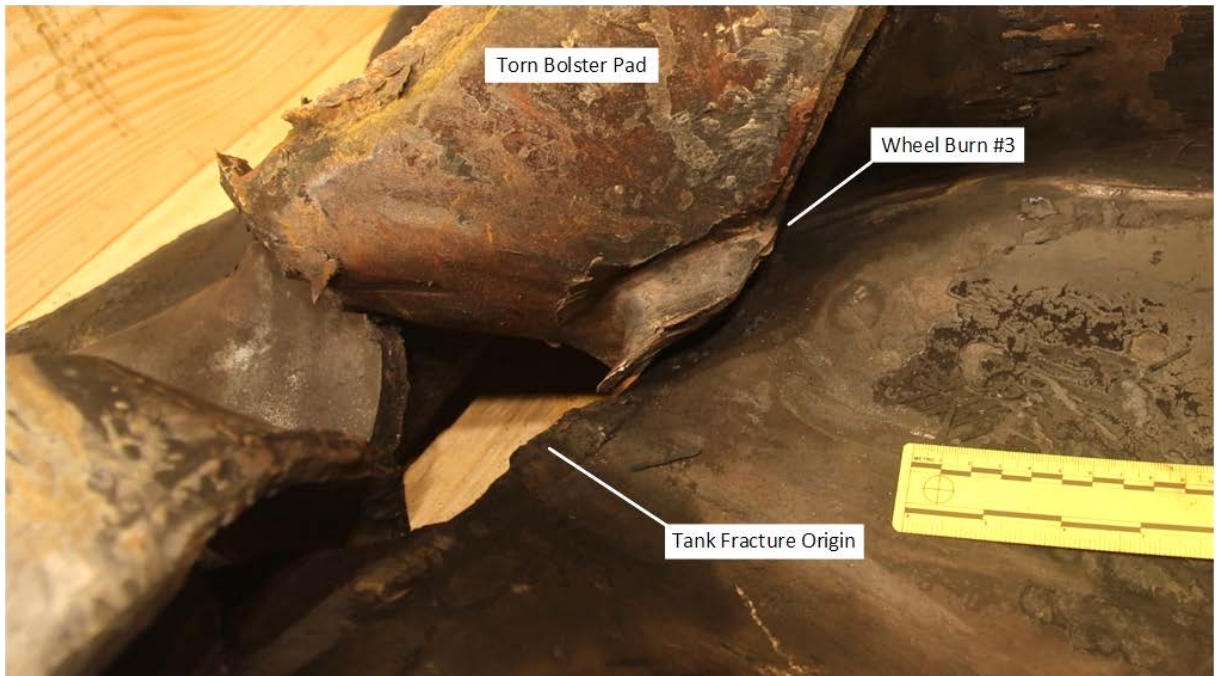
- Wheel burn #3 was situated on the B-side of the bolster pad at the point of origin of the tank shell fracture and near the edge of the bolster pad fracture referenced in Figure 6 location E.

Figure 11. UTLX 209403 proximity of wheel burn #3 to tank fracture origin.

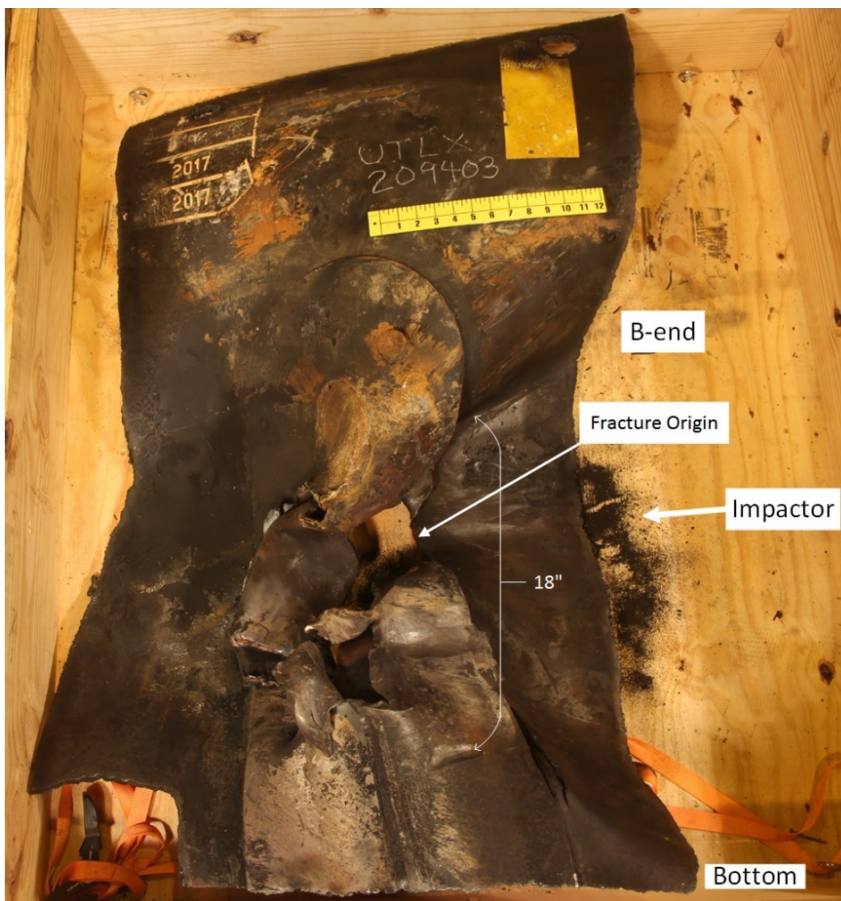
- Immediately adjacent to the tank shell breach was an 18-inch area that was buckled inward between wheel burns #1 and #3 (Figure 12). The earlier staging area tank car examination showed that this deformation extended beyond the bolster region into the B-end head.<sup>3</sup>

Figure 12. UTLX 209403 tank shell coupon from the B-L bolster region showing the shell fracture origin and buckled shell dimensions.

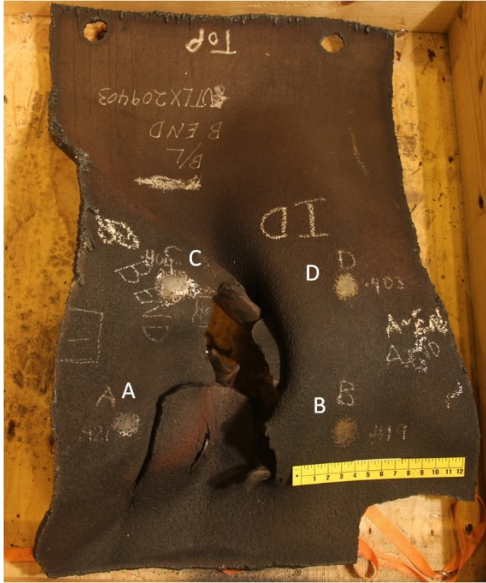
Four ultrasonic thickness (UT) test locations were selected, two on each side of the shell breach and in locations exhibiting minimal buckling (Figure 13). A Union Tank Car Company level III NDT technician collected UT measurements from the interior surface.<sup>6</sup> Corrosion was removed by grinding to shiny metal prior to measuring shell thickness.

Location	Thickness (inch)	Location	Thickness (inch)
C	0.404	D	0.403
A	0.421	B	0.419
Bottom of Plate

Figure 13. UTLX 209403 tank shell coupon B-L bolster region, ultrasonic thickness measurement locations A through D. Shiny circular areas are locations where corrosion was ground away before testing.

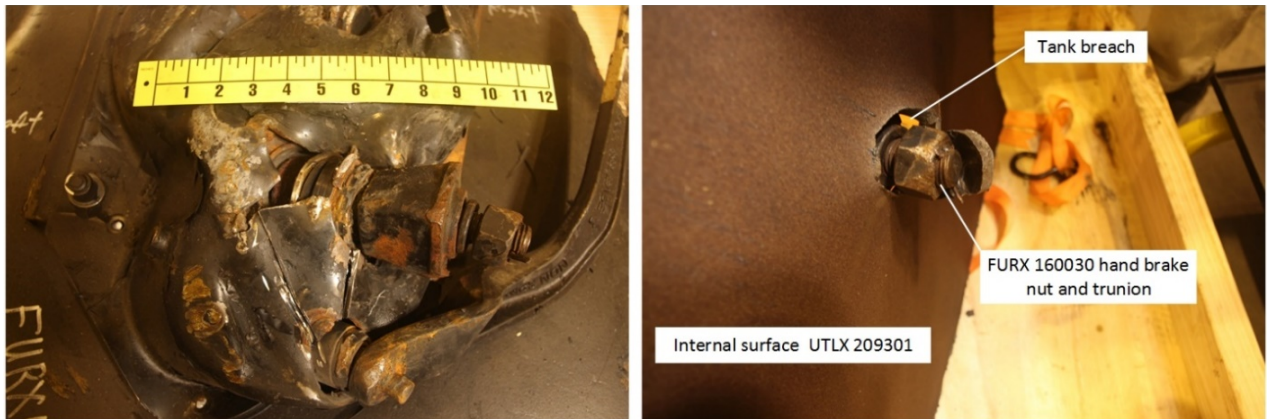
- The brake wheel trunnion was bent about 45-degrees toward the left (Figure 14 left).
- The nut and trunnion was removed from the brake wheel assembly and inserted into the punctured shell plate of UTLX 20930, where it was manipulated until it dropped into place (Figure 14 right)

Figure 14. FURX 160030 brake wheel assembly (left). UTLX 209301 punctured tank shell coupon with nut and trunion inserted for fit test (right).

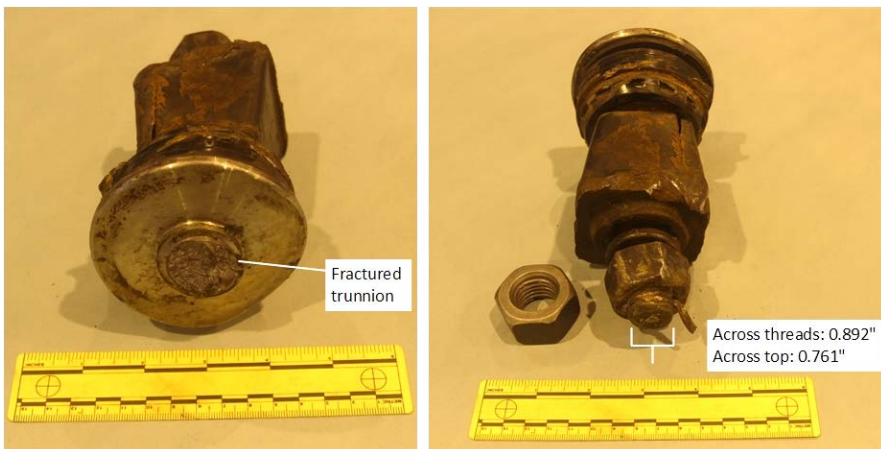
- The end of the trunnion measured 0.761-inch, and across the threads was 0.892-inch (Figure 15). The trunnion was fractured inside of the handbrake body, about 6-inches from its end.

Figure 15. FURX 160030 fractured brake wheel trunnion rear view (left). Front view (right) with trunnion measurement notations, and exemplar brake wheel nut.

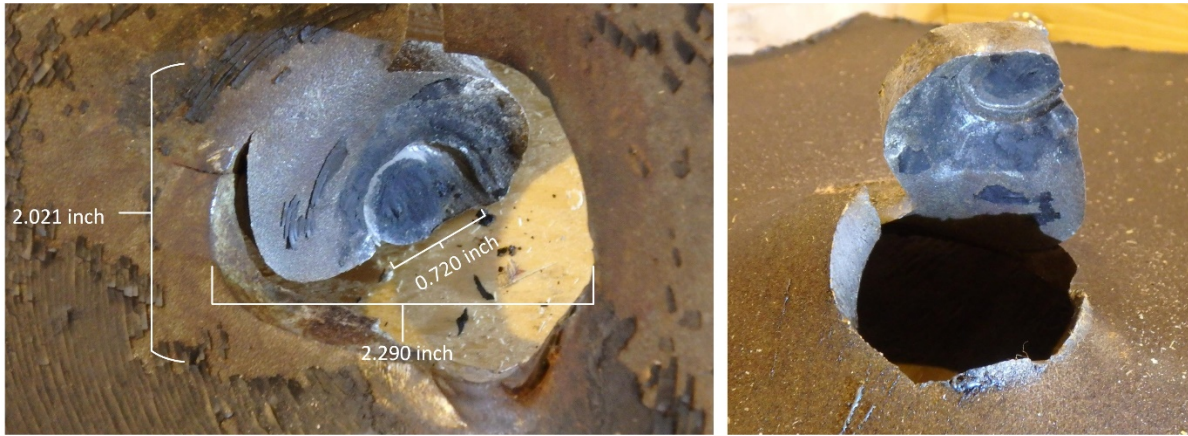
- The breach in the UTLX 209301 tank shell coupon measured 2.290 x 2.021 inches.
- A rounded mark found on an inwardly deformed flap of steel at the puncture site measured 0.720-inch (Figure 16).

Figure 16. UTLX 209301 shell coupon left side Ring 2 external surface with dimensions of puncture marks noted (left). The internal shell surface with flap of punctured steel is shown in the right photograph.
