**HAZARDOUS MATERIALS GROUP
FACTUAL REPORT**

**Derailment of CSXT Train Q38831 with
Subsequent Hazardous Materials Release
Hyndman, Pennsylvania, August 2, 2017**

DCA17FR011

Report Date: December 6, 2017

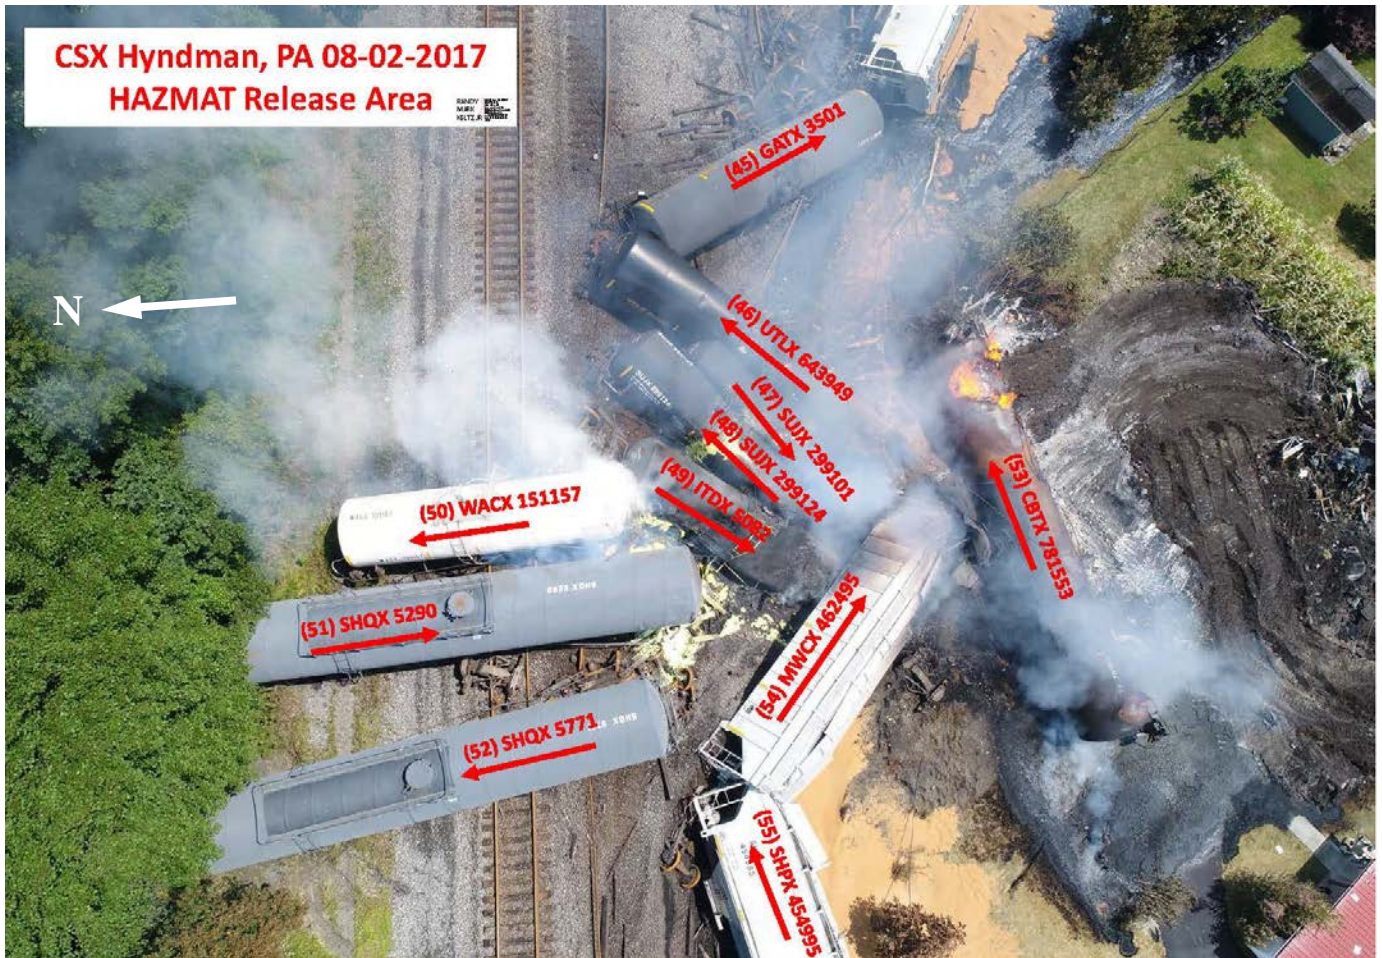
Figure 1: Accident scene hazardous materials release area, showing rail car direction of travel (arrows).

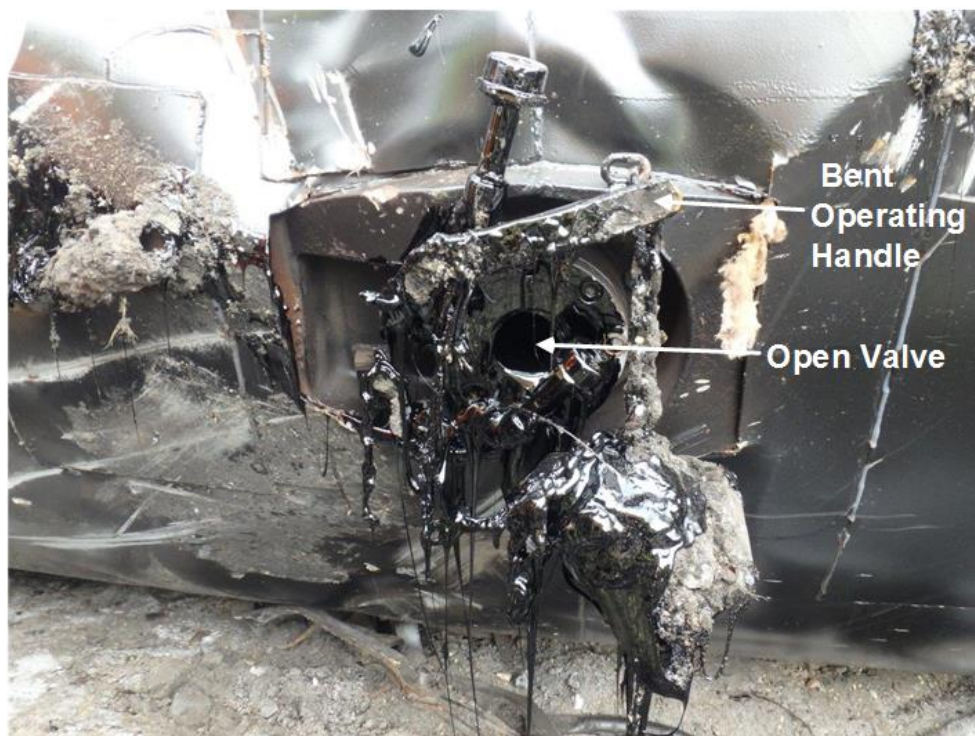
The bottom outlet valve nozzle was missing, the operating handle was bent, and the ball valve was in the completely open position (Figure 2). The entire load of asphalt, about 23,000 gallons, released and pooled on the two residential properties north of Cleveland Street in Hyndman.

Figure 2: UTLX643949 open bottom outlet valve.

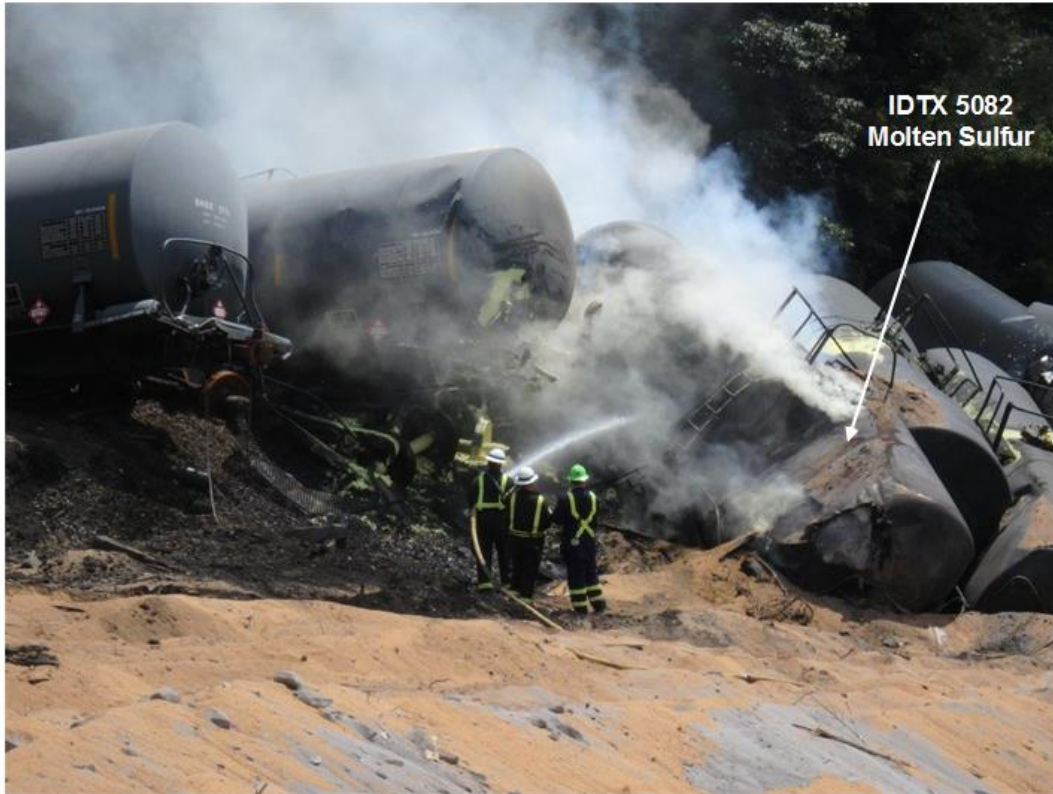
The majority of the 13,000 gallons of molten sulfur product contained in IDTX5082 released and ignited (Figure 3). The tank car sustained a 7-foot transverse shell tear in the right center of the car. The bottom of the car sustained a 32 x 18-inch puncture mid-way between the bottom outlet valve and the A-end at about 7-8 o'clock.

Figure 3: Burning molten sulfur released from tank car IDTX5082, August 4, 2017.

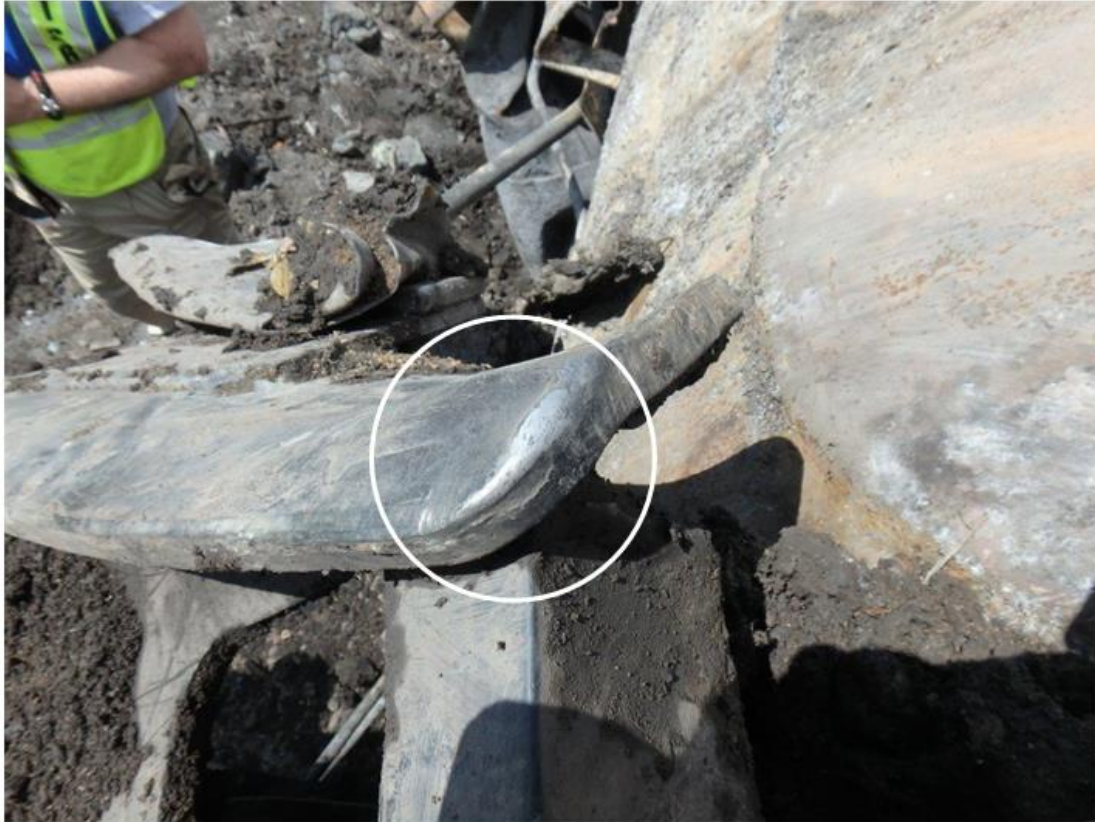
The Hazardous Materials Group examination found a metal-contact witness mark on the B-end left upper body bolster web structure (Figure 4). Investigators secured the upper body bolster structure for laboratory comparison to the geometry of the puncture site in propane tank car CBTX781553.

Figure 4: ITDX5082 upper B-L body bolster frame structure contact witness mark, August 5, 2017

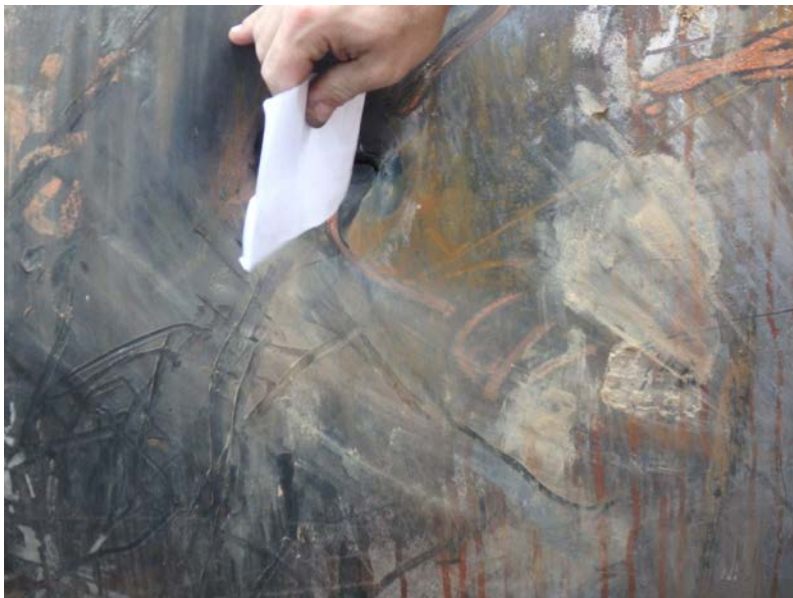
The Group traced the shape of the edge of the upper body bolster web structure onto a sheet of paper shown in Figure 4 and compared this shape to the geometry of the punctured shell in propane tank car CBTX781553 (Figure 5).

Figure 5: Hazardous Materials Group comparing the shape of the ITDX5082 B-L body bolster web structure to the CBTX781553 puncture location (August 5, 2017).

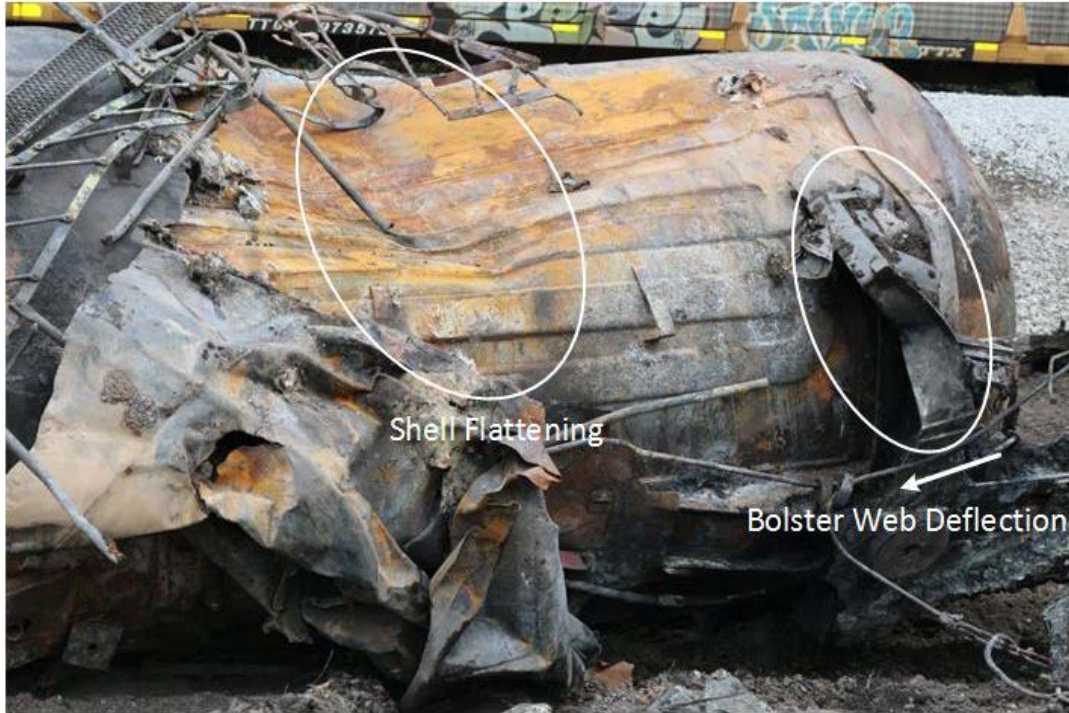
The B-L side of the tank sustained flattening and a crease. The B-L body bolster (exhibiting the above described witness mark) was deflected inboard toward the A-end with about a 90-degree bend in the upper half of the structure (Figure 6).

Figure 6: ITDX5082 tank shell flattening, and bolster web deflection B-L side, August 5, 2017.

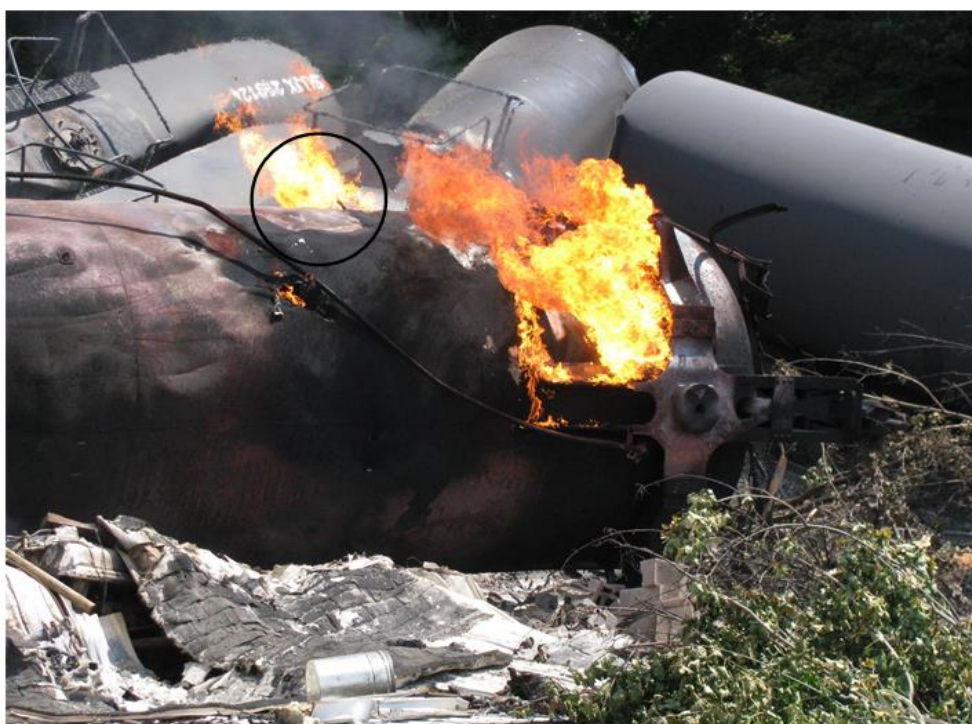
The A-end of CBTX781553 was leading in the eastbound train consist. The car came to rest with the A-end facing east, parallel to and about 2 car lengths south of the track. The bottom of the car was in contact with a pool of burning molten sulfur released from ITDX5082. The car was punctured and released burning propane, with torch fires escaping from holes and gaps in the jacket at several locations across the length of the car. The most vigorous flame was observed at the A-R end (Figures 7 and 8). As the incident progressed, the fire became restricted to the A-end of the car. Aerial video and visual examination of the pressure relief device did not show any evidence that it had ever activated.

Figure 7: CBTX781553 A-end puncture location (circled), August 3, 2017, 10:23 a.m. (CSXT photo).

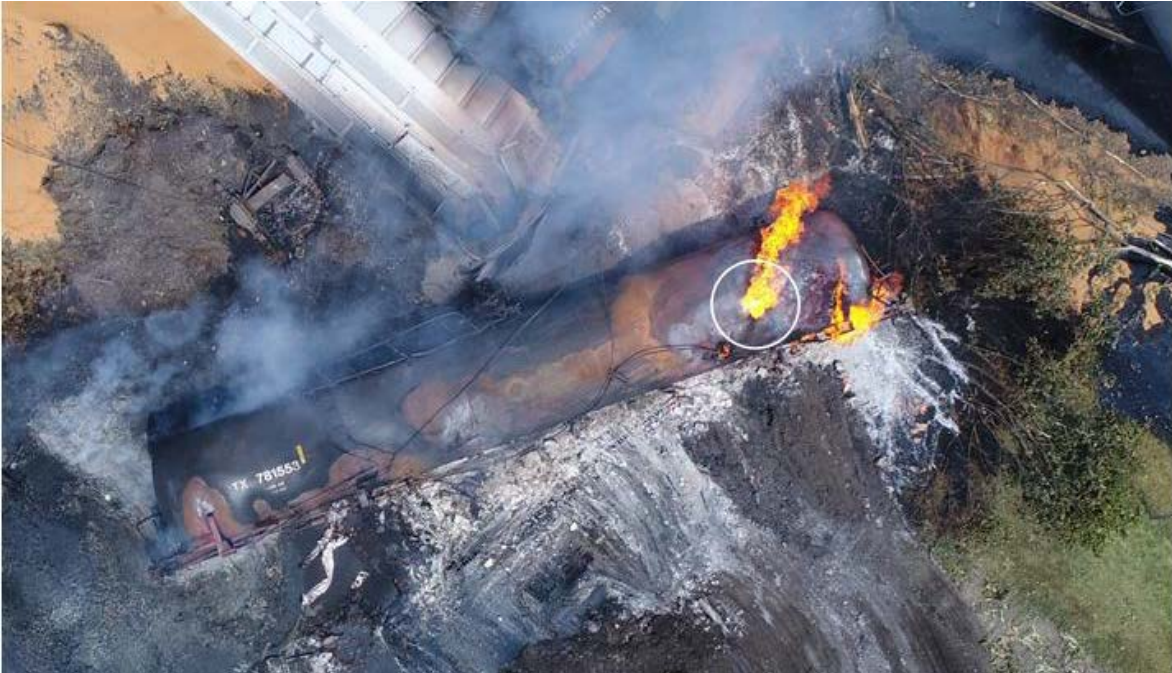
Figure 8: CBTX781553, puncture location circled, August 3, 2017, 2:46 p.m.

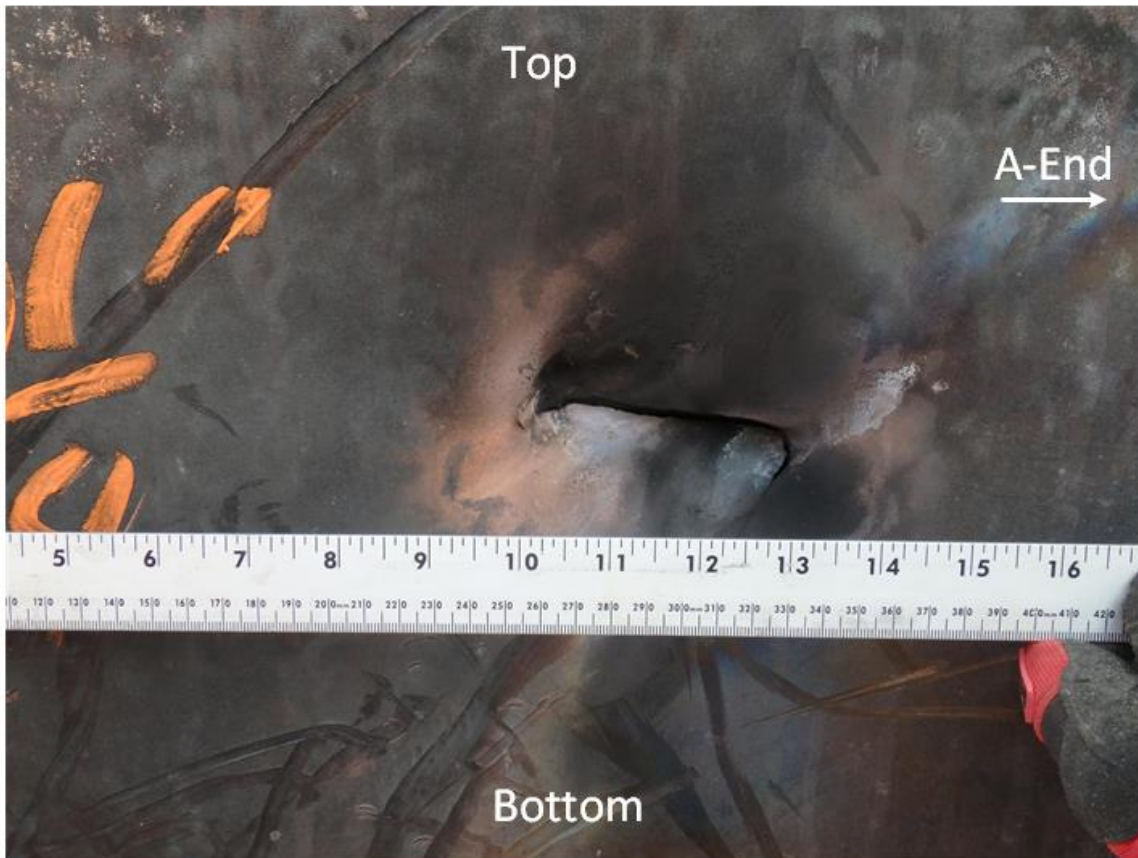
Investigators inspected the tank car, finding a shell puncture about 3 o'clock on the A-R end in the first (1st) barrel section (Figures 9 and 10). The puncture measured about 3.25 inches and was oriented longitudinally. The puncture was within a dent measuring about 3.5 inches deep, with evidence of sliding contact in an upward direction. The shell fracture was isolated to the impact area and did not show any visual evidence of brittle propagation. Ultrasonic gauge thickness measurements found thinning from 0.630 inches in nearby unaffected area to 0.537 inches at the top edge of the puncture.

Figure 9: Tank Car CBTX781553 Puncture in Barrel Ring 1, Exterior Surface, August 4, 2017.

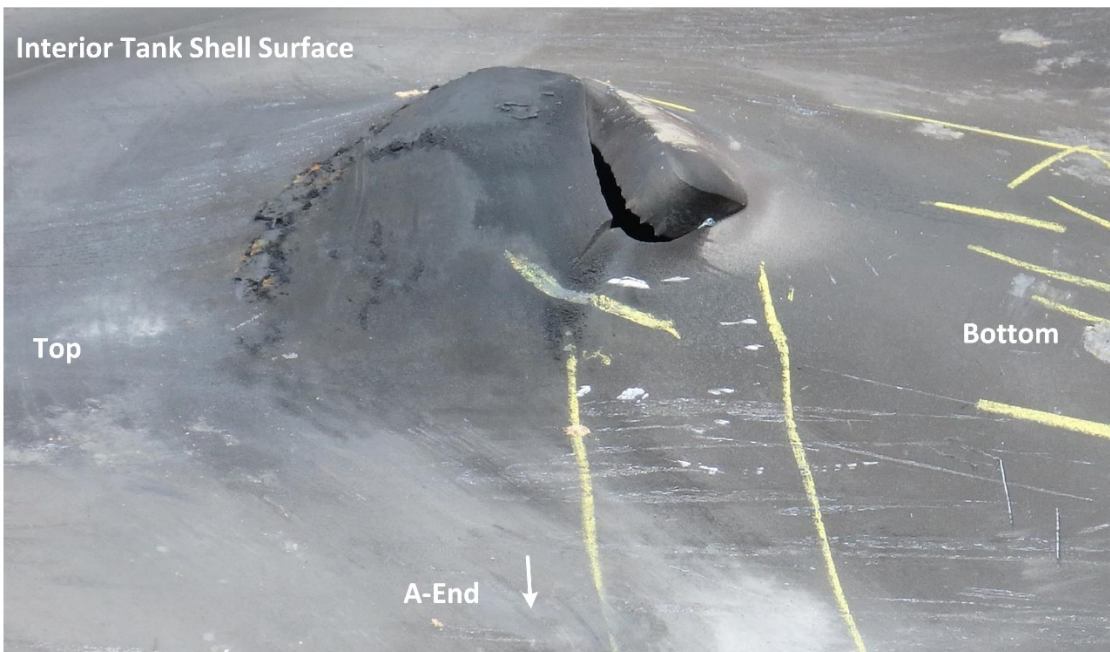
CSXT removed a coupon of the punctured tank shell in Ring 1, allowing the Group to examine the interior surface of the puncture as shown in Figure 10. Penetration into the shell became deeper toward the A-end side of the puncture feature. At the A-end side of the puncture, the crack turned downward about ½ inch in the circumferential direction. Investigators noticed that carbon was deposited on the interior shell surface above the breach.

Figure 10: CTBX 781553 Interior surface of the shell puncture, August 5, 2017.

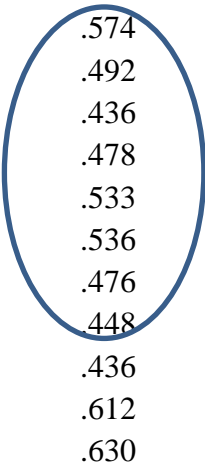
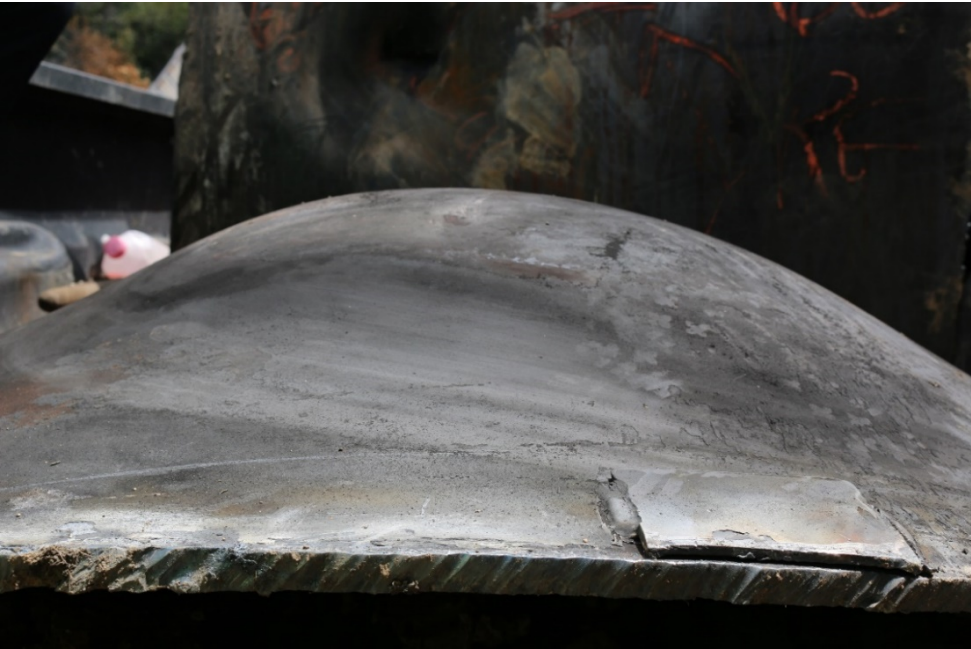
A shell bulge was observed closer to the A-end above the A-R bolster web in Ring 1 of the tank shell. The bulge measured 27 inches in the longitudinal direction and 56 inches in the circumferential direction and protruded outward about 6-inches. Ultrasonic thickness measurements found that the shell thinned from 0.630 inches in nearby unaffected area, to 0.436 inches at the thinnest location near the edge of the bulge (Figure 11). The Certificate of Construction reported a nominal shell thickness of 0.608-inch.

Ultrasonic thickness gauge shell thickness measurements were taken at about 2-inch intervals across the center of the bulge as indicated below. The circled area represents a bulge in the tank shell.

Figure 11: CBTX781553 tank shell coupon showing the bulge profile, August 5, 2017.

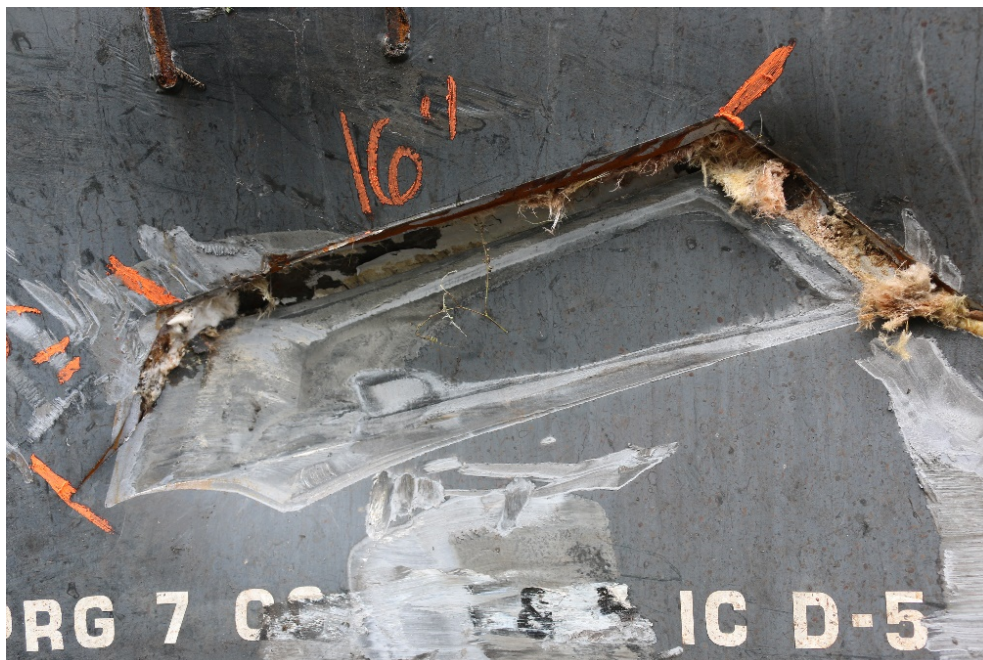
The A-end head sustained a centered 36-inch by 36-inch dent, 8-inches deep. Within this dent, the A-end head shield sustained a deep 16-inch long horizontal angular gouge in the center of the dent that penetrated the ½-inch-thick head shield (Figure 12). Beneath this penetrated headshield, no evidence of damage to the tank head itself was observed. The jacket adjacent to the head at the B-R side was buckled. The jacket was torn about 5-inches by 18-inches at the lower right center of the car, however, no damage was transmitted to the tank shell. The tank car sustained no breaching damage.

Figure 12: Propane tank car SHQX5771, gouge sustained by A-end head shield, August 5, 2017.

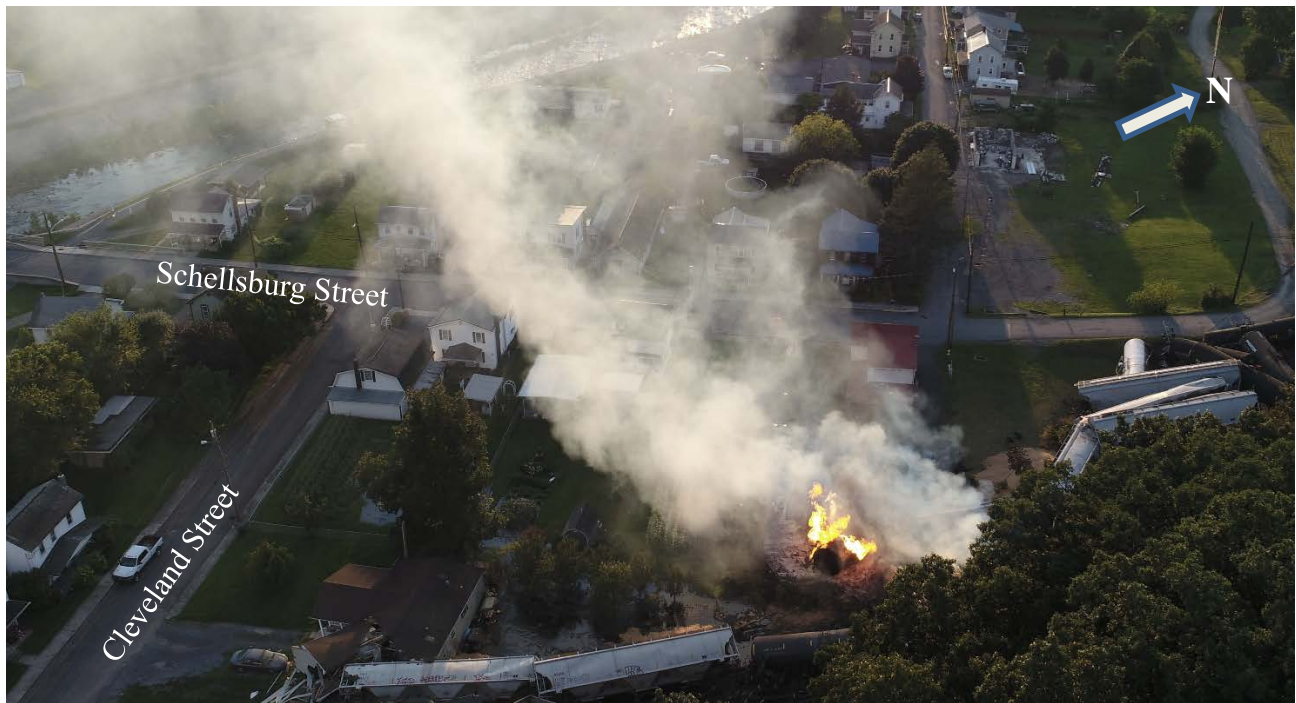
The CSXT incident commander said that he eventually became convinced that the CBTX781553 was not going to have a catastrophic release. The next meeting of the unified command resulted in a decision to continue letting the car burn while responders focused on air monitoring and restricting access to the area (Figure 14).

Figure 14: Accident scene August 2, 2017, 7:45 p.m. (courtesy CSXT).

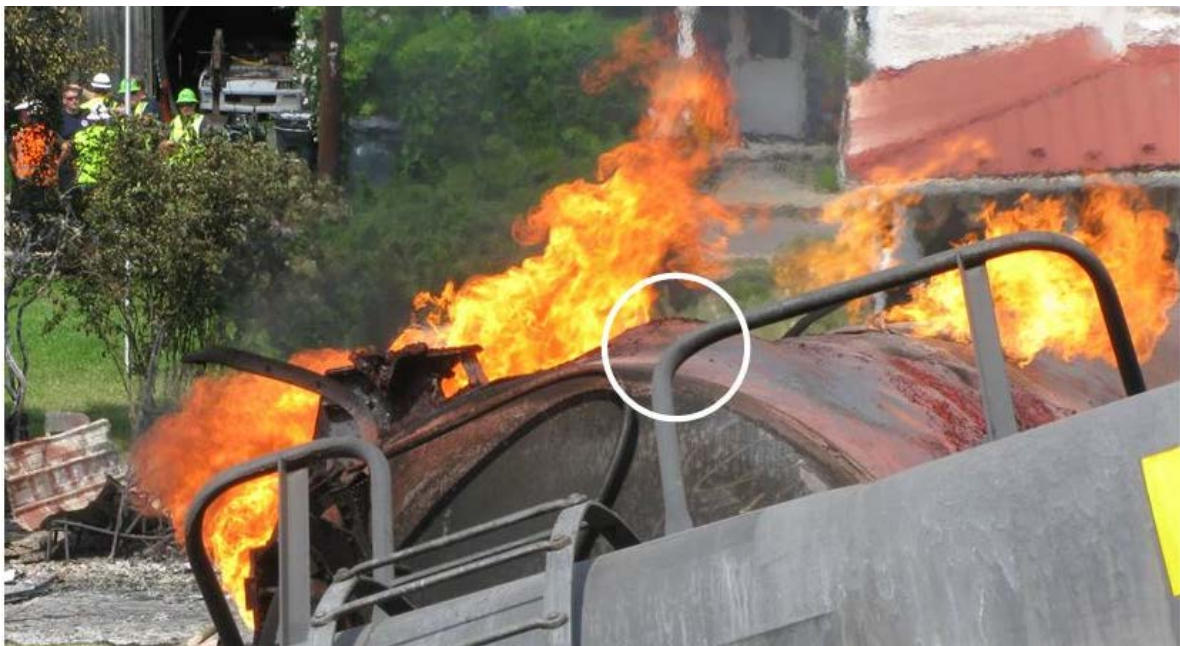
The CSXT operations section chief said that by the time the shell bubble was discovered, there was almost no pressure or product left in the car (Figures 15 and 16). He said by then, CSXT was in the process of purging vapor from the tank car and they were confident the situation was under control. He emphasized:

Figure 15: Tank car CBTX781553 showing the area where a bulge formed under the jacket (circled), August 3, 2017, 9:58 a.m. (courtesy CSXT).

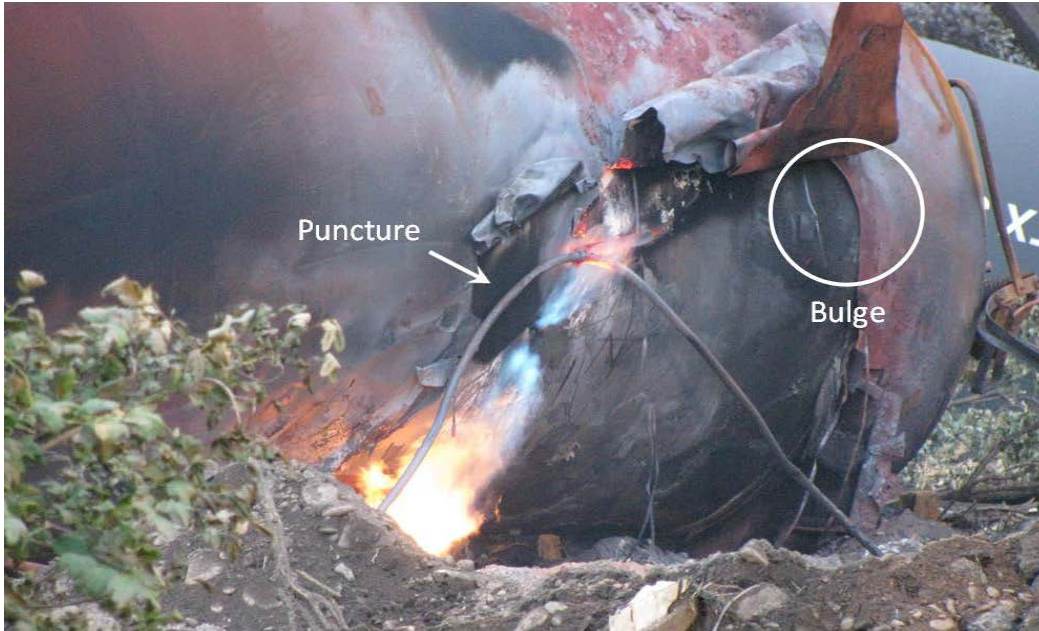
Figure 16: Tank car CBTX781553 after the jacket was peeled from the puncture area, August 4, 2017, 6:36 a.m. The edge of the shell bulge is visible under exposed jacket (circled). The puncture is covered with square of magnetic patching material (Courtesy CSXT).
