# National Transportation Safety Board

HMD22LR001

## **HAZARDOUS MATERIALS**

Group Chair's Factual Report  
July 20, 2022

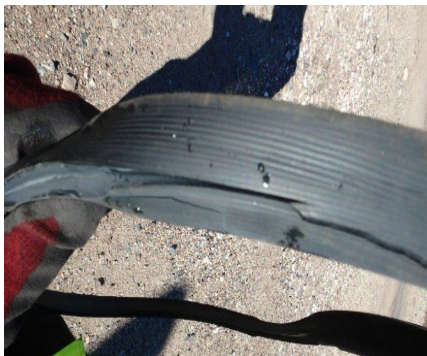
NTSB investigators found the elastomeric manway gaskets on 26 of the derailed cars were thermally destroyed (see Appendix A for further details). Figure 3 shows a gasket removed from a minimally damaged tank car (TILX 731757, #72) involved in the derailment (identified as Buna-N), which was submitted to the NTSB laboratory for examination (Control # HMD22LR001-HAZ-004). Upon removal from the manway, investigators observed a cut in the gasket surface. Figure 4 pictures a thermally damaged elastomeric gasket that had been reduced to carbon removed from TILX 731758, #65) also submitted to the NTSB laboratory for examination (Control #HMD22LR001-HAZ-006).

*Figure 3. Nitrile rubber Buna-N manway gasket removed from TILX 731757 (#72) for lab analysis (Control# HMD22LR001-HAZ-004). January 28, 2022.*

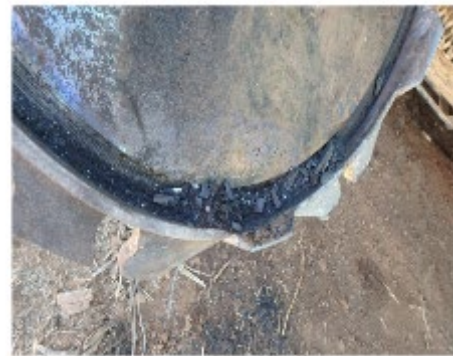
*Figure 4. Thermally damaged manway elastomeric Buna-N gasket reduced to carbon, TILX 731758 (#65). Removed for lab analysis (Control#HMD22LR001-HAZ-006). January 28, 2022.*

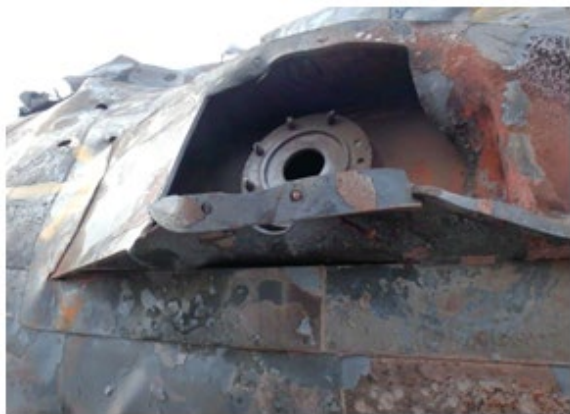
Three structural failures of the BOV center skid were observed following this derailment. The skid failures accompanied a mechanical breach to the BOVs and loss of product, to include shearing of the full BOV assembly and ball valve from the saddle (Figures 5 - 8).

*Figure 5. Center skid structure collapsed, shearing full BOV assembly and ball valve, TILX 731739. January 27, 2022.*

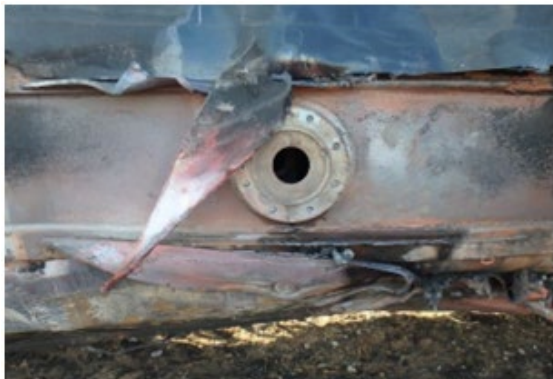
Figure 8. Skid structure missing/sheared away along with full BOV assembly and ball valve. Angular flap of center skid remains. TILX 731680. January 27, 2021.

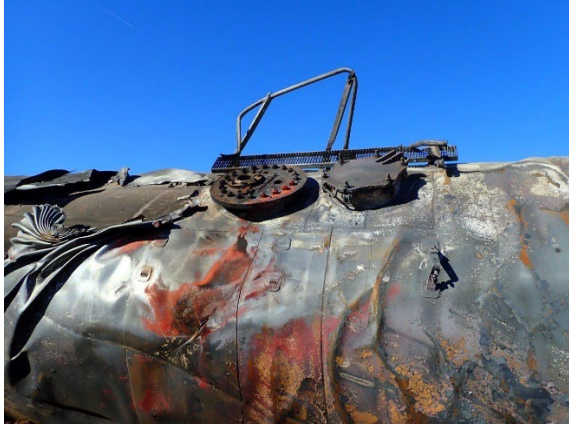
NTSB investigators found two tank cars with top fittings mechanical damage and breaches: (Figure 13) shows TILX 731462 with all top fittings and valves sheared off, and Figures 14 and 15 show damage to the protective housing of CRDX 300133 and one 3-inch valve partially sheared from the flange.

*Figure 13. Missing top fittings protective housing with all top fittings sheared from flange. TILX 731462. Courtesy Trinity Industries Leasing, Inc., January 9, 2022.*

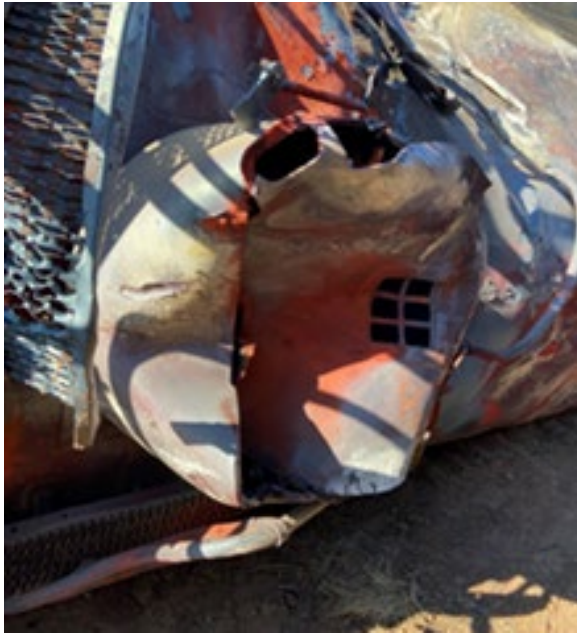
*Figure 14. Mechanically damaged top fittings protective housing. CRDX 300133. Courtesy Federal Railroad Administration, January 11, 2022.*

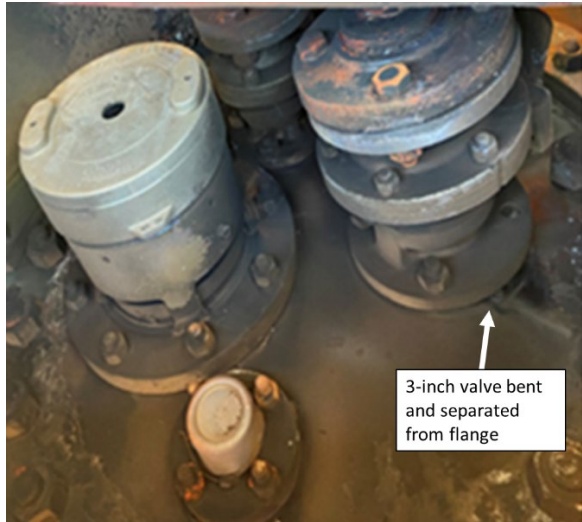
Figure 15. Three-inch valve sheared from flange below damage to protective housing. CRDX 300133. Courtesy Federal Railroad Administration, January 11, 2022.

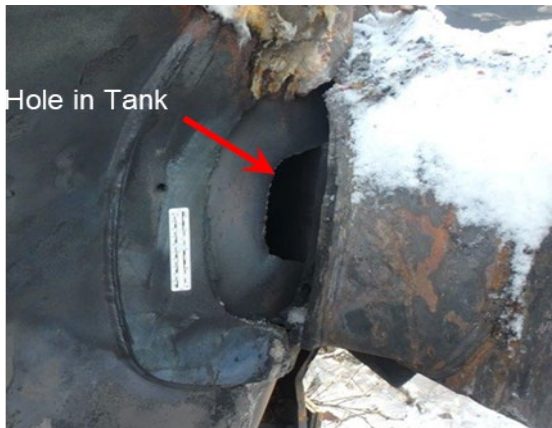
Figure 16. Tank shell breach showing separated head brace and fractured re-pad. TILX731751. January 27, 2022.

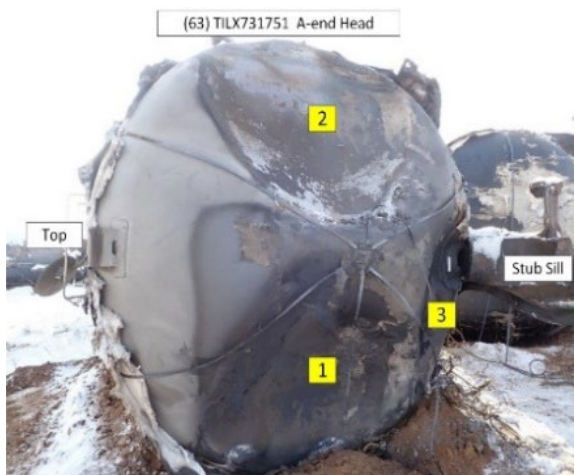
Figure 17. A-end head identifying three localized impacts, TILX 731751. January 27, 2022.

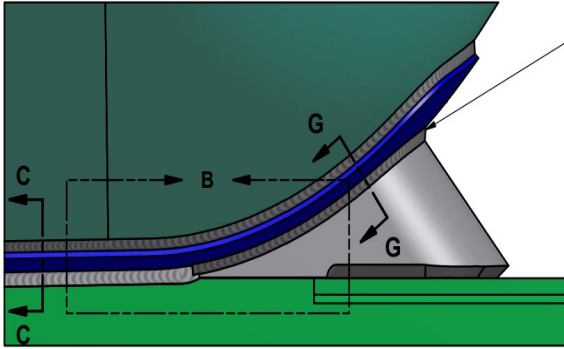
A-end stub sill head pad section with tank breach at the fractured A-3 stub sill “window weld” removed from the tank car and sent to the NTSB laboratory for examination (Control # HMD22LR-HAZ-002) (Figure 18). Figure 19 drawing of the head brace assembly shows welds in Section G-G, where the fracture occurred.

Figure 19. Drawing of head brace depicting re-pad and welds at location of tank fracture. (Courtesy, Trinity Industries Leasing, Inc.)

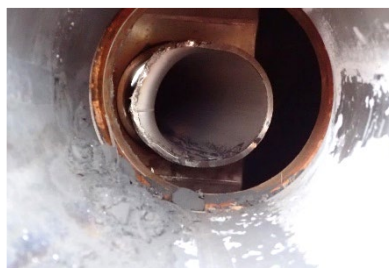
Follow up inspection of the derailed tank cars revealed four eduction pipes displaced along with damage to the BOV ball valve as seen in figures 20 and 22. Investigators found broken welds at the guide assembly that were designed to

Figure 20. Flared (impact damaged) eduction pipe bottom as seen through the open bottom outlet ball valve, TILX 731748. January 27, 2022.

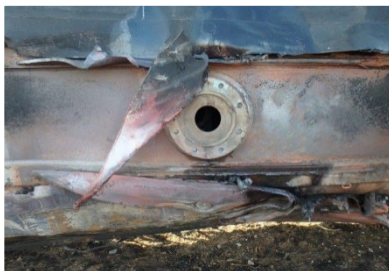
1(a) Missing bottom outlet valve and saddle, and sheared skid protection structure.

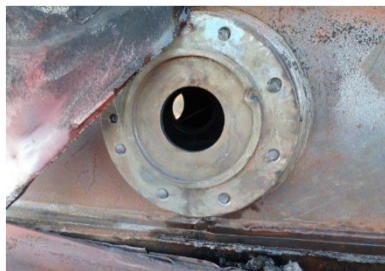
1(b) Full BOV assembly sheared away from the saddle.

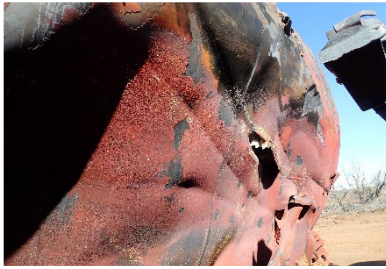
2.1(a) Buckled A-end stub sill. Head brace and pad.

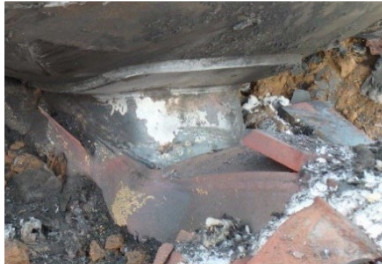
2.1(b) A-end head brace and pad with fractured head brace-to-stub sill weld.

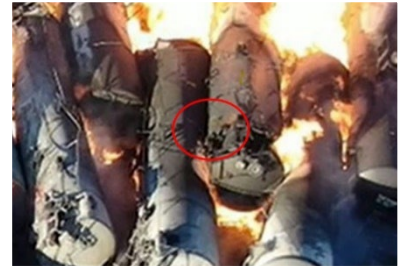
2.1(c) Adjacent car (43) TILX731782 resting on left side of top fittings protective housing of (44) CRDX300110, with flame impingement. Pool fire at A-end of the car.

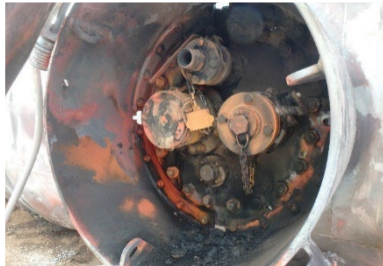
3(b) Thermally damaged top fittings.

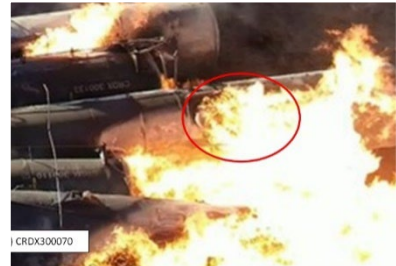
3(c) Flames from top fitting protective housing and manway area.

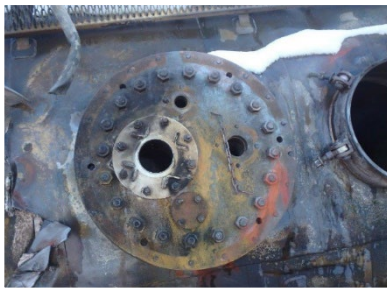
*4(a). Top fittings flange, missing protective housing, missing valves and PRD.*

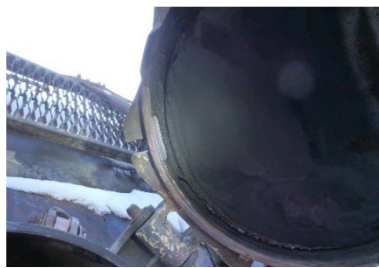
*4(b). Thermally destroyed manway gasket and carbon on interior of manway cover.*

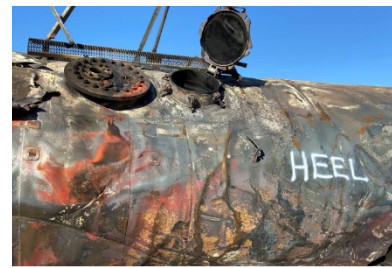
*4(c). Thermally damaged manway and sheared shop fittings.*

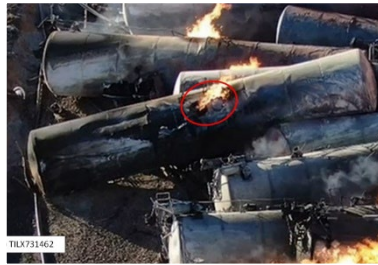
*4(d). Flames from top fittings area.*

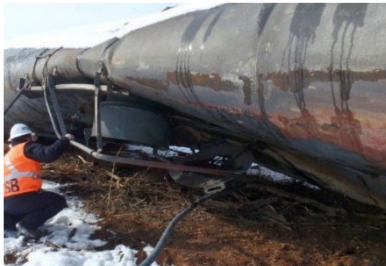
5(a). Crushed shell material, top and left side.

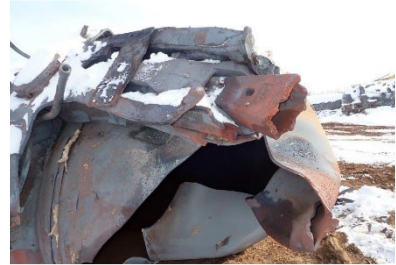
5(c). Fractured/torn B-end head with outward deformation of material.

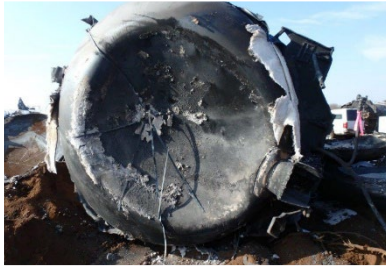
7(a). B-end head, rounded dent, fractured stub sill.

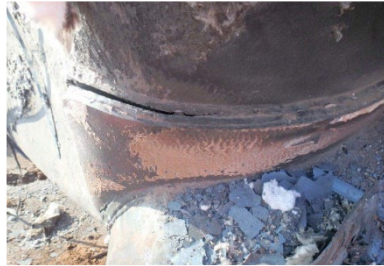
7(b). Fractured A-2 head pad weld and separated head pad.

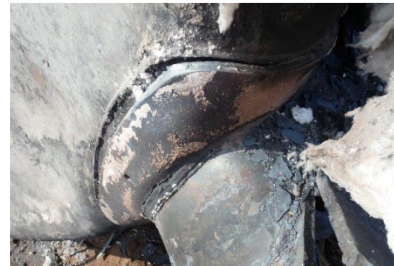
7(c). Fractured A-1 and A-2 head pad welds and cracked head brace-to-head pad weld.

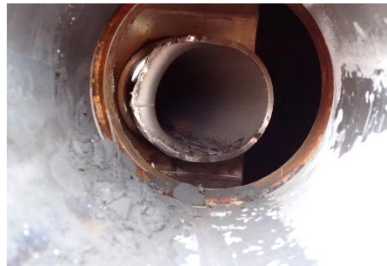
7(d). Flared (impact damaged) education pipe bottom as seen through the open bottom outlet ball valve.

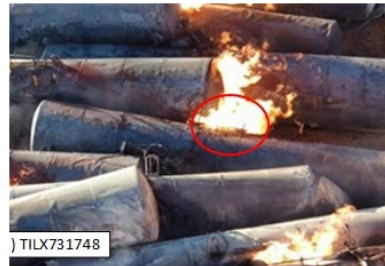
7(e). Flame from manway and top fittings housing.

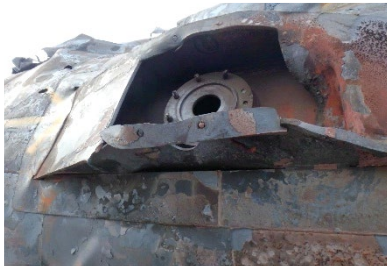
8(a). Collapsed portion of skid protection structure with bottom outlet valve missing.

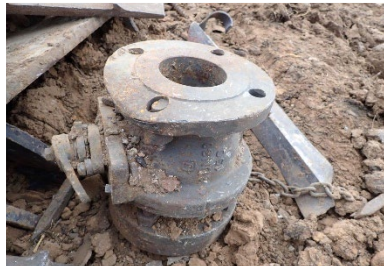
8(b). Separated 3-inch top valve with impact damage.

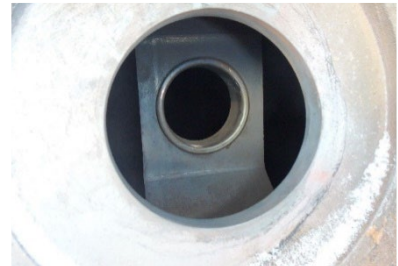
8(c). Eduction pipe flange over BOV opening.

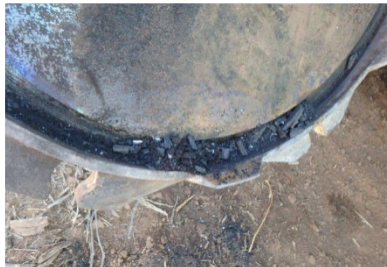
8(d). Thermally damaged manway gasket material.

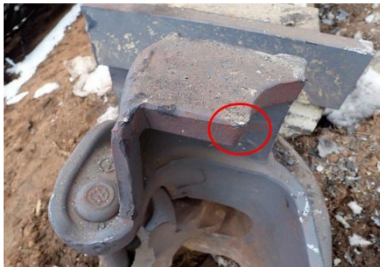
8(e). B-end coupler upper shelf sharp radius witness mark.

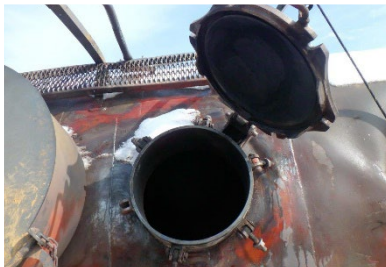
9(a). Thermal damage to tank jacket around the manway.

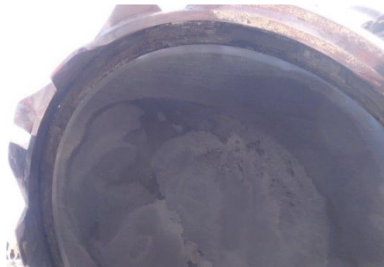
9(b). Internal surface of manway cover with thermally damaged gasket.

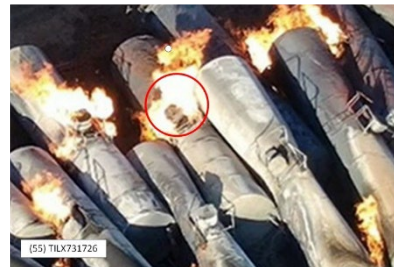
9(c). Flame from manway and top fittings protective housing.

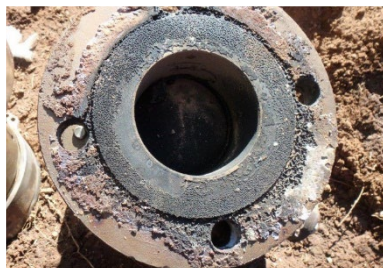
10(d). Thermally damaged liquid valve gasket.

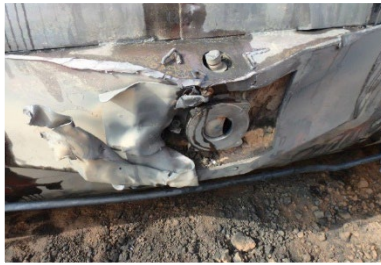
11(a). BOV skid protection structure, shallow dent A-end side (right side in photo).

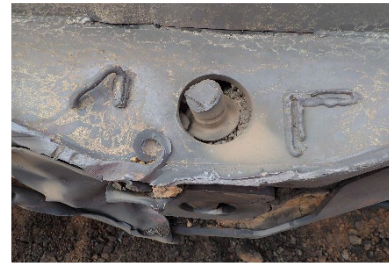
11(c). BOV stem adaptor with top surface torsional fracture. Slotted end was severed and missing.

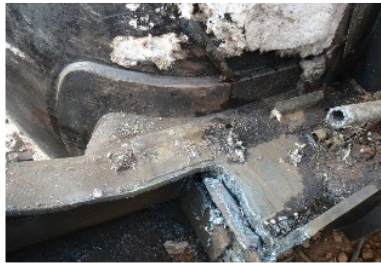
11(d). Repaired B-end right A-2 head pad fillet weld.

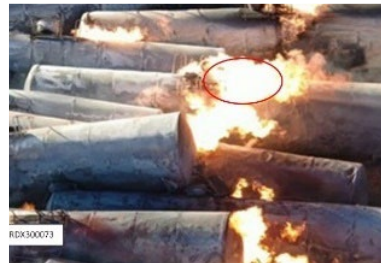
11(e). Flames in manway area.

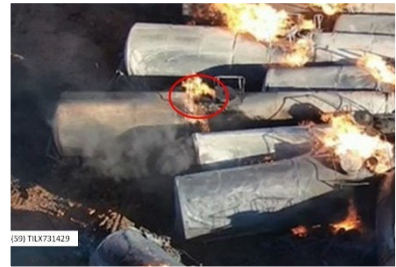
12(c). Flames in manway area.

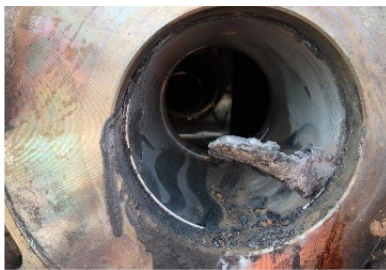
13(a). Mass of melted and extruded Teflon ball valve packing and eduction pipe flange seen through the BOV hole.

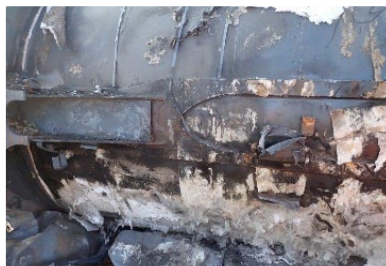
13(d). No breaching damage identified at the B-end stub sill inboard at tail piece following jacket removal.

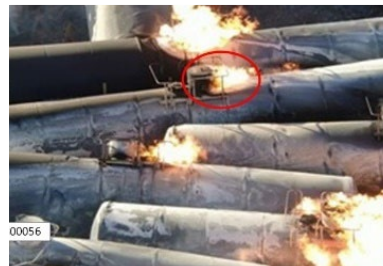
14(e). Flames from top fittings protective housing.

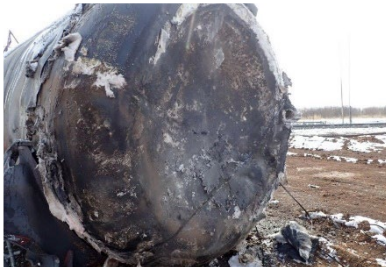
14(a). Rounded dent to A-end head as seen after head shield removal.

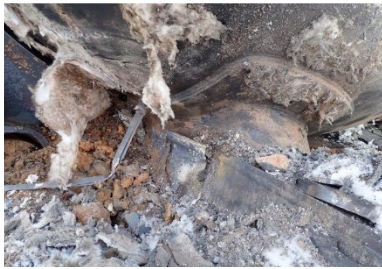
14(b). Fractured stub sill web at head brace and head pad. No tank breaching damage in this area.

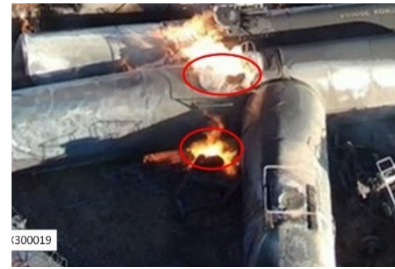
14(c). Flames at top fittings protective housing, manway, and bottom outlet valve areas.

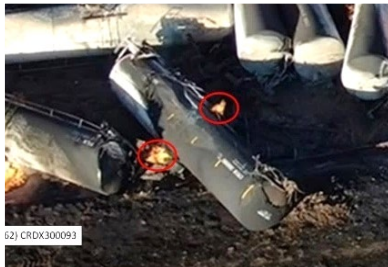
15(a). Flames at bottom outlet valve and manway.

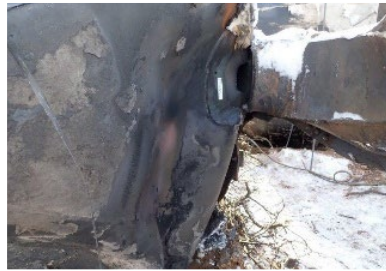
16(b). A-end stub sill and head damage.

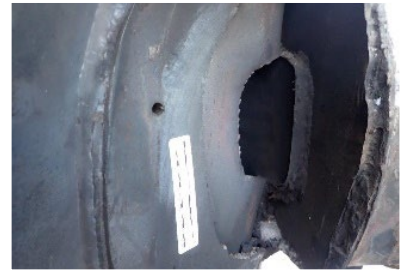
16(c). Fractured A-end head beneath fractured and separated head pad.

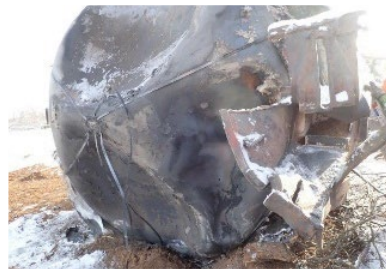
16(e). Stub sill web damage.

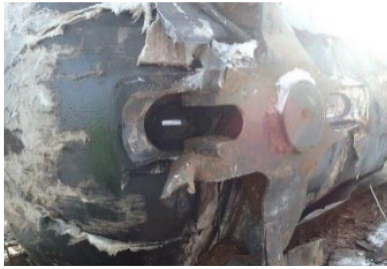
17(a). The A-end stub sill was fractured from the head brace with a piece of its broken web bent to the right.

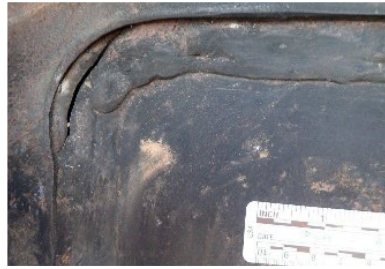
17(b). Cracked A-end A-3 weld, left forward corner.

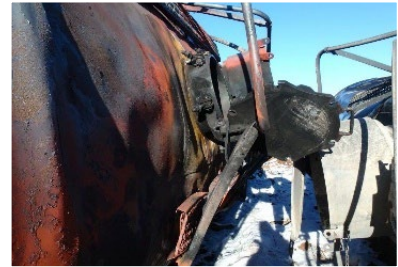
18(c). Scorched jacket surrounding manway and top fittings housing. Thermally damaged gasket material was hanging loose from the open manway.

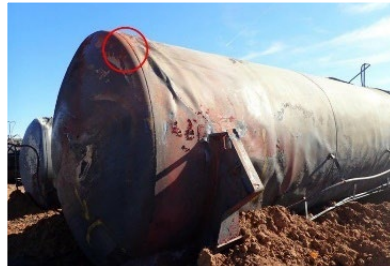
18(d). A-end breach location as indicated by flames in aerial imagery.

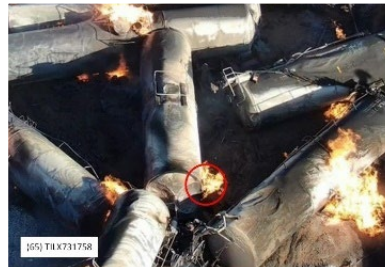
18(e). Flame indicates undocumented breaching damage at A-end head/shell interface, about 2:00.
