National Transportation Safety Board

WPR23LA004

AIRWORTHINESS

Specialist's Factual Report

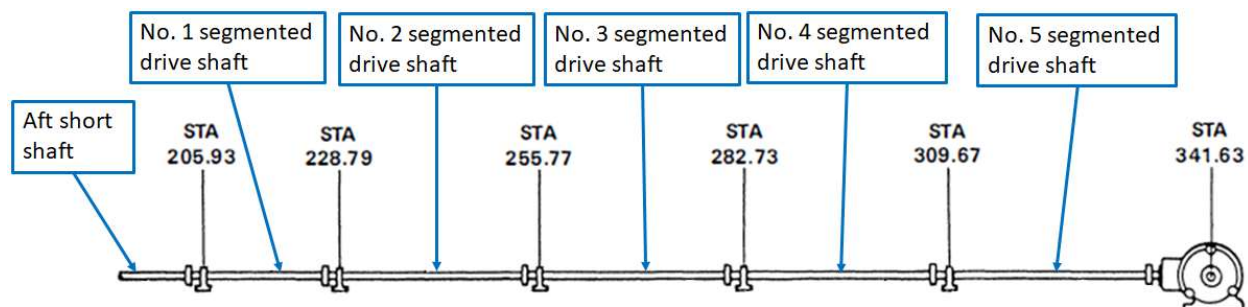
Figure 1. A diagram of the segmented drive shaft system. (Image courtesy of Bell)

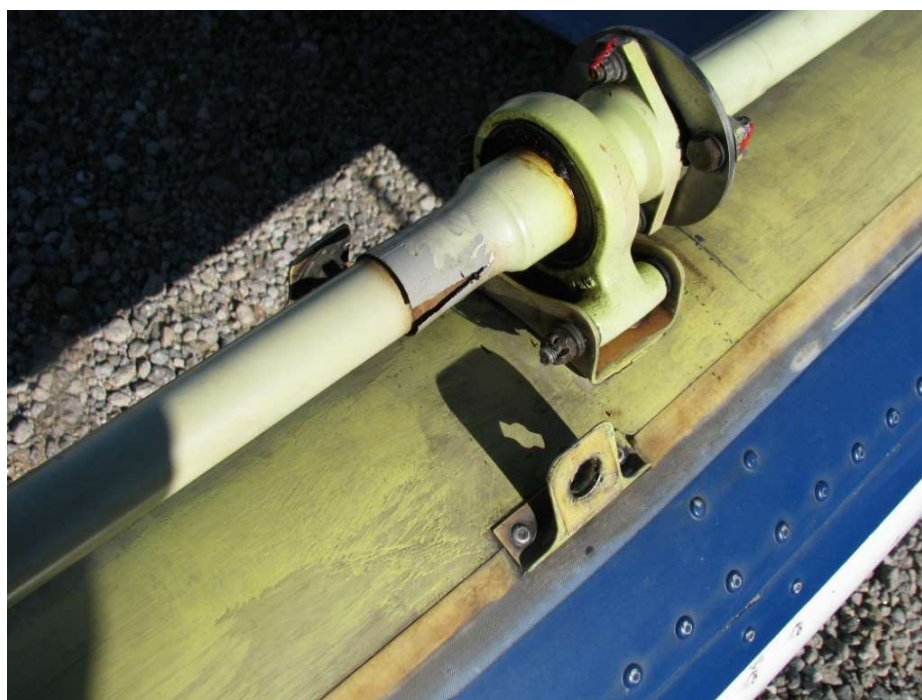
Postaccident examination of the helicopter found that on the No. 4 segmented tail rotor drive shaft (**Figure 1**), the splined adapter on the forward end of the drive shaft had separated from the drive shaft tube (**Figure 2**), possibly due to a disbond between the splined adapter and the shaft tube. The No. 4 segmented drive shaft was retained for further examination. The scope of this report is focused primarily on the No. 4 segmented tail rotor drive shaft of the accident helicopter and the inspections required of the segmented tail rotor drive shafts.

Figure 2. The separated splined adapter at the forward end of the No. 4 segmented tail rotor drive shaft. (Image courtesy of Bell)

Examination of the recovered wreckage found the splined adapter at the forward end of the No. 4 segmented drive shaft had separated from the drive shaft tube. The No. 4 segmented drive shaft was subsequently shipped to the NTSB Materials Lab in Washington, District of Columbia for further examination.

Lab examination of the No. 4 segmented drive shaft found no evidence of anomalous damage within the splined connection. The serial number marking "VN12657" was observed on the outer surface of the splined adapter. The adhesive material between the shaft tube and the splined adapter showed evidence of heating and resolidification. Additional findings from the materials lab examination can be found in Materials Laboratory Factual Report No. 23-081 in the docket for this investigation.

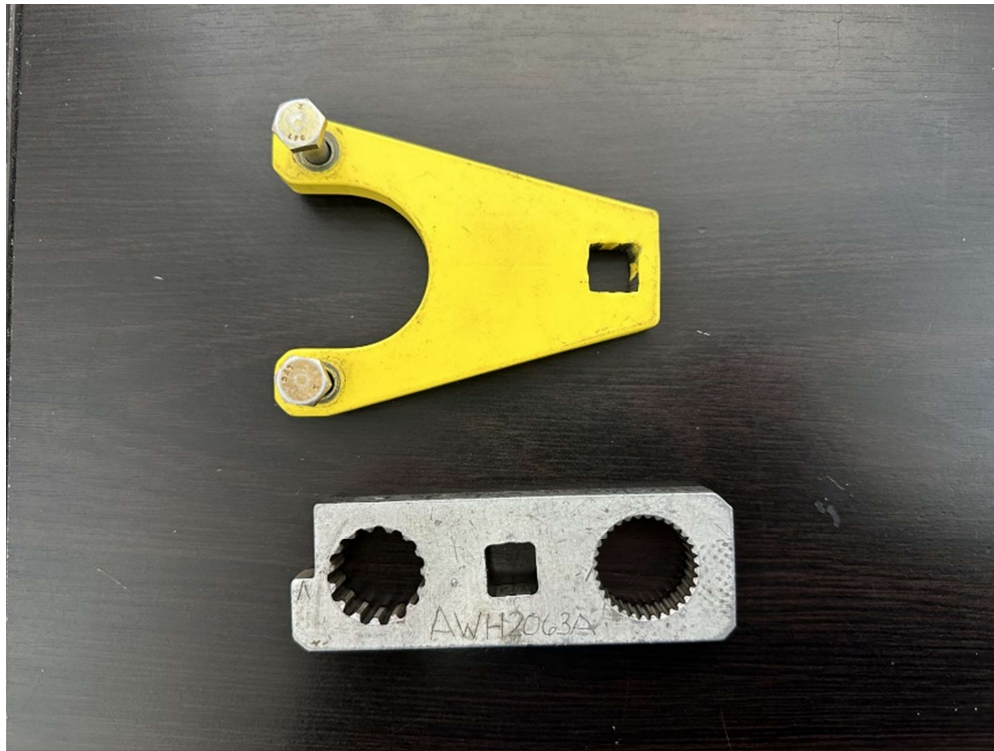
The operator's director of maintenance stated that they used a bonded shaft tool sourced from Helicopter Work Aids in Pineville, Louisiana, to accomplish Part I of ASB No. 206-20-139. Additionally, a second tool, containing internal splines, was installed on the oil cooler drive shaft to hold the tail rotor drive line while the bonded shaft tool was used to apply the proof load. **Figure 3** shows the bonded shaft tool and the splined tool utilized by the operator to accomplish the proof load test. Examination of the bonded shaft tool used by the operator found the dimension between the square drive to the centers of the bolt holes was about 3.019 inches (**Figure 4**). According to Bell ASB No. 206-20-139 and 206L-20-184, the bonded shaft tool may be ordered or locally manufactured. The ASB provided the dimensions of the bonded shaft tool¹⁰ for local manufacture, which was to have a 3.00-inch distance between the square drive to the centers of the bolt holes.

Figure 3. The tools used by the operator to accomplish the proof load test. (Image courtesy of Organ Mountain Aviation Company)

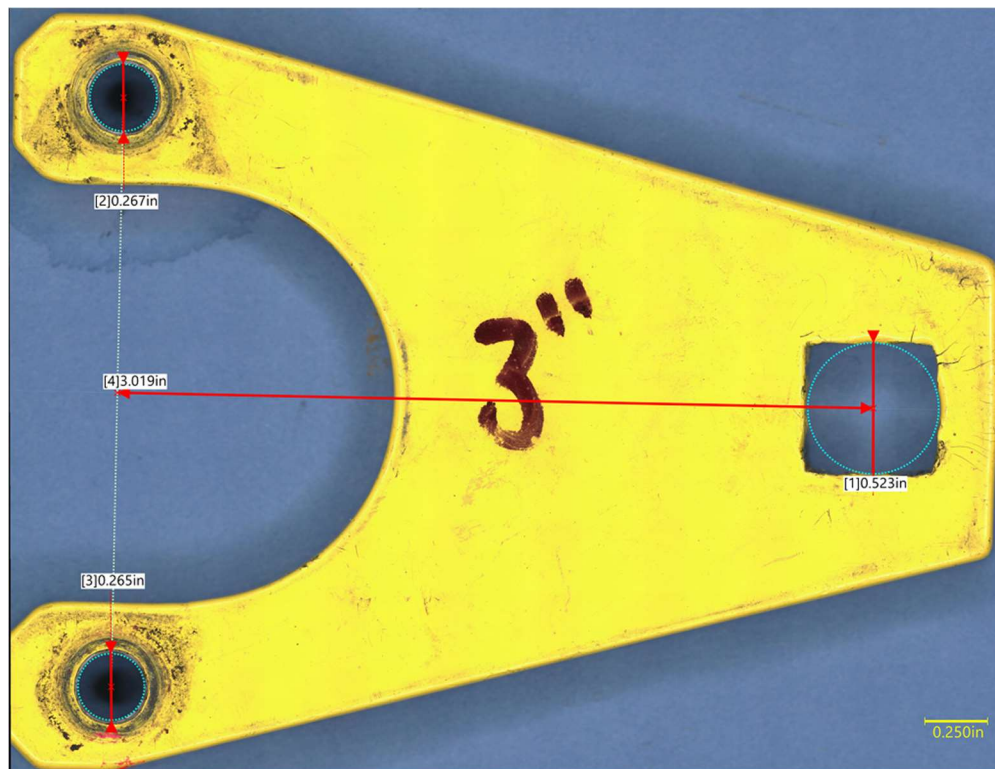
Figure 4. Measurement of the bonded shaft tool.
