WPR23LA004

Group Chair's Factual Report - Attachment 1

Bell Alert Service Bulletin No. 206-20-139

SUBJECT: SEGMENTED TAIL ROTOR DRIVESHAFTS 206-040-330-003/-101, 206-040-931-009/-011/-101/-103, 206-040-365-101/-105/-121/-123 WITH BONDED ADAPTERS, PROOF LOAD TEST OF.

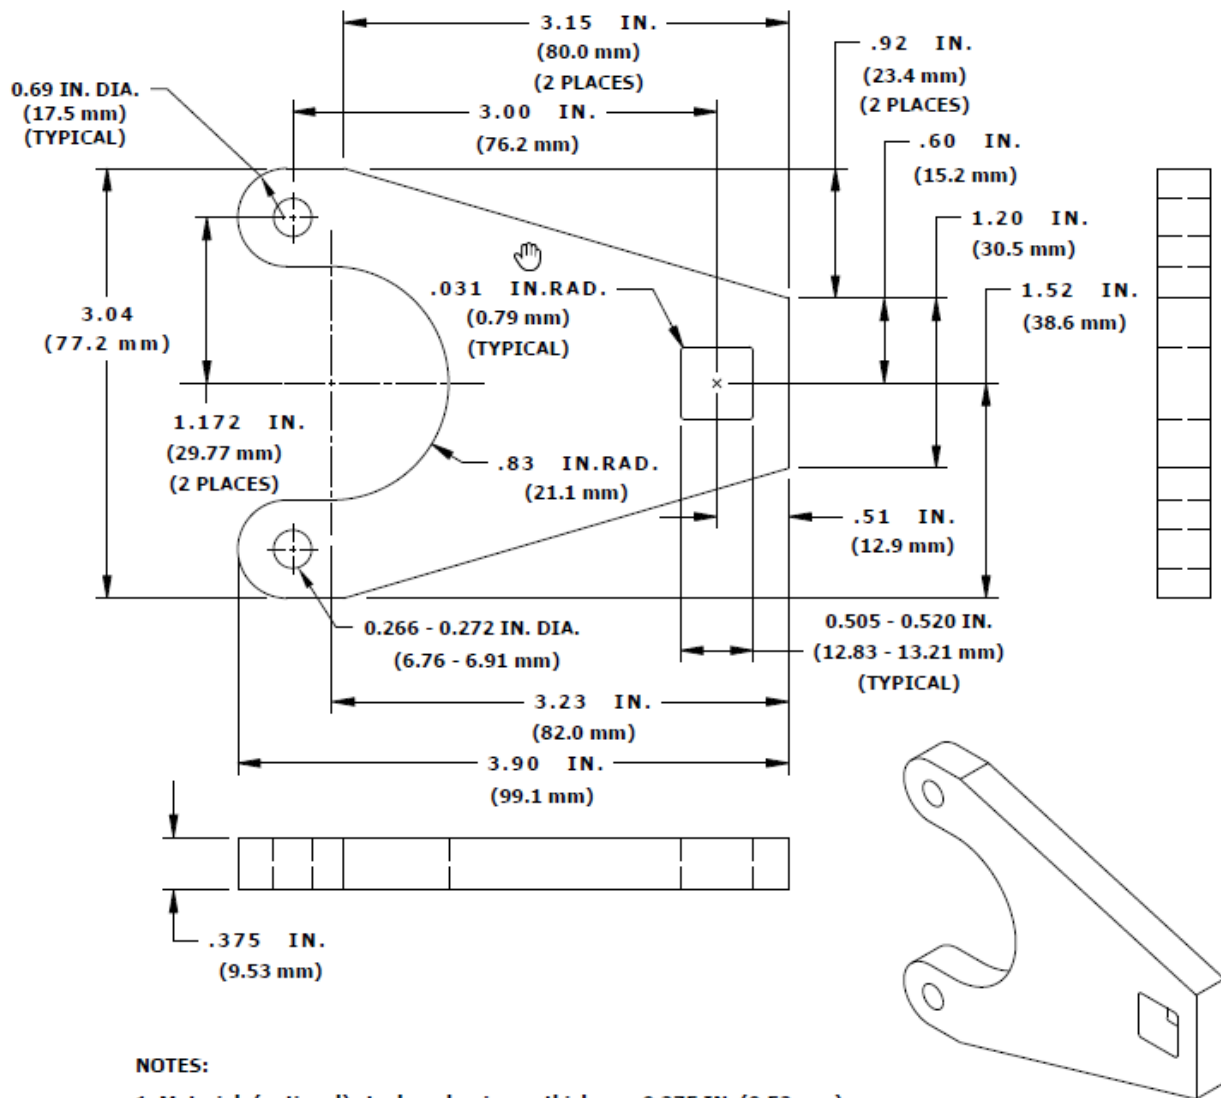
Figure 1 – Bonded Shaft Tool (206-244-001-101)

The bonded shaft tool part number 206-244-001-101 (QTY 2 required) can be procured through your Bell Supply Center or locally manufactured using the information provided on Figure 1.

If the forward short shaft is removed, install the (206-040-328) sliding adapter and work aid (Bonded Shaft Tool 206-244-001-101) on the forward splines of the oil cooler fan shaft. The bonded shaft tool 206-244-001-101 can be locally manufactured using the information in Figure 1 or can be purchased from a Bell Supply Center.

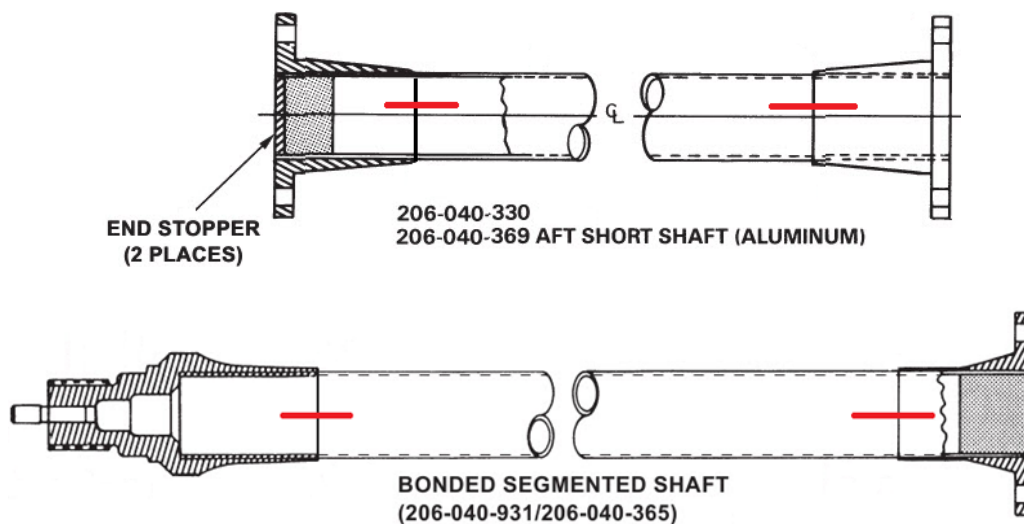
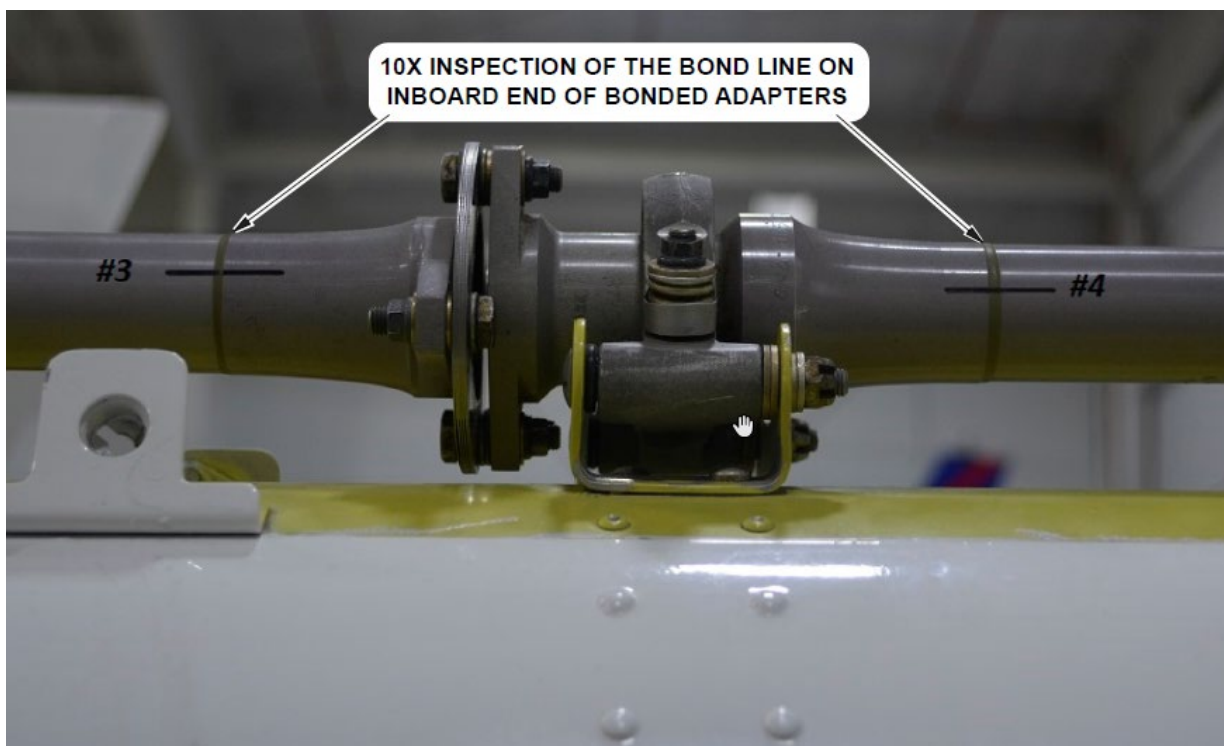
Figure 2 – Example of Tail Rotor Driveshaft Numbering and Index Marking

3. Carry out a detailed visual inspection of the bond line on the inboard end of the flange of the bonded tail rotor driveshafts using a 10X magnifying glass (Figure 2). If the bond line area shows damage such as cracked or missing adhesive or evidence of corrosion, the affected shaft is deemed un-repairable and must be removed from service and scrapped. Replace affected driveshaft(s) with a riveted tail rotor driveshaft(s) (TB 206-06-186).

4. Index-mark each bonded tail rotor driveshaft and adapters with a fine tip felt marker (Figure 2) and number the shafts (example: Aft SS, 1, 2, 3, 4 and, 5. Driveshaft #5 being the closest to the tail rotor gearbox).

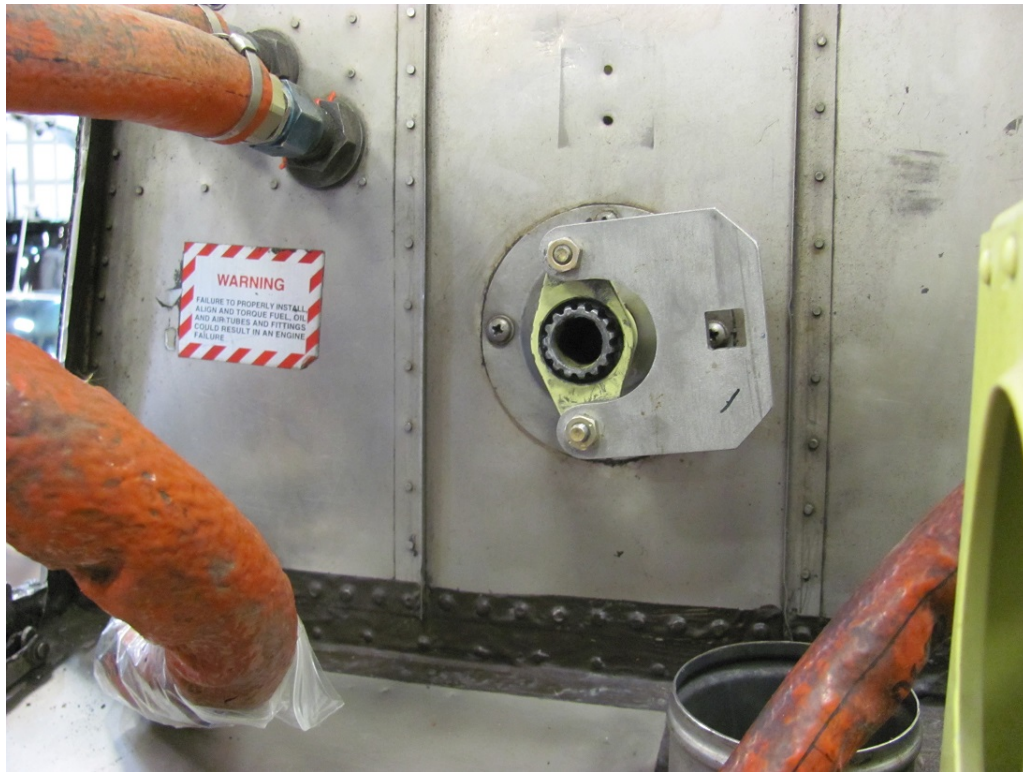
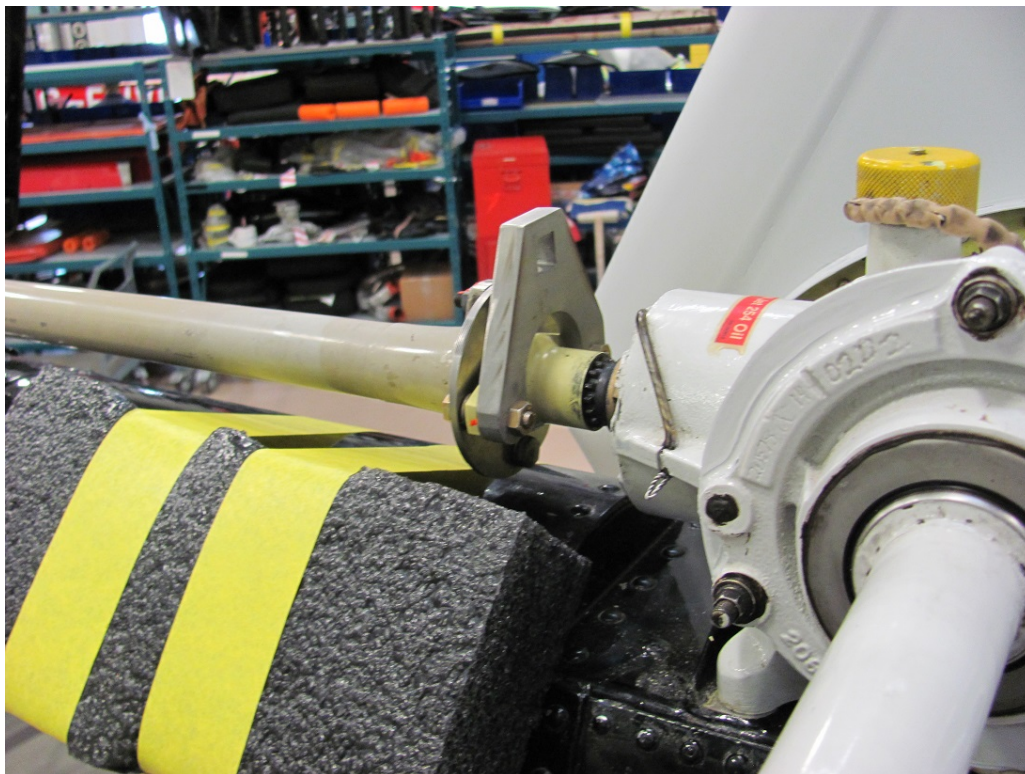
Figure 3 - Examples of Bonded Shaft Tool Installations

6. Install the bonded shaft tool on the (206-040-328) sliding adapter flange of the forward splines of the oil cooler blower shaft using two (2) AN174-12 or NAS6604-12 bolts, current washers AN960-416L, and nuts MS21042L4, NAS9926-4L or MS35650-3252 nut, or equivalent (Figure 3).
7. Remove two (2) AN174 bolts from the (206-040-328) sliding adapter on the input pinion of the tail rotor gearbox.
8. Install the second bonded shaft tool on the aft face of the sliding adapter (206-040-328) of the input pinion of the tail rotor gearbox using two (2) AN174-12 of NAS6604-12 bolts, current washers AN960-416L, and nuts MS21042L4, NAS9926-4L or MS35650-3252 nut, or equivalent (Figure 3).

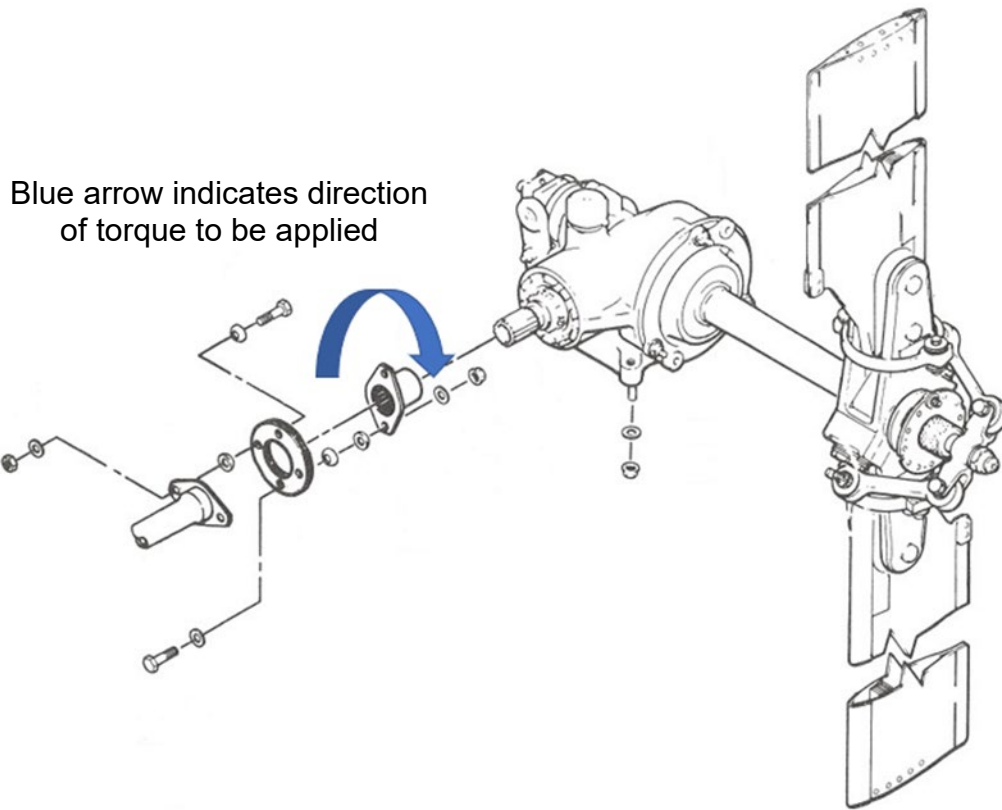
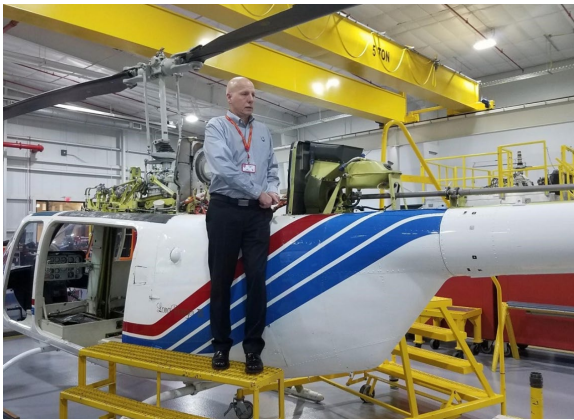
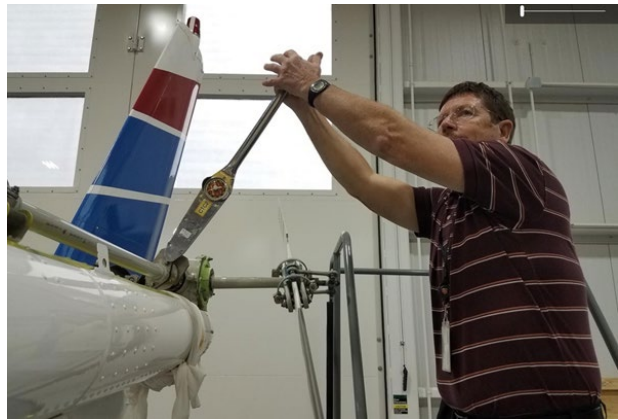
Figure 4 – Proof Load testing

9. One person is required to hold the bonded shaft tool on the splines of the forward end of the oil cooler blower shaft with a ½-inch square drive breaker bar (Figure 4).

10. One person is required to hold the torque wrench on the bonded shaft tool installed on the sliding adapter (206-040-328) of the tail rotor gearbox input pinion (Figure 4).

11. For helicopters equipped with the 1.0-inch diameter shafts 206-040-330-003/-101 and 206-040-931-009/-011/-101/-103 carry out the proof load testing of the installed driveshafts by applying the equivalent of 82 foot-pounds (111 Newton-meters). Stand on the left side of the tailboom (tail rotor side), position the torque wrench vertically (12 o'clock) and pull down until the required torque is reached. For helicopters equipped with the 1.25-inch diameter shafts 206-040-369-001/-101 and 206-040-365-101/-105/-121/-123, carry out the proof load testing of the installed tail rotor driveshafts by applying the equivalent of 123 foot-pounds (167 Newton-meters) of torque.

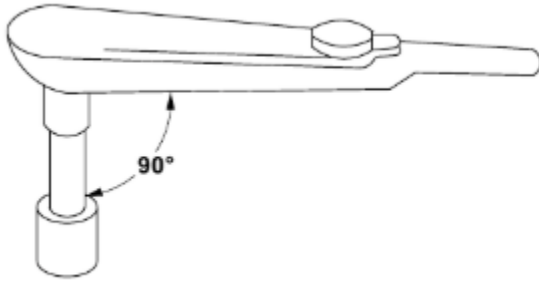
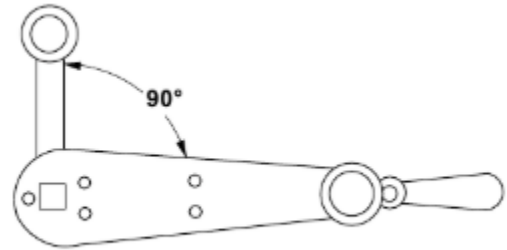
**Figure 5 – Nonconcentric Type Attachments
(Ref) BHT-ALL-SPM, Chapter 2**

Use a ½-inch square drive dial-type torque wrench capable of measuring up to 150 foot-pounds (237 Newton-meters). Refer to BHT-ALL-SPM, Figures 2-1, 2-2 and 2-3 concentric and non-concentric type attachments. Examples of torque values when using concentric and nonconcentric attachments are shown in Figure 5.

Applied and indicated torque values are the same.
