WPR23LA004

Group Chair's Factual Report - Attachment 2
Bell Alert Service Bulletin No. 206L-20-184

ALERT SERVICE BULLETIN

SUBJECT: SEGMENTED TAIL ROTOR DRIVESHAFTS 206-040-369-001/-101, 206-040-365-001/-117/-125 WITH BONDED ADAPTERS, PROOF LOAD TEST OF.

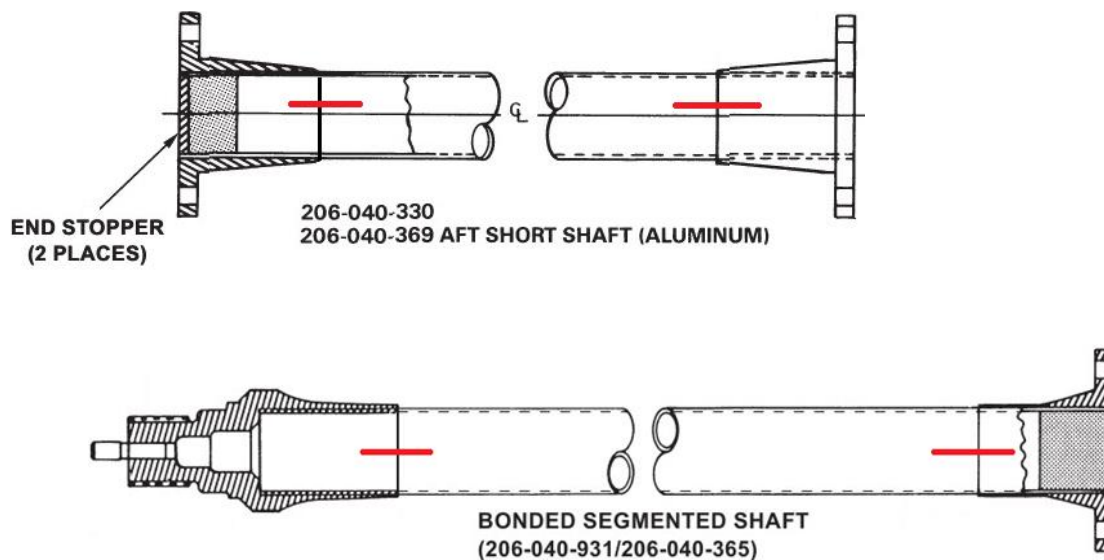
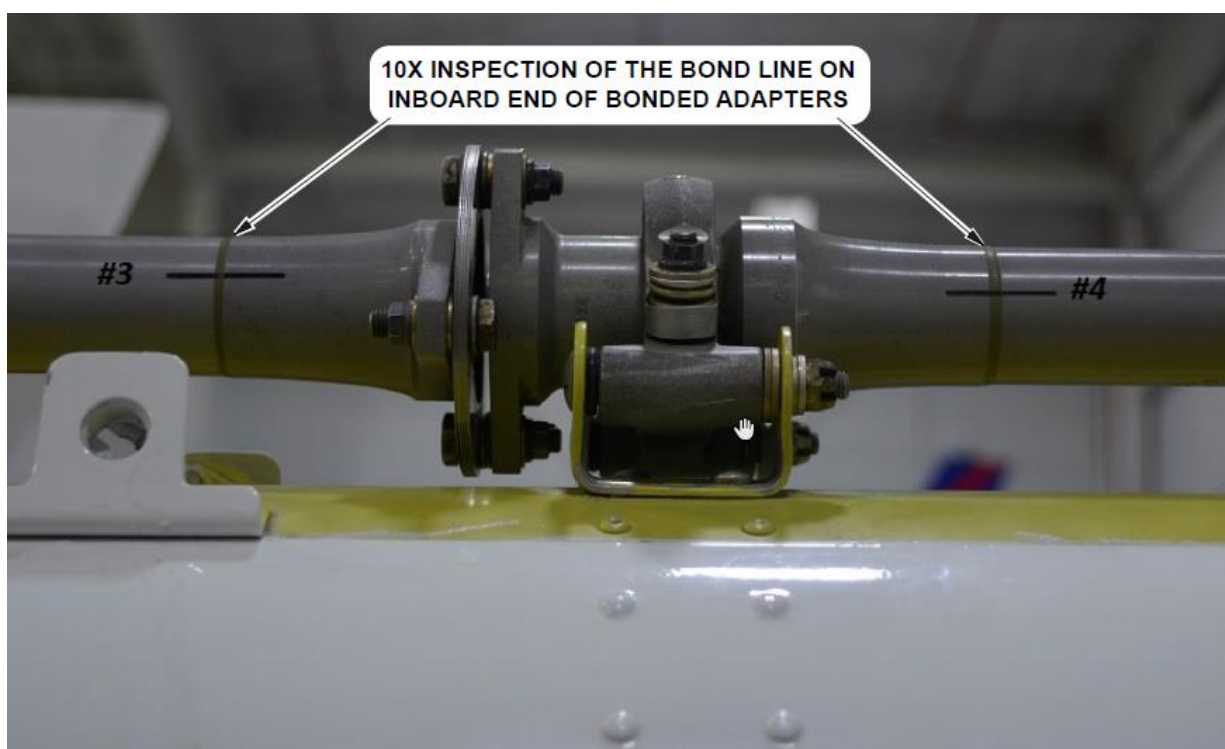
Figure 1 – Example of Tail Rotor Driveshaft Numbering and Index Marking

3. Carry out a detailed visual inspection of the bond line on the inboard end of the flange of the bonded tail rotor driveshafts using a 10X magnifying glass (Figure 1). If the bond line area shows damage such as cracked or missing adhesive or evidence of corrosion, the affected shaft is deemed un-repairable and must be removed from service and scrapped. Replace affected driveshaft(s) with a riveted tail rotor driveshaft(s) (TB 206L-02-207).

4. Index-mark each bonded tail rotor driveshaft and adapters with a fine tip felt marker (Figure 1) and number the shafts (example: Aft SS, 1, 2, 3, 4 and, 5. Driveshaft #5 being the closest to the tail rotor gearbox).
