**Highway Attachment -MSHP Crash Report**

**RRD22MR010**

MISSOURI UNIFORM CRASH REPORT

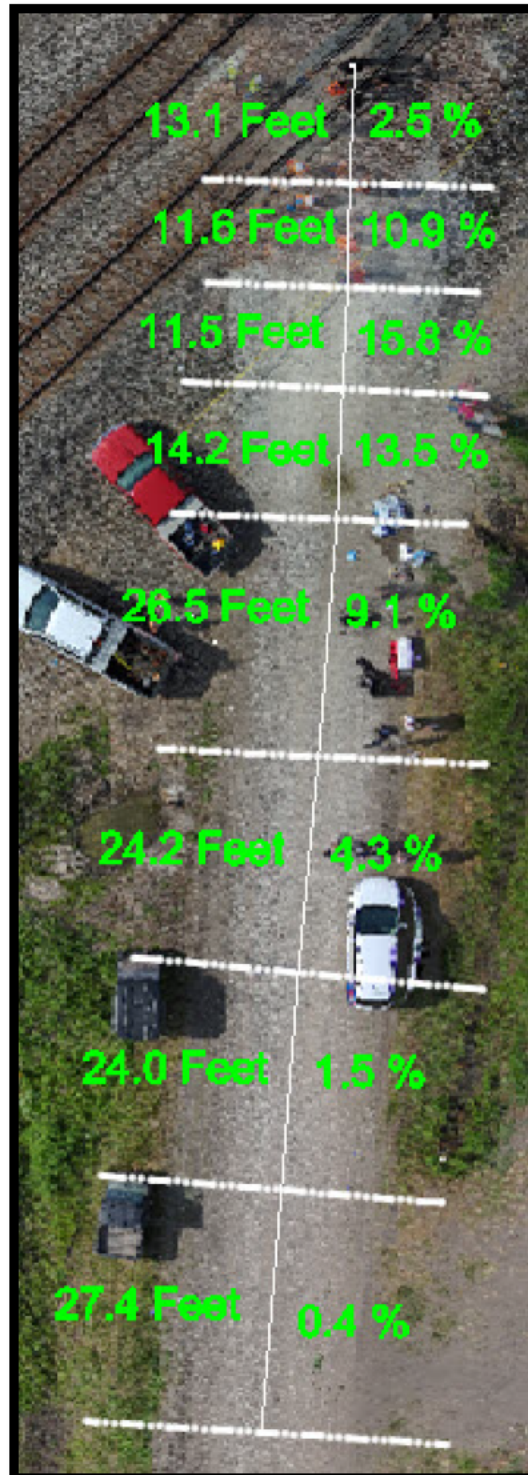
Using a three-dimensional model created on the day of the crash, I verified my smart level measurements. I found the northbound approach to the railroad crossing reached a maximum grade of approximately 15.8 percent. The average grades of the approach can be seen in the following image from IMS MAP360 software.

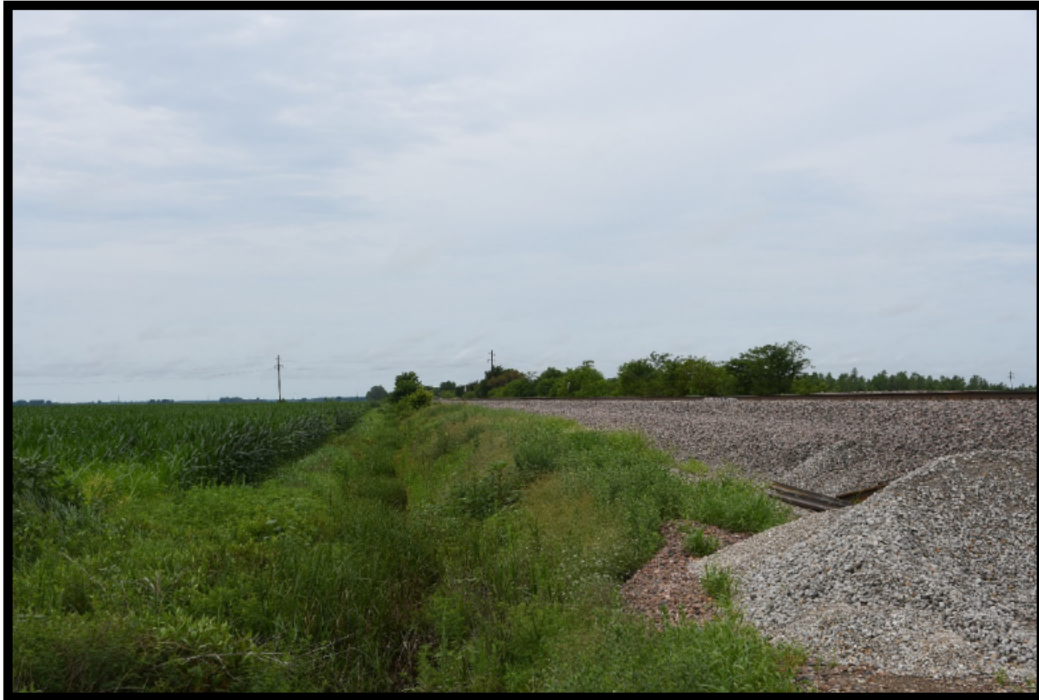
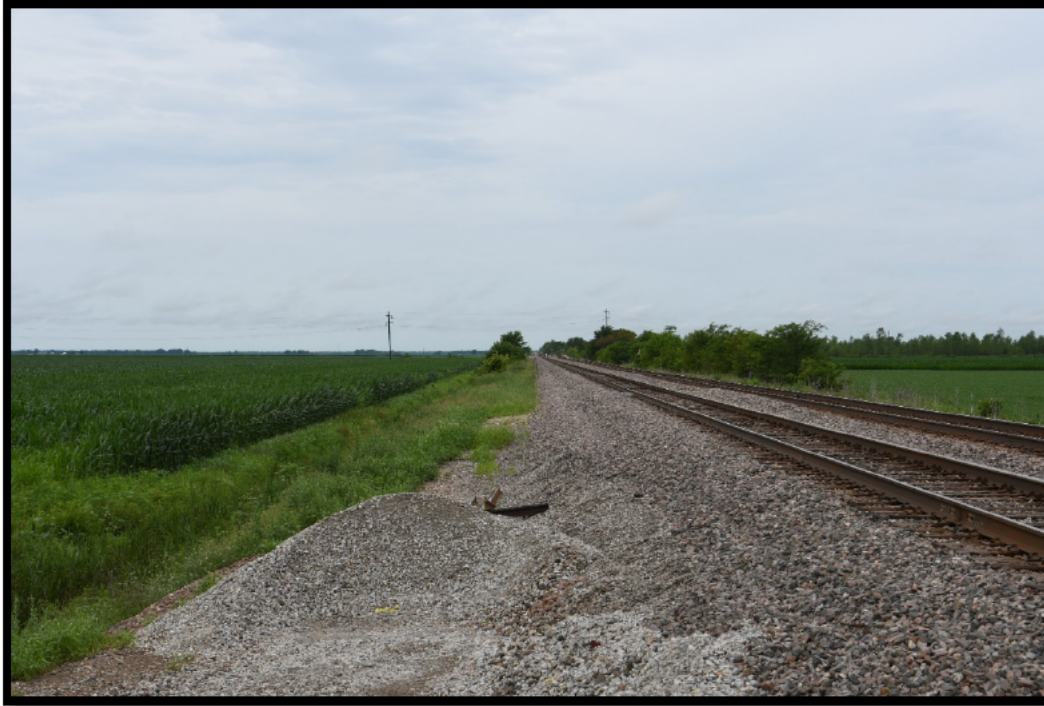
About 677 feet to the west of the area of impact, along the south side of the railway, vegetation was observed along the railway edge. Taller vegetation was observed about 966 feet from the area of impact. If a northbound vehicle were to stop 50 feet south of the nearest rail, the vegetation would have limited the sight distance of an

approaching eastbound train. If a vehicle stopped 15 feet of the nearest rail, the vegetation did not obscure an approaching eastbound train. This indicated sight distance may have been a contributing factor in this crash. The following photographs, DSC\_0021 and DSC\_0032, represent the sight distance from 50 feet and 15 feet, respectively from my standing point-of-view.

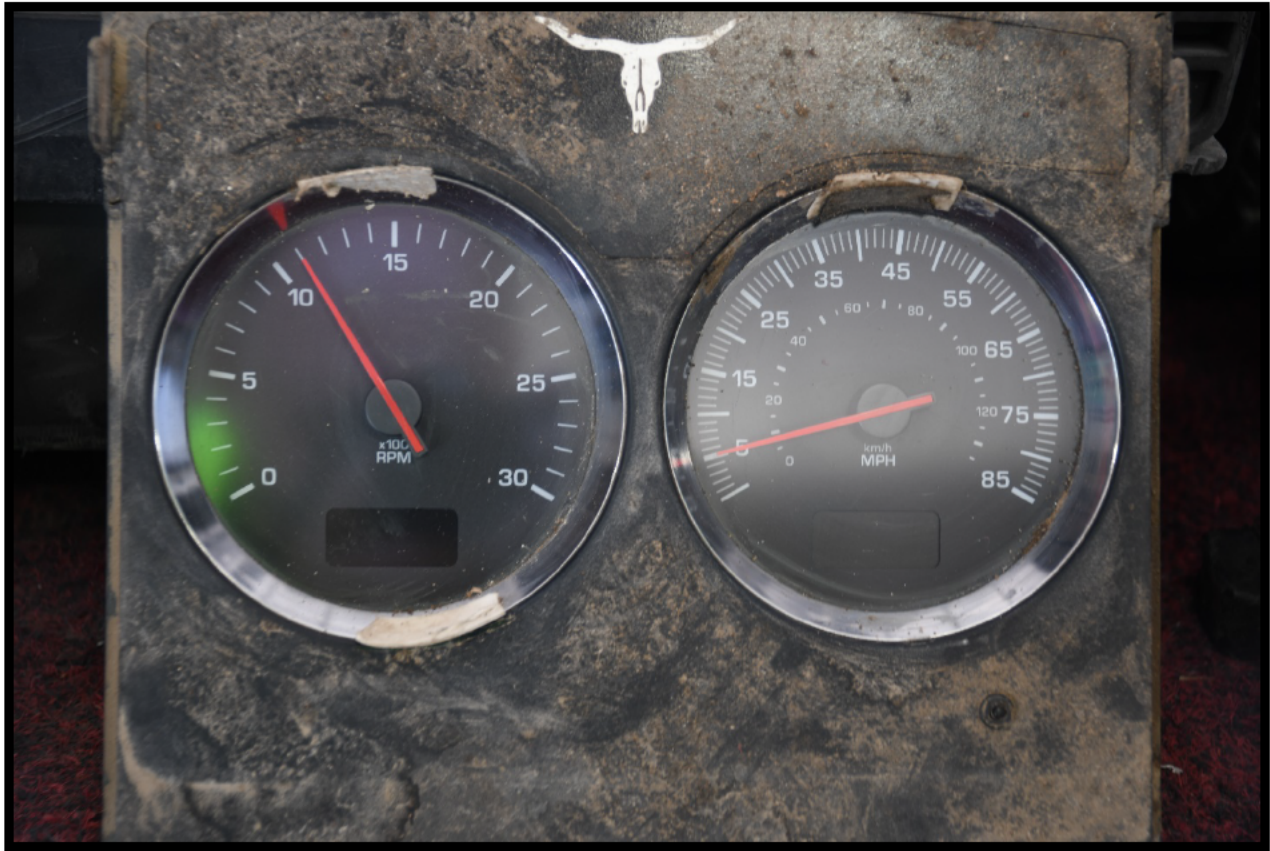
I removed the gauge panels from the vehicle. The rear drive axle gauges indicated below their lowest reading of 150 psi and the two pusher axles indicated 0 psi. The engine boost gauge was at about 10 psi. The fuel filter gauge was at about 3 inches of Mercury. The primary air and secondary air gauges were both at about 110 psi. The fuel gauge was at just below half of a tank. The air brake pressure gauge was at the lowest range of about 0 psi. The speedometer and tachometer gauges can be seen in the following image, DSC\_0144.

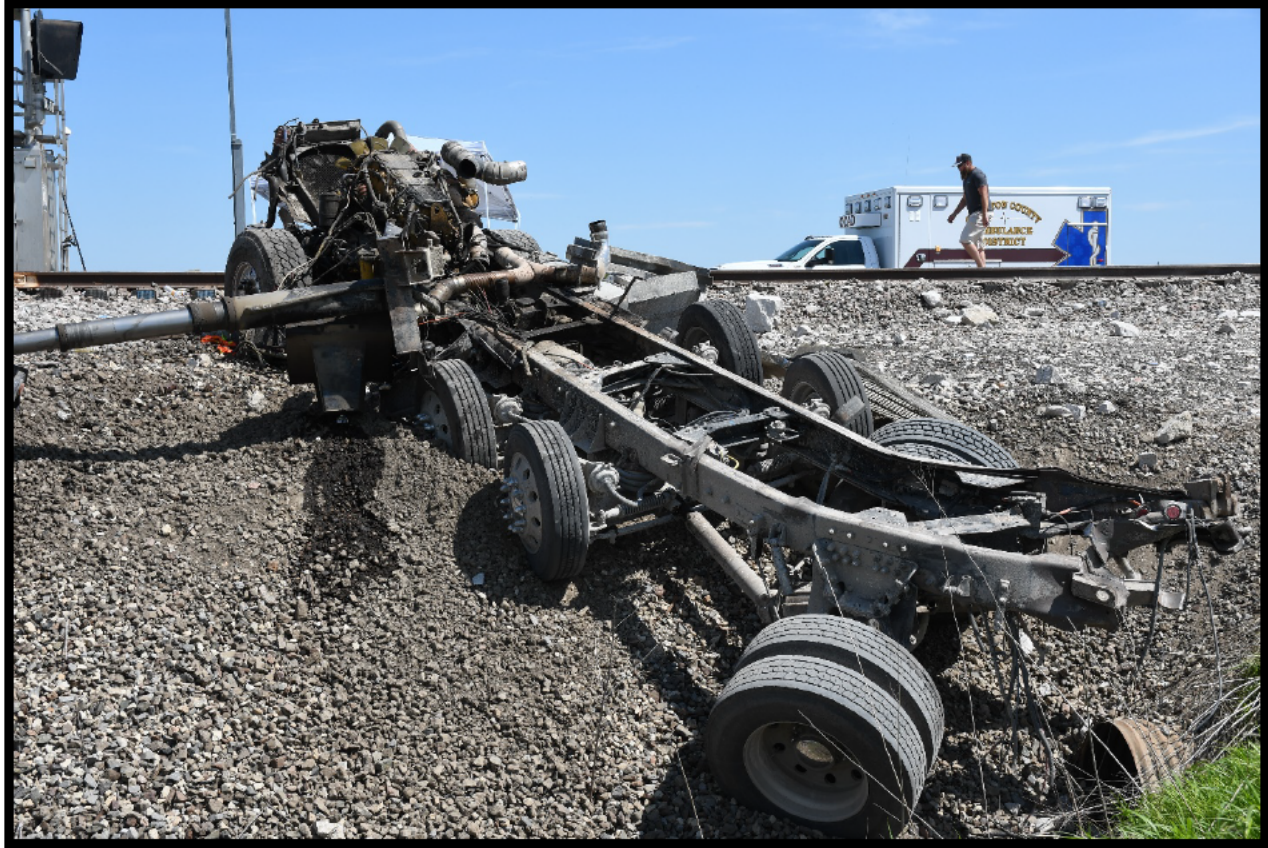
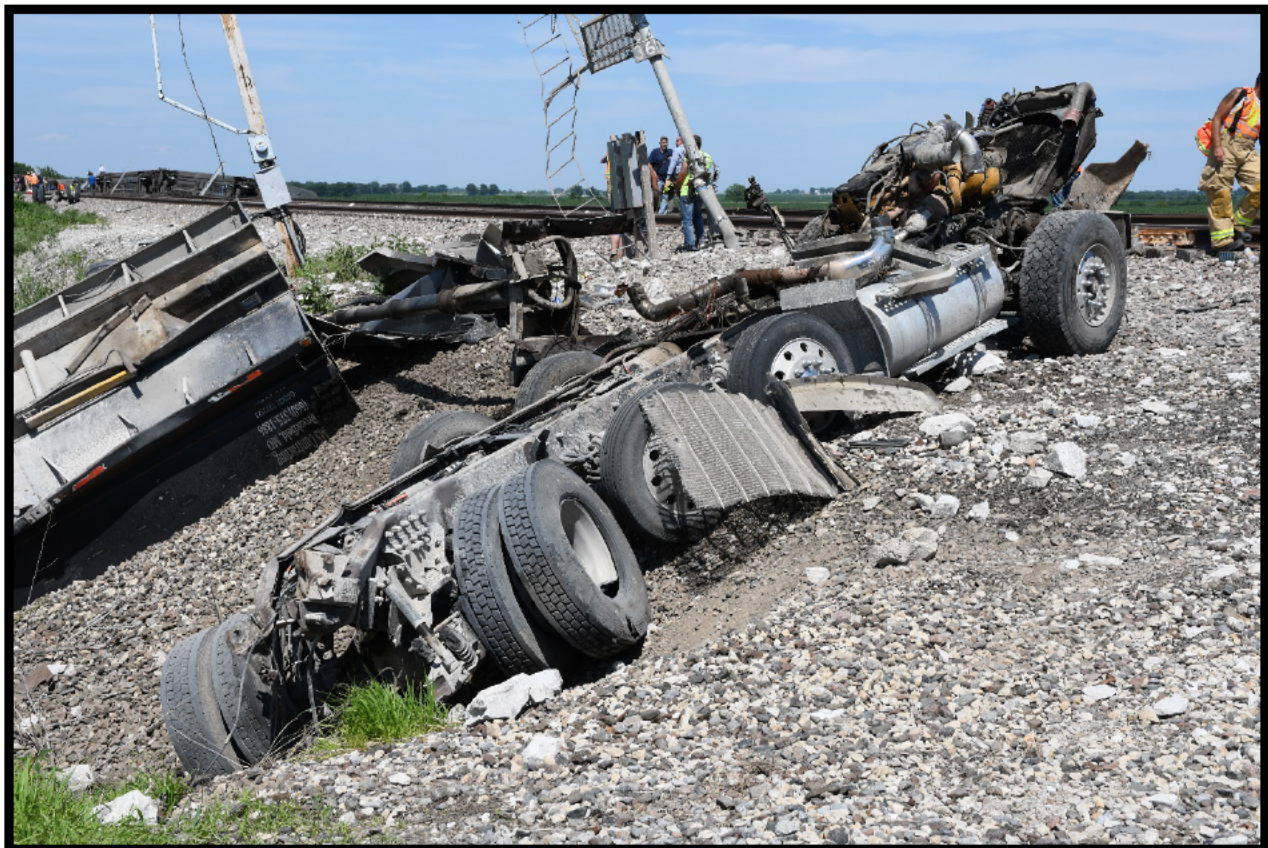
The hood and headlight assemblies had been destroyed in the crash. The front bumper remained intact and appeared undamaged. The left front wheel and left pusher wheels appeared to be in their factory positions. The left wheels of axle 4 were forced rearward as the frame bent laterally to the right. The fifth axle had torn away during the collision event. The right wheels of axle 4 had rotated forward as the frame bent laterally to the right. The right pusher axle wheels and right front wheel appeared to be in their factory positions. Vehicle #1 can be seen from the left and right at final rest in the following images, DSC\_0004 and DSC\_0005, respectively.

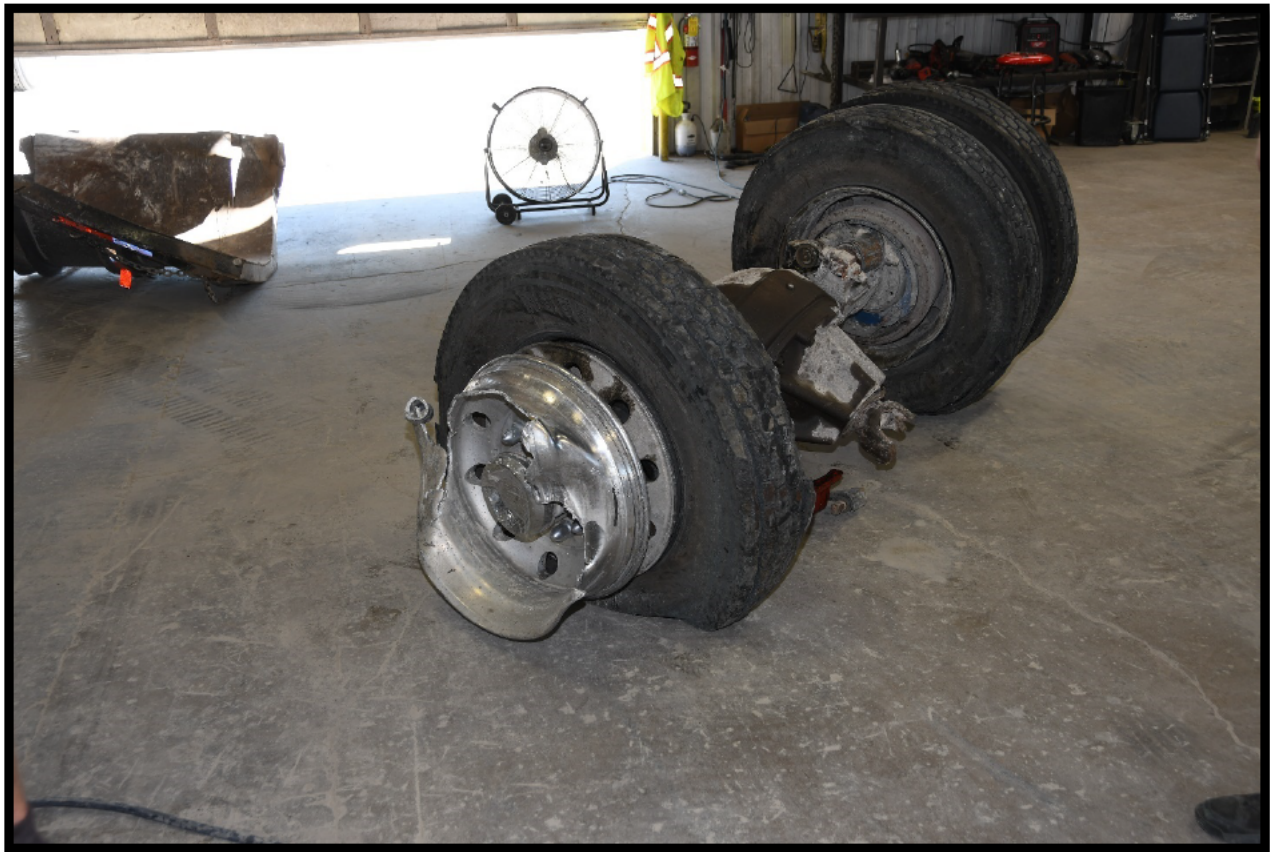
The fifth axle was torn away from the frame during the collision. All four tires were deflated and had torn rubber along the tread and sidewalls. The left outside wheel was broken, bent, and ripped. A portion of the damage likely occurred during the initial collision and remaining damage occurred during a secondary collision with the left rear of the lead locomotive and left front of the second locomotive of Vehicle #2. The fifth axle can be seen in the following image, DSC\_0024.

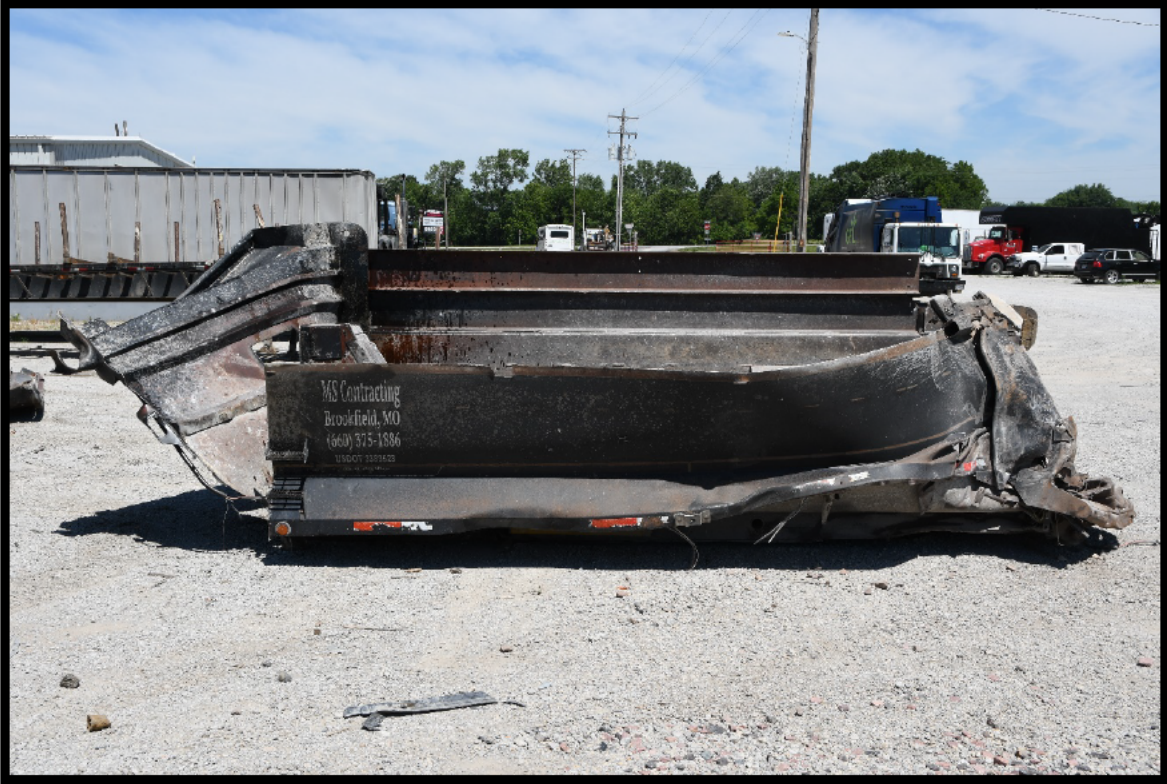
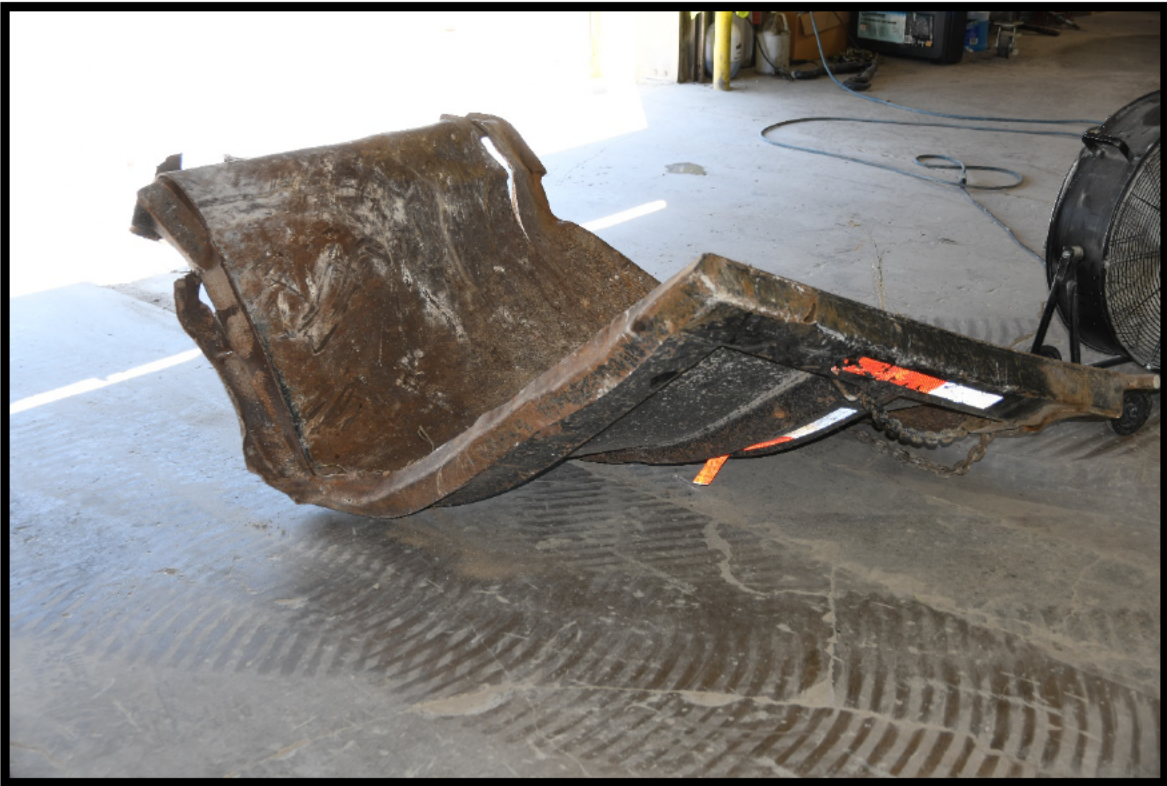
The Vehicle #1 dump bed rear pivot pins had shorn away from the frame while the hydraulic lift cylinder remained attached to the frame. The dump bed breached as the left front of the bed tore away from the left side wall. The left rear corner of the bed was crushed laterally to the right from impact with the front of Vehicle #2. The tailgate was no longer attached to the bed and was found in the debris field. The tailgate was crushed laterally to the right and was bowed. The bed and tailgate can be seen in the following images, DSC\_0224 and DSC\_0153, respectively.

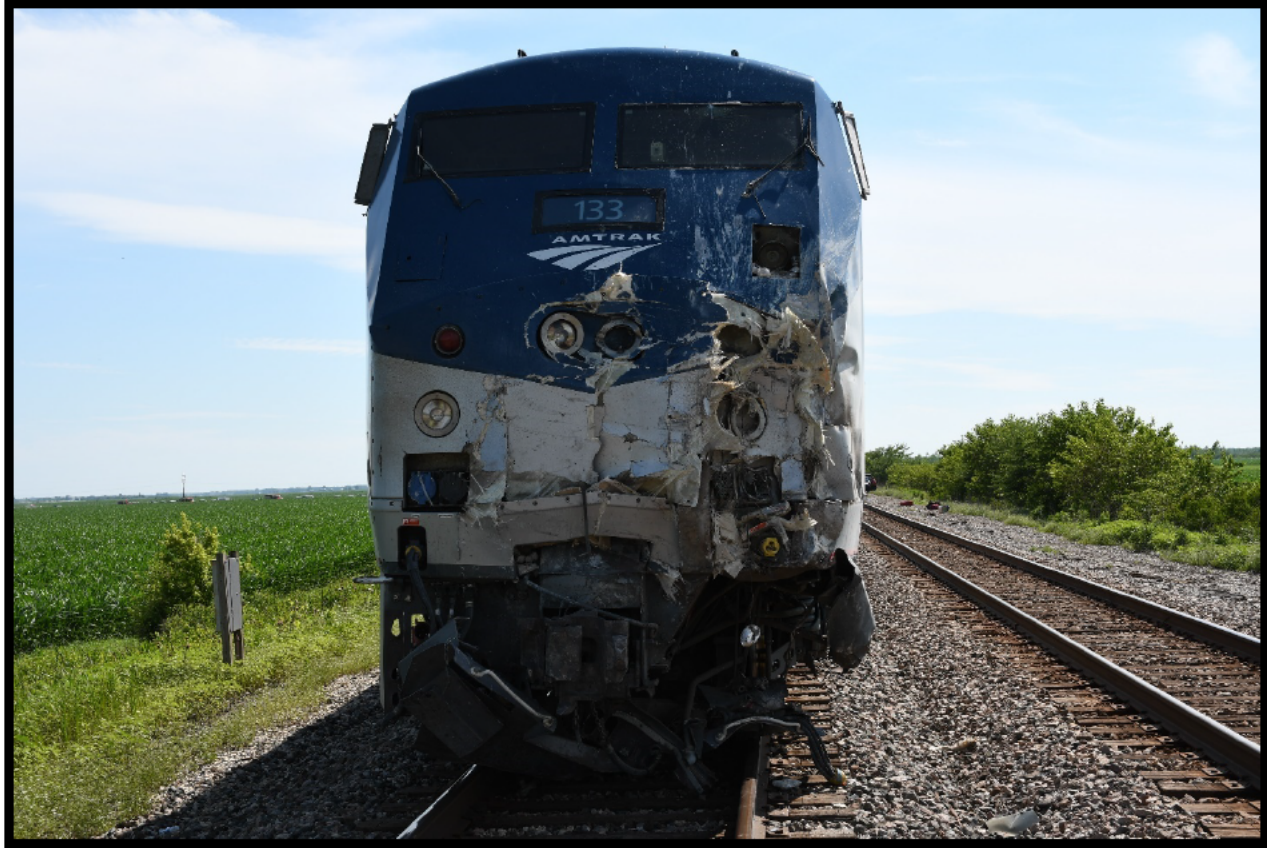
Engine 133 remained upright. I noted the front of Engine 133 was damaged and crushed. The left steady headlight was destroyed as was the left flashing headlight. The right headlights remained intact but were no longer activated upon my arrival. The left windshield was broken and gravel dust remained embedded in the glass, trim and paint. The front axle remained on the railway tracks. The second axle had derailed. The sheet metal on the left side of the locomotive was bent. The left front ladder was broken and bent rearward. The left rear ladder was bent inward under the locomotive body. The sheet metal directly behind the rear ladder was bent and had rubber transfer upon it which gave indication of a secondary impact with the detached fifth axle of Vehicle #1. The third and fourth axles of the locomotive had derailed. Engine 133 can be seen at final rest in the following image, DSC\_0039.

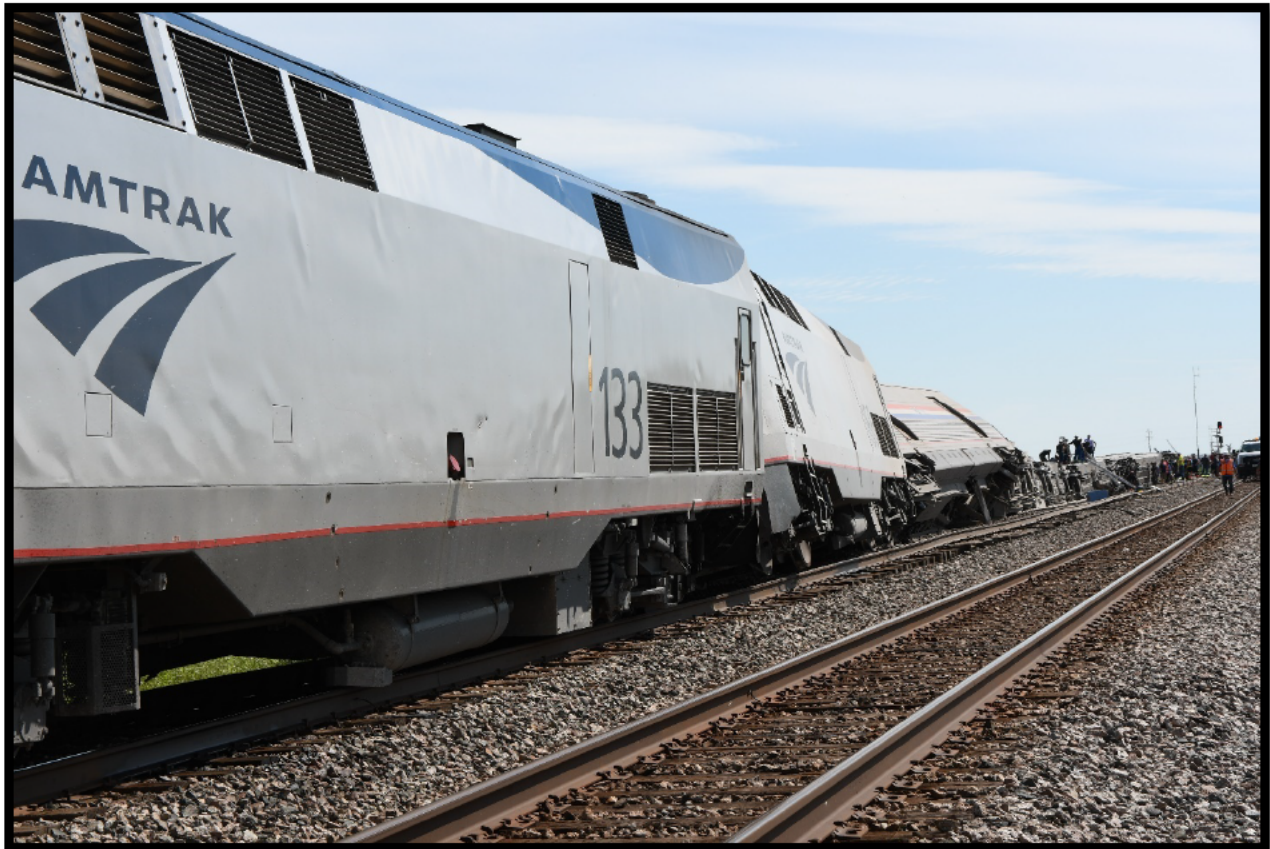
The six Superliner passenger cars and the dining car had derailed and rested upon their right sides, south of the Main 2 tracks.

The train can be seen at final rest in the following terrestrial image, DSC\_0044.

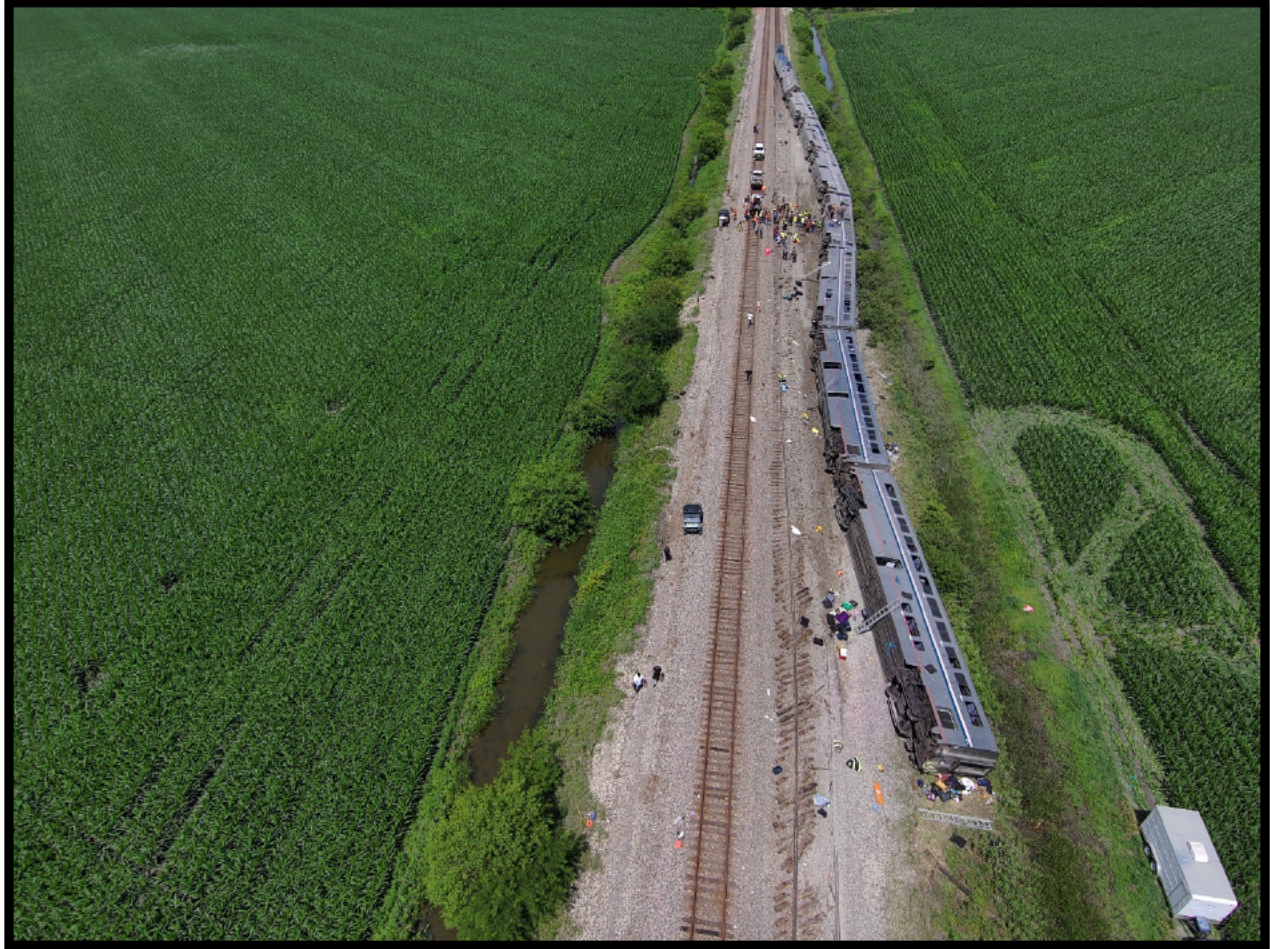
The train can be seen at final rest in the following aerial image, S1001400.

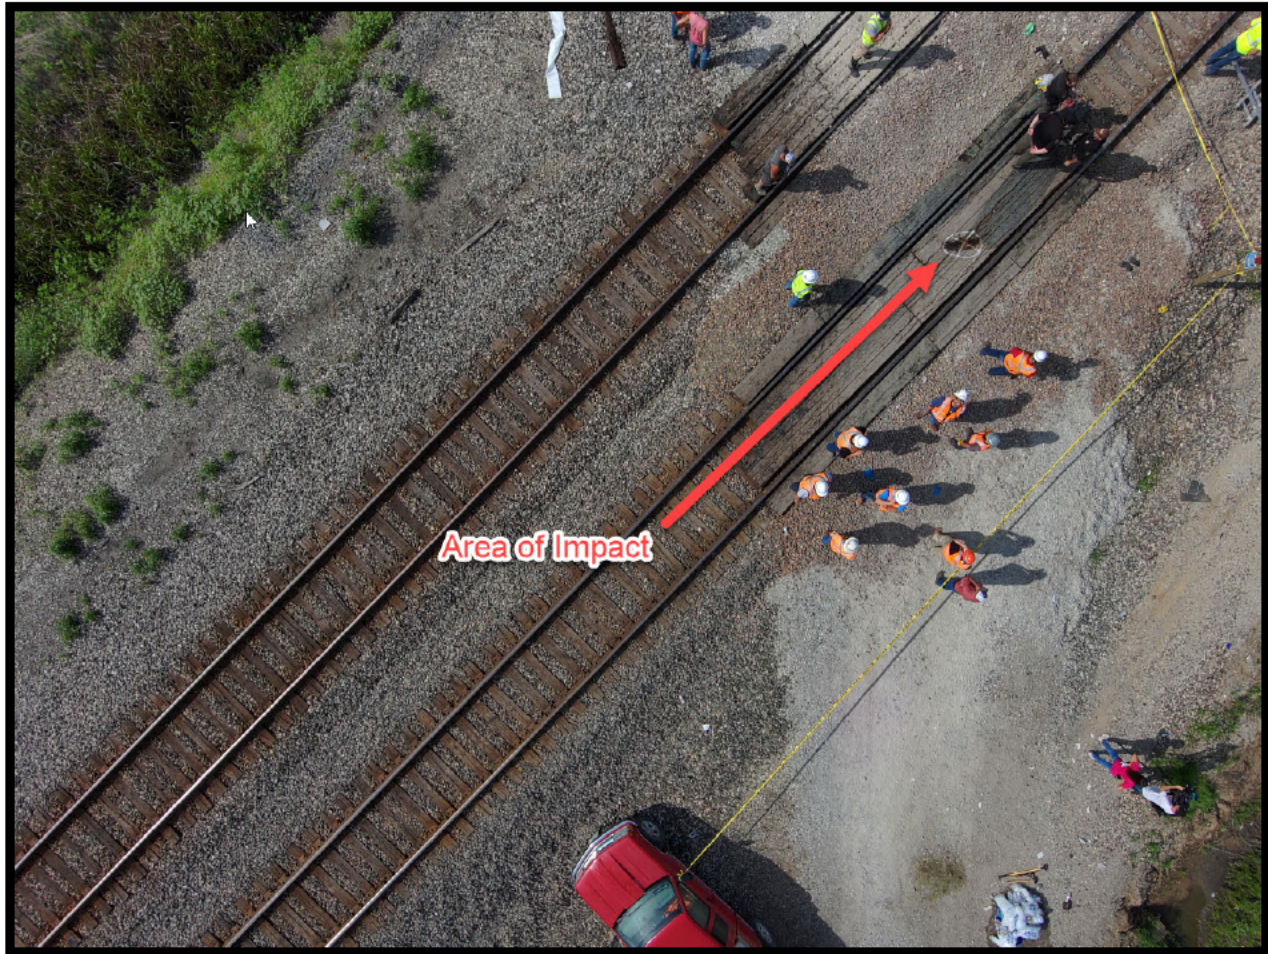
The area of impact was identified by a large gouge in the wooden plank structure of the Main 2 crossing. Tire marks were visible leading to the northeast from the gouge. The gouge and tire marks can be seen in the following image, which was edited to denote the area of impact, S1001444.

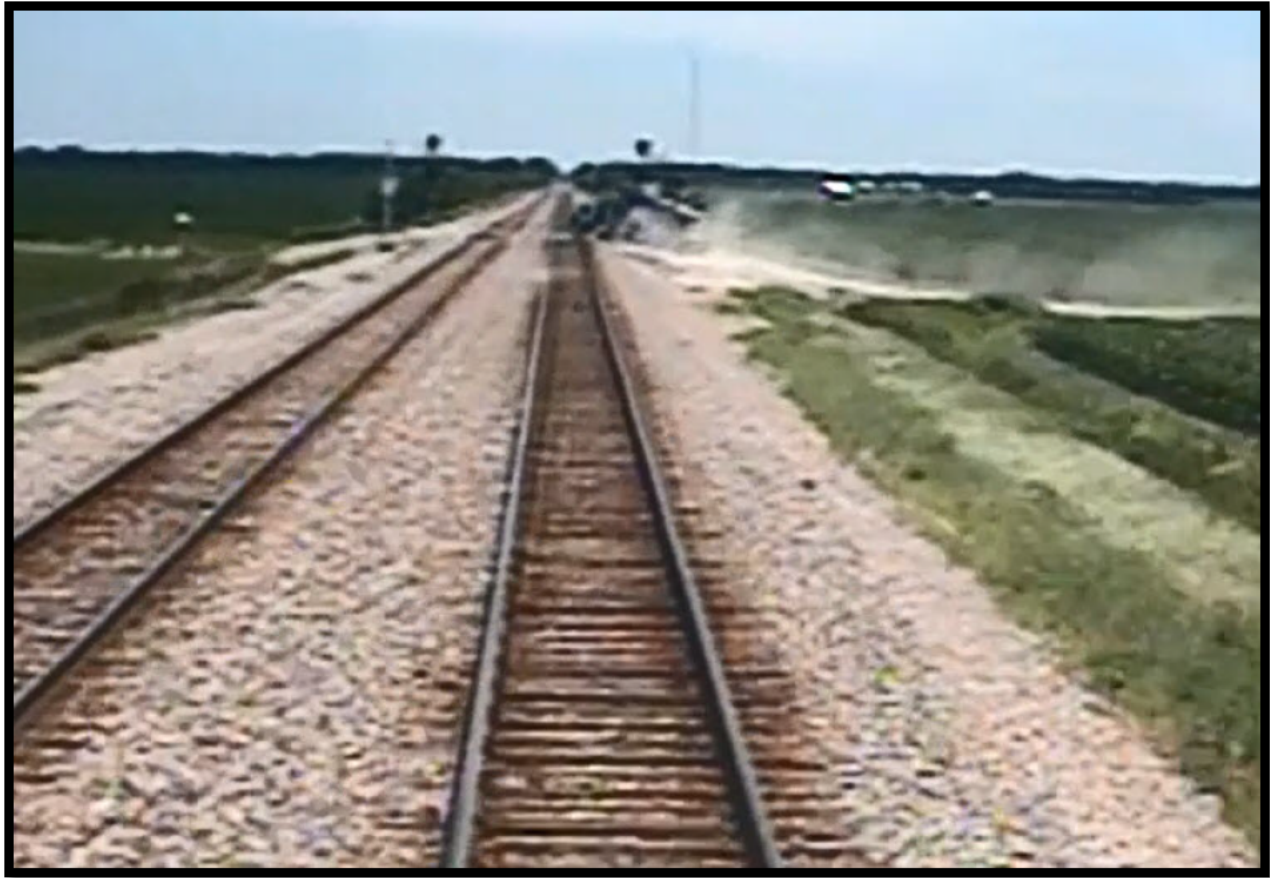
In reviewing the forward-looking camera footage from Vehicle #2, I noted Vehicle #1 failed to stop for the stop sign prior to crossing the railroad tracks. Vehicle #1 was moving slowly as it crossed Main 2 prior to the crash. The speed of Vehicle #1 in the video appeared consistent with the speed of the exemplar vehicle during the testing on June 30. They both appeared to be below 10 miles per hour. These observations along with Witness #1's statement about his speed at the crossing would indicate the Vehicle #1 speedometer which was at about 5 miles per hour was likely the speed of Vehicle #1 at the time of impact.

Vehicle #1 can be seen failing to stop and entering the crossing in the following screenshot from the video. The dust cloud can also be seen to trail the truck and the left side of the cab is not obscured by the gravel dust cloud.
