**NATIONAL TRANSPORTATION SAFETY BOARD
OFFICE OF HIGHWAY SAFETY
WASHINGTON, D.C.**

**HIGHWAY FACTORS GROUP CHAIRMAN’S
FACTUAL REPORT**

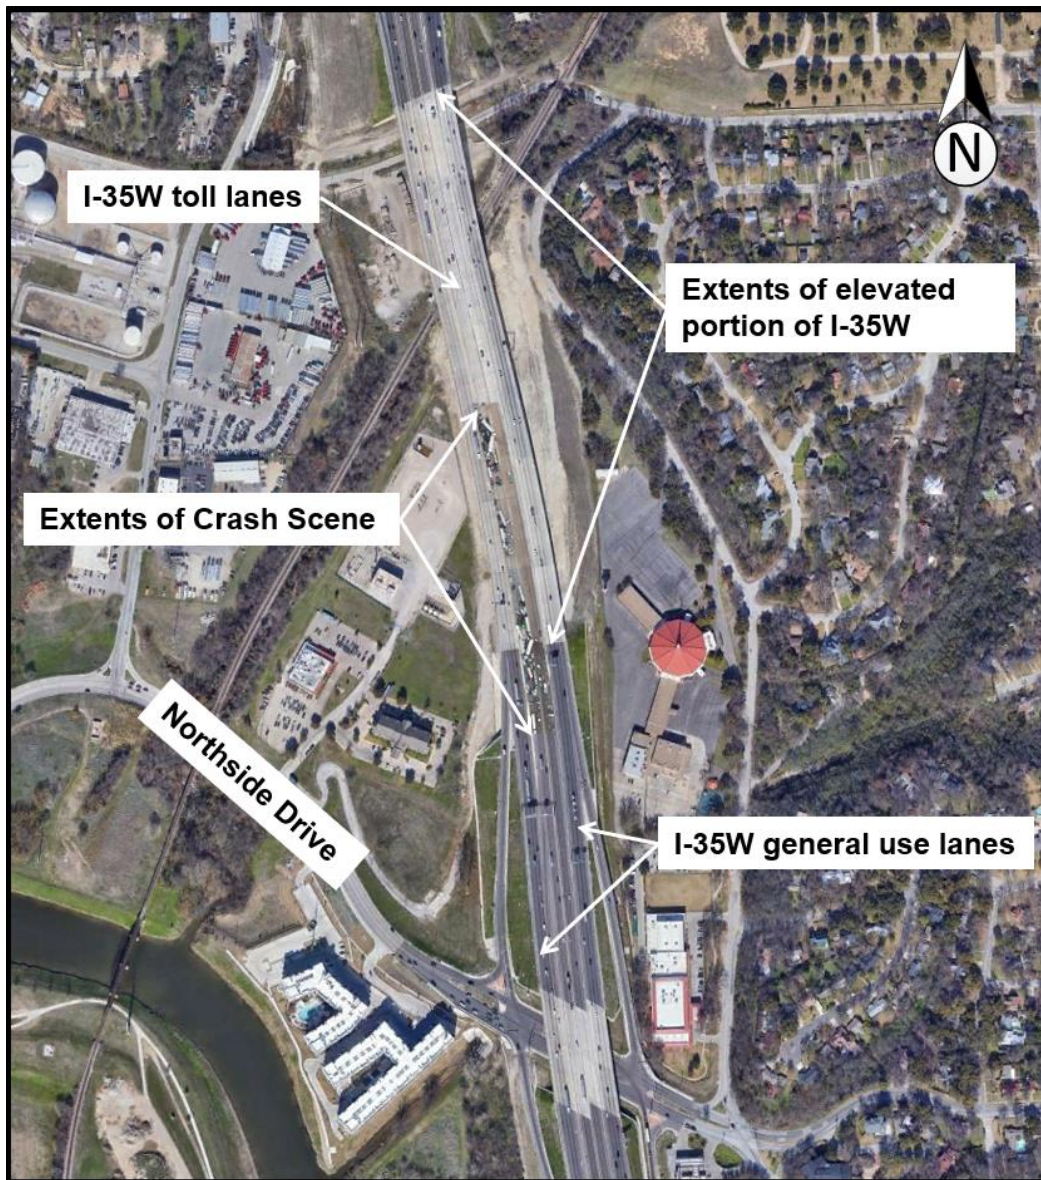
Figure 3 – Extent of the crash scene was approximately 1,100 feet and much of the crash occurred along an elevated 1,900 feet long portion of I-35W (Source: Google Earth image revised).

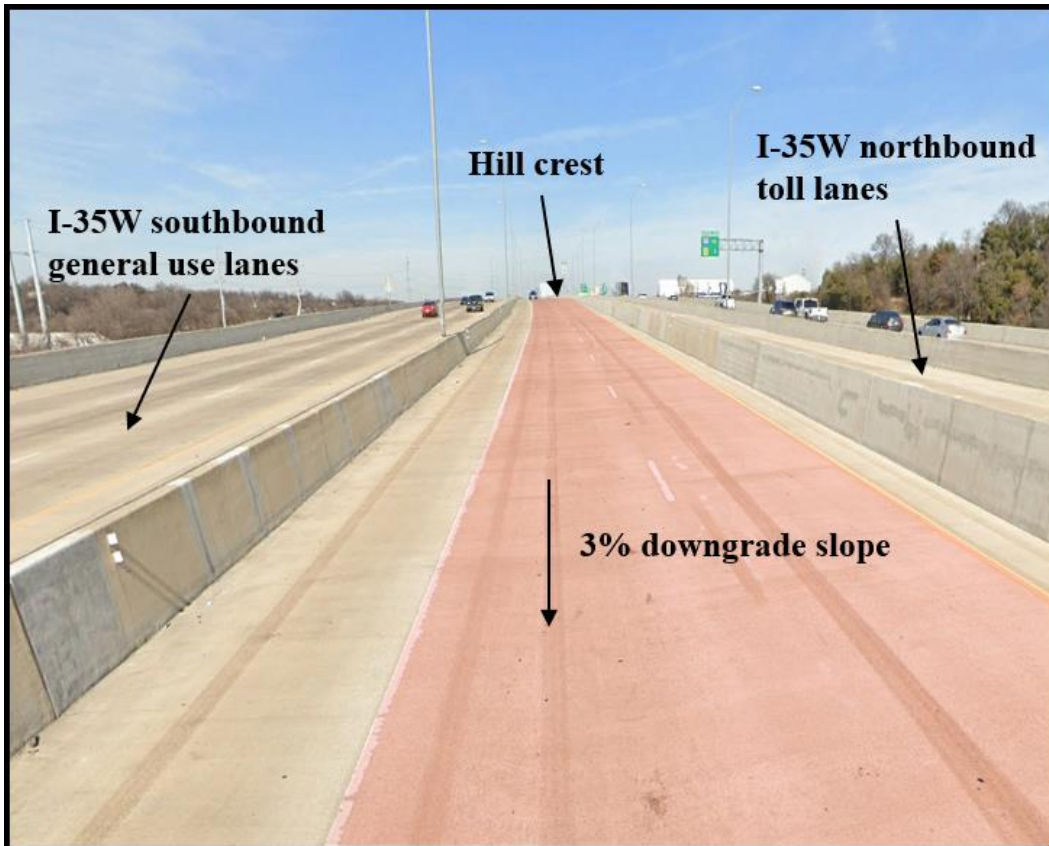
Figure 6 illustrates the I-35W southbound toll lanes, highlighted in red, looking to the north showing the hill crest and 3% downgrade slope leading up to the crash location.

Figure 6 – View of I-35W southbound toll lanes, highlighted in red, looking to the north showing the hill crest and 3% downgrade slope leading up to the crash location (Source: Google Earth Street view image from January 2020, revised).

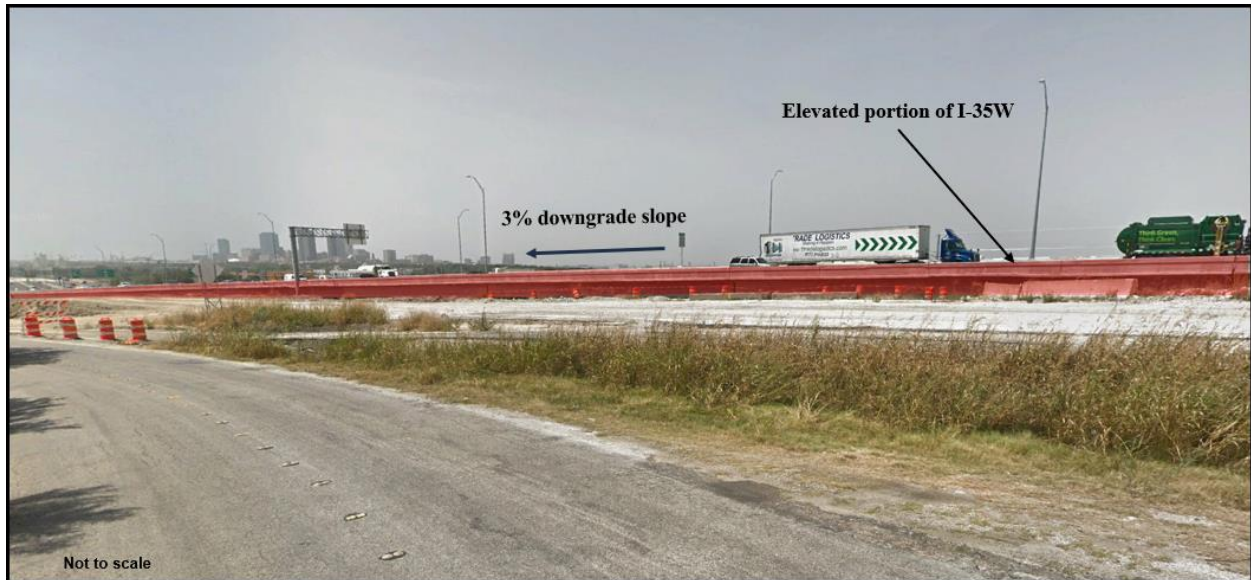
Figure 7 – View of 3% downgrade slope of the elevated portion of I-35W, highlighted in red, prior to the crash location looking to the southwest (Source: Google Earth Street view image, revised).

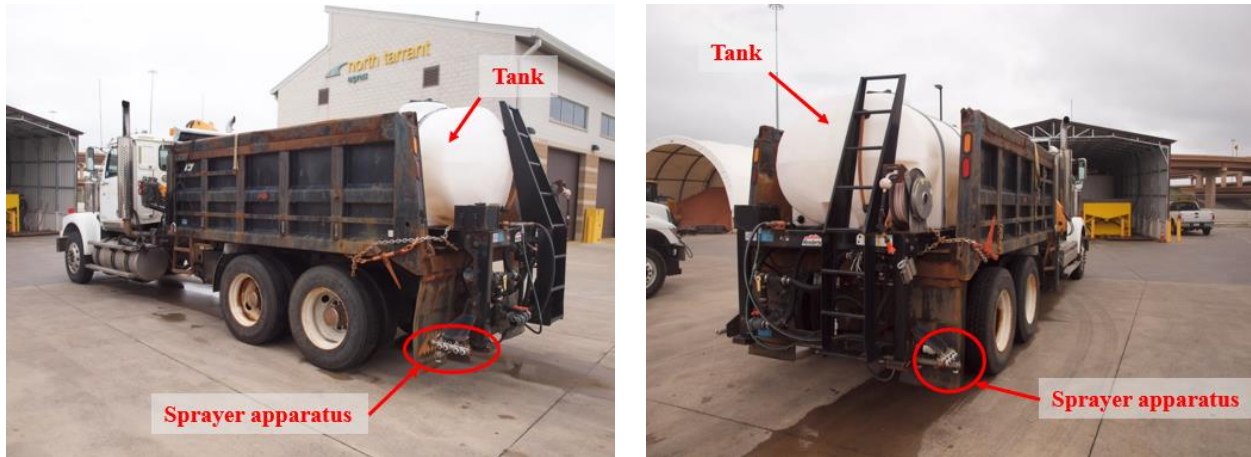
Figure 23 – NTEMP S3 truck and brine sprayer that applied the brine solution to the I-35W southbound toll lanes located at the NTEMP S3 maintenance facility (Source: photograph taken on April 29, 2021, by NTSB investigators).

The NTEMP S3 advised NTSB investigators the optimum efficiency of the Ice Slicer NM brine solution was 24-to-72 hours (or 1-to-3 days) in advance of a storm. For the reader's reference, the Ice Slicer NM brine solution was applied by NTEMP S3 maintenance technicians to the I-35W southbound toll lanes approximately 44 hours before the crash.

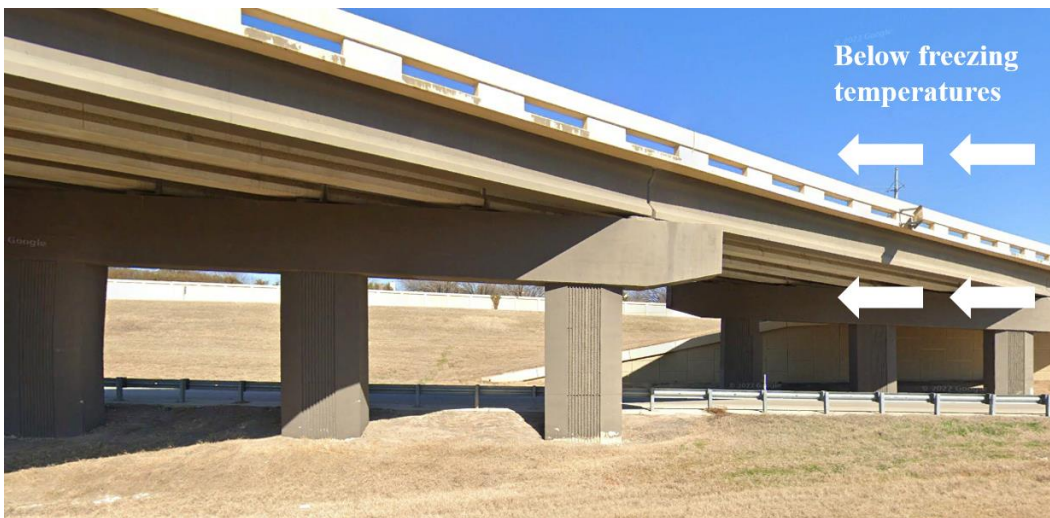
Figure 24 illustrates the underside of a generic bridge. Bridges are exposed to the surrounding air on all sides.⁶⁷ Bridge decks will at some point match below freezing temperatures, and the combination of below freezing temperatures and a small amount of precipitation can create a thin layer of black ice on the bridge.⁶⁸

Figure 24 – Underside of a generic bridge. White arrows represent surrounding air on all sides of the bridge and not wind direction (Source: Google Earth Street view image revised).
