Preliminary Report: RRD22LR002

Railroad Preliminary Report

Houston, TX

October 29, 2021

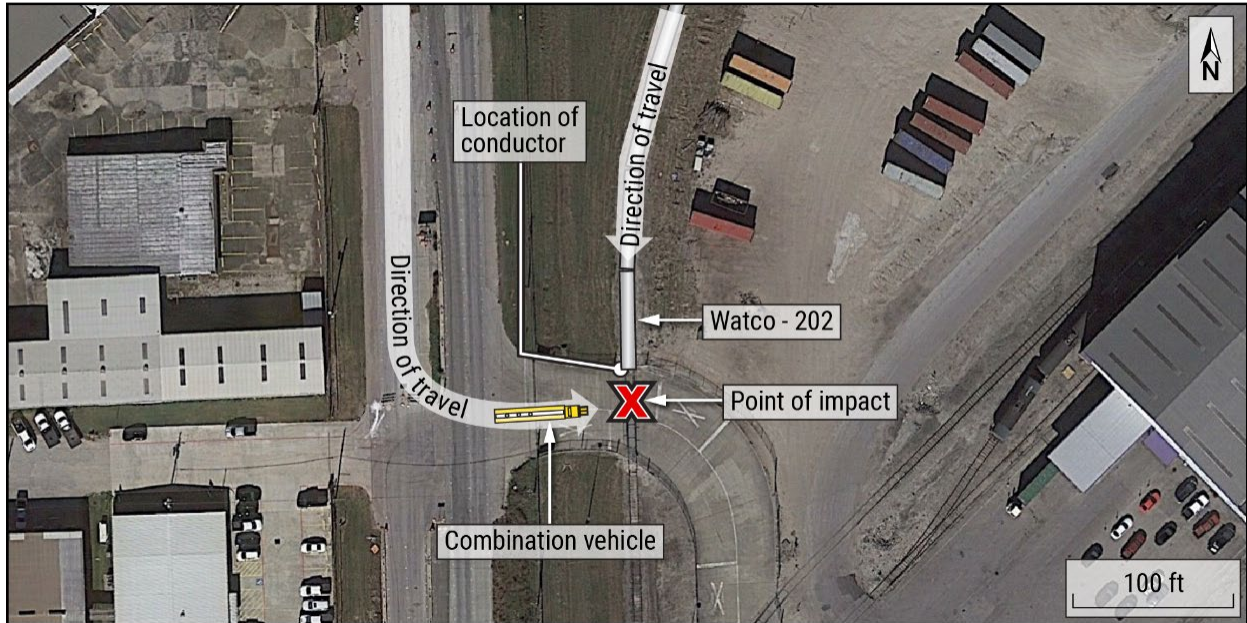
Figure. Aerial view of the accident scene.
