# THE HOWARD AVIATOR

## Fuel Tank Selection on the Howard DGA-15P

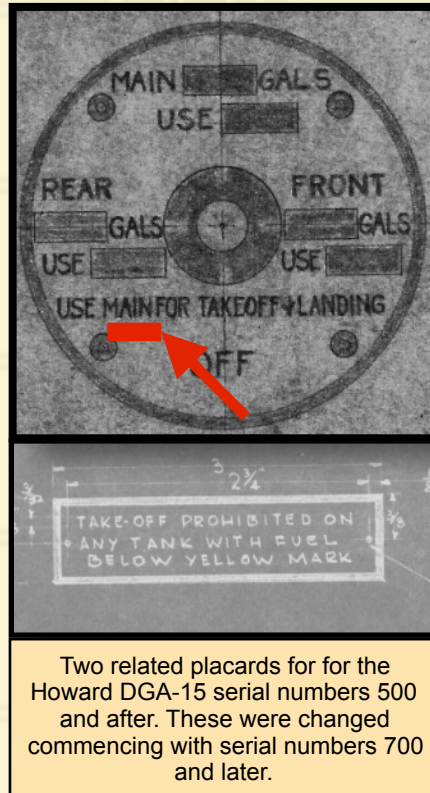
Two related placards for the Howard DGA-15 serial numbers 500 and after. These were changed commencing with serial numbers 700 and later.

DGA-15 factory drawings indicates that the selection of the forward tank has not always been the factory guidance. When viewing the factory drawings, and referencing the placards for the aircraft serial numbers 500 to 700, the direction to the pilot is to select the main tank for take-off and landing. Further, another placard for that same series of aircraft indicates that one may not take-off with any tank selected that indicates less than a fuel quantity above the yellow band. The implication from that placard is that in this series of early Howards, take-off was indeed permitted on the main tank. However, this was only when the fuel total in that tank was above the yellow mark and therefore sufficient to preclude the un-portioning of the fuel pickup.

A Howard with a serial number in the 500 series may be placarded to allow take-offs with the main tank selected. However, should this be the case, and the pilot elects to select the main, the factory drawings clearly indicate the need for another placard which demands that the fuel quantity in that tank be above the yellow band on an appropriately marked fuel gauge.

It is incumbent upon the owner and operator of the aircraft to ensure that the placarding and instrument markings of the aircraft are consistent with the factory requirements for that particular serial number.

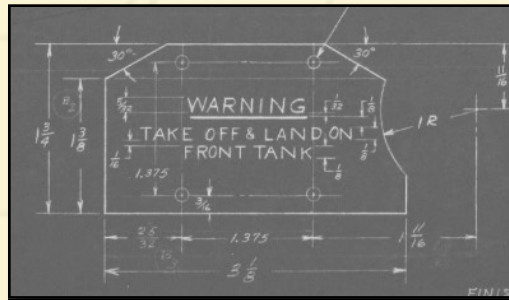
All Howards from serial number 700 and beyond should have a placard for the fuel selector which stipulates that the forward tank must be selected for take-off and landing. This point is re-emphasized commencing with serial 934 which adds another instrument panel

Fuel placard for the instrument panel of later serial numbered Howards. This was added at serial number 934 and for all Howards thereafter, indicating a re-emphasis on the import of this operational directive.
