National Transportation Safety Board

MBTA Accident Brookline, MA

NTSB Accident Number: #RRD21FR013
Trolley Collision with Derailment

Human Performance / System Safety Group Factual Report

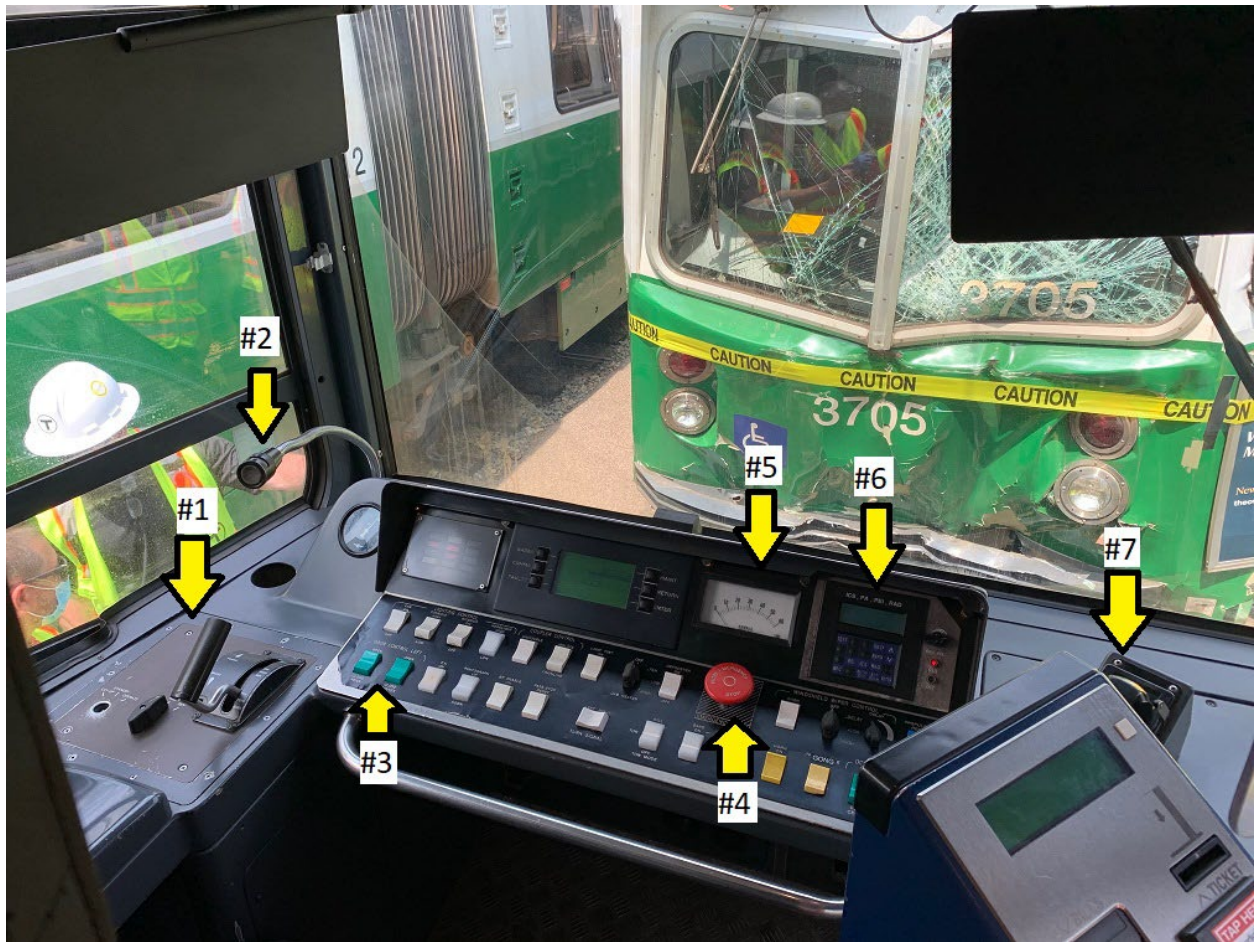
Photo 2: Operator's cab of a Type 8 vehicle (striking vehicle, car 3894).

Investigators observed the deadman feature, which is built into the master controller handle (Photo 2). To engage the propulsion via the master controller it must first be rotated 90-degrees and held in that position (Photo 3). With the master controller moved forward, in ‘propulsion’, letting go of the controller (for example, due to incapacitation) immediately places the train in emergency braking. The handle must be placed into full-service brake to recover the brake system.⁶ The trolleys are not equipped with forward collision avoidance or Positive Train Control, however MBTA is developing a Train Protection System for the Green Line. One of its

- 1) The master controller handle and vehicle deadman (activated by turning clockwise)
- 2) Public address system
- 3) Green buttons on Type 7, Type 8 and Type 9 streetcars are door controls
- 4) Circular red plungers on Type 7, Type 8 and Type 9 vehicles are the emergency brake applicators. These are commonly referred to as “the mushroom”
- 5) Vehicle speedometer
- 6) Communications Control Panel (CCP). The CCP allows for the operator to talk to other train crew members via an intercom (ICS), or to communicate with the OCC by radio (RAD), and passengers via the Passenger Emergency Intercom (PEI)

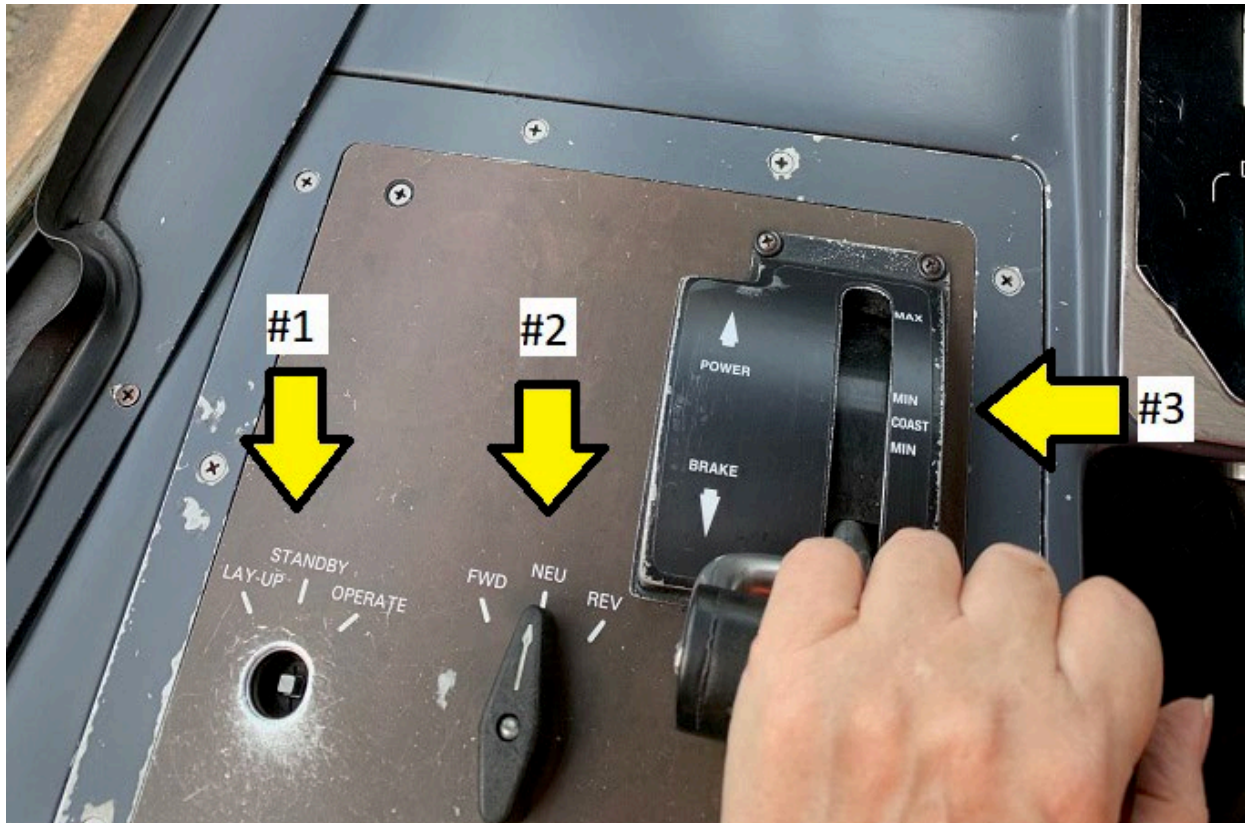
Photo 3: Close up photograph of the master controller, transfer switch, and reverser on a Type 8.

- 1) Transfer switch: This is where the operator places his or her key to give power to the train. “Lay up” is the “off” position. “Standby” is the is the position for the car to be powered up, but with the master controller still locked. Trailer car operators have their cars in standby at all times. “Operate” provides power to the master controller and readies the cab to be the lead car of a consist.

- 2) Reverser: The reverser provides direction to the vehicle’s motors. When in lay-up or standby, the reverser must be in neutral. Once placed into operate, the reverser can be placed in forward or reverse.

- 3) The master controller: The master controller is present on both the Type 8 and Type 9 vehicles. It is used by the operator of the lead car of a consist. The forward-most position of the controller is maximum power. In the center is coast. Below coast, closer to the operator, is braking. The further the controller is pulled back, the more braking power will be applied. The two furthest back positions are full service brake + track brake, and emergency, the latter does the same thing as the mushroom emergency brake.
