# **NATIONAL TRANSPORTATION SAFETY BOARD**

## **TRACK & ENGINEERING FACTUAL REPORT**

**DCA17FR011**

**CSXT Railroad, Derailment with Hazardous Materials Release and Fire**

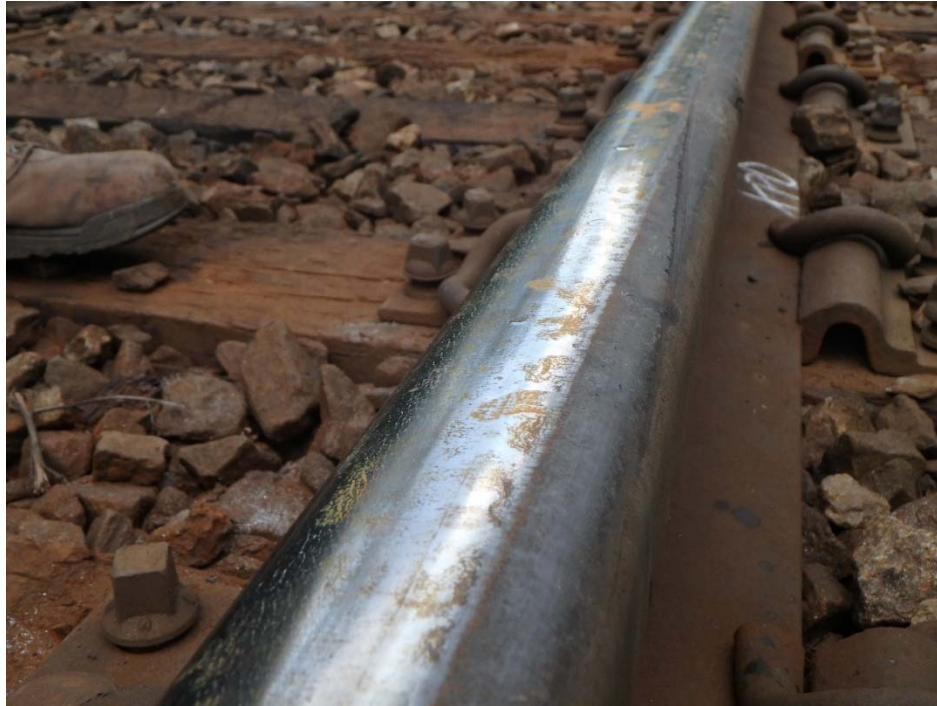
The investigation team determined that the POD (the location where the normal wheel and rail interface was disrupted) was near milepost BF 193.82 on main track No.2.<sup>2</sup> Investigators identified a flange mark traversing over the top of the rail head of the high rail in the curve.<sup>3</sup> This flange mark was determined to be at about an 8-degree angle. Corresponding wheel departure marks were identified across the top of the rail head of the low rail of the curve. Investigators also photo documented flange and tread marks from the derailed rail car wheels that were found on various track components.

**Figure 2. Photo showing wheel flange departure mark across high rail in curve at POD.**

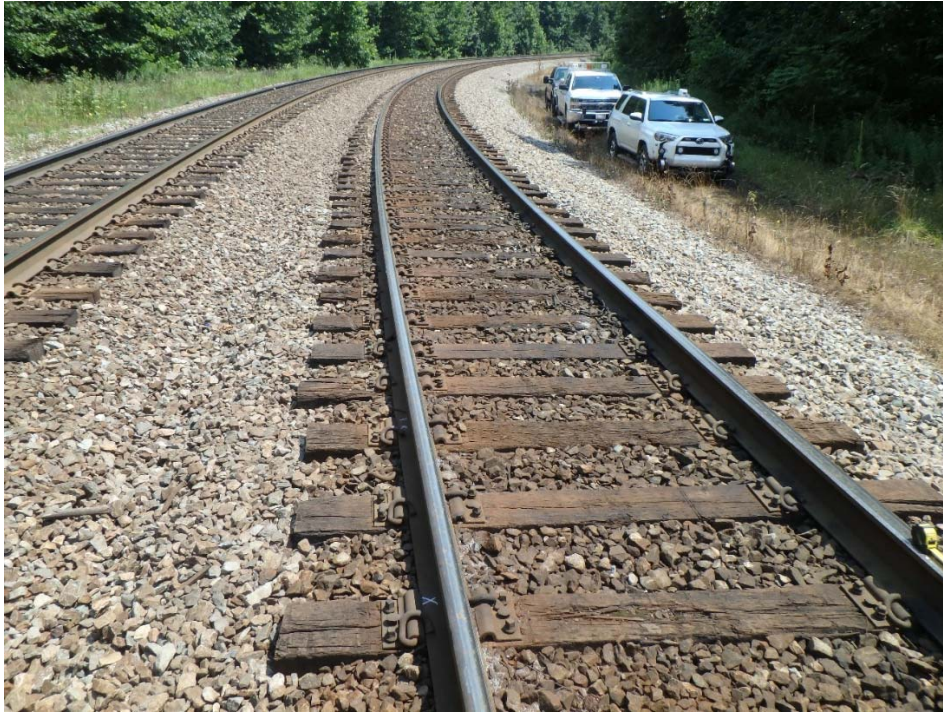
Track note measurements taken near the POD revealed an average degree of curvature of 8.33 -degrees with about 3.25-inches of super-elevation in the accident curve. Based on FRA curve elevation and speed limitations (Vmax) the curve qualified to be

**Figure 3. Accident curve facing east toward direction of accident train travel.**
