Acoustic Microscopy of WPR18FA013

Prepared for the NTSB

By S.R. Cain, IEEC

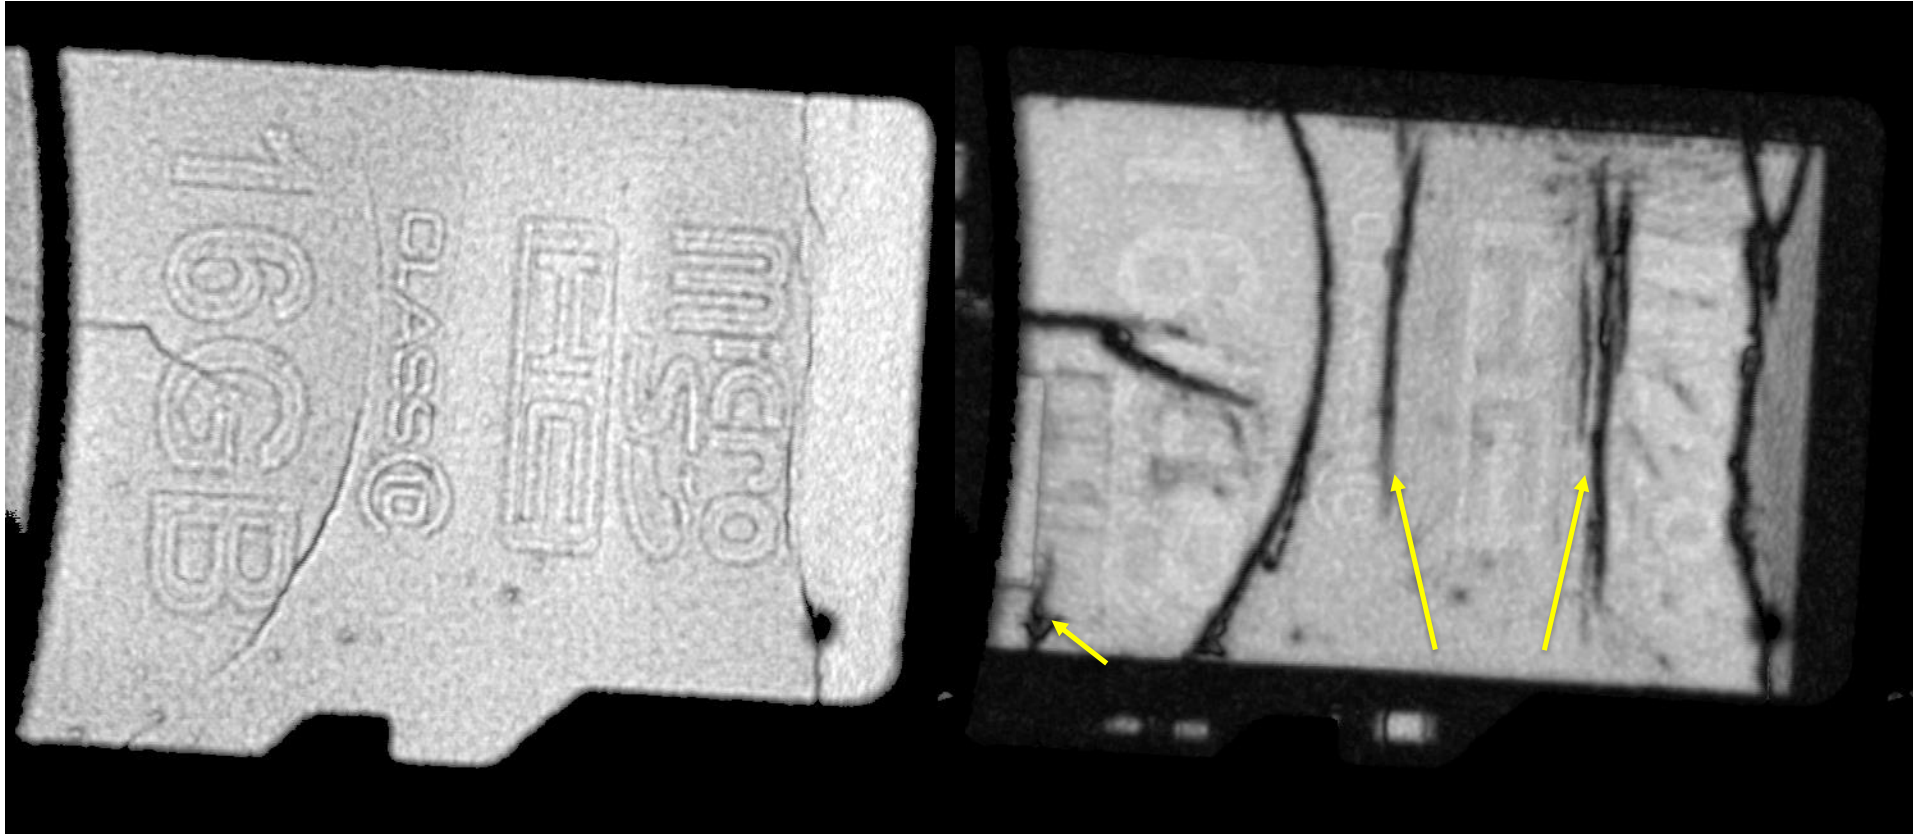
Comparison of Surface and Chip Images

The highlighted cracks in the chip image do not appear in the surface image, indicating that the damage is below the surface – conclude that the chip is cracked
