RE: Accident Number: DCA20MA059, Crash of Sikorsky S76-B, Calabasas, California, January 26, 2020, 0945 PST.

Enclosed with this letter is Island Express Helicopters, Inc.'s Party Submission pursuant to NTSB protocol. Enclosed are three attachments pertaining to the following areas of concern:

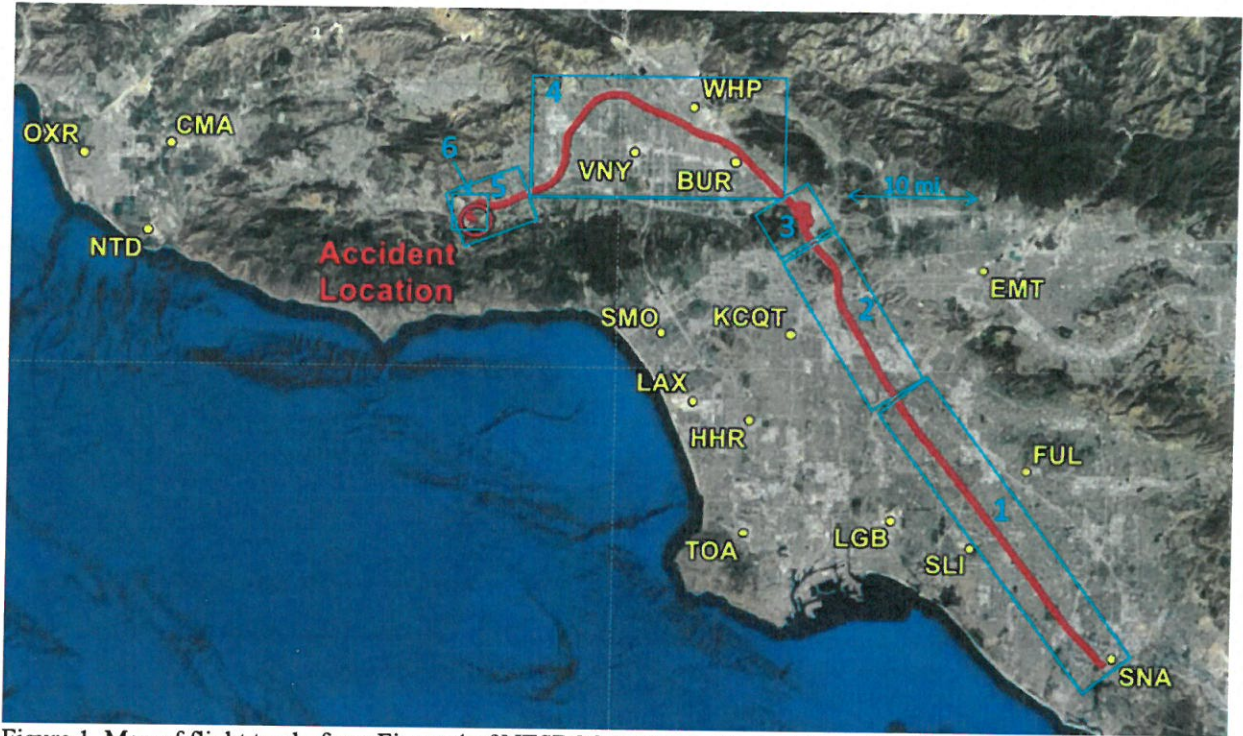
Figure 1. Map of flight track, from Figure 4 of NTSB Meteorology Factual Report, with added overlays in cyan.

The transitions in weather conditions between the boxes in Figure 1 were not as abrupt as suggested by the box boundaries. Smooth transitions likely occurred. Some variation in ceiling and visibility likely occurred within each box and the weather conditions are necessarily provided below in terms of ranges. The changes were most rapid in Box 5, which contains the smaller area (Box 6) where the accident occurred.

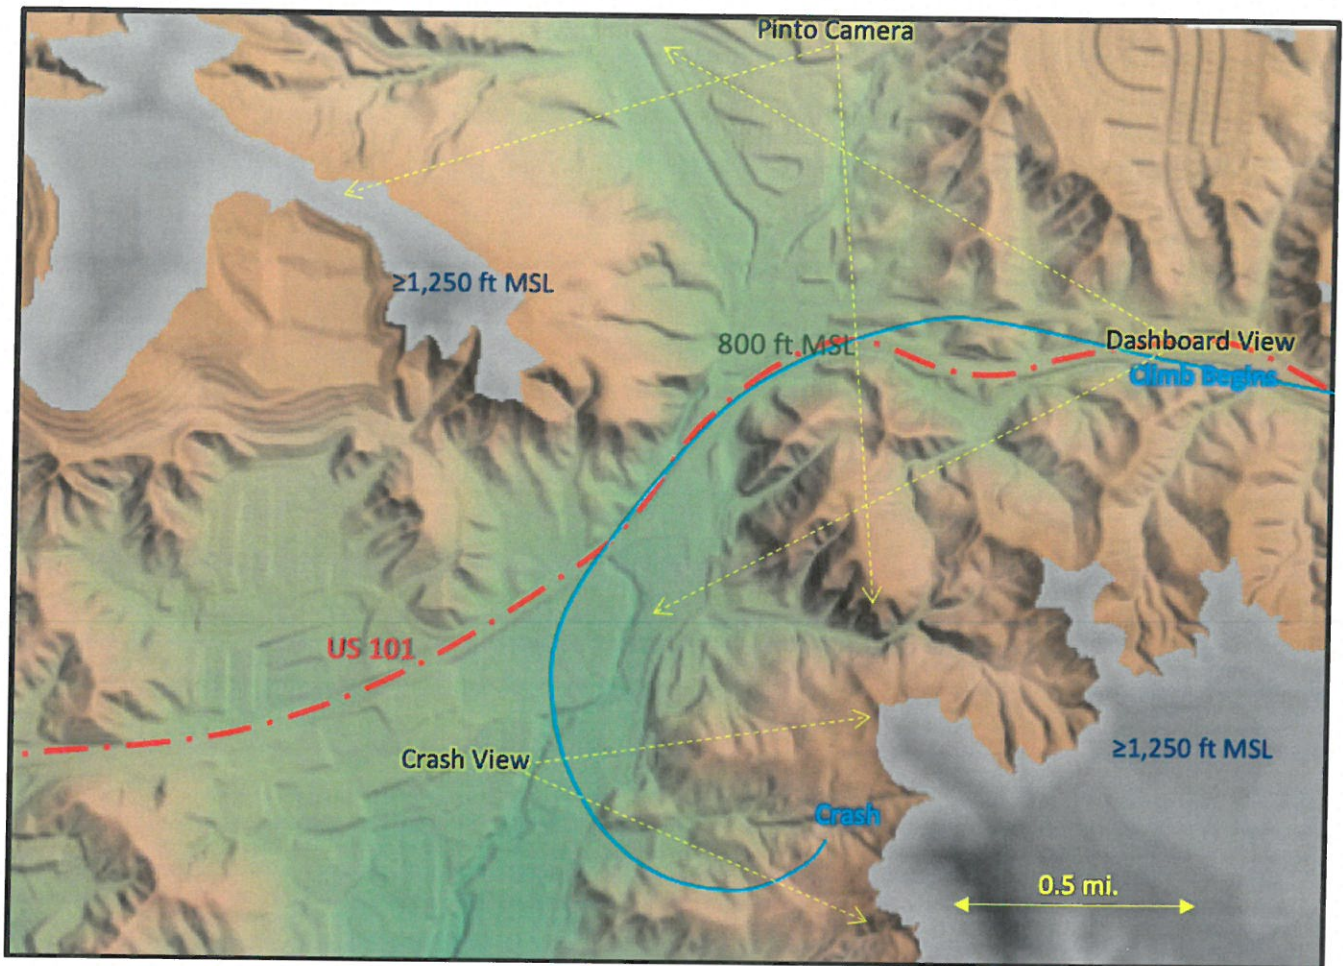
Figure 2. Topographic relief map for area of accident. Cyan curve is ground track. Approximate views of video cameras are included. Gray shaded terrain is at least 1,250 feet MSL. US 101 (in red) is about 800 feet MSL at the curve.

The hill ahead of the aircraft, as it was heading west toward the southwestward curve of US 101, was obscured by cloud. After the aircraft had just passed over the road construction site and was still below the overcast, the pilot could have seen (at about 9:44:20 AM) that the overcast was lower ahead (below the altitude of the aircraft) and that the top of the hill was shrouded in cloud. At that distance (about 1.5 miles), details of the terrain below the ceiling would have been only dimly discernible, due to the reduced visibility. The aircraft began to climb at about 9:44:33 AM.

Prior to entering Box 6, the aircraft had not entered cloud (generally remaining below the ceiling by several hundred feet) and had flown at least 500 feet above the ground. Where US 101 begins to turn southwest, the elevation is approx. 800 feet MSL (as marked in Figure 2). The overcast was at 1,200 to 1,300 feet MSL (400 to 500 feet AGL above US 101) and the visibility below the overcast was restricted to about 1 to 1 ½ miles. The NTSB Meteorology Factual Report shows the relative humidity readings in this area was 100%, higher than elsewhere along the route, which is consistent with the low ceiling and low visibility only being encountered in Box 6. The boundary between the mist (light fog) and the overcast was indistinct. At this unique location along the route it would have been difficult to impossible for the aircraft to remain at an altitude of 500 feet AGL and remain in the clear while making the turn to follow US 101.
