NATIONAL TRANSPORTATION SAFETY BOARD

IIC FACTUAL REPORT

RRD19FR004

Employee Switching Fatality- Bayview Yard

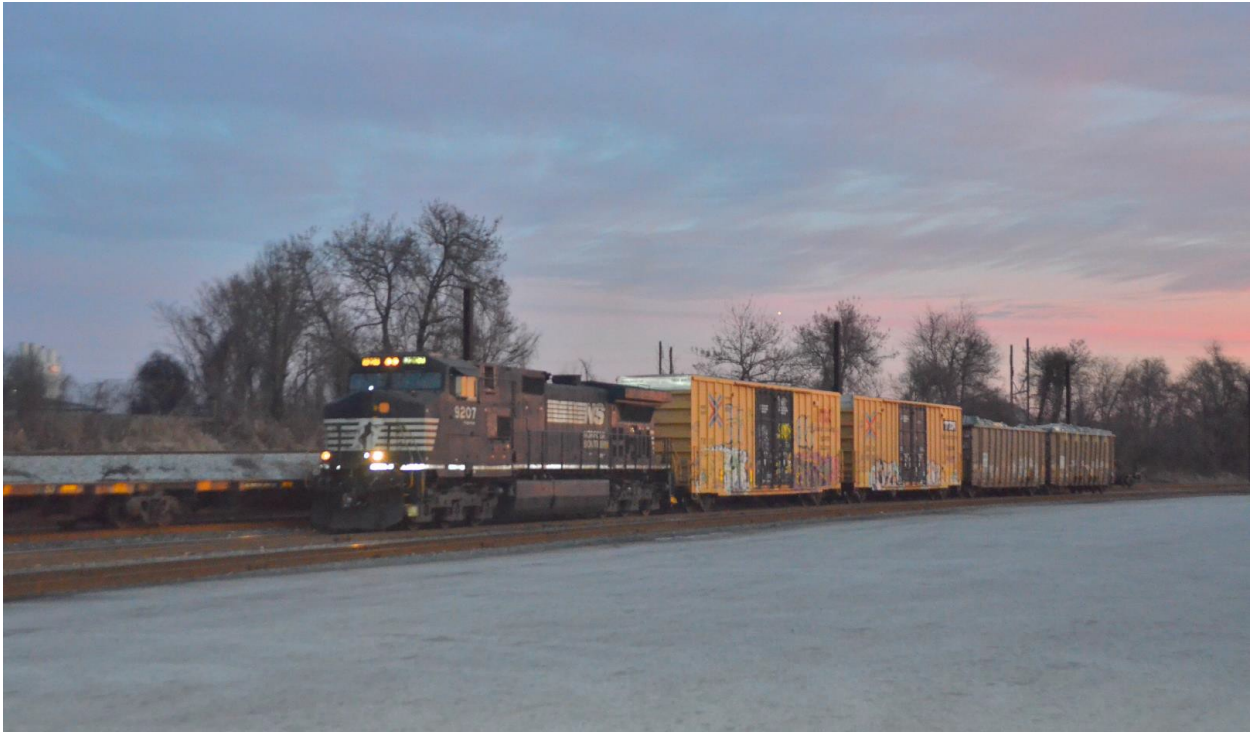
Figure 1- photo of accident train H63 sitting on the Bank track. Photo courtesy of FRA.

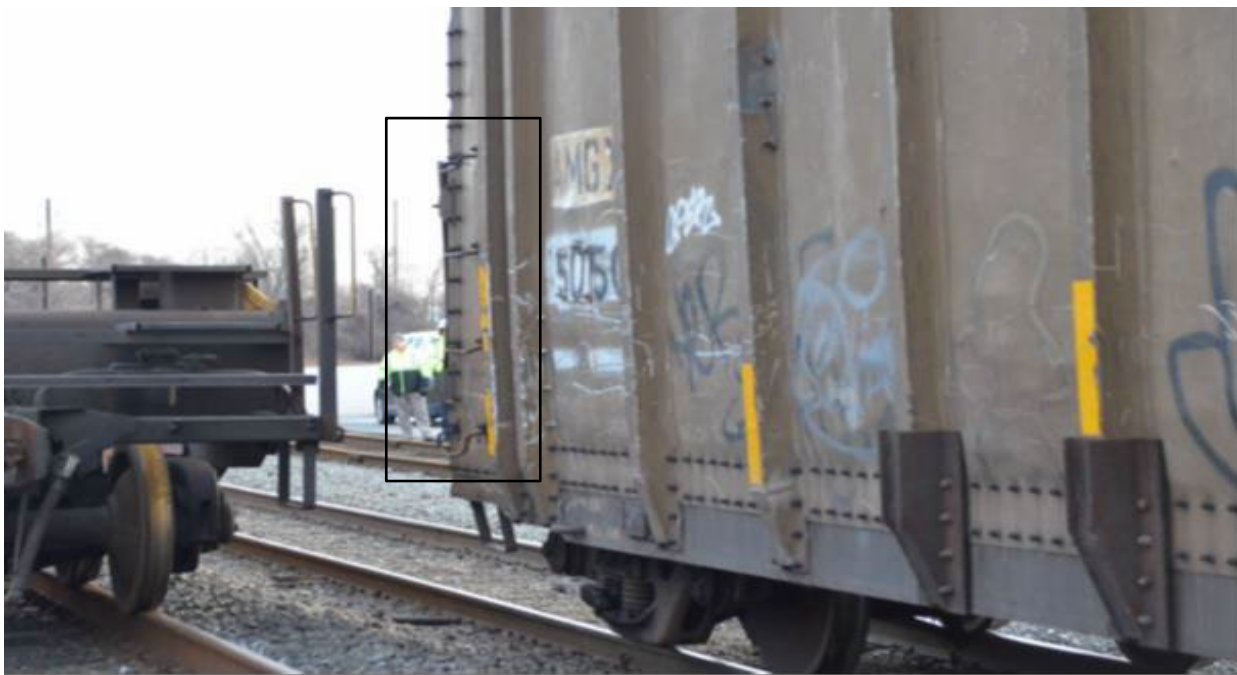
Figure 2- black rectangle indicates the location where the conductor was believed to be riding, while attempting to pass the standing DTTX intermodal cars on the adjacent track.

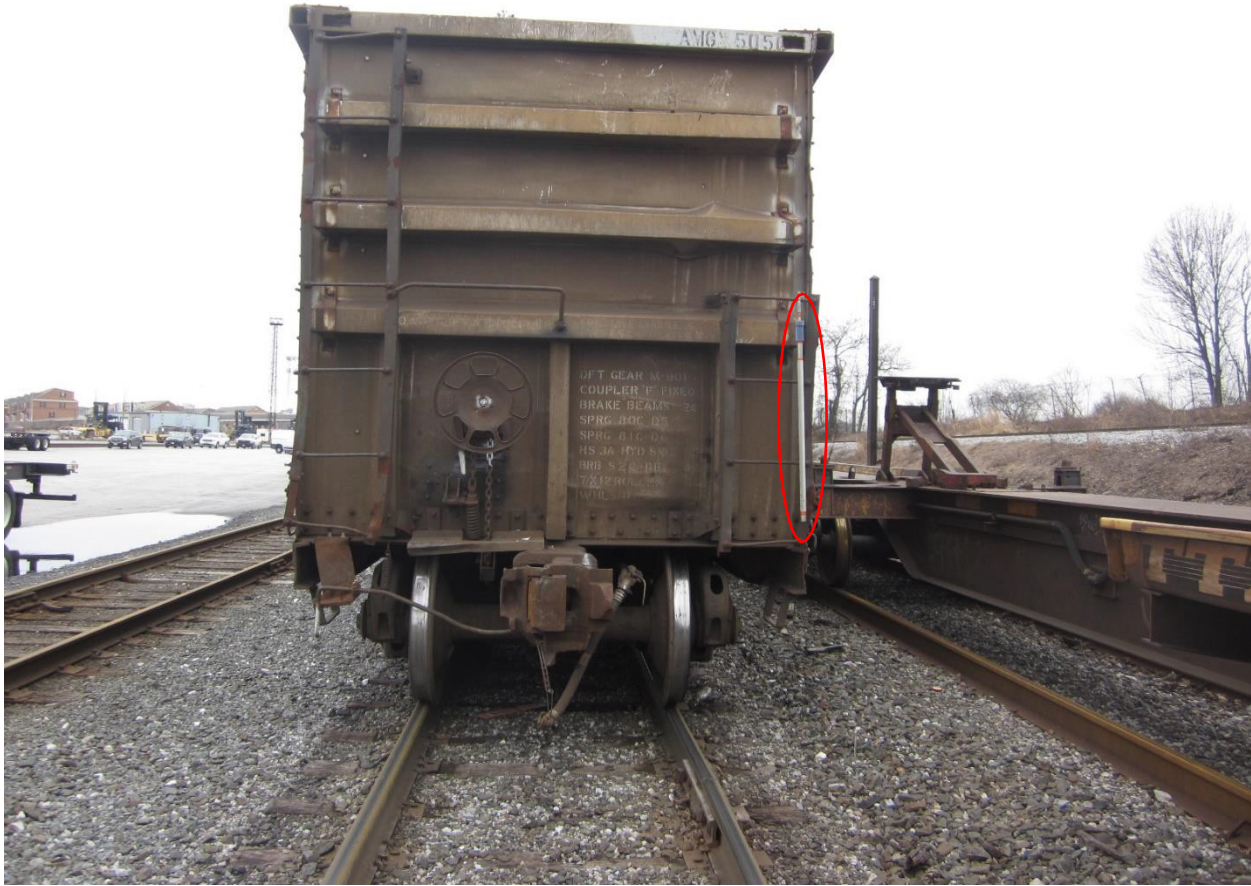
Figure 3- photo shows the rear of the railcar. The conductor was believed to be riding on the right side of the railcar. Notice the conductors brake stick hanging from the rear of the railcar on the engineer's side of the train.

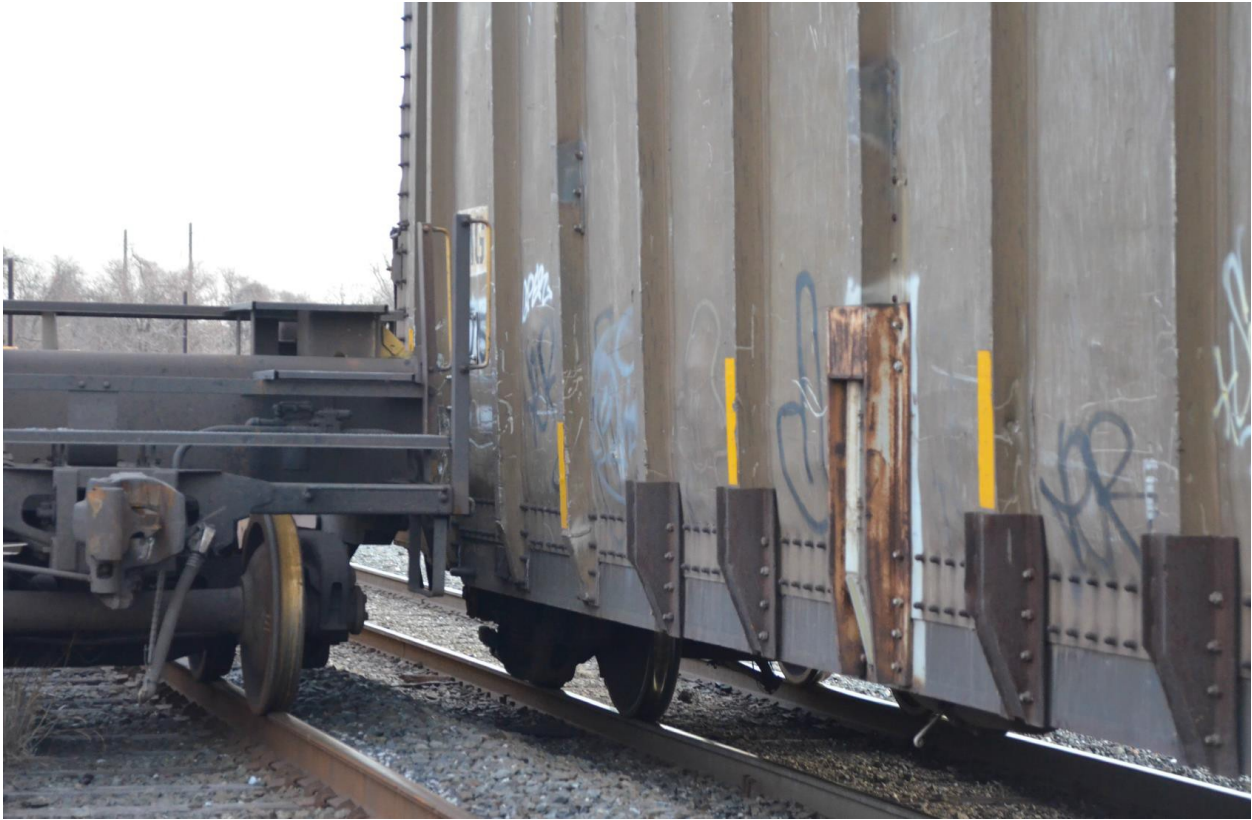
As the train reversed north about 570 feet, the lead railcar traversed a section of the Bank track that curved to the right, creating limited clearance between the adjacent tracks. As the train continued back; it passed the first of three stationary DTTX intermodal cars sitting on the left adjacent track. As the train continued reversing north, the engineer spotted the conductors lantern on the ground and radioed the conductor, asking him if he had dropped his lantern.

Figure 4- photo showing the high-side gondola passing the standing intermodal railcars. The intermodal railcars to the left of the picture are sitting on the Perryville track. Notice the limited clearance between the railcars.

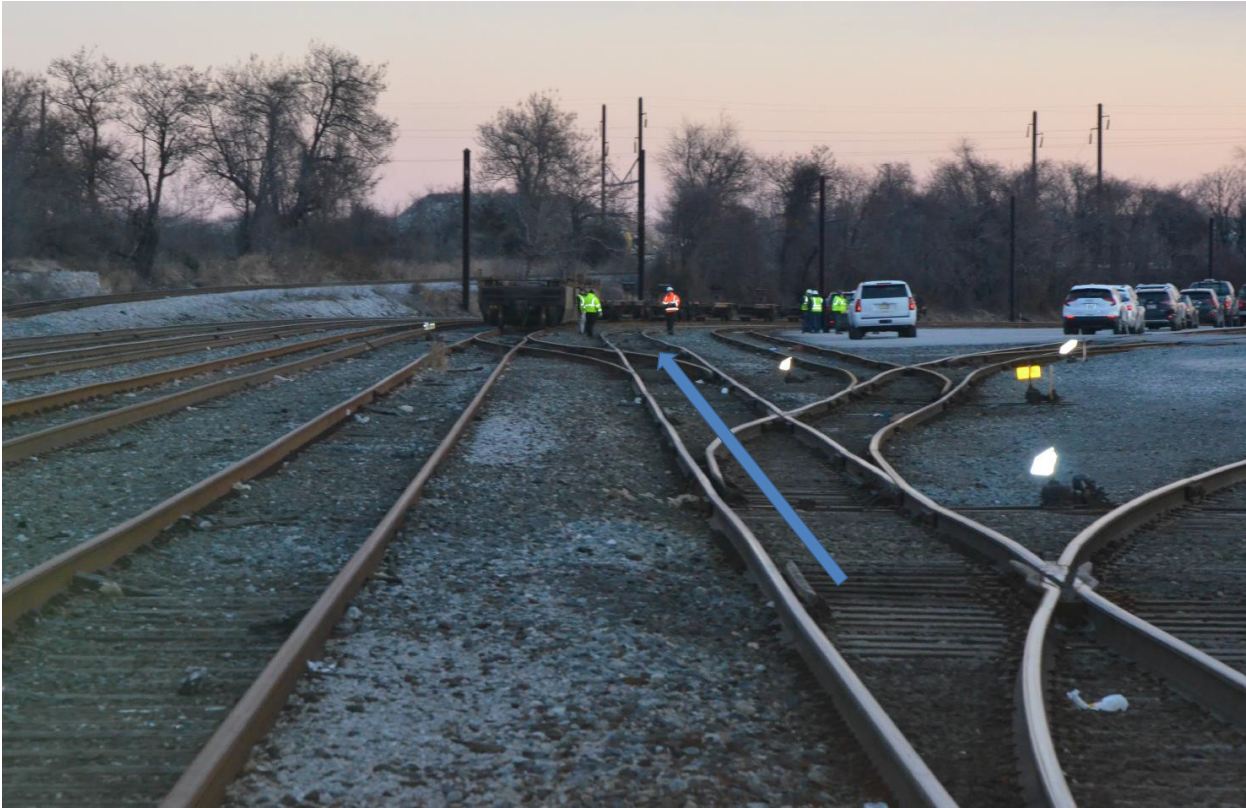
Figure 5- photo taken looking north towards the accident track location (Back track). Blue arrow indicates the trains reverse travel route. Notice the standing DDTX intermodal railcars to the left of the accident track (Perryville Track).

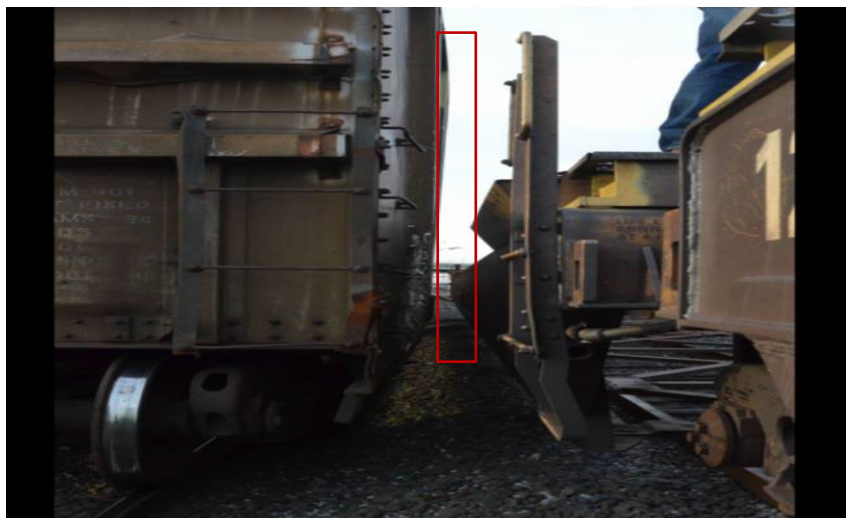
On February 8, 2019, investigators had the articulating high-side gondola positioned on the Bank track directly beside the first standing DTTX intermodal car so that investigators could take between car measurements. Investigators took eight between car measurements at the front, middle and rear of the DTTX car. At the rear of the DTTX intermodal car, and where the track profile curved to the right; investigators measured the smallest clearance between the cars at nine inches.

Figure 7- photo shows the limited clearance between the high-side gondola and the adjacent DTTX intermodal railcar.

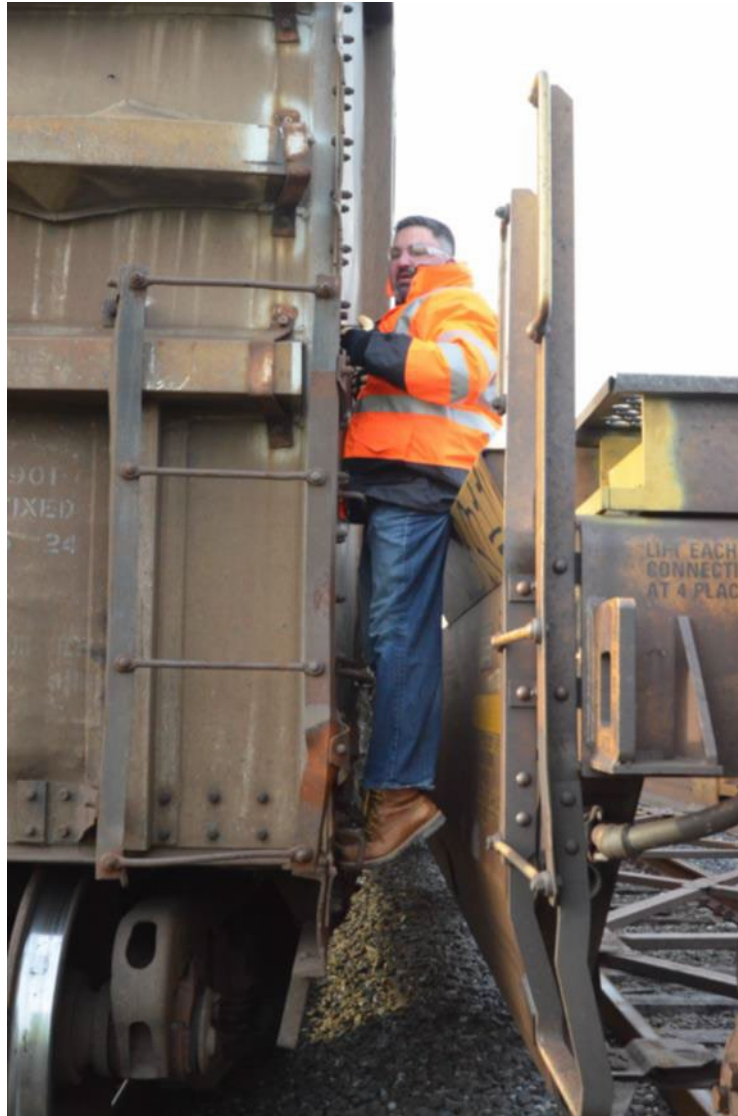
Figure 8- photo shows an investigator attempting to climb the accident railcar in the no clearance area between the two cars.
