NATIONAL TRANSPORTATION SAFETY BOARD

RRD18FR006

Amtrak Roadway Worker Fatality

**Bowie, Maryland Factual Report
April 24, 2018**

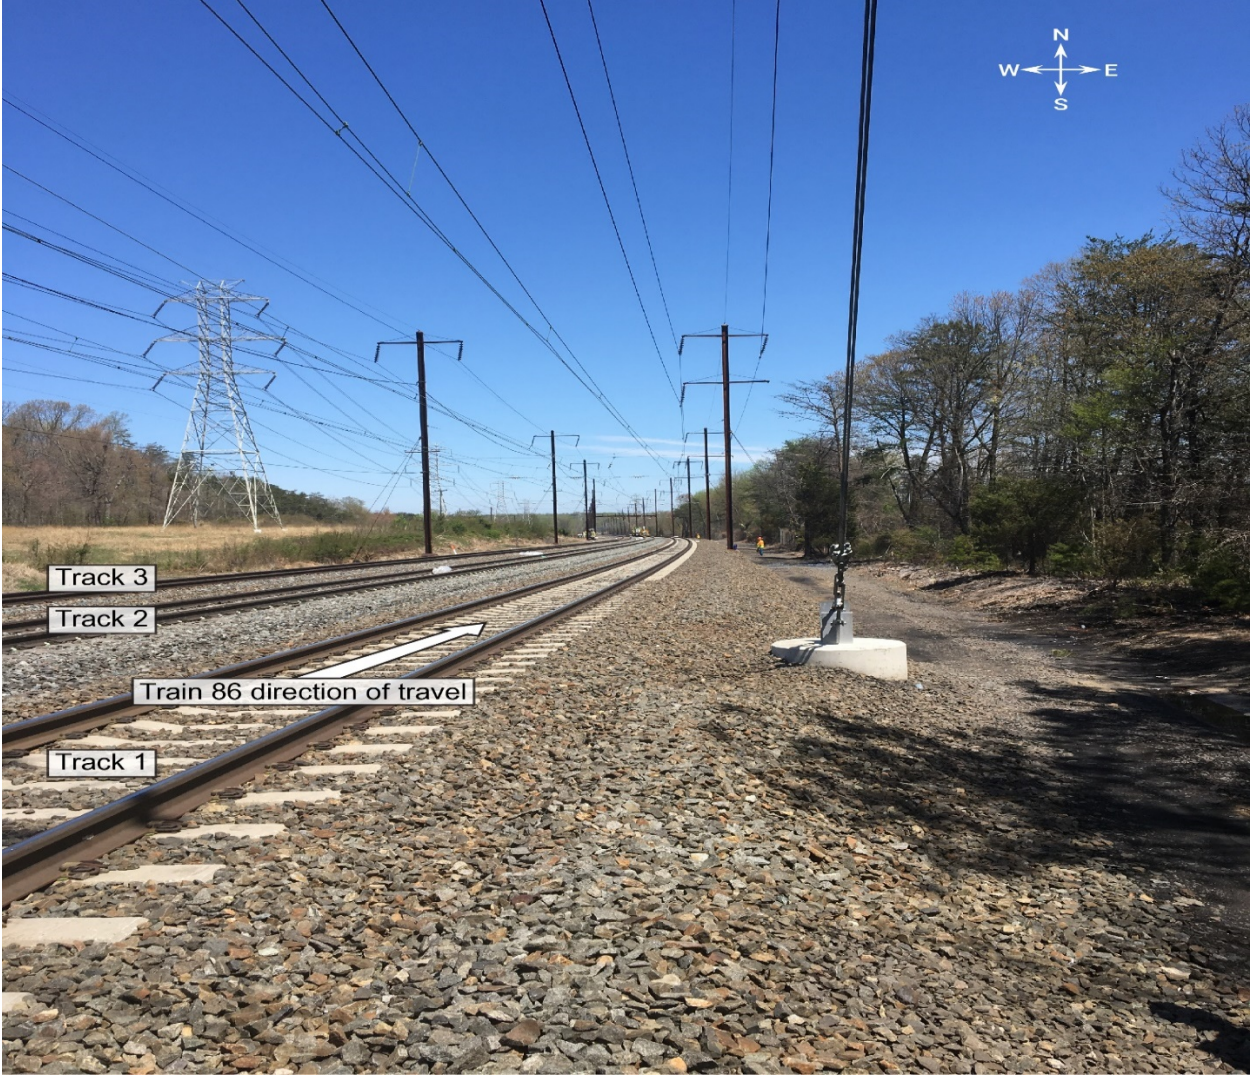
Figure 1- photo taken from Bowie State platform looking north into curve 404. Track 1 is the track to the right of the picture.

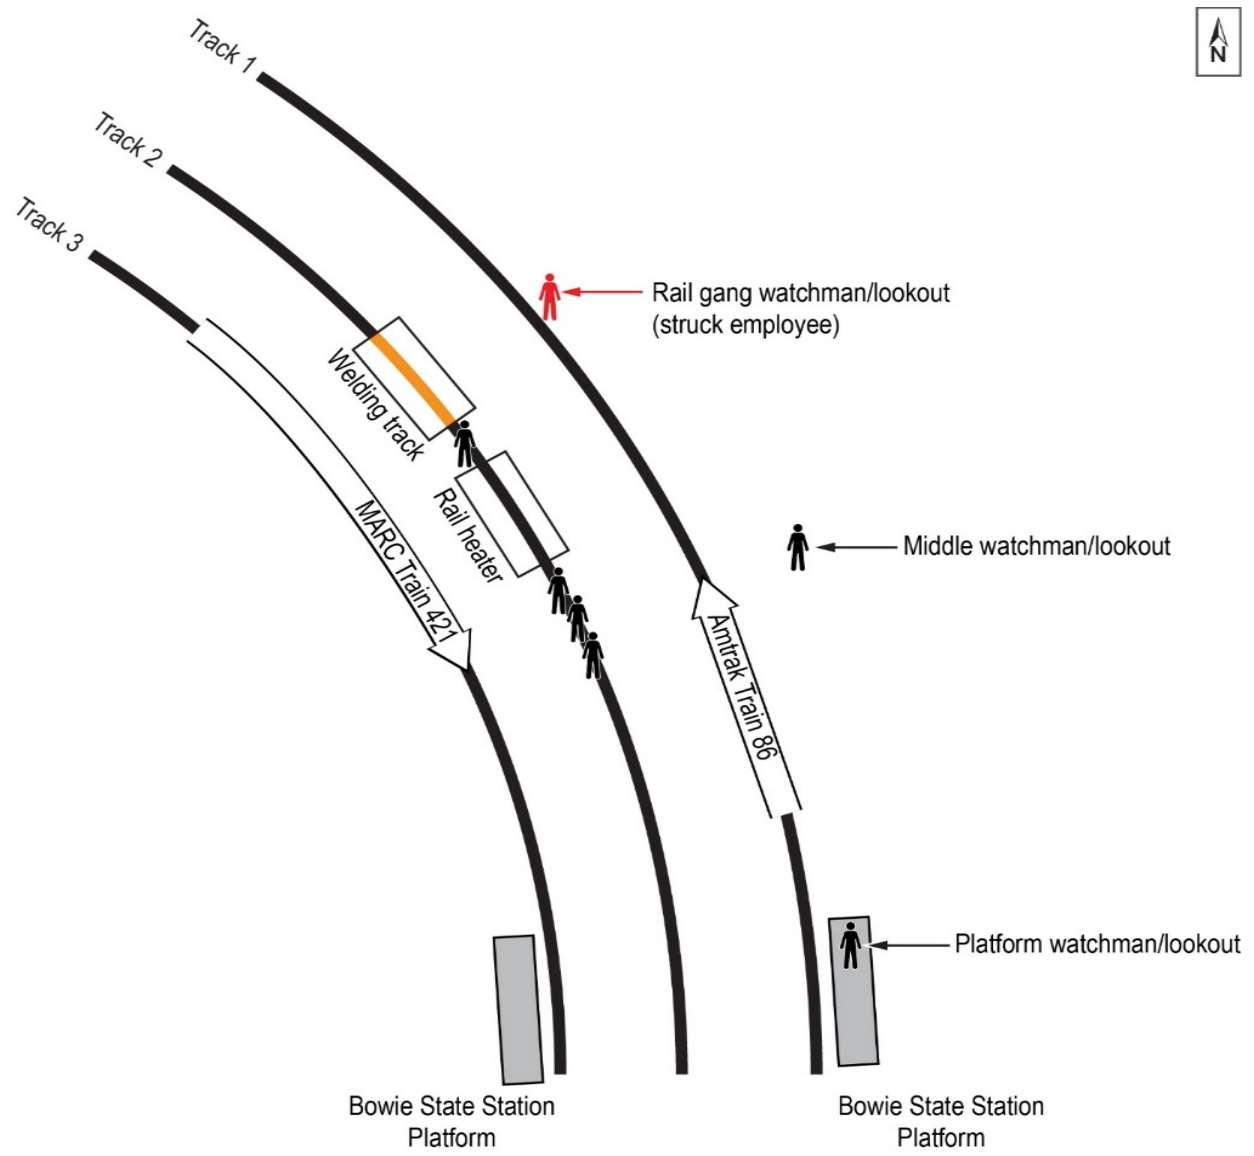
Figure 2- graphic of accident
