**Tank Car Derailment Damage  
FACTUAL REPORT**

**December 22, 2020, Derailment of BNSF Railway Freight Train  
U-TNDFEP-0-36T and Subsequent Hazardous Materials Release**

**Custer, Washington**

**HMD21LR001**

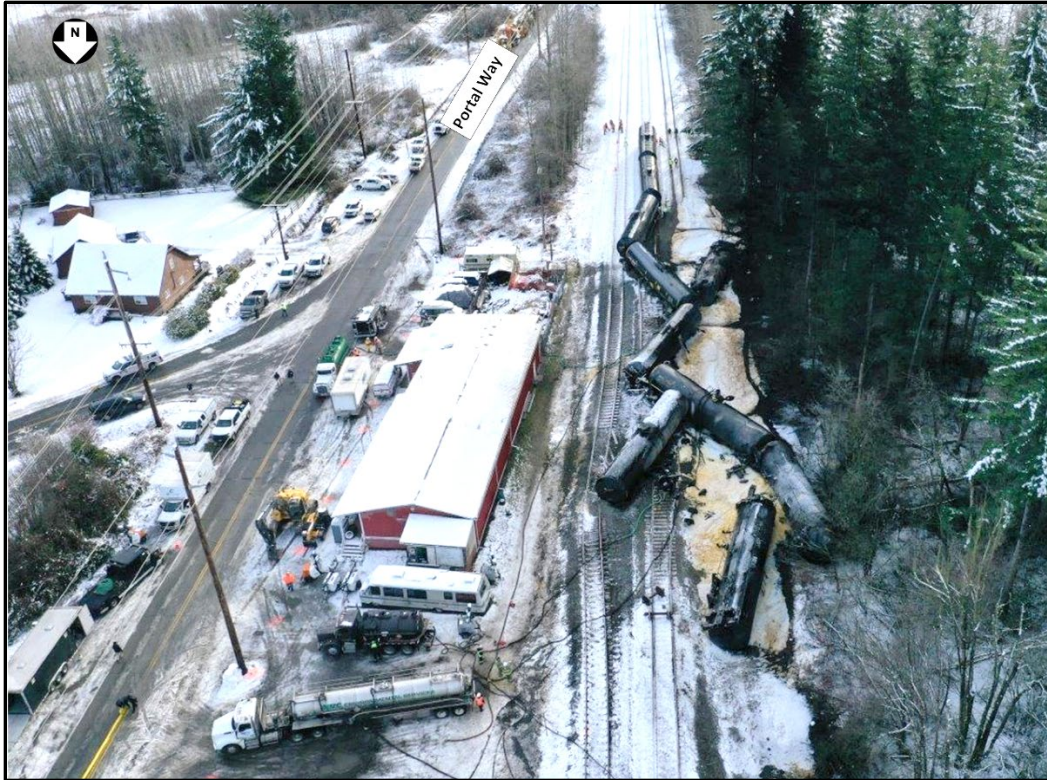
Figure 2. Accident scene looking south, December 23, 2020.

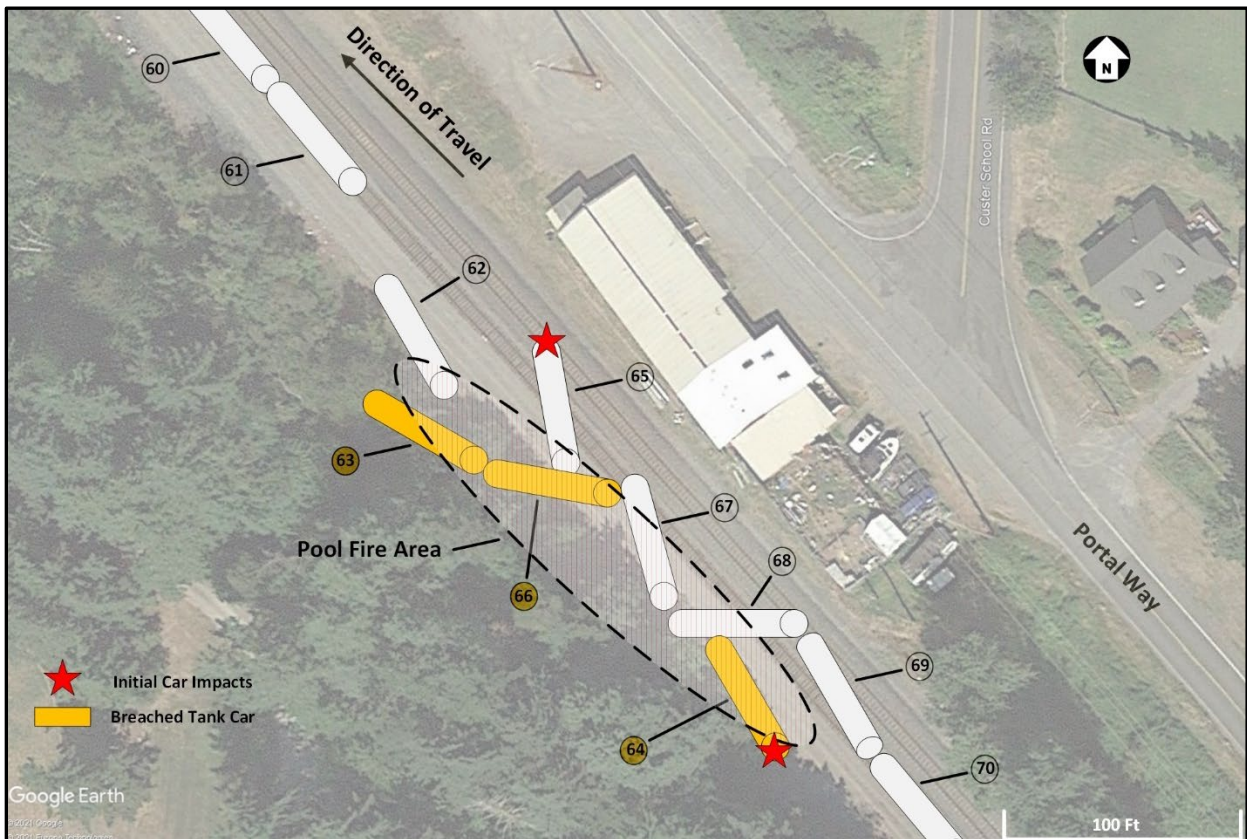
Figure 3. Derailment diagram with approximate tank car resting positions overlaid on pre-accident Google Earth image. Breached tank cars are indicated in orange. Base imagery date: August 15, 2020.

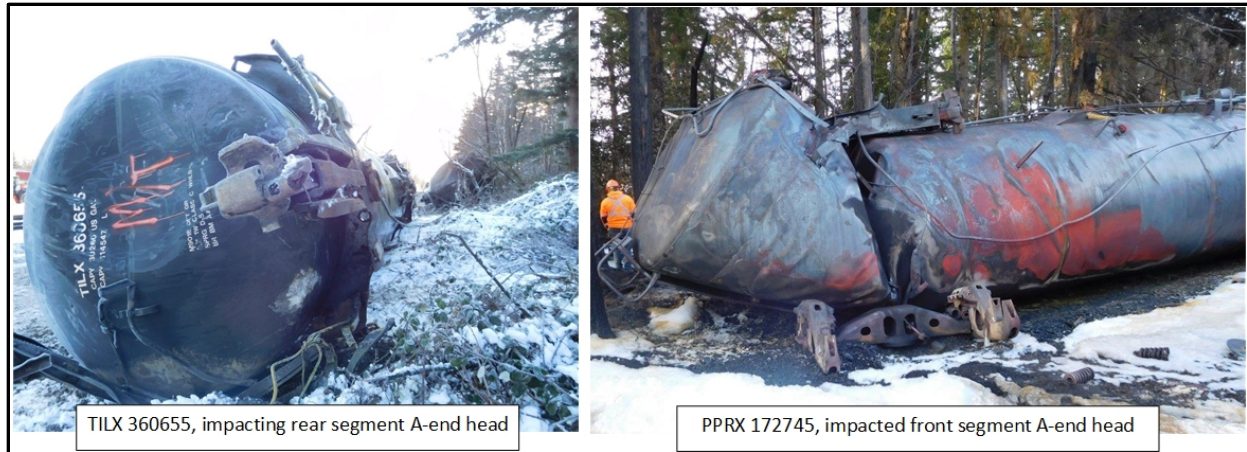
Video evidence showed the train had separated between line numbers 64 and 65. The impacting car was the separated leading A-end head of line 65 (TILX 360655), and the impacted car was the trailing A-end head of line 64 (PPRX 172745), see Figure 4.

Figure 4. Impacting A-end of TILX 360655 (left) and impacted A-end of PPRX 172745 (right), courtesy Washington UTC.

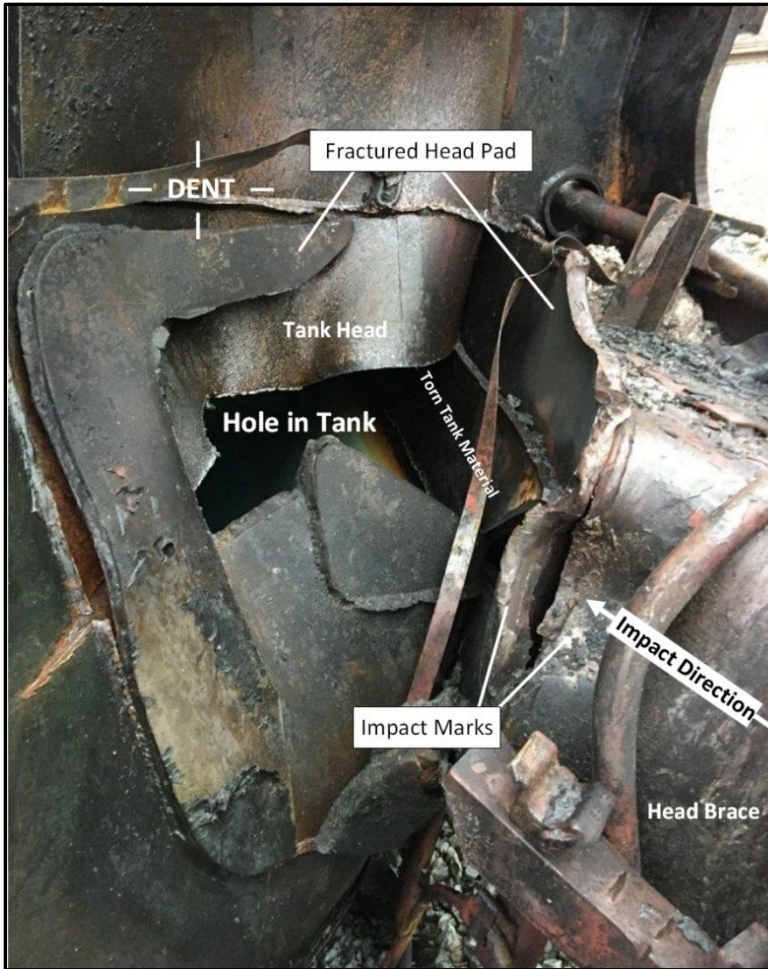
The A-end of the tank car in line 63 (PPRX 172933) sustained a shell buckle and crack that breached the car. Underframe damage at the B-end head contributed to the breach and release of crude oil.

A portion of the B-end head pad was torn from the tank and remained attached to the stub sill as it separated. Both the head pad and tank head fractured during this separation, leaving a hole in the tank that measured roughly 12 inches in diameter. Localized impact and inward deformation of the tank head close to the head brace fractured the head pad. Witness marks left by the impacting object were found at the front of the head brace and head pad. A segment of the head brace-to-head pad weld was cracked at the location of this impact. A piece of torn tank head material remained attached to the portion of fractured head pad retained by the stub sill welds (Figure 5).

*Figure 5. B-end Head breach as seen after tank jacket removal. The stub sill is attached to the tank head at through the head pad, January 5, 2021, courtesy Washington UTC.*

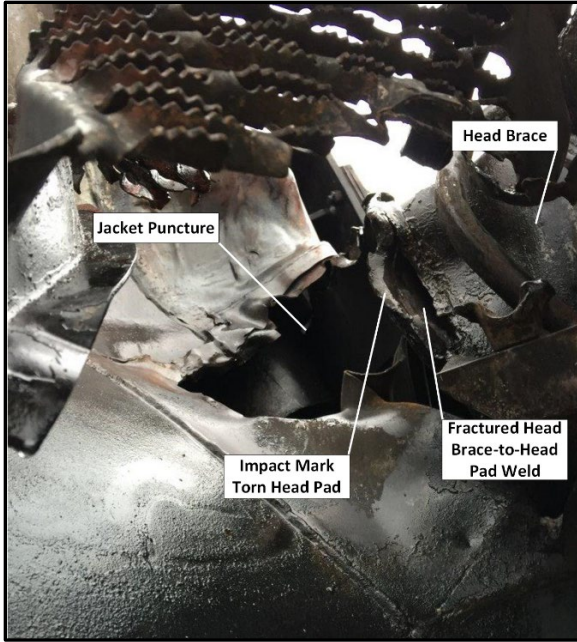
The B-end of line 63 (PPRX 172933) was coupled to the A-end of line 62 (PPRX 172350) in the train. The lower shelf of the A-end coupler of PPRX 172350 was fractured and missing. Examination of the B-end head of PPRX 172933 at the accident scene found a puncture in the tank jacket at the location of the damage shown in Figure 5 (see Figure 6).

Figure 6. PPRX 172933 B-end head impact location, showing punctured jacket material forward of the head brace, December 30, 2020, courtesy Washington UTC.

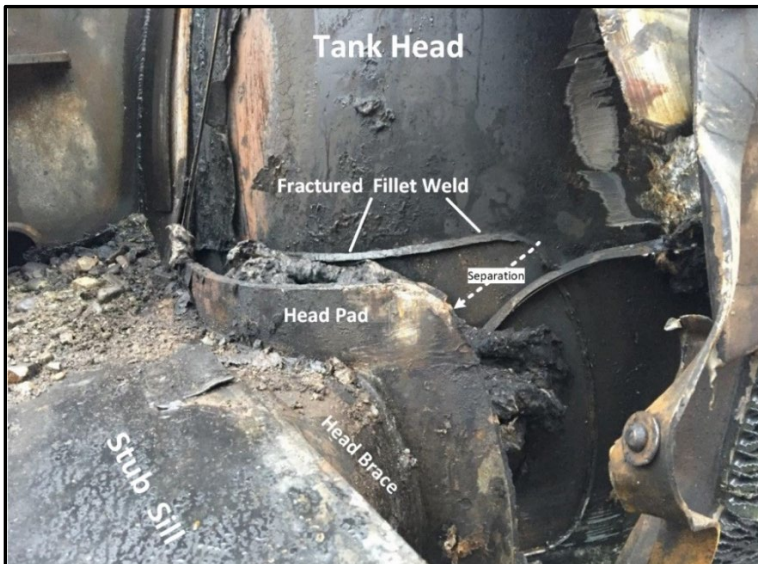
At the opposite end of the tank car, the A-end head pad fillet welds were fractured as the pad pulled away from the tank head, however the cracked weld did not transition into tank head parent metal and no breach occurred (Figure 7). Downward force on the stub sill was associated with severe tank buckling inboard of the body bolster near the termination of the stub sill tail piece. The A-end of the tank was bent about 45 degrees downward at this location.

Figure 7. A-end head pad separation from tank, fractured fillet weld, January 5, 2021, courtesy Washington UTC.

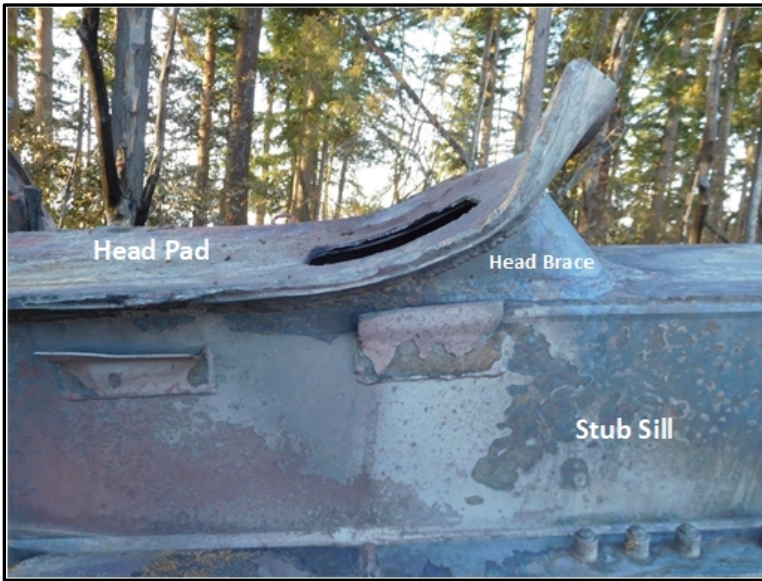
The impacted A-end stub sill of line 64 (PPRX 172745) folded under the car almost 180 degrees and the tank shell buckled with a crack that breached the car inboard of the bolster.

The trailing A-end stub sill was folded down and inboard almost 180 degrees. The head pad-to-tank fillet welds were fractured, and head pad was torn from the head without tank penetration. The stub sill and head brace-to-head pad welds did not fracture (Figures 8 and 9).

*Figure 8. PPRX 172745 A-end stub sill with separated head pad, December 24, 2020, courtesy Washington UTC.*

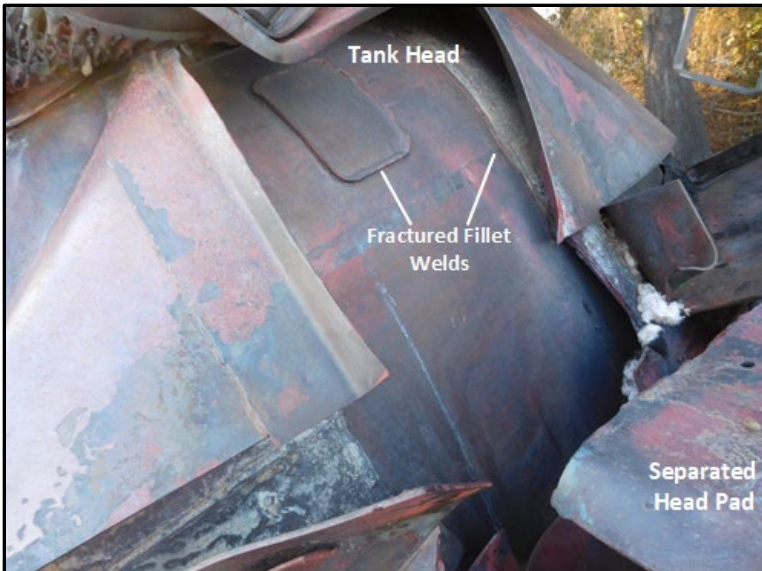
*Figure 9. PPRX 172745 A-end head and separated head pad, December 24, 2020, courtesy Washington UTC.*

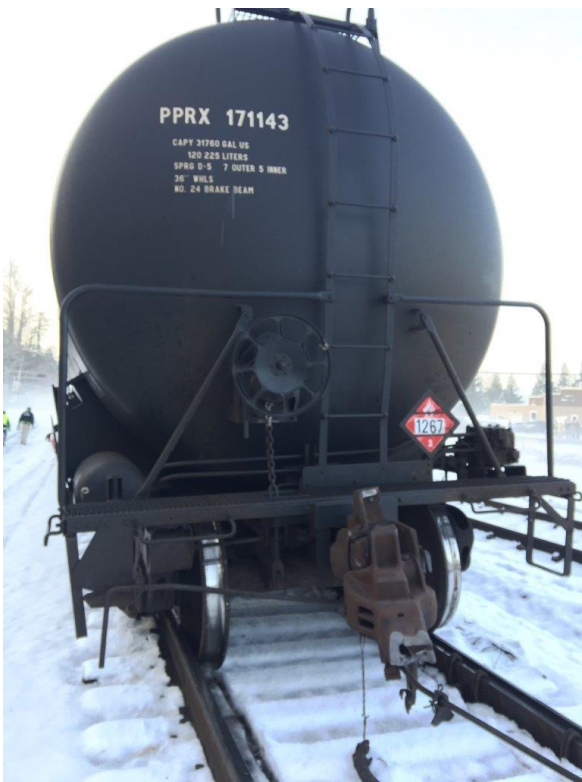
*1(a) Resting position, trailing B-end head, derailed trucks.*

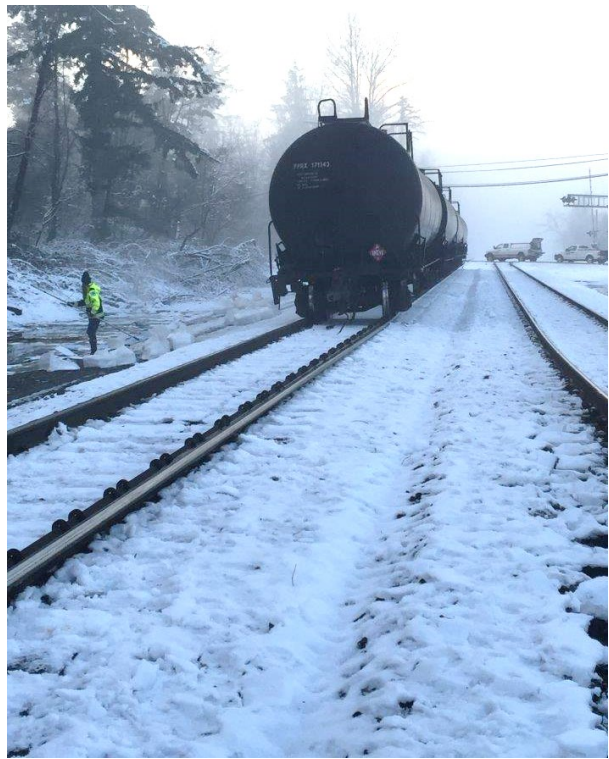
*1(b) B-end trailing head, looking north, direction of travel.*

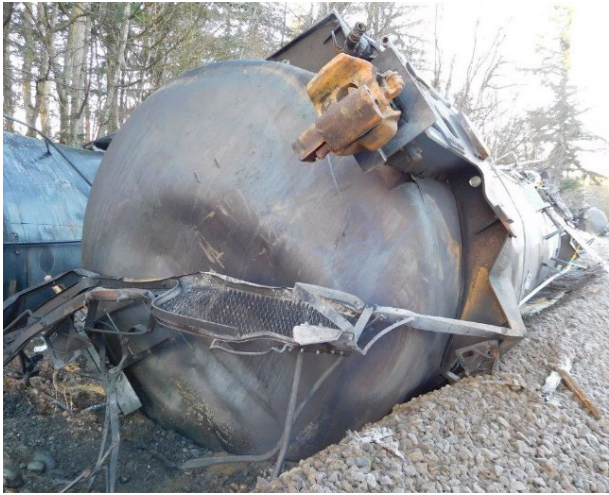
2(a) A-end head before jacket removal.

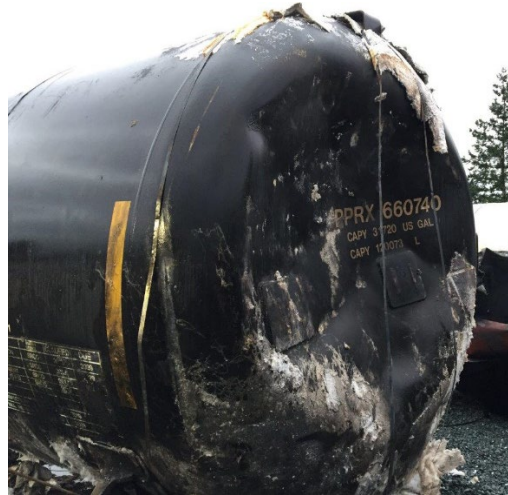
2(b) A-end head after jacket and headshield removal. Former reporting mark is showing.

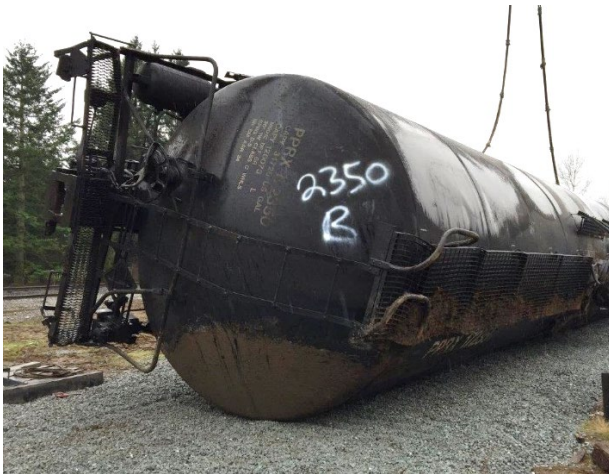
2(c) Staging area, B-end head.

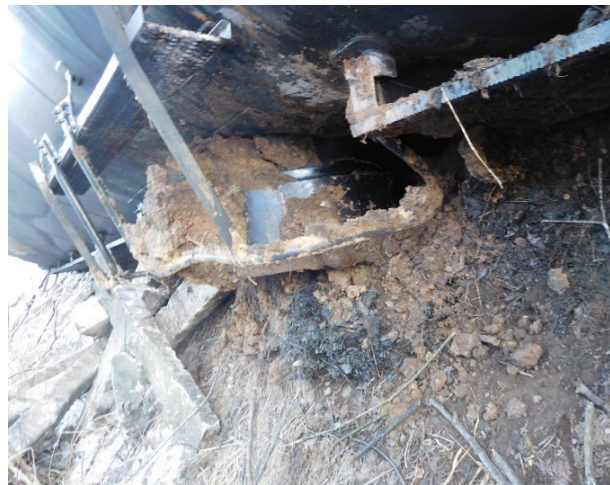
Tank cars in positions 62 and 64 rolled over onto top fittings protective housings, however the top fittings were not mechanically damaged.

2(d) Resting position, rollover-impacted top fittings protective housing.

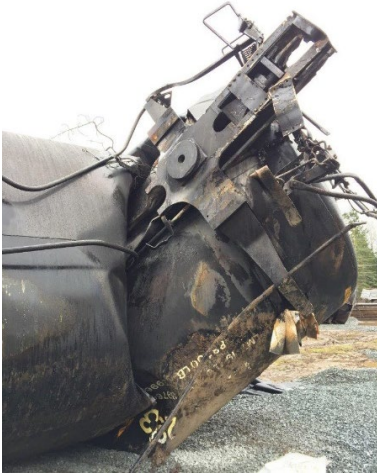
3(a) Buckled A-end tank shell, bottom view.

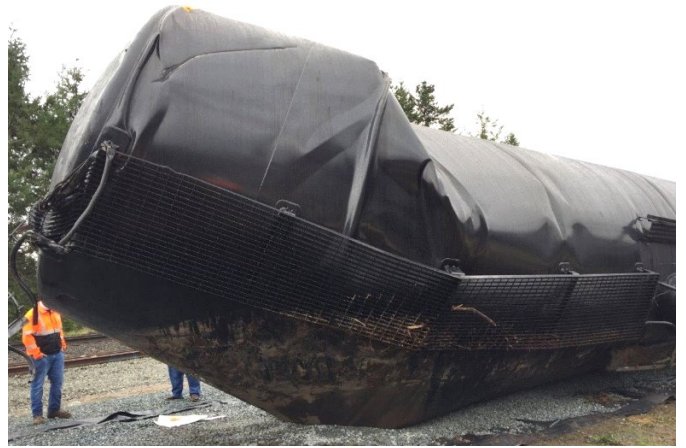
3(b) Buckled A-end tank shell top view.

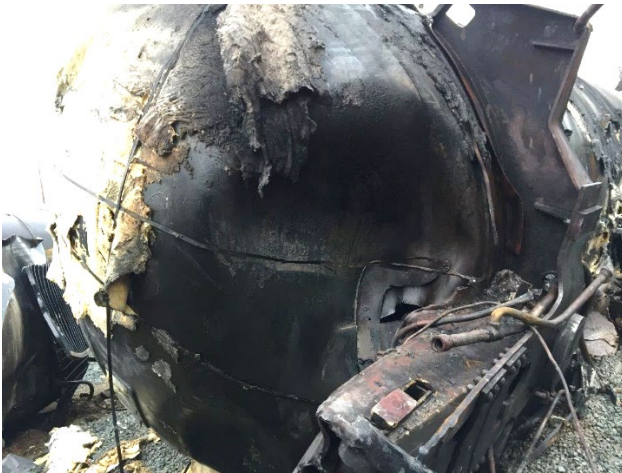
3(c) Impacted B-end head after jacket and head shield removal.

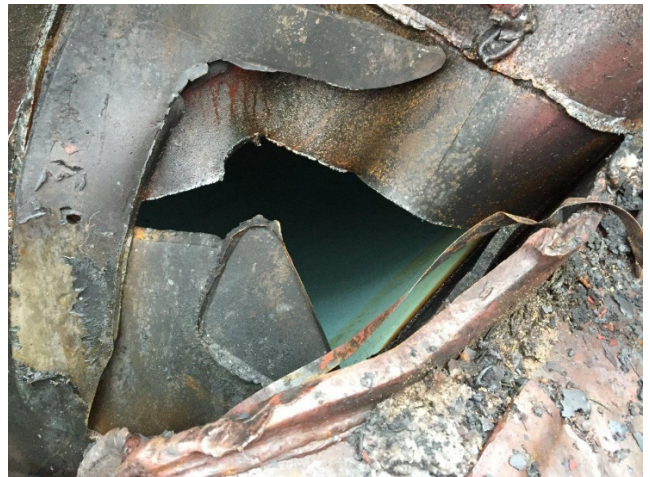
3(d) Fractured B-end head pad and hole in tank.

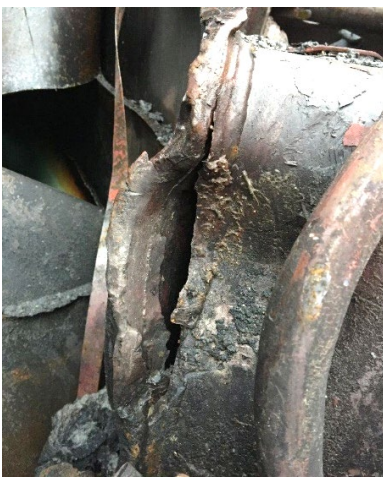
3(e) Impact mark B-end head brace, head brace weld, and fractured head pad.

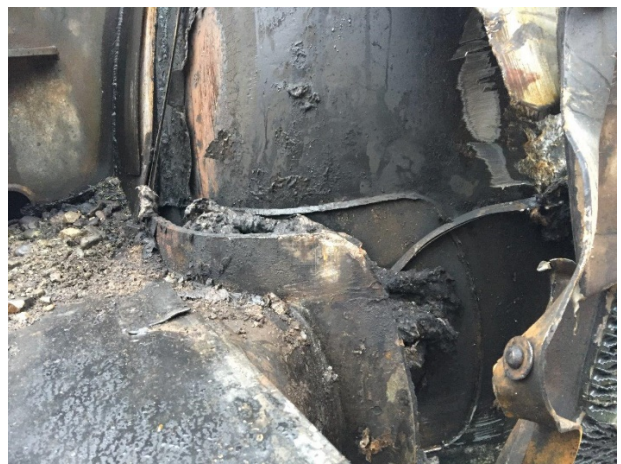
3(f) Separated A-end head pad and fractured fillet weld.

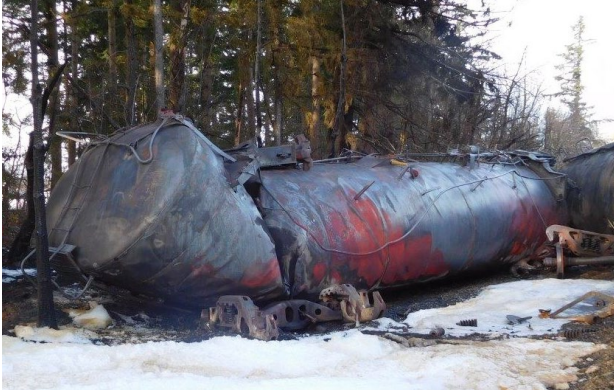
*4(a) Resting position upside-down, viewing A-R side.*

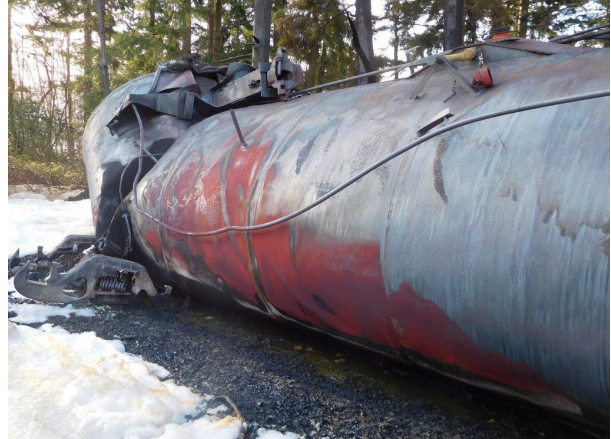
*4(b) Resting position, B-R side looking towards A-end.*

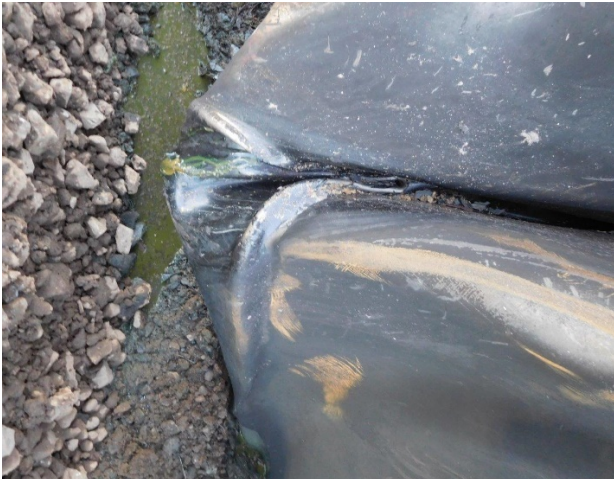
*4(c) A-R buckled tank shell, cracked, and releasing material.*

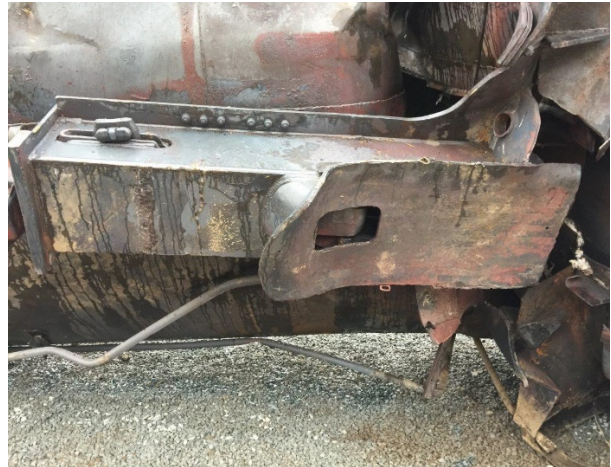
*4(d) A-end stub sill folded 180 degrees inboard, head pad remained attached to sill and head brace*

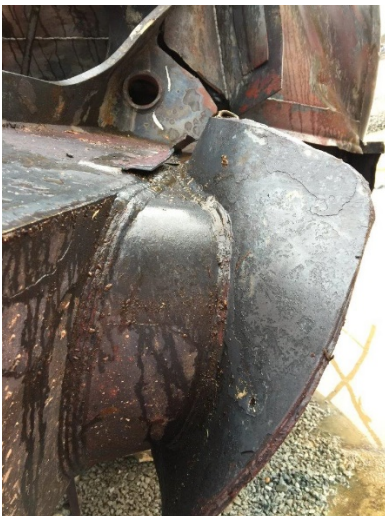
*4(e) A-end head pad-to-head brace attachment. Head pad has separated from the tank.*

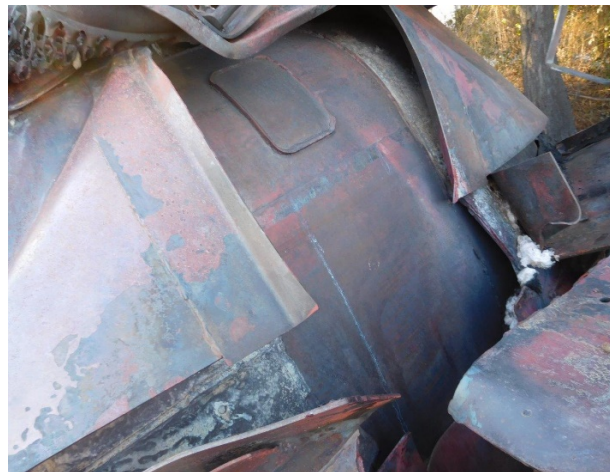
*4(f) A-end separated head pad attachment point. No tank head/shell breaching damage.*

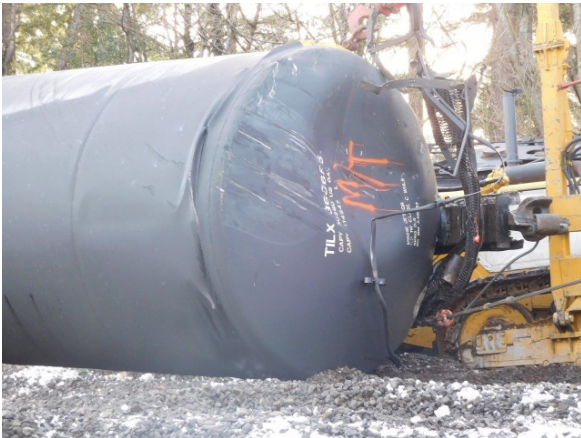
5(a) Staging area, A-end leading head.

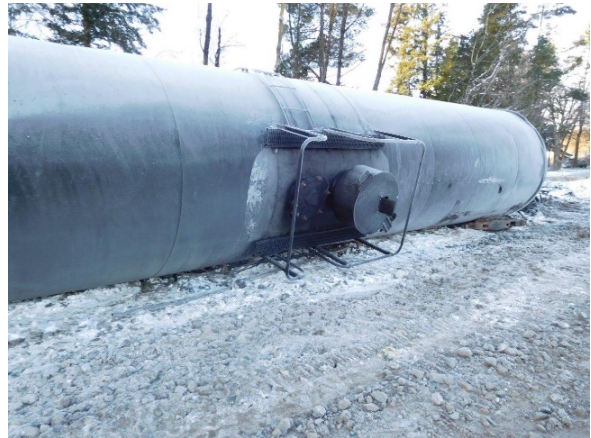
5(b) Staging area, top surface.

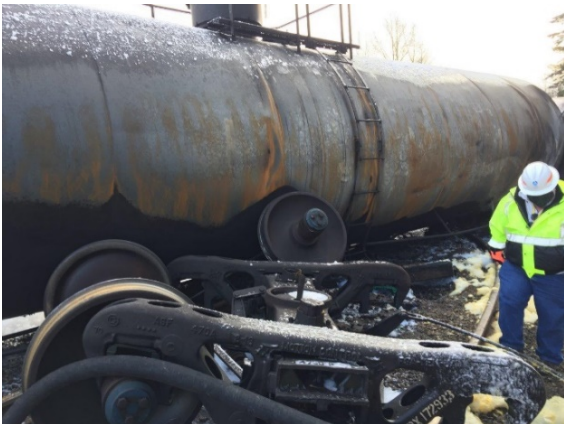
5(c) Resting position, left side, thermal damage to jacket.

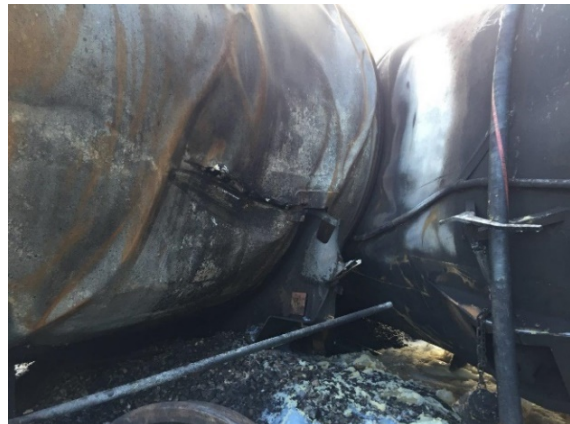
5(d) Resting position, B-L side and B-end head in contact with trailing car, line 64.

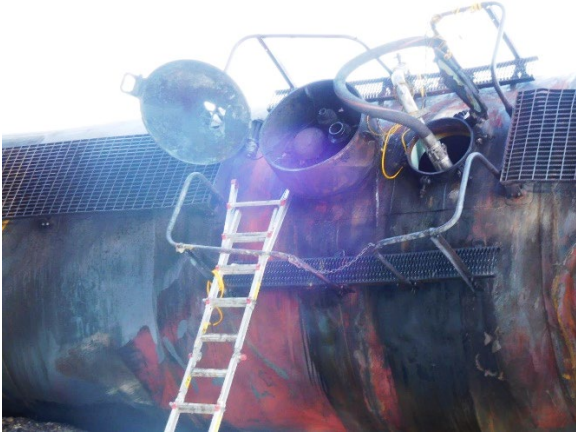
6(a) Left side, top fittings, and manway.

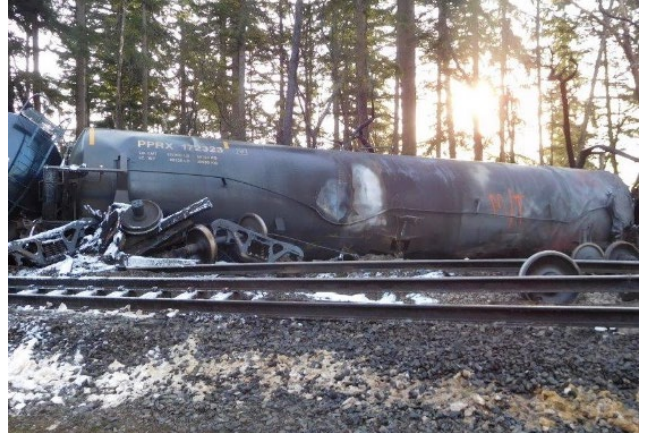
6(b) Resting position, right side.

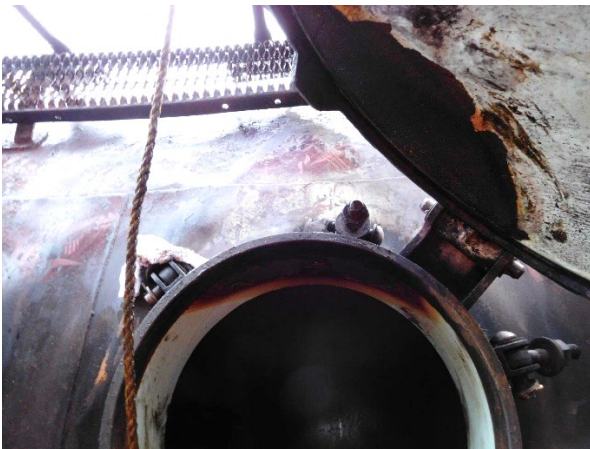
The tank car in line 66 (PPRX172323) released crude oil from pressure relief device activation and thermal damage to the manway gasket.

6(c) Manway and burnt gasket and interior cover surface.

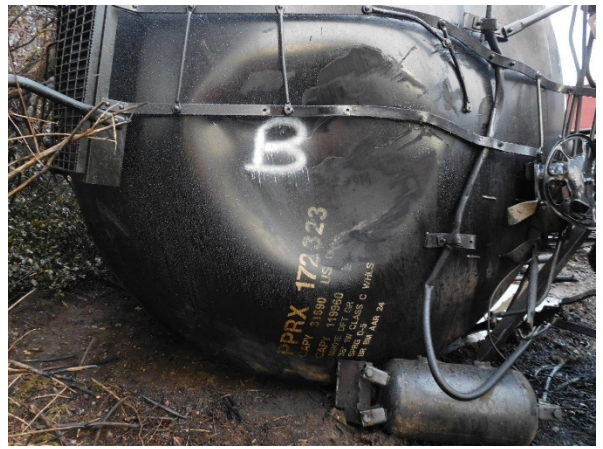
6(d) Dented B-end head.

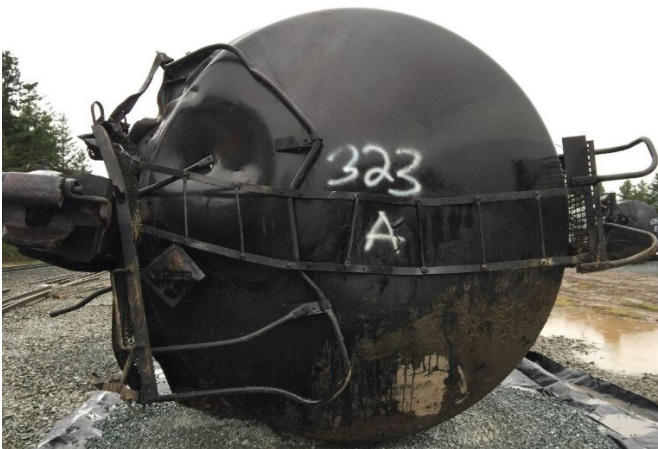
6(e) Dented A-end head. Penetrated head shield.

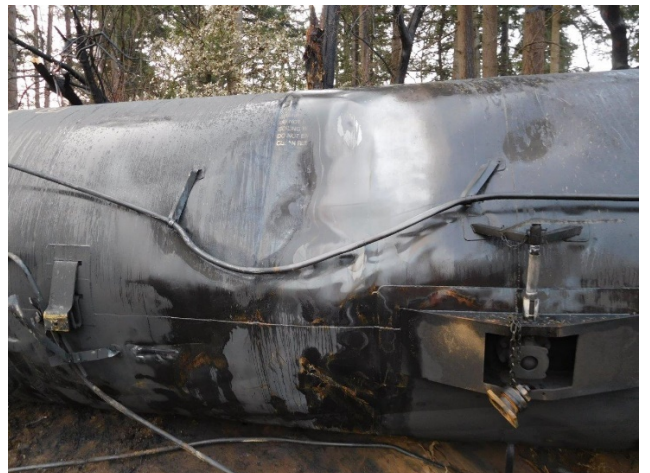
6(f) Lower right-center dent, sheared BOV nozzle.

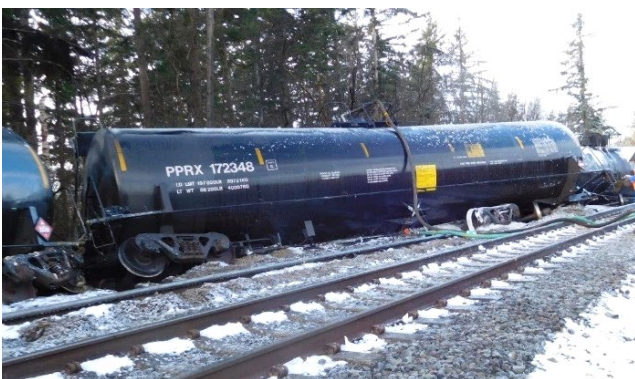
7(a) Resting location, right side.

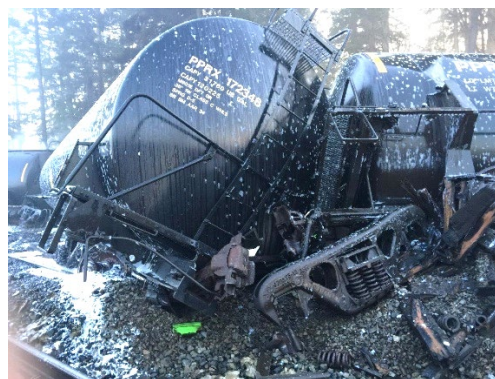
7(b) Resting location, A-end head

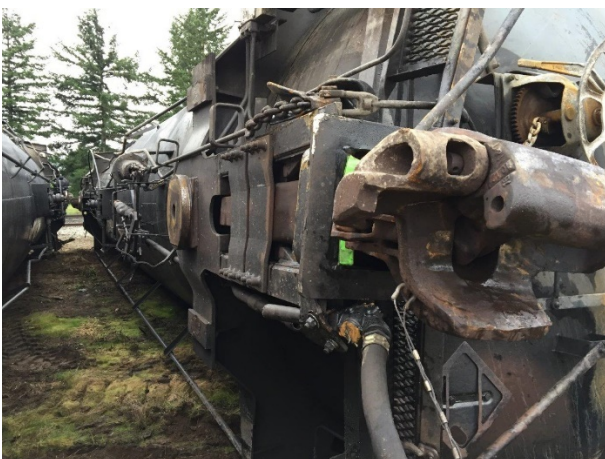
7(c) B-end underframe, bottom.

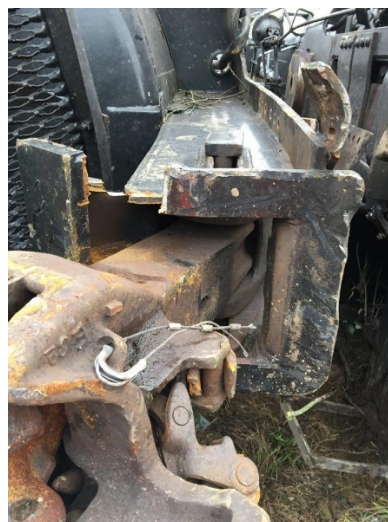
7(d) Displaced A-end coupler. Torn draft sill top plate.

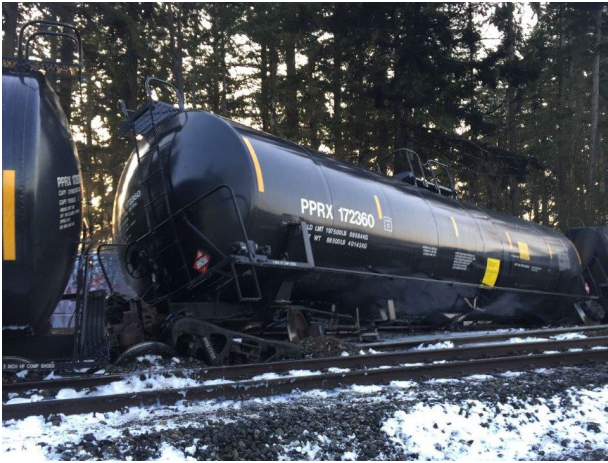
8(a) Resting position, right side.

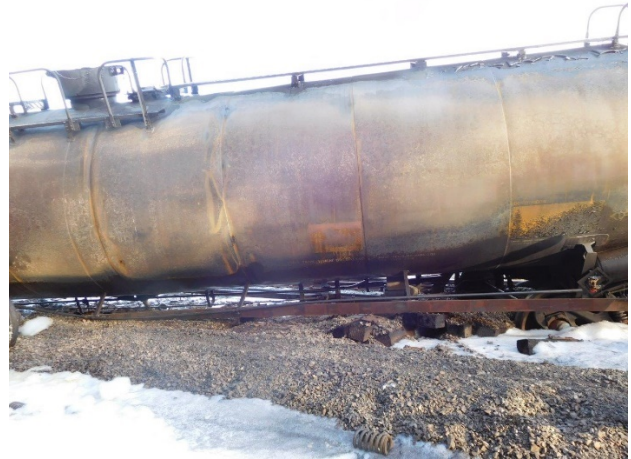
8(b) Thermal damage to left side.

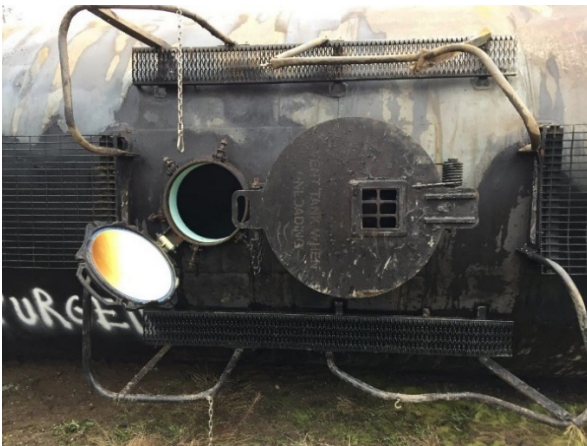
8(c) Top fittings, thermal damage to manway cover.

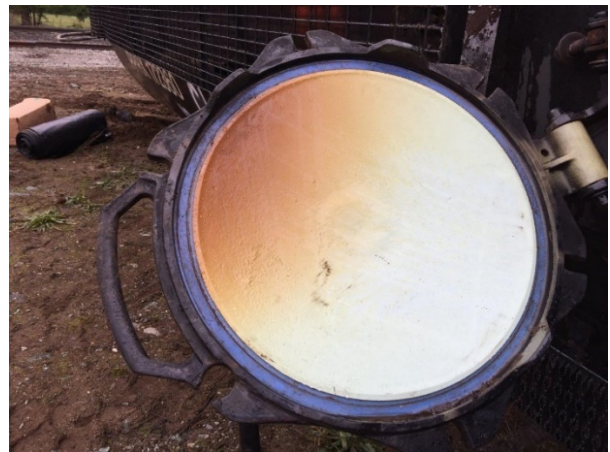
8(d) Manway cover, interior surface thermal damage.

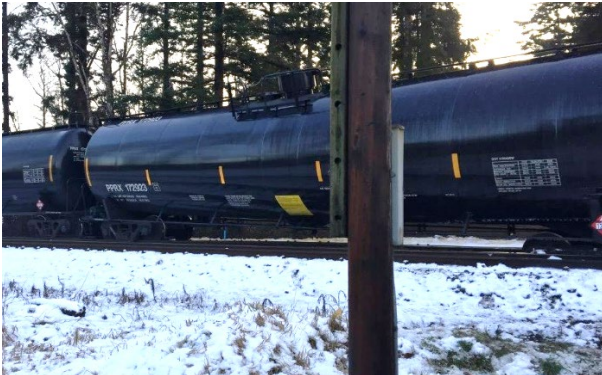
9(a) Resting position, right side.

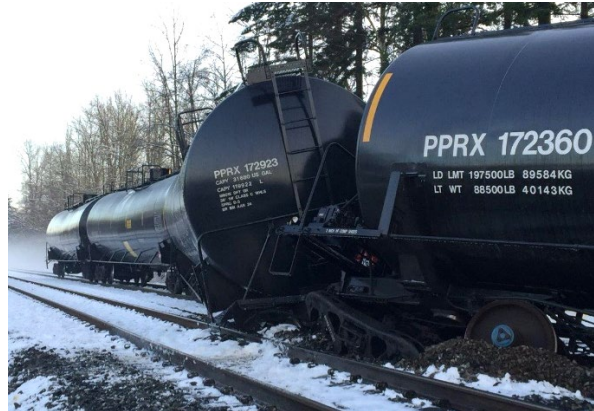
9(b) Resting position, A-end head.

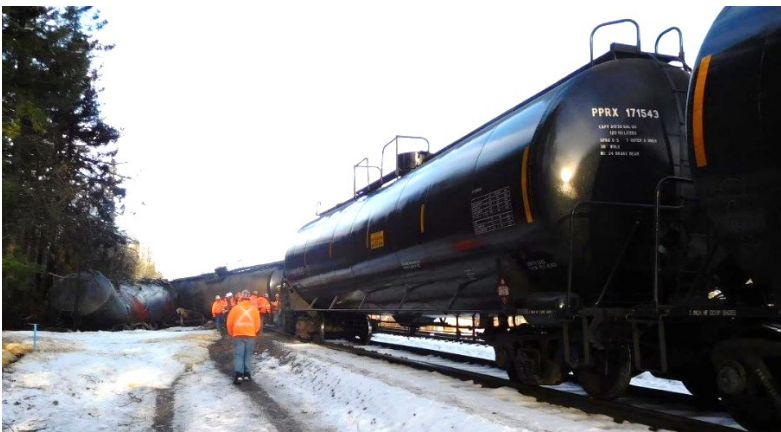
10(a) Resting position, left side.
