National Transportation Safety Board

Investigator in Charge Factual Report

Operator: Pacific Gas & Electric
Location: San Francisco, CA
Incident Date: February 6, 2019
NTSB No.: PLD19MR001

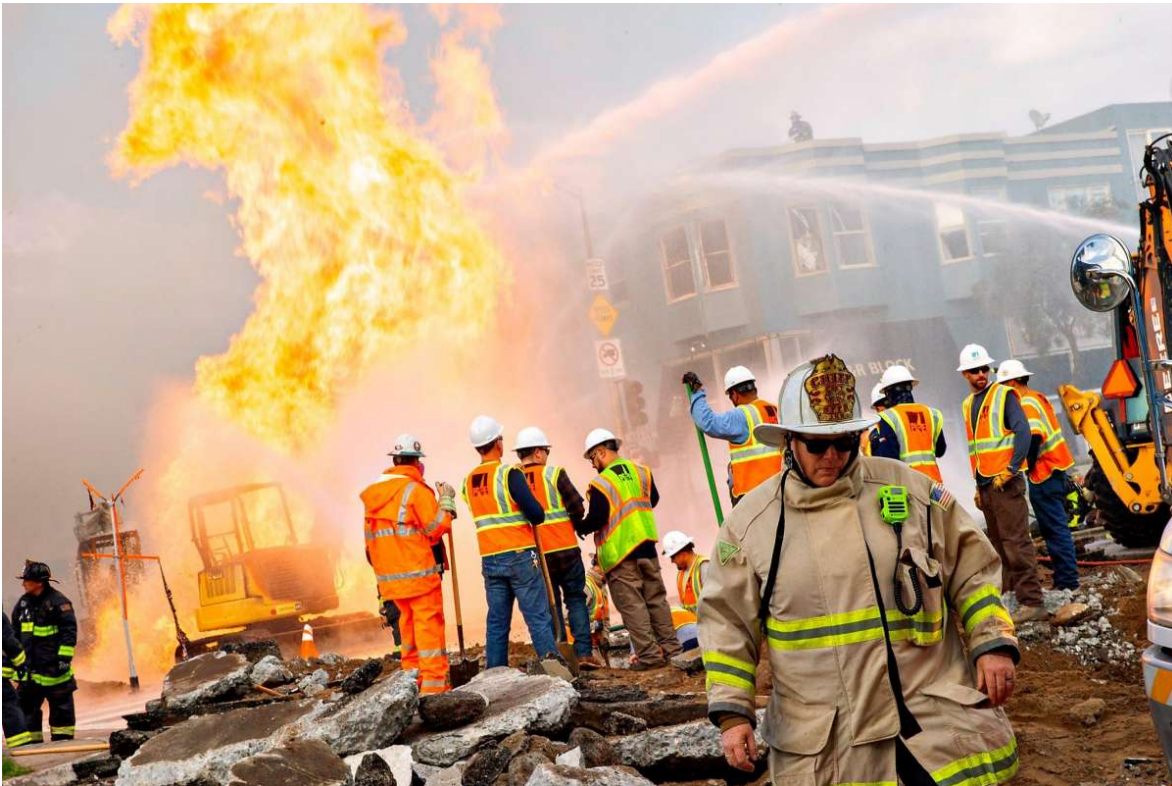
Figure 1. Emergency responders at the accident location. (Photograph by Santiago Mejia, *The Chronicle*.)

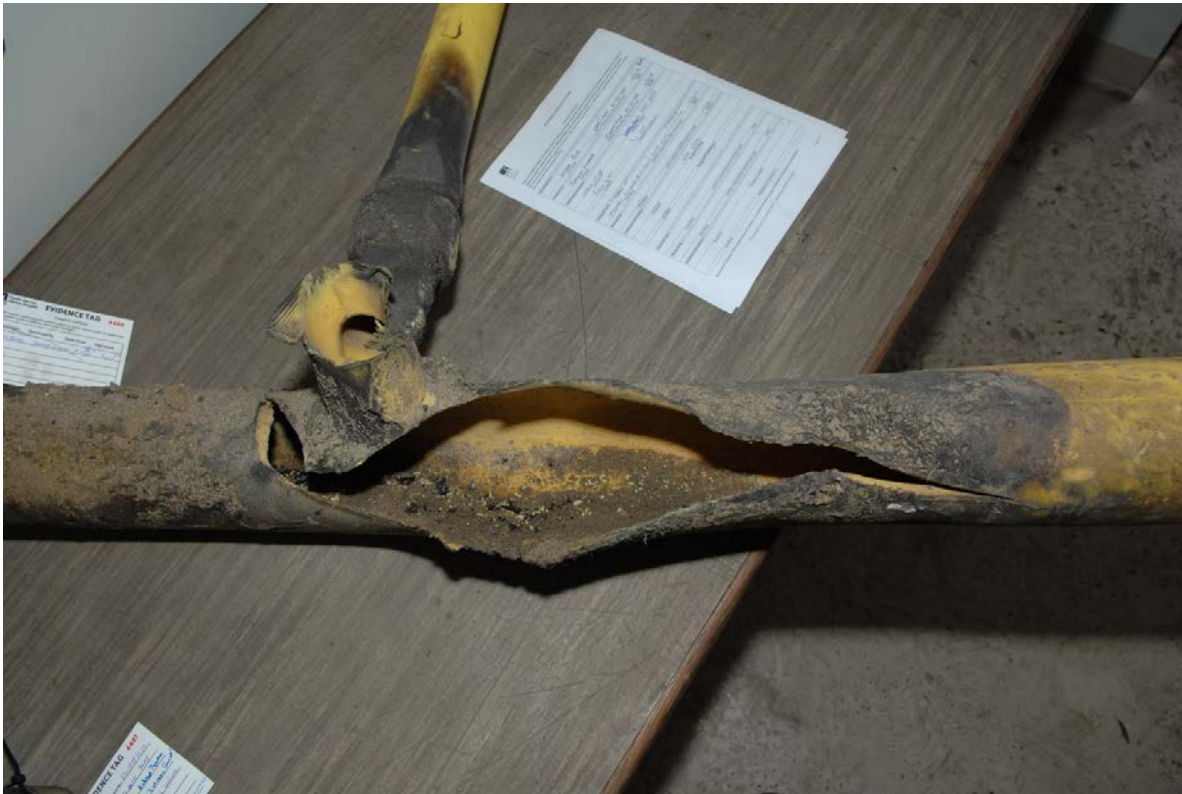
An inward-facing bend in the 2-inch main was found 1.25 inches from the outlet of the fused saddle

connection (Figure 2). Further details on the physical evidence can be found within the Materials Laboratory Factual Report.

Figure 2. 2-inch to 4-inch branch connection post-accident. (Photograph by Federal Bureau of Investigation Evidence Response Team)

with the operator, he stated that the tee caused him an issue “because it was higher than the 2-inch gas line that he exposed and he thought that he had enough room.” The DiRT investigator concluded that Kilford had struck the branch connection while mechanically excavating within the tolerance zone due to a failure to properly expose the 2-inch and 4-inch mains and branch connection.

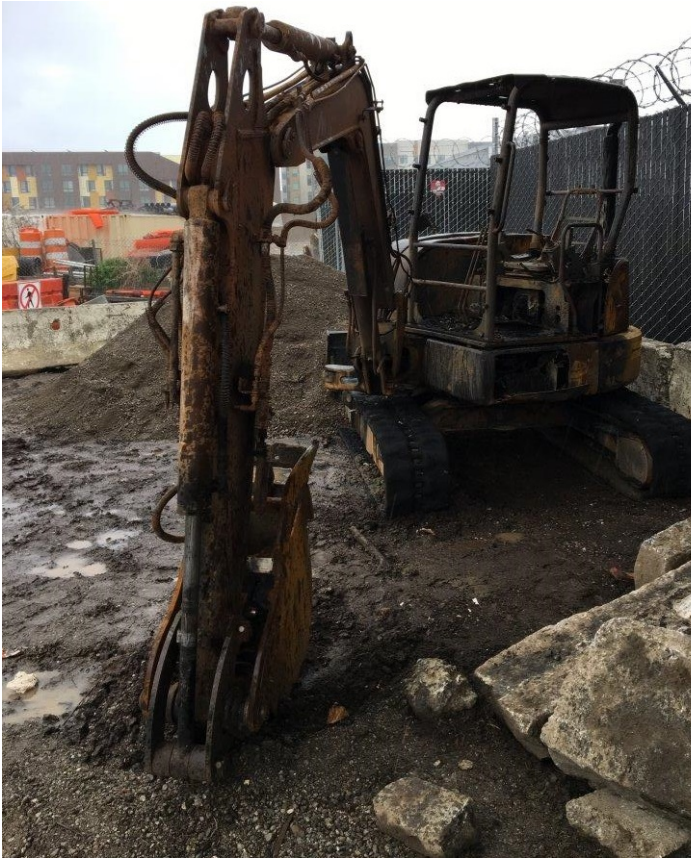
Figure 4. CAT 305E2 CR mini excavator in storage post-accident.

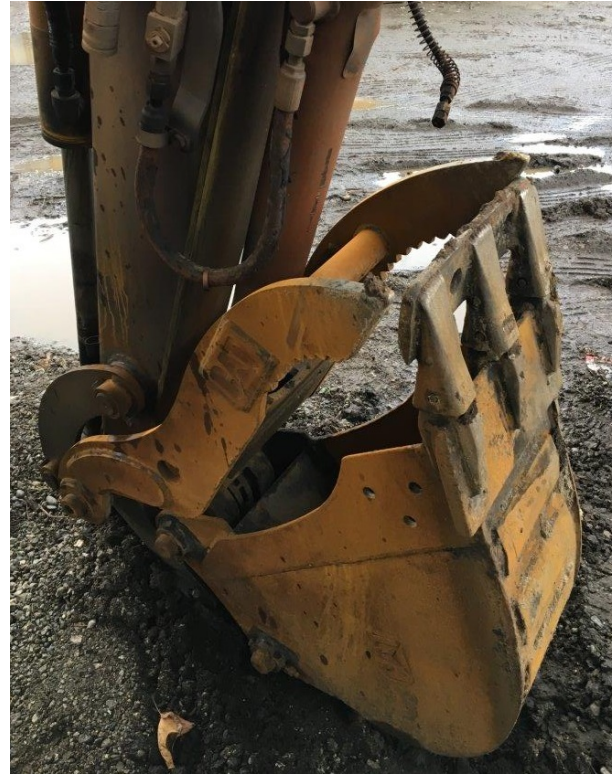
Figure 5. Closer-in view of bucket attachment post-accident.

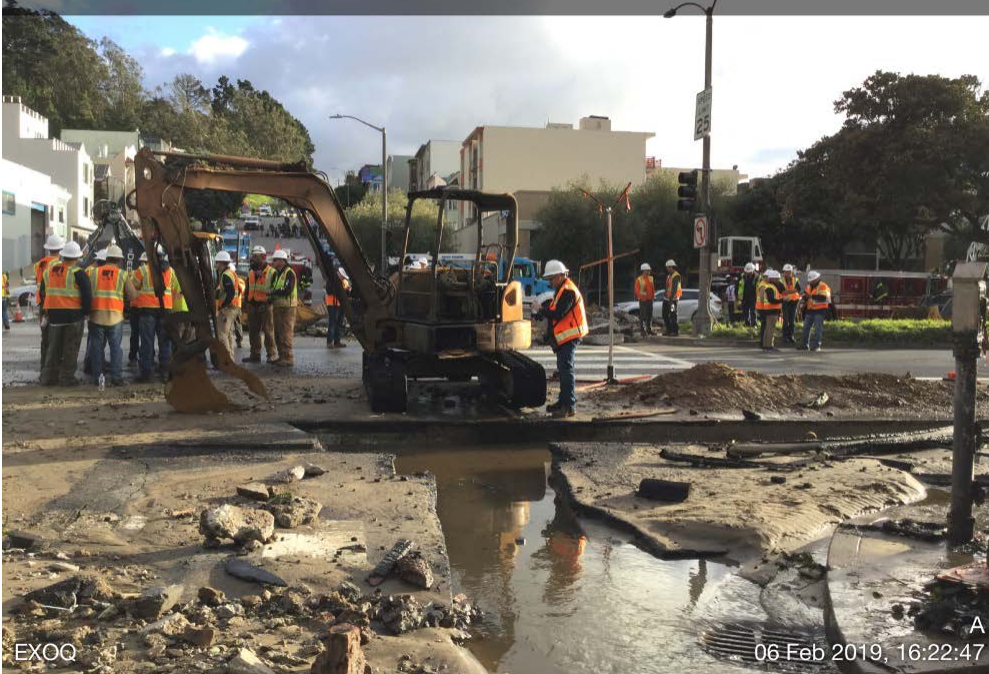
The release of gas from the damaged branch connection was apparent to the excavation crew due to a loud sound and soil being thrown into the air. The spotter states he immediately climbed out of the trench and ran to the north, away from the release site. The operator states he left the excavator, then remembered he left his phone in the excavator cab and went back. When he went back to the excavator to retrieve his phone, the gas ignited. The operator was uncertain if he had left the excavator on or turned it off; the spotter states the excavator was left off. The traffic control technician stated the operator moved the mini excavator bucket out of the trench after the gas started releasing.⁴² The other three employees also ran from the direction of the release. None of the five Kilford employees were injured, nor was the traffic control technician.⁴³ There are no indications in the interviews or provided documentation that any Kilford employees called 911, 811, or PG&E after the gas release or that any of the Kilford employees attempted to evacuate the public from the surrounding area or buildings.⁴⁴ The photographs below show the mini excavator as found after the fire was extinguished (Figures 7 and 8).

Figure 7. Photograph of the trench along Parker Avenue and the mini excavator as found post-fire. View facing due south. Photograph courtesy of PG&E.

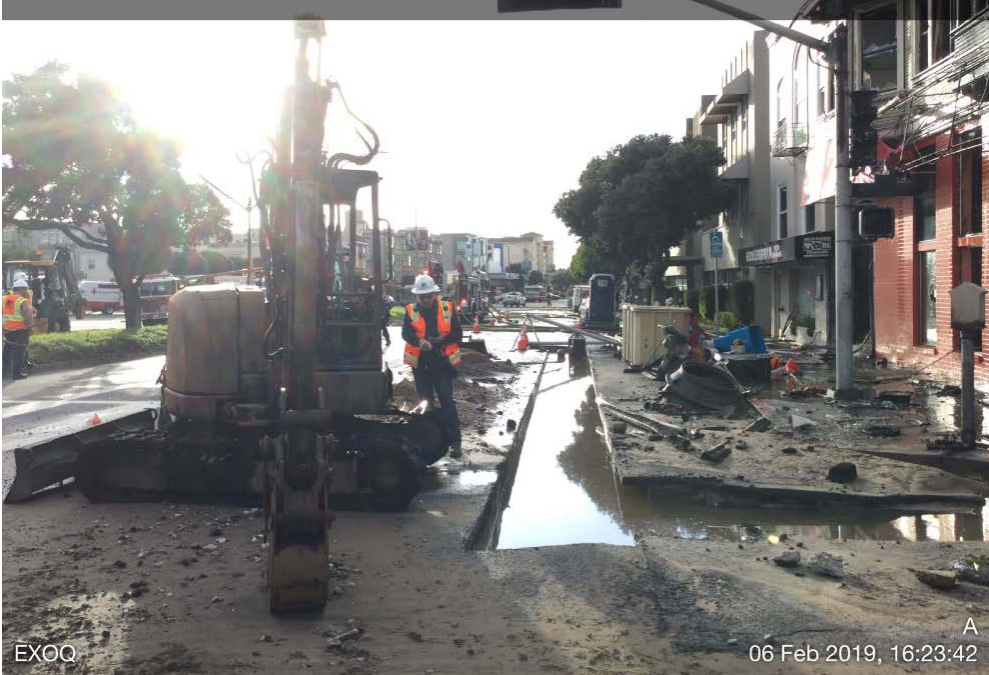
Figure 8. Photograph of the trench along Geary Boulevard and the mini excavator as found post-fire. View facing due west. Photograph courtesy of PG&E.

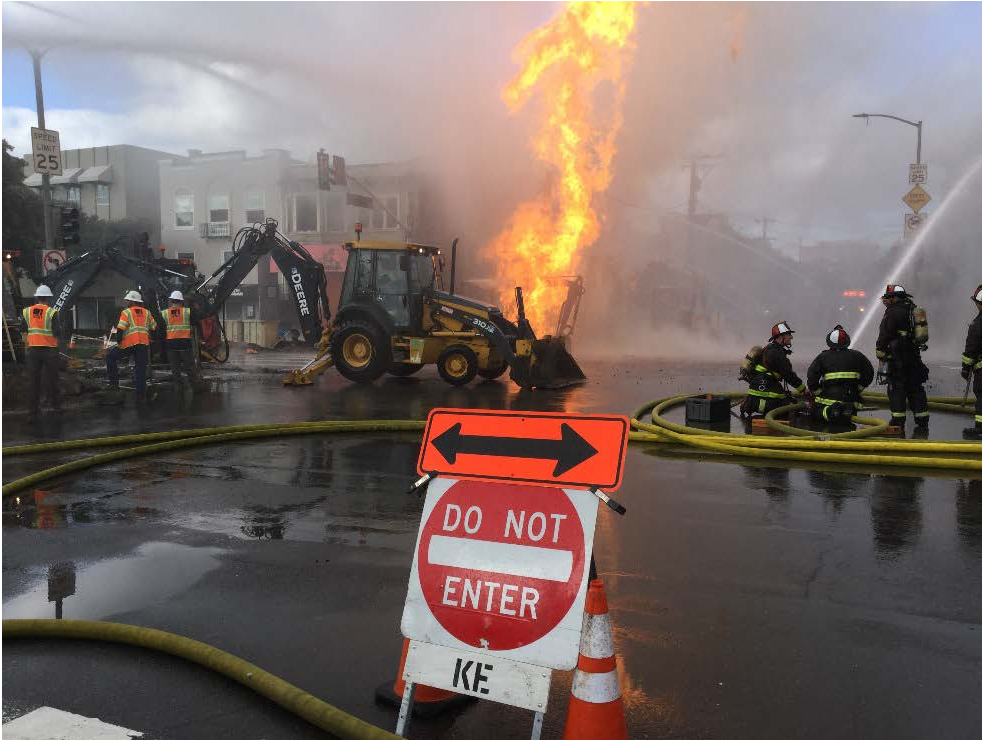
About 6 seconds after gas began releasing from the pipeline, an unknown ignition source caused the gas to ignite.⁴⁵ The flames, which extended above the height of a two-story building, impinged upon Hong Kong Lounge II, a fully occupied restaurant located at 3300 Geary Boulevard. Restaurant employees and patrons self-evacuated the restaurant immediately, and there were no injuries to the public. The photograph below shows the accident scene with the fire ongoing (Figure 9).

Figure 9. Photograph of accident scene during emergency response. View from the southeast corner of the intersection of Geary Boulevard and Parker Avenue. Photograph courtesy of PG&E.

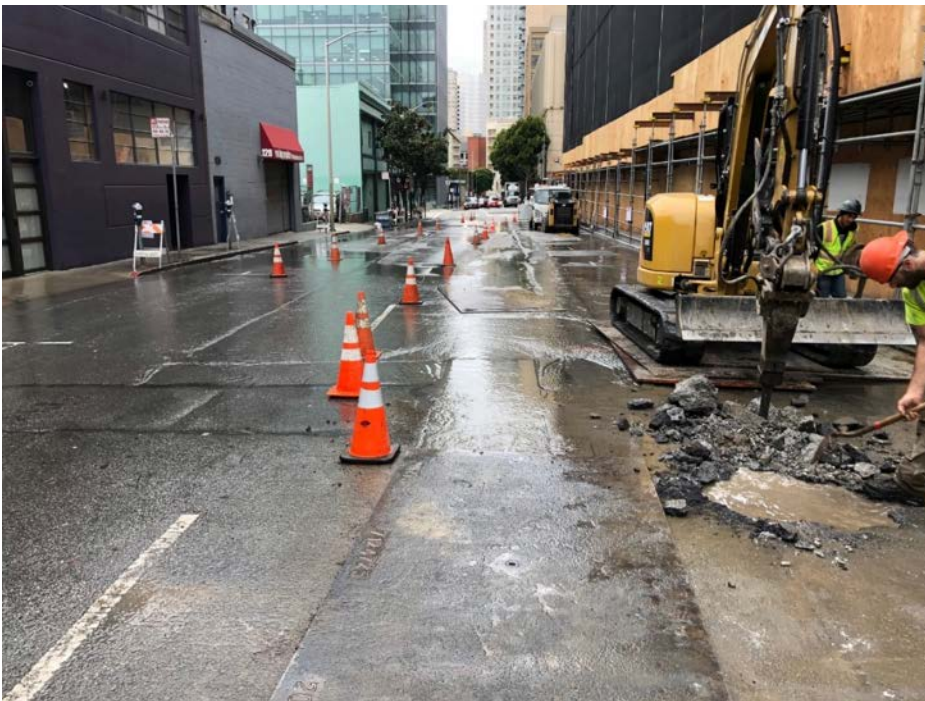
Figure 10. Hawthorne Street after water main damaged. CAT 305 E2 excavator on right with jackhammer attachment. View facing northwest.

⁵⁰ Photographs show the excavator near the line strike area after the incident with a jackhammer attachment, not a toothed bucket. Documentation from Kilford states a toothed bucket was used and was the implement which damaged the pipe.

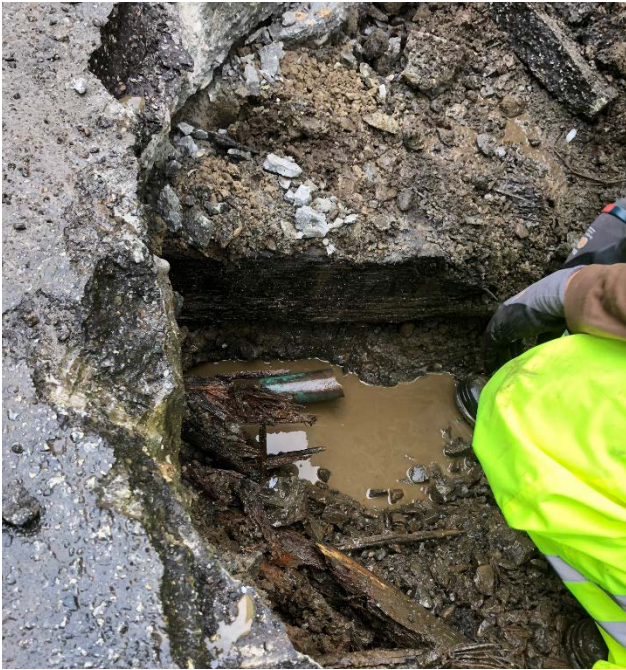
Figure 11. Damaged water main on Hawthorne Street. Photograph courtesy of Kilford Engineering, Inc.
