Alaska Airlines 1282  
Boeing 737-9  
Portland, OR  
January 5, 2024

John Lovell, AS-10  
Investigator-in-Charge

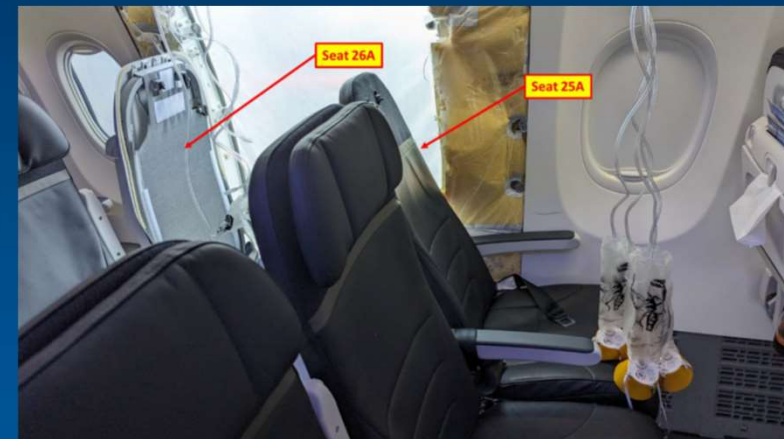
- When the depressurization occurred emergency masks deployed
- Secured the flight deck door
- Donned oxygen masks
- Attempted to communicate with the flight deck
- Assessed the cabin and assisted passengers
- Prepared cabin for emergency landing

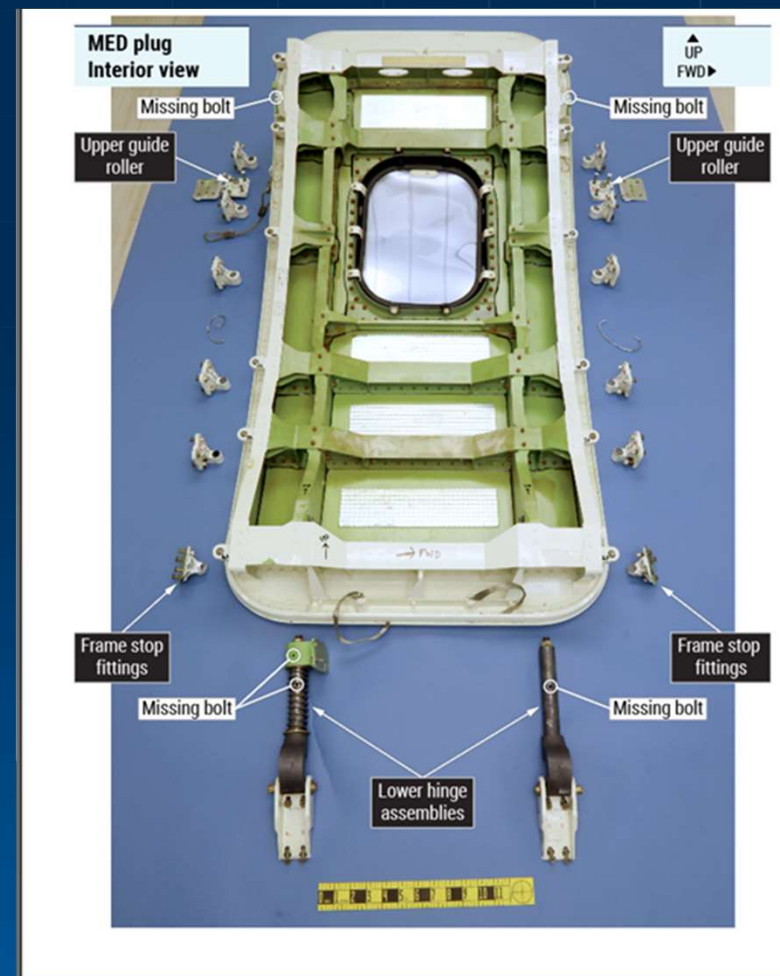
## Mid Exit Door (MED) Plug

- Left MED plug was recovered in a backyard
- MED plug is a customer option
- MED plug is not intended to be opened during operations
- MED plug is only operated for inspections
- MED plug left Boeing Renton facility and was delivered to Alaska Airlines without 4 retaining bolts required to secure it to fuselage

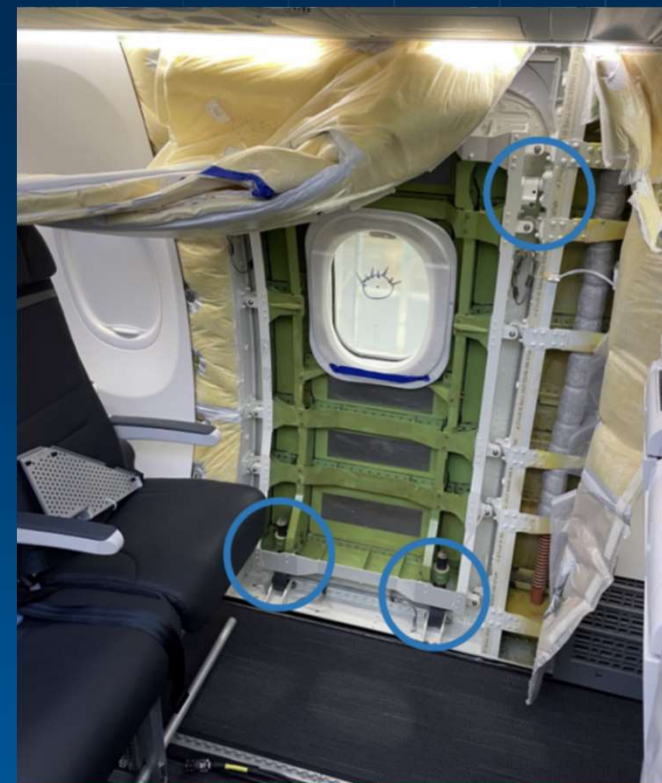
- Boeing production has 9 factory flow day positions of which 6 can affect the MED Plug
- On September 1, 2023, NCR created for 5 damaged rivets on edge frame, forward of left MED plug on flow day 9
- Rivet work required left MED plug opened
- On September 19, 2023, rivets replaced
- Photo documentation indicate left-hand MED plug closed some time between September 18<sup>th</sup> and 19<sup>th</sup>, 2023, without 4 retaining bolts installed
