## INVESTIGATION REPORT

**Date of Incident:** June 26, 2022

**Type of Incident:** Vessel Fire

**Vessel Involved:** *M/V Mary Dupre (Dupre Marine Transportation) 1450 bhp*

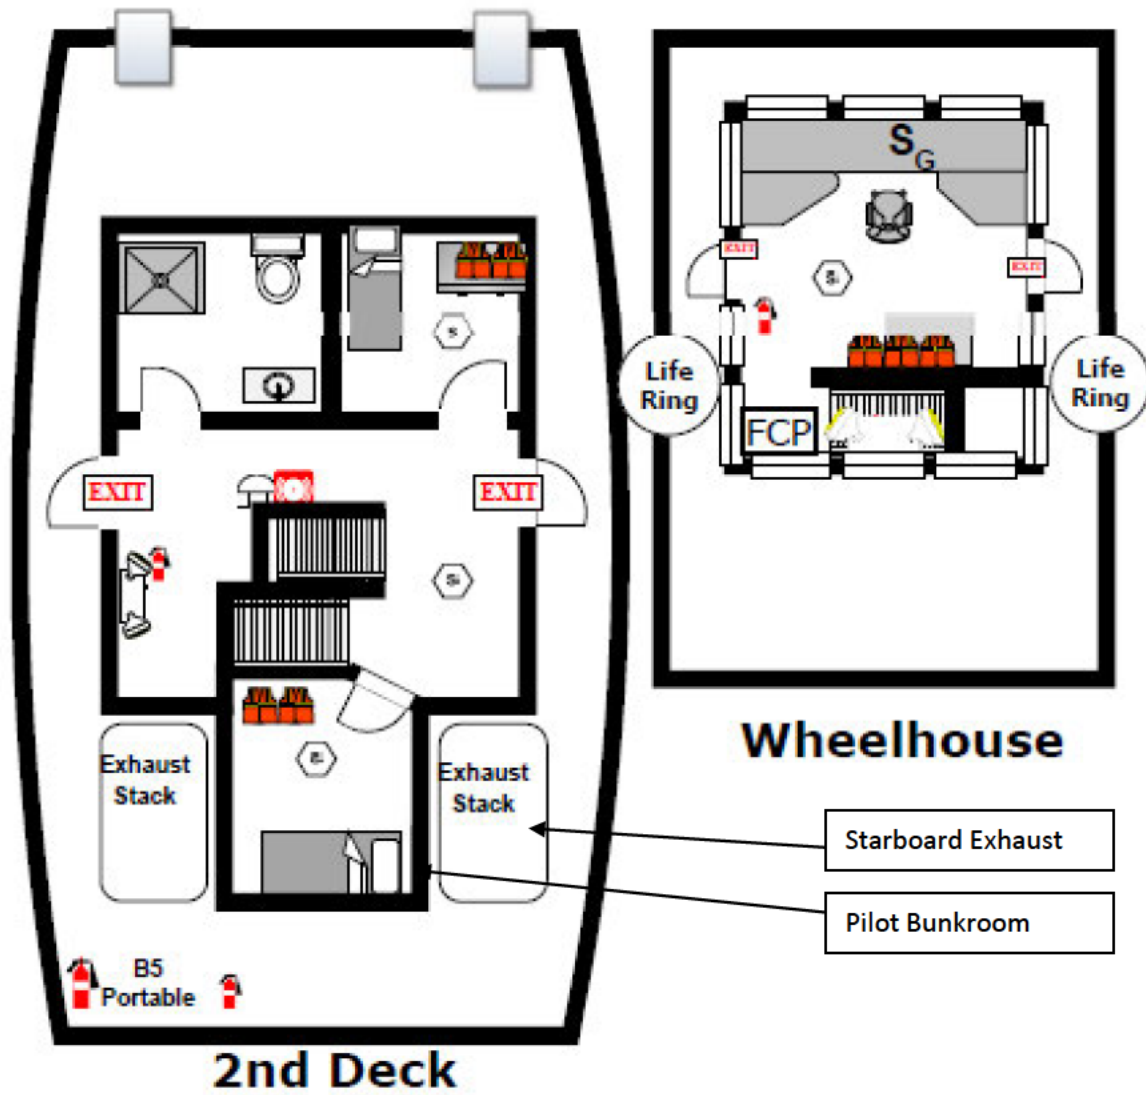
Photo #1 General Arrangement 2<sup>nd</sup> Deck and Wheelhouse

- The Pilots bunkroom on the *MV Mary Dupre* is located between the vessels two exhaust stacks. (See photo #1) The fire originated in the walls of this bunkroom and quickly spread.

- Equipment Failure
  - Testing Strategy Not Effective
    - Installation Design Inadequate
      - The layout of the *MV Mary Dupre* is designed in such a way that the Pilots bunkroom is sandwiched between the two vessel exhaust stacks. These two stacks inner walls touch the outside walls of the bunkroom. The heat that is generated by the stacks and is present on these walls has no place to escape other than inside of the walls of the bunkroom. Normally, this would not be a hazard as fire retardent and heat resistant insulation was placed inside these walls to mitigate any risks that the heat may present, but in the event of a broken muffler inside of the stacks, the heat increases to a degree that the isulation is rendered ineffectual. If the design of the *MV Mary Dupre* would have accounted for this flaw and a gap would have been present between the walls of the stacks and bunkroom, the heat could have escaped and the fire prevented. (See photo #1)

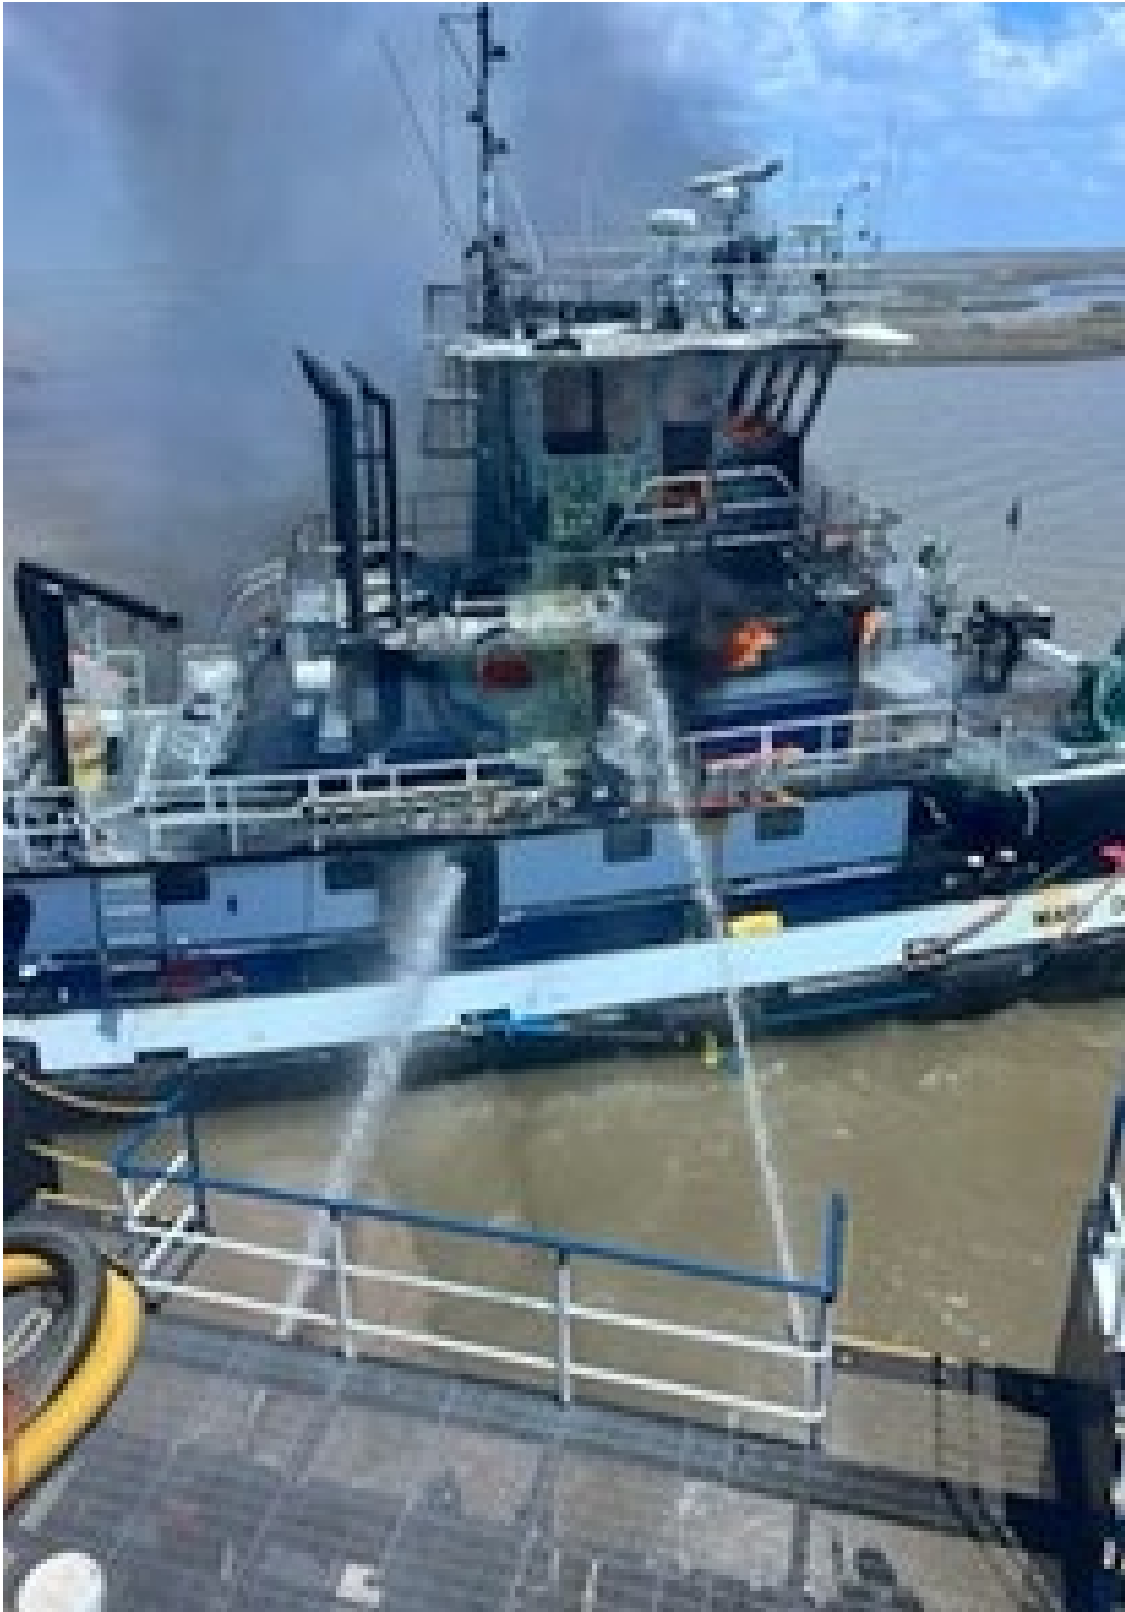
Photo #2 Firefighting Efforts

- The crew of the *MV Mary Dupre* initiated firefighting response but was unable to continue due to heavy smoke in the vessel.
- Crews of the *MV Ave Maria*, *MV Cynthis K*, *MV Martha Renae*, and *MV Redfish* aided in extinguishing the fire by applying water to the *MV Mary Dupre*.
- T&T Salvage was dispatched to the scene to assist in firefighting duties.
- Notifications:
  - Dupre Marine Transportation
    - Port Captain-Frank Bumgarden
    - Port Engineer-Jeremy Cavalier
  - Kirby Inland Marine
    - Port Captain-Leopold Bernard
  - Texas General Land Office
  - National Response Center
  - USCG
    - [REDACTED]

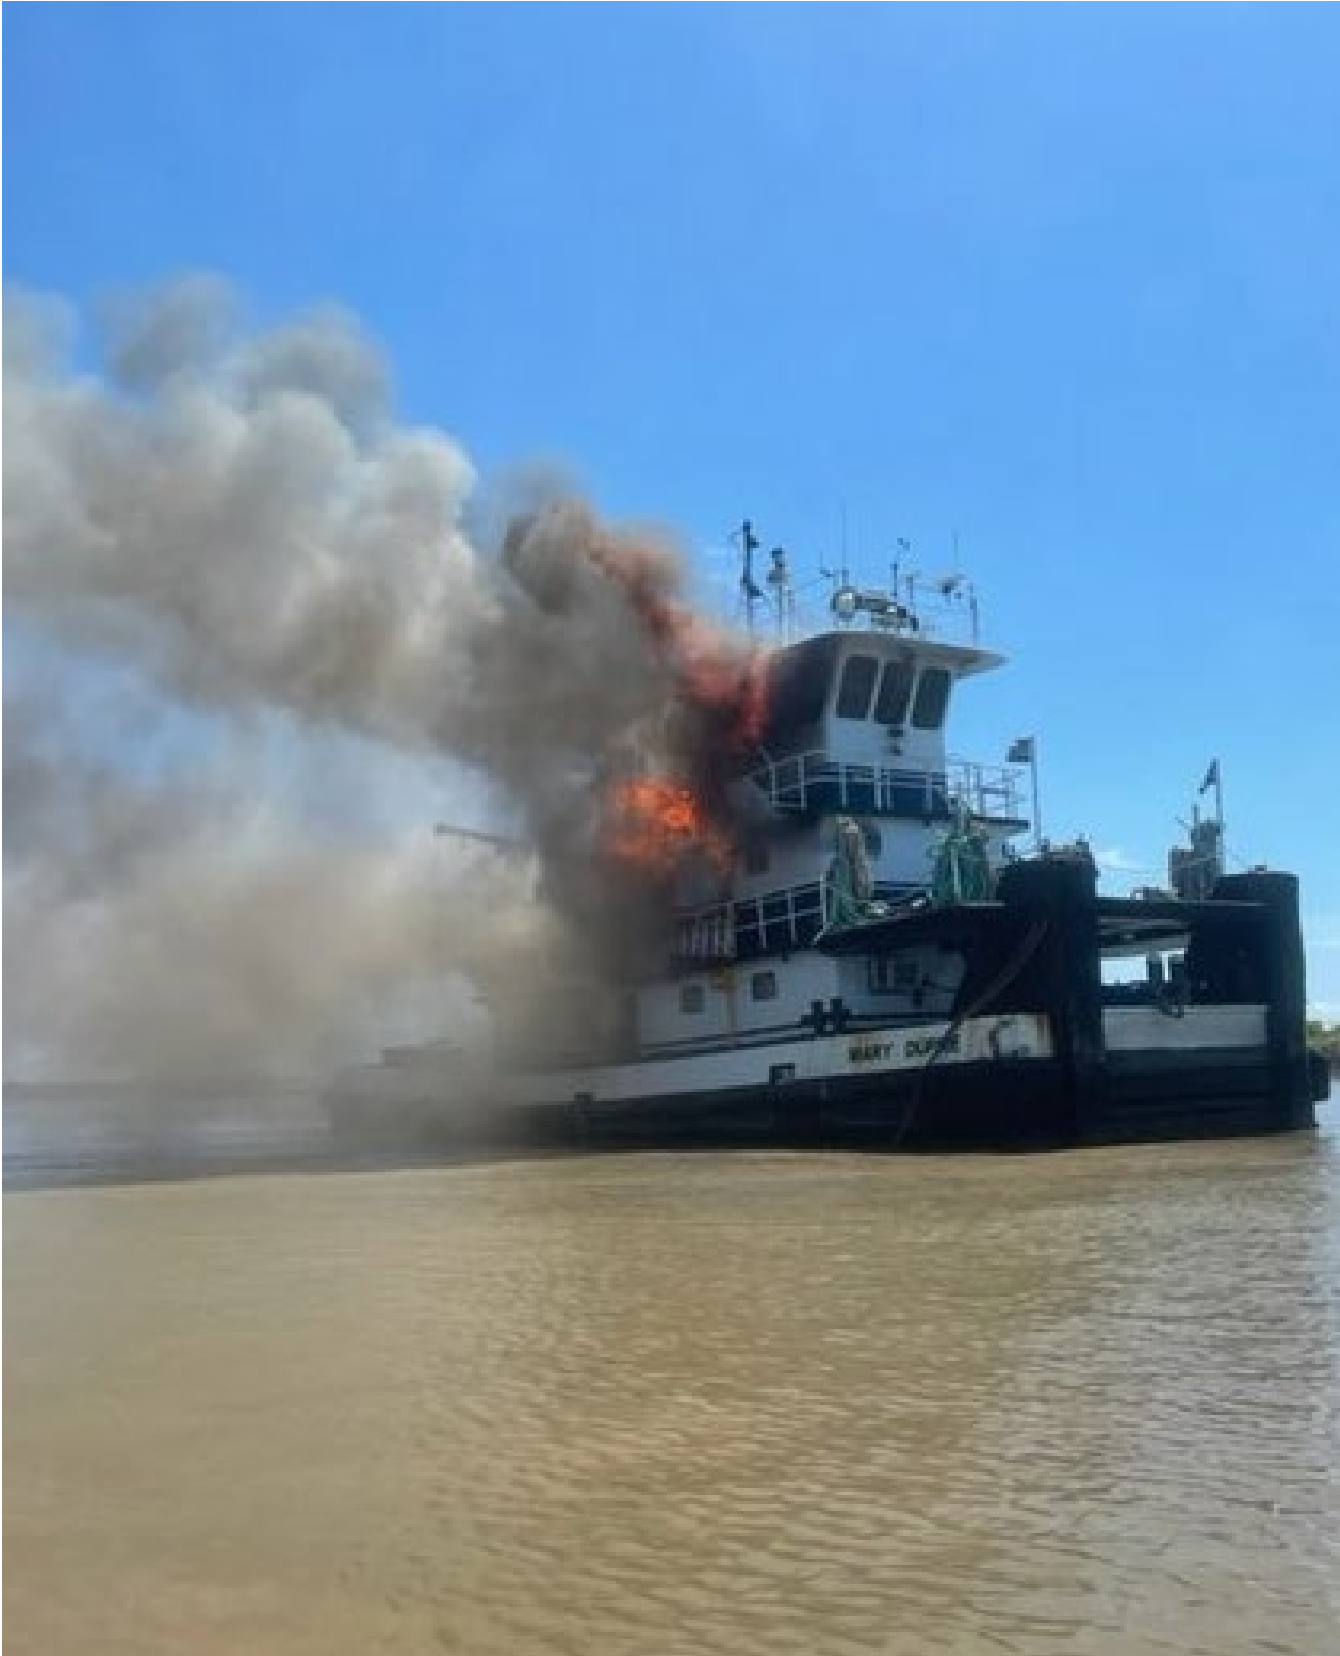
Photo #3 Vessel Fire

removed, the smoke began to intensify, and the Master ordered the crew to abandon the vessel. Once safely off the vessel the crew observed a fire on the second deck and the wheelhouse that was quickly spreading.

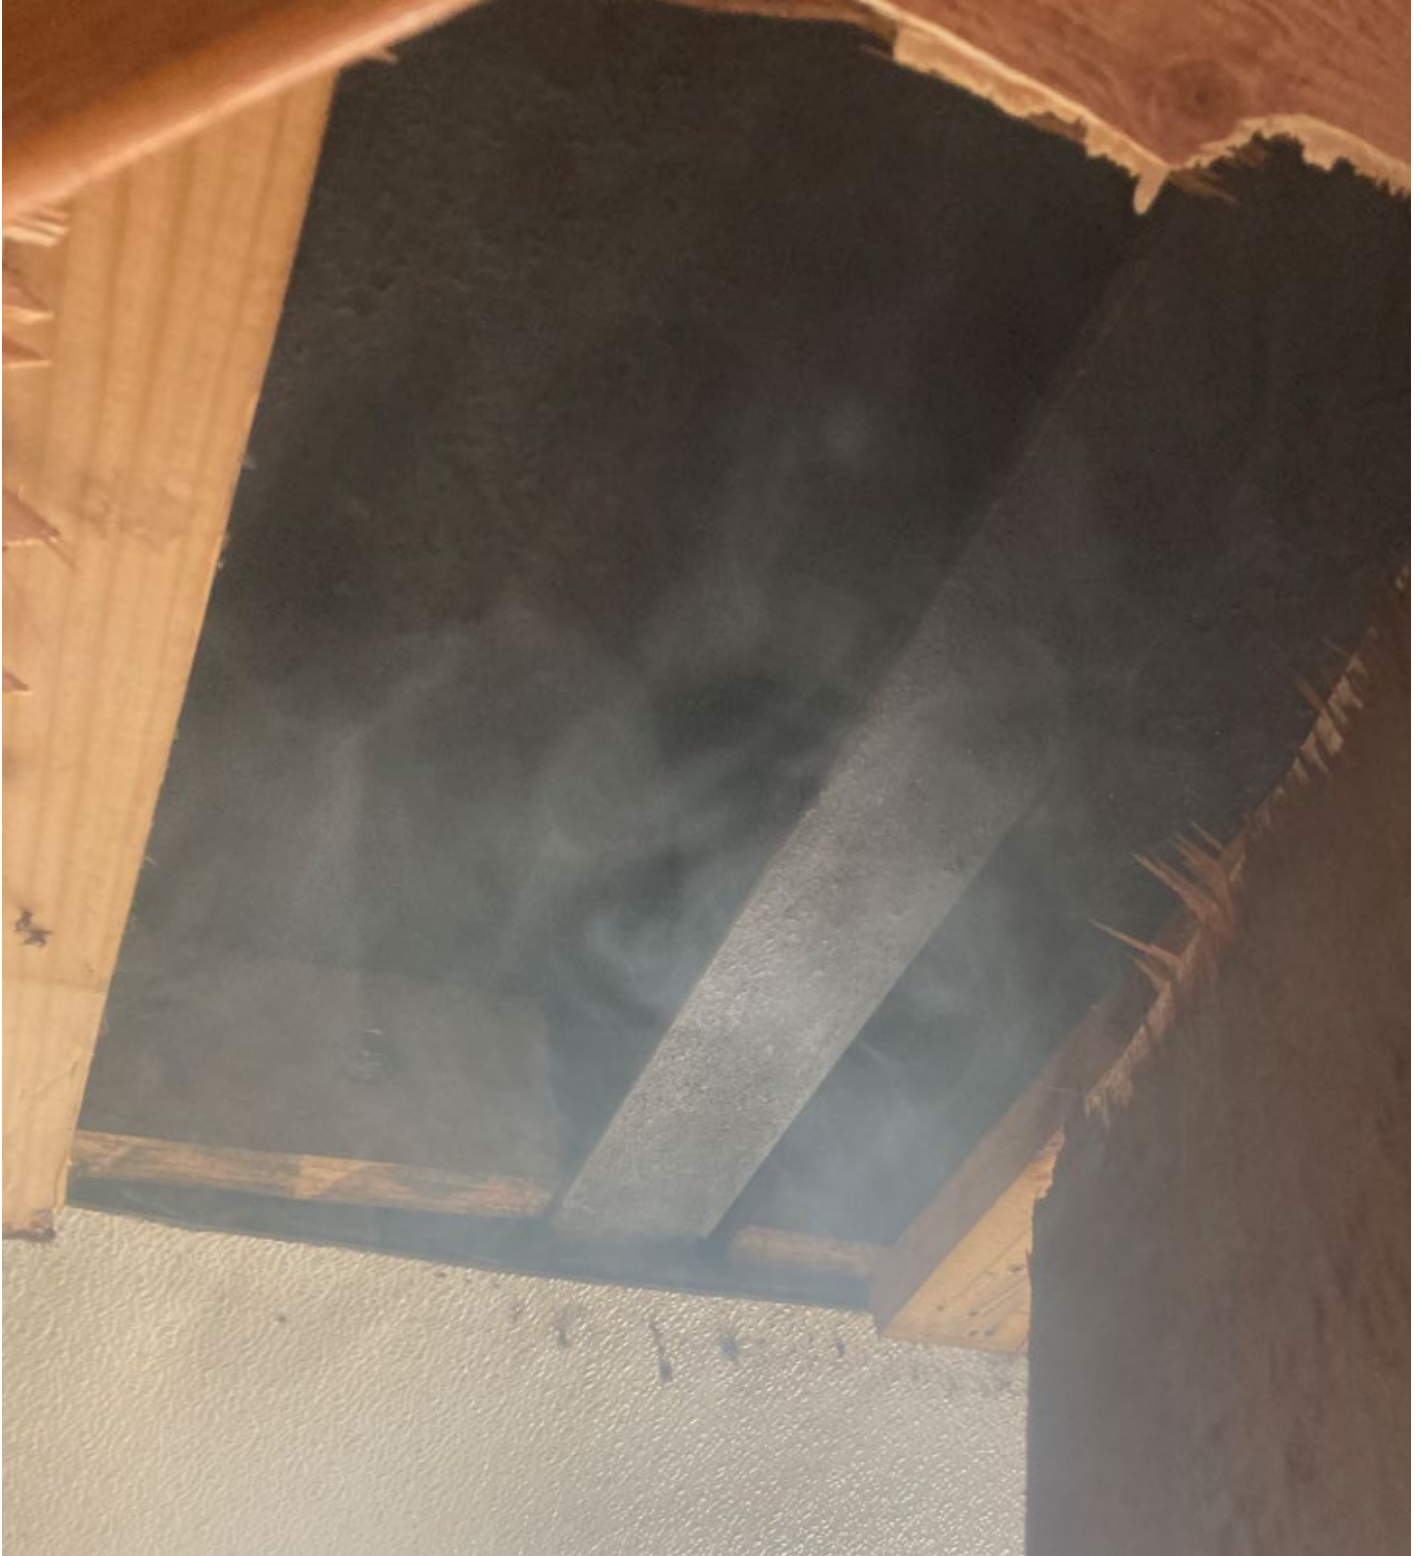
Photo #4 Removed Panel (Ceiling)

- The off-duty Pilot and both vessel Deckhands investigated the source of the smoke and eventually removed a panel from the ceiling (See photo #4). When the panel from the ceiling was removed the smoke in the vessel intensified and thwarted any ongoing efforts to eliminate the fire.

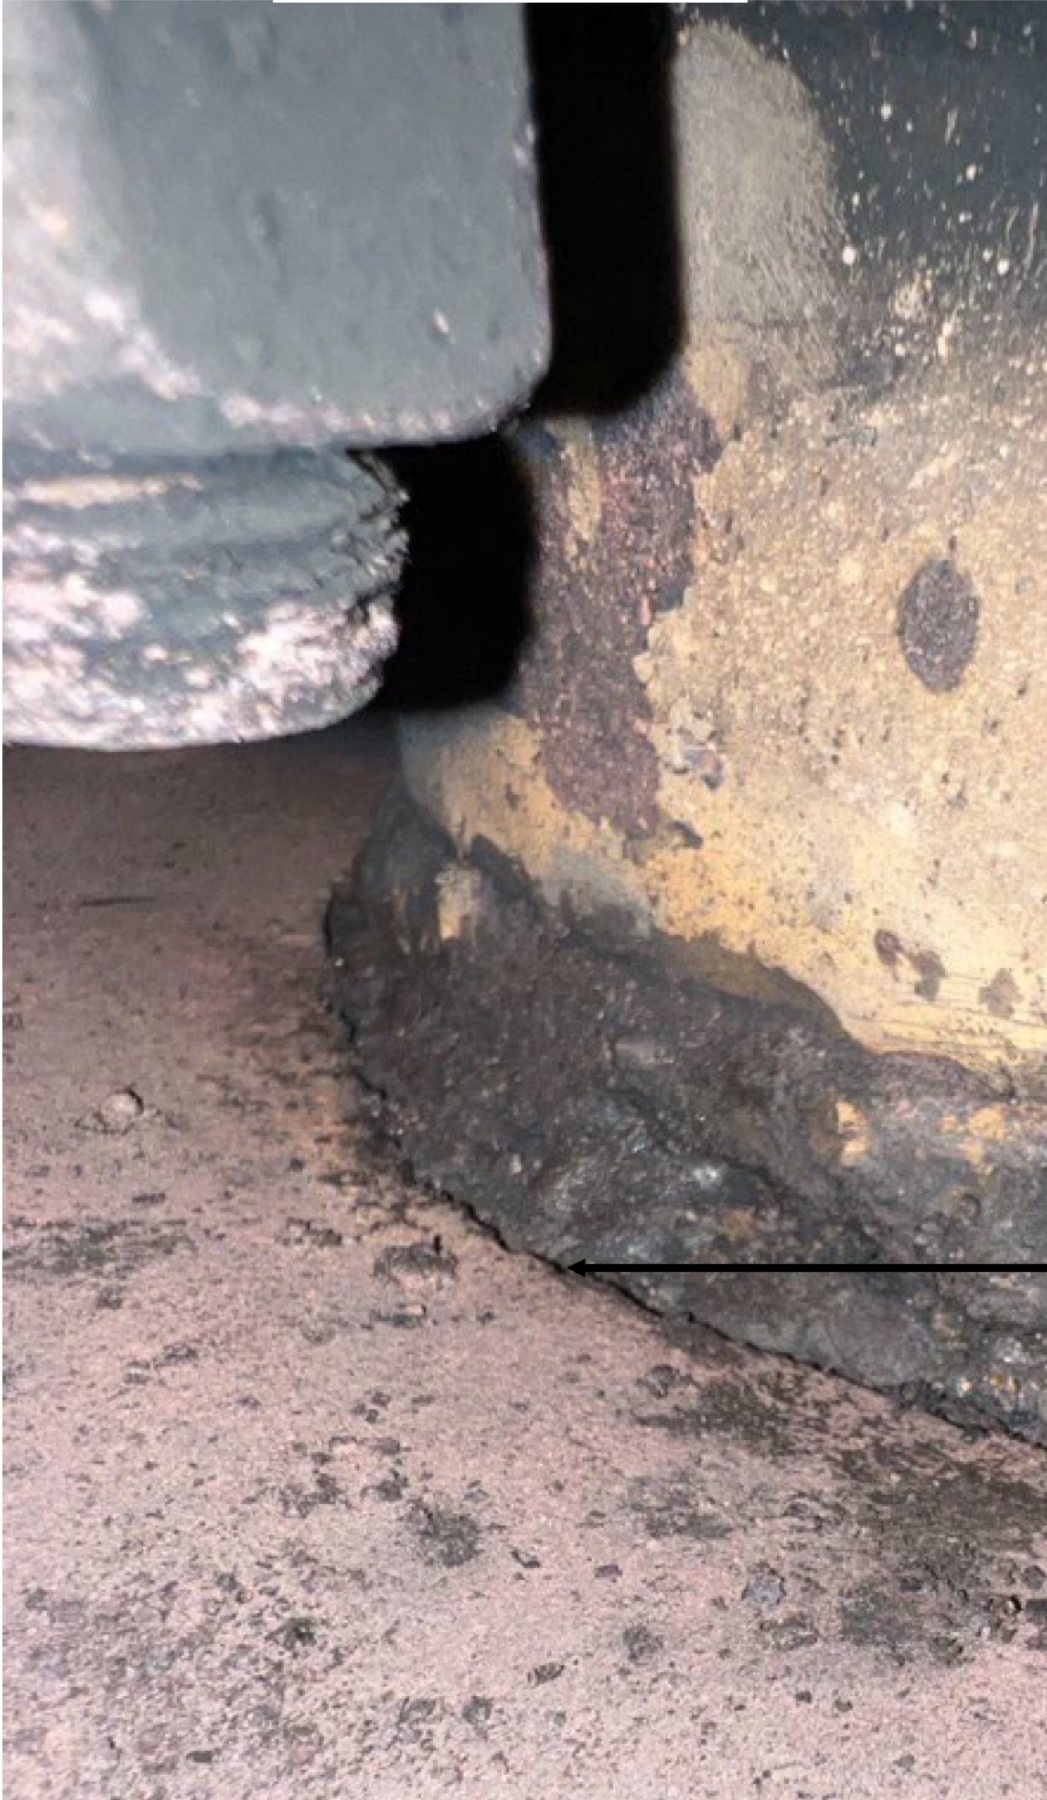
Photo #5 Cracked Muffler

- T&T Salvage and the USCG cleared the *MV Mary Dupre* to be moved to J&S Contractors in Freeport TX.
- While investigating the source of the fire, a Marine Surveyor, Dupre Marine Transportations Port Engineer and Operations Manager, and marine investigators from the USCG identified a cracked muffler in the starboard exhaust stack that was allowing excessive heat to contact the metal walls of the stack. (See Photo #5)
- No injuries resulted from this event.

increased inside of the starboard stack to a degree that would ignite a fire within the wall of the bunkroom, and it was discovered that the muffler located within the starboard exhaust stack was cracked. This crack allowed excessive heat to escape the muffler and increase the heat of the stack walls to the point where the paint started to bubble (See Photo #6). Because of the design and layout of the vessel, the excessive heat was allowed to penetrate the wall of the Pilot bunkroom and eventually cause the wood within this wall to ignite. If the muffler in the starboard exhaust stack would have not failed, the walls of the stack would have not heated to a degree that would have posed a risk.

Crack in Muffler

<b>Title</b>	<b>Description</b>	<b>ETF</b>
Lessons Learned	Lessons learned will be formulated and distributed to all vessels within Dupre Marine Transportations fleet via email and added to the vessel visit agenda for discussion during management vessel visits. These lessons will include: <ul style="list-style-type: none"> <li>• A description of the event.</li> <li>• How the event could have been prevented.</li> <li>• A review of Dupre Marine Transportation fire response procedures.</li> <li>• The testing of smoke detectors and the assurance that they are operational at home and on a vessel.</li> </ul>	7/26/2022
Procedural/Inspection Revision	Dupre Marine Transportation currently has no vessels that are designed with exhaust stacks butted up against a cabin and has no plans of acquiring a vessel with this design, but Dupre Marine Transportation drydocking procedures will be revised to include the inspection of mufflers within exhaust stacks in the event that such a vessel is acquired.	7/26/2022

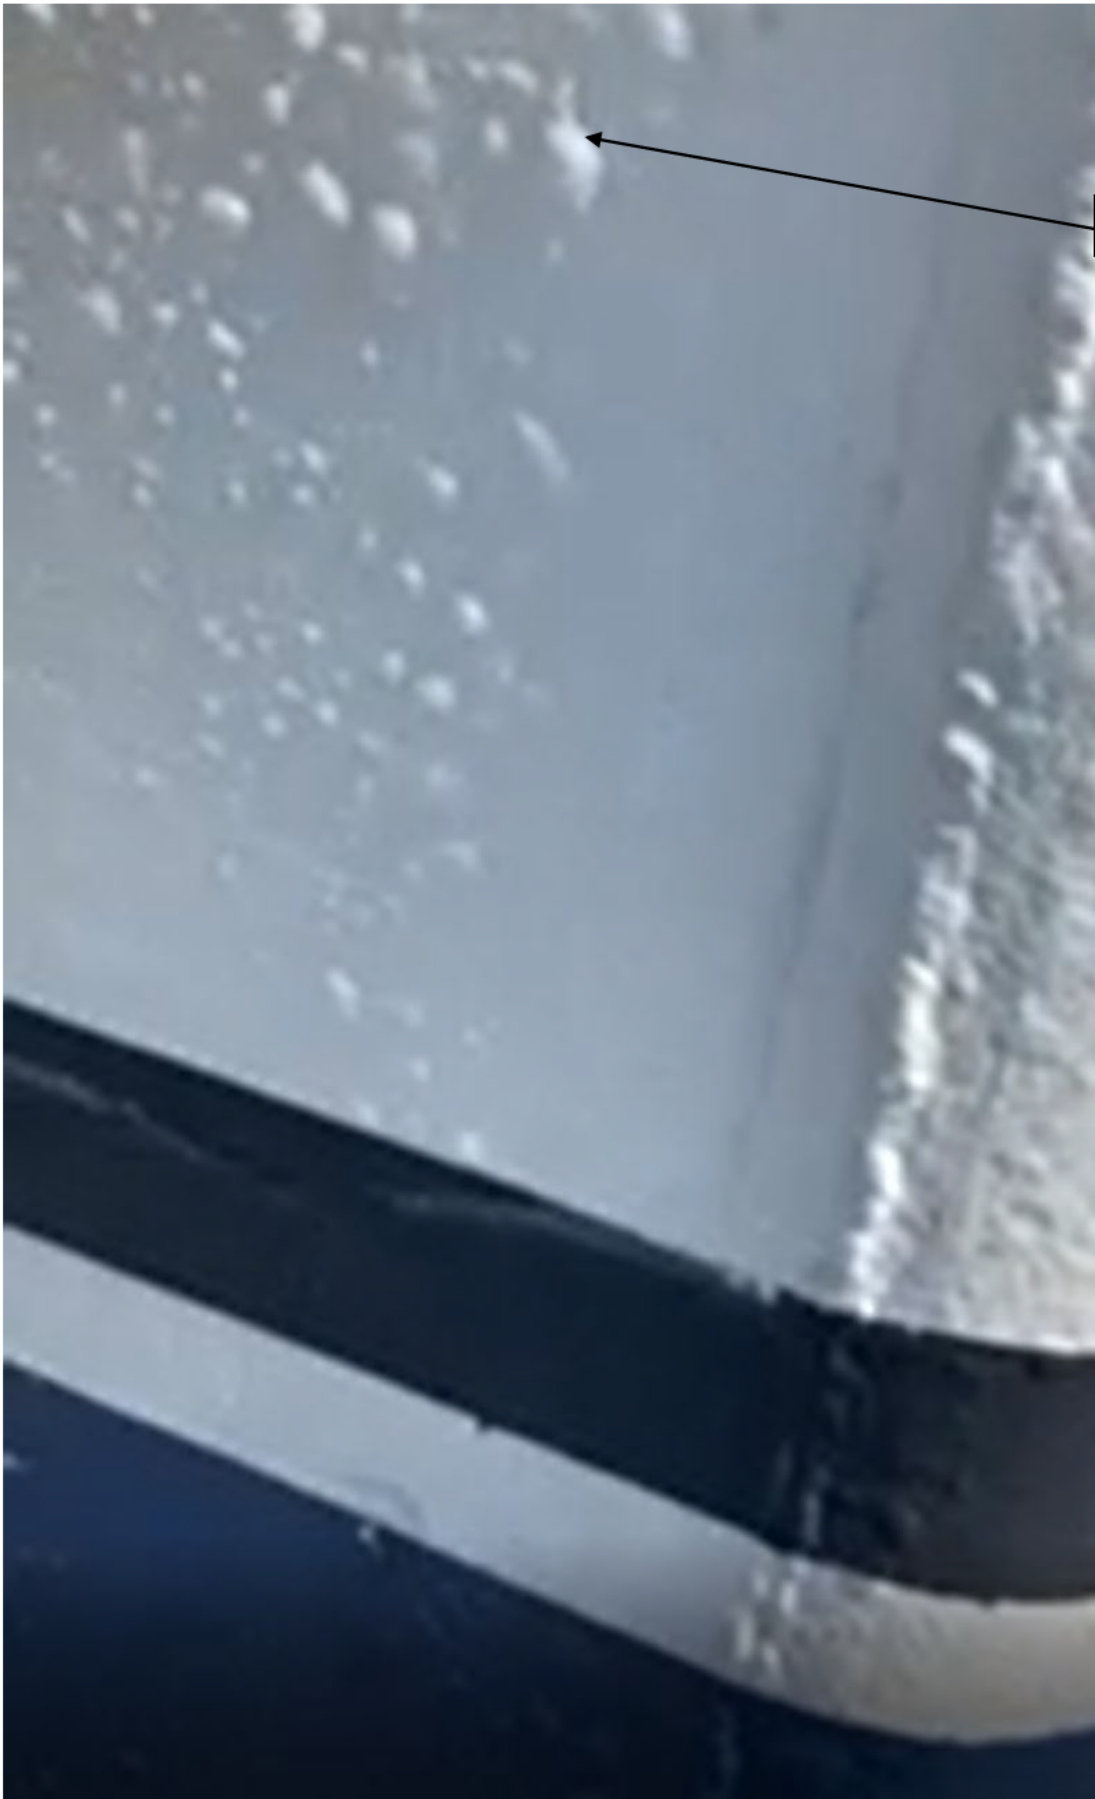
Photo #6 Starboard Stack

Bubbling Paint
