National Transportation Safety Board

West Reading, Pennsylvania
March 24, 2023

INTEGRITY MANAGEMENT

Group Chair's Factual Report
Report Date: October 13, 2023

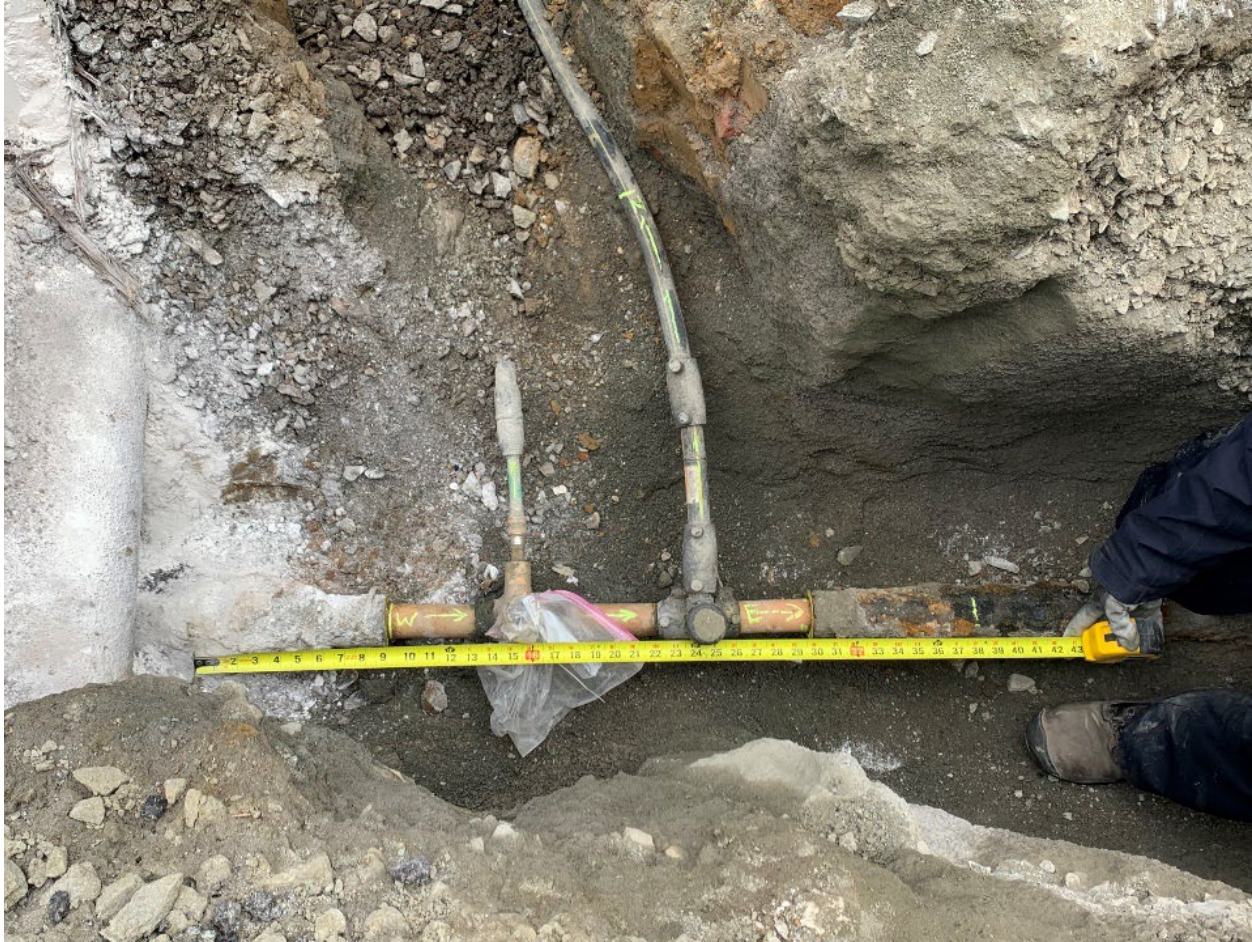
Figure 2. Retired service tee and new service for RM Palmer Building 2

The original Aldyl A service tee was found to be cracked and leaking after the accident. Stray gas was analyzed post-accident by ECHELON Applied Geosciences

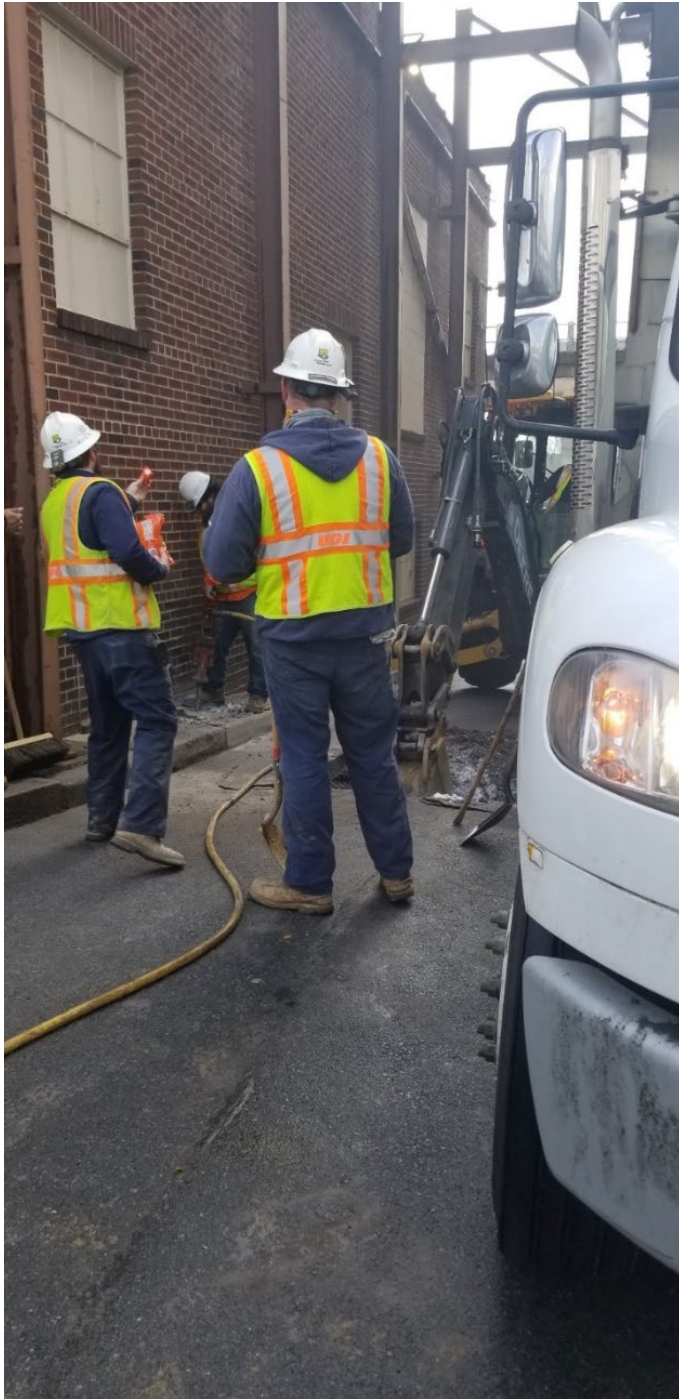
Figure 3. White powder visible in photograph during work performed on February 16, 2021 (Courtesy of R.M. Palmer)

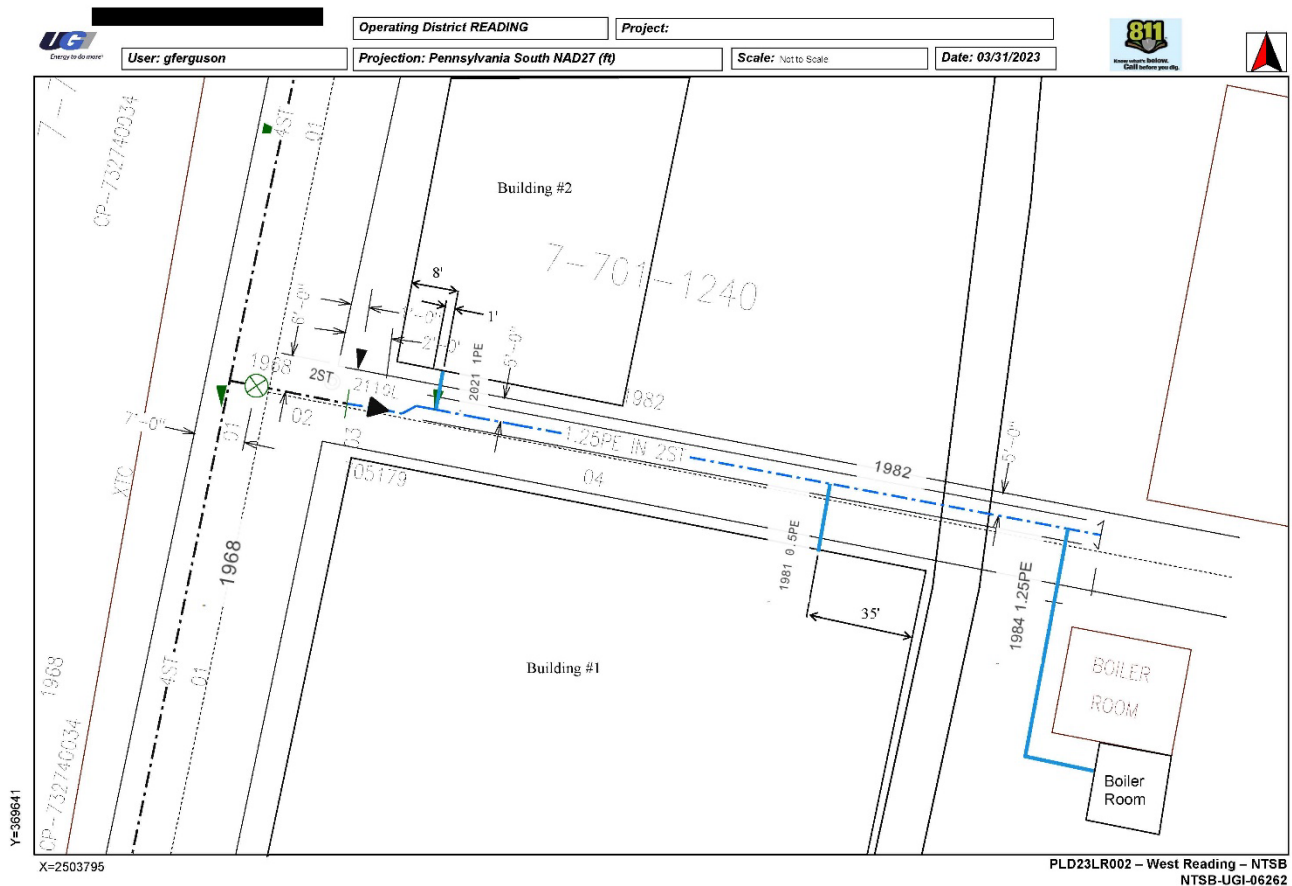
Figure 5. UGI map of failure area¹⁸
