## **NATIONAL TRANSPORTATION SAFETY BOARD**

### **INVESTIGATION SUMMARY**

**CEN22FA113**

Location: Heath, Ohio  
Date: February 1, 2022  
Aircraft: Cessna 182T (N716MC)  
NTSB IIC: Joshua Lindberg

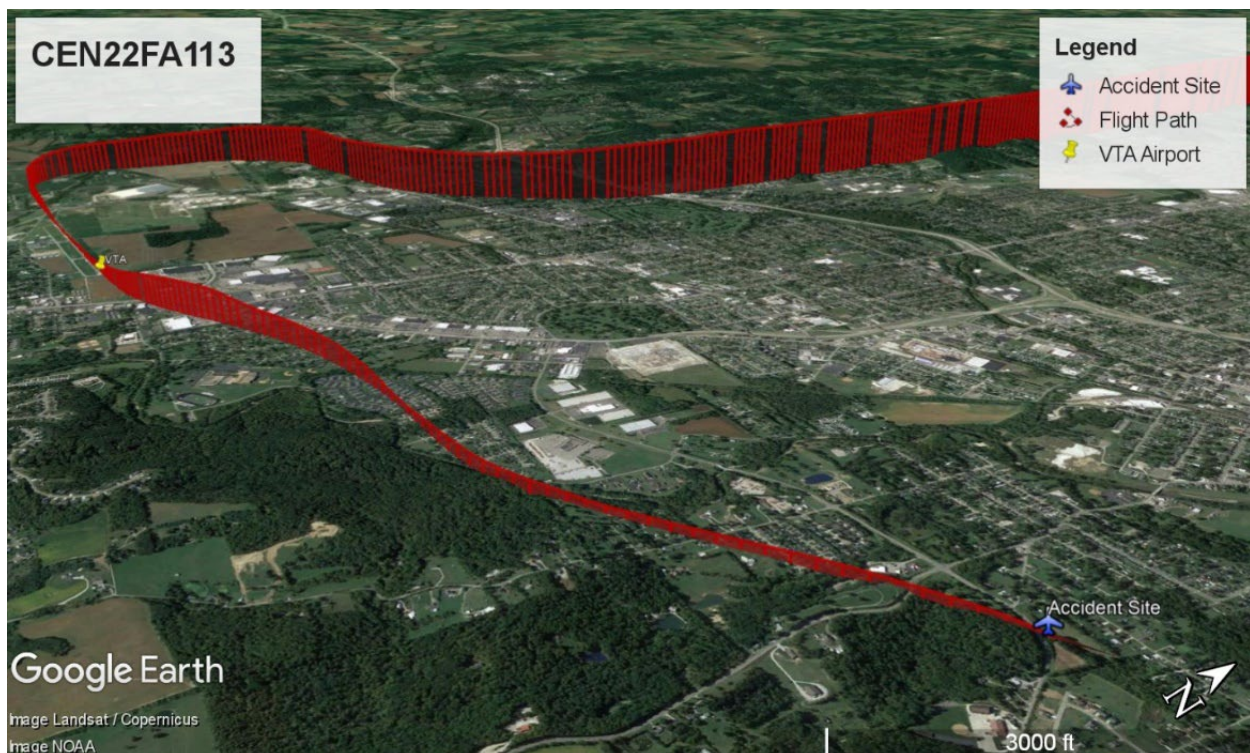
Figure 1. Google Earth overlay that depicts the accident flight path and points of interest.

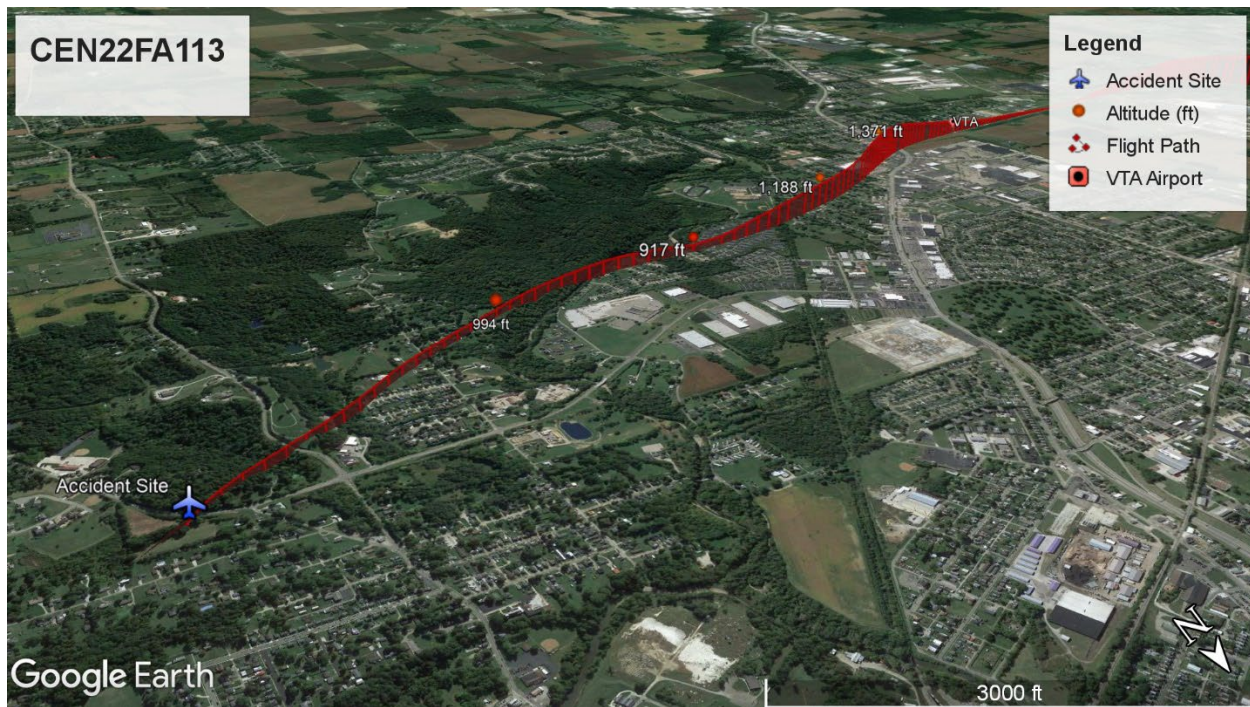
Figure 2. Flight path – departure and low-level flight to the accident site.

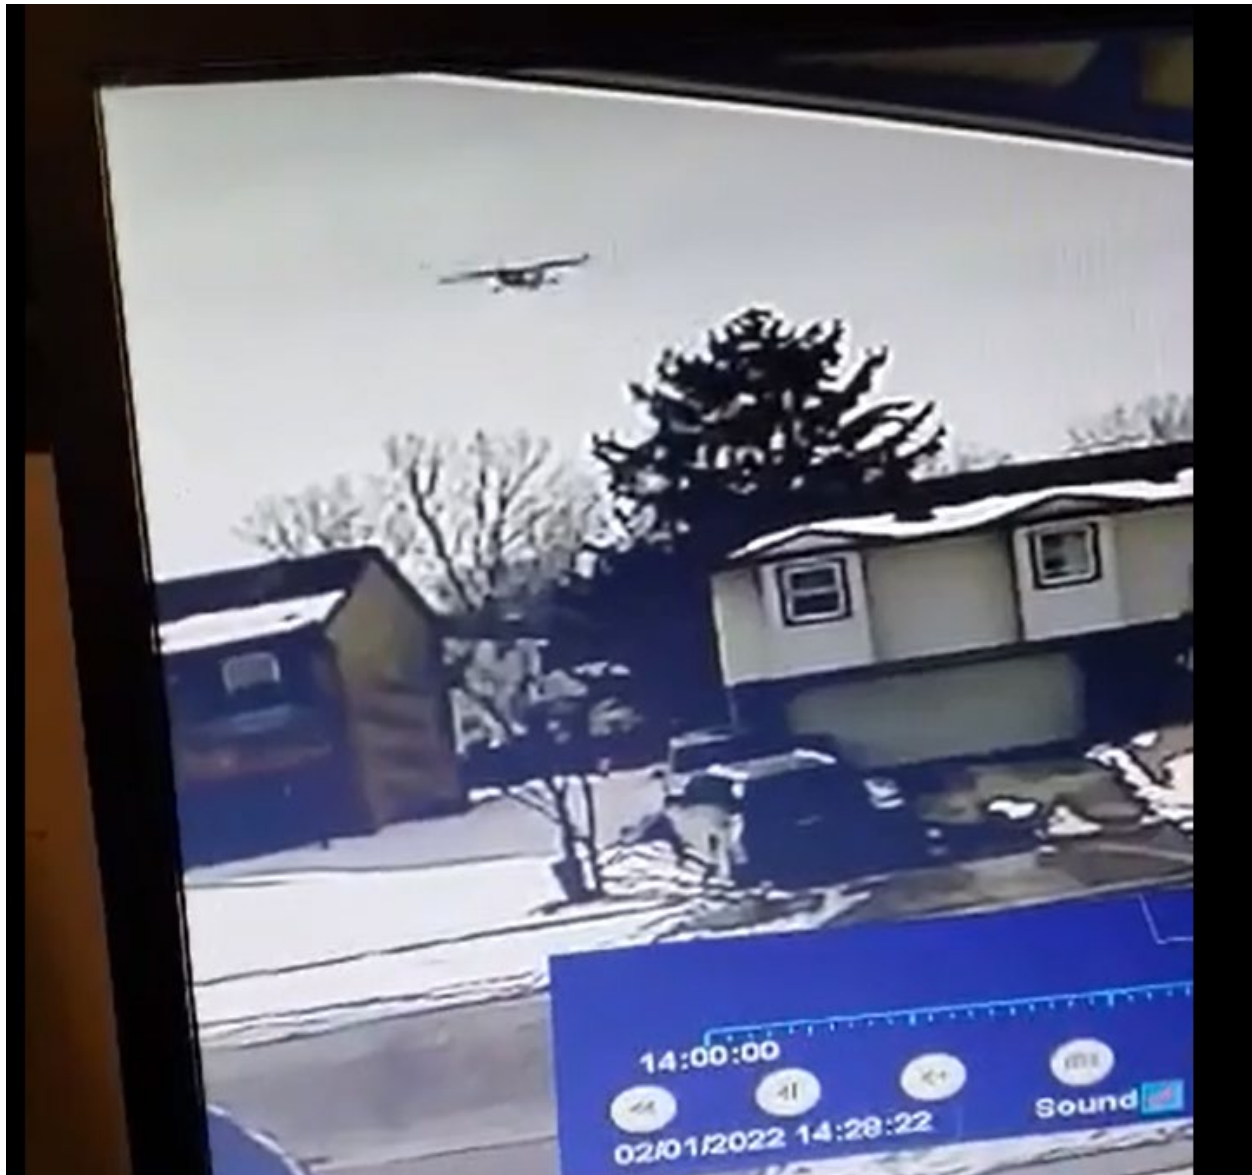
A doorbell camera video along the route of flight, about one nautical mile southwest of the accident site, showed the airplane flying at a low altitude and in a slight left bank. The airplane appeared to be flying fast as if it was operating with moderate to high engine power. (Figure 3).

Figure 3. A resident in the area where the airplane flew over sent a recording from their doorbell camera that showed the airplane flying at a low altitude in a slight left bank.

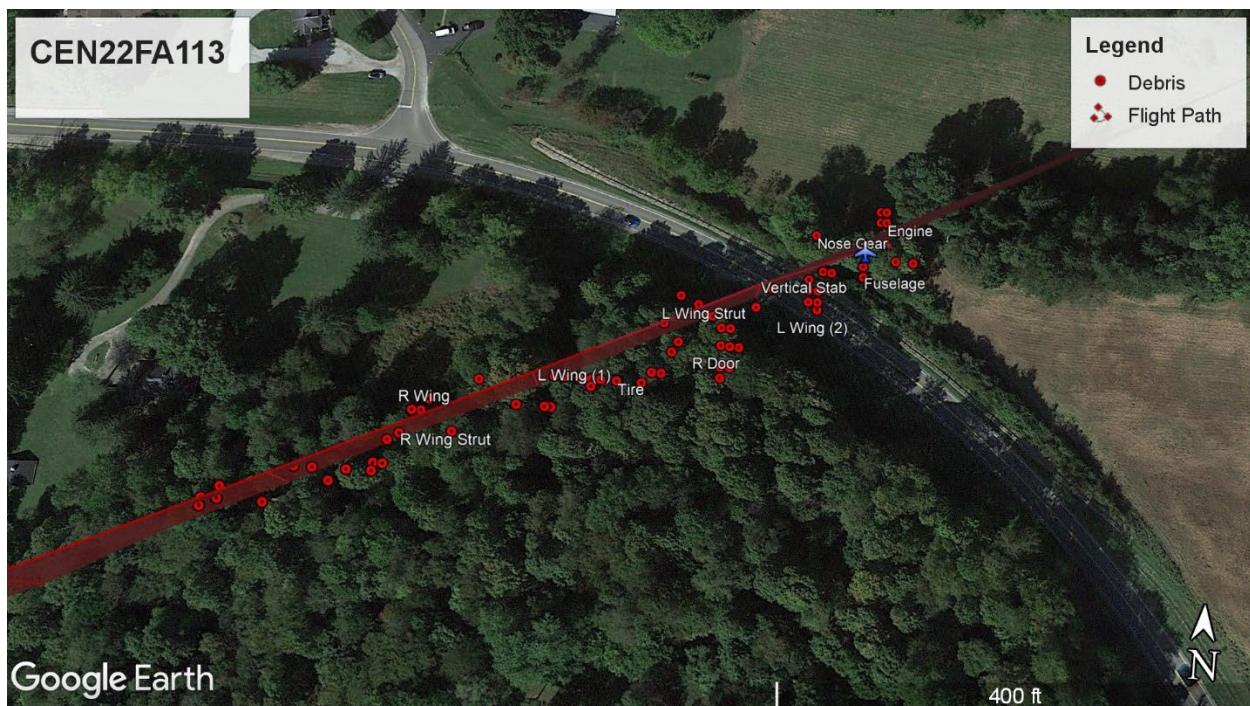
Figure 4. End of flight path with airplane debris marked along the wreckage path.

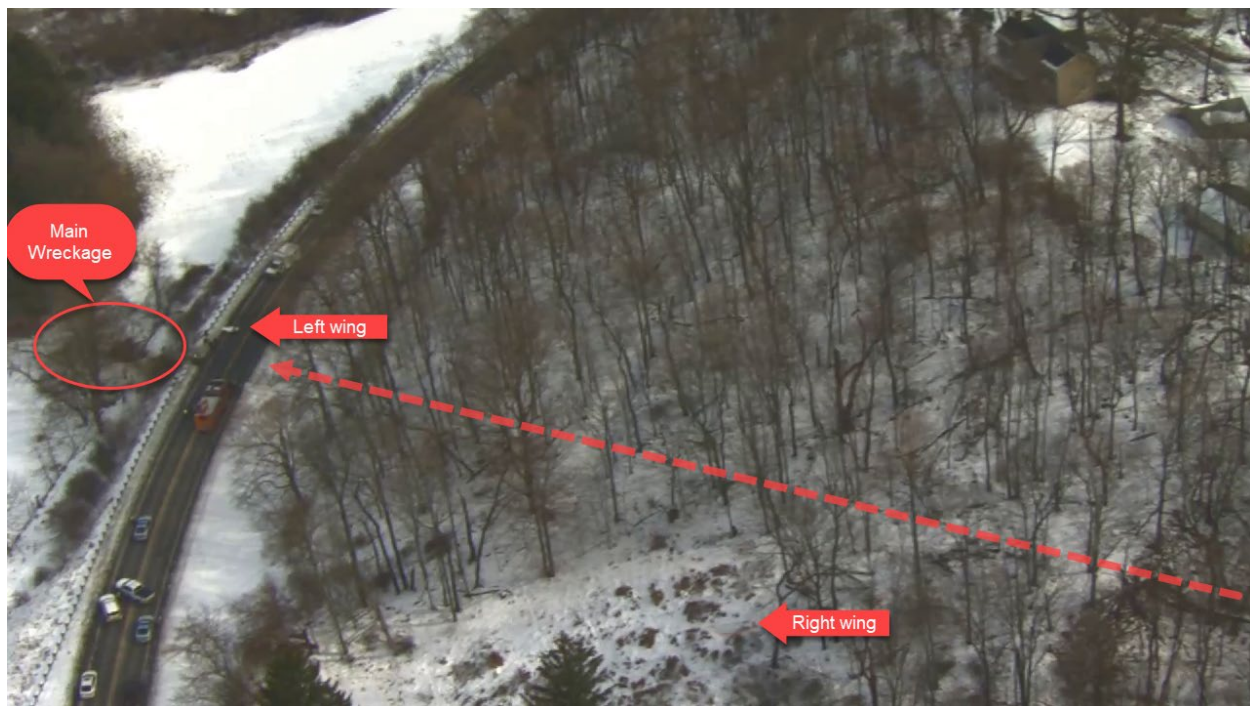
Figure 5. Aerial view of the accident site with the wreckage path parked in red.

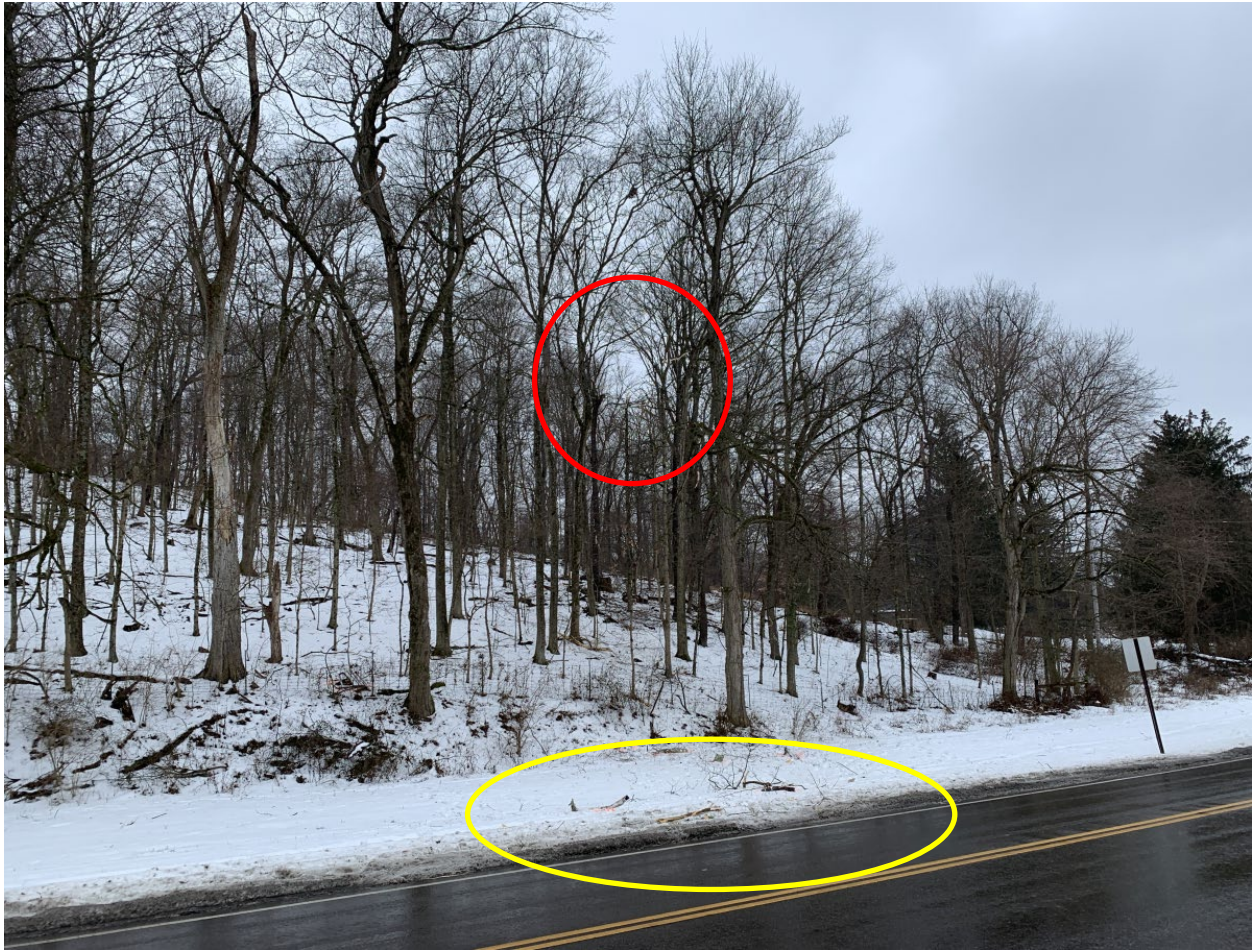
Accident site was located in Heath, Ohio, elevation 918 ft MSL, coordinates 40.038324° / - 82.399166°. The accident site about 2.5 nm and magnetic heading 074° from the end of runway 9 at Newark-Heath Airport (VTA). The airplane impacted a densely wooded area in a wings level, nose low attitude. Impact marks were observed on trees to the southwest of the main wreckage. From the initial tree impact to the end of the debris path was about 230 yards and oriented 064° magnetic. The initial tree impact was about 50 ft high with corresponding airplane debris on the ground beginning near that point. The right wing was about 70 ft from the initial impact and found on the left side of the debris path. About 30 tree branches and limbs were observed in the debris path that had been cut by the propeller blades. There were many broken tree limbs and impact marks in the trees along the debris path, and most of the limbs had been broken 25 to 50 ft high.

Figure 6. This photo was taken facing back toward the initial impact point (circled in yellow) and shows a hole in the trees above the debris field, which is circled in red. The hole in the trees corresponds with airplane debris and broken tree limbs in the woods directly underneath.
