National Transportation Safety Board

CEN21FA368

INVESTIGATION SUMMARY

Location: Strasburg, North Dakota
Date: August 10, 2021
Time: 0740 central daylight time
Airplane: Rockwell International S2R, N4956X

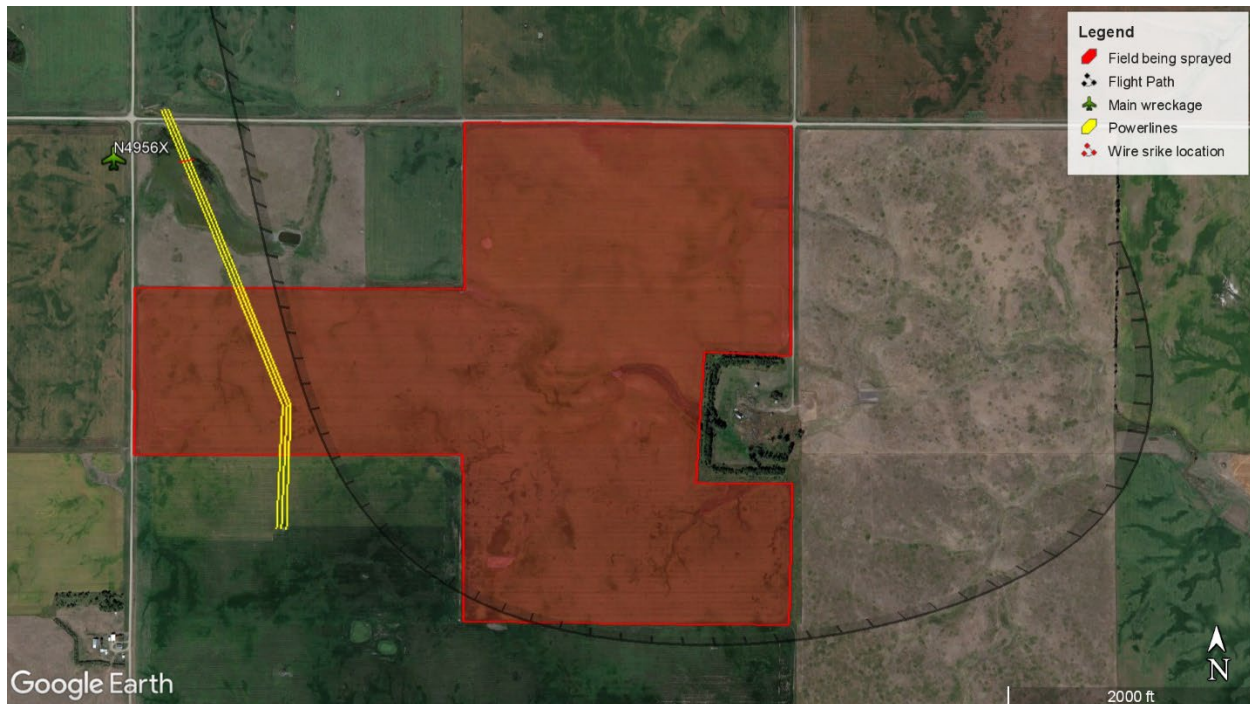
A witness driving eastbound observed the airplane flying west after it exited the sunflower field. The airplane then collided with the power lines, then crashed onto a road and slid into a field.

Figure 1. The field being sprayed in red, power lines in yellow, and main wreckage location overlaid onto Google Earth.
