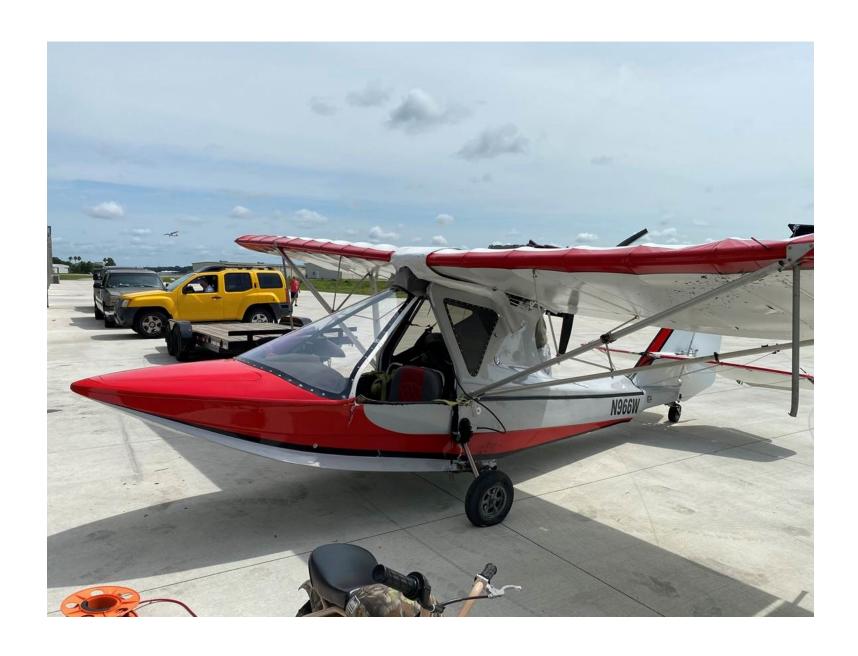
Photo 1 – Left main gear temporarily attached

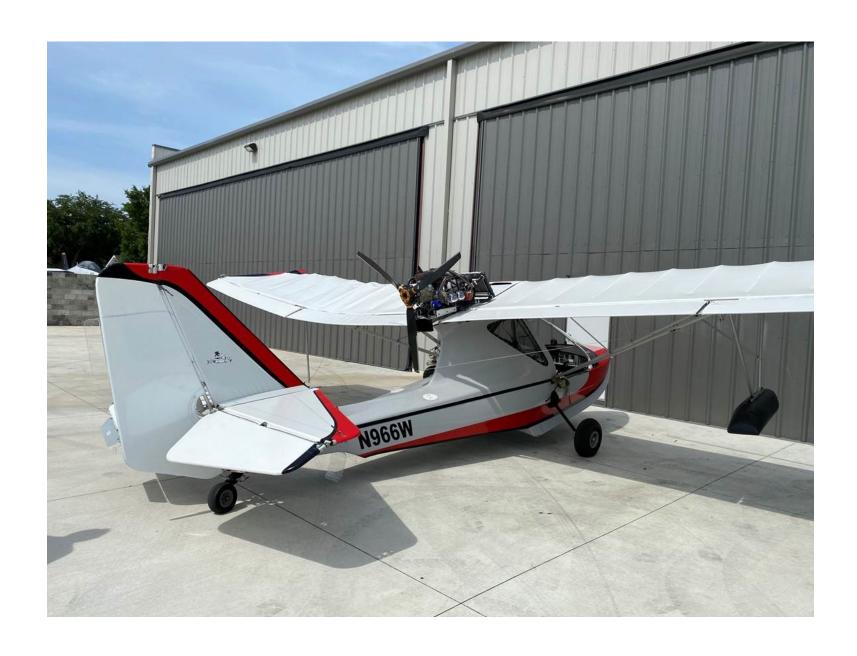
Photo 2 – Left wing tip bent up, Spar bent
