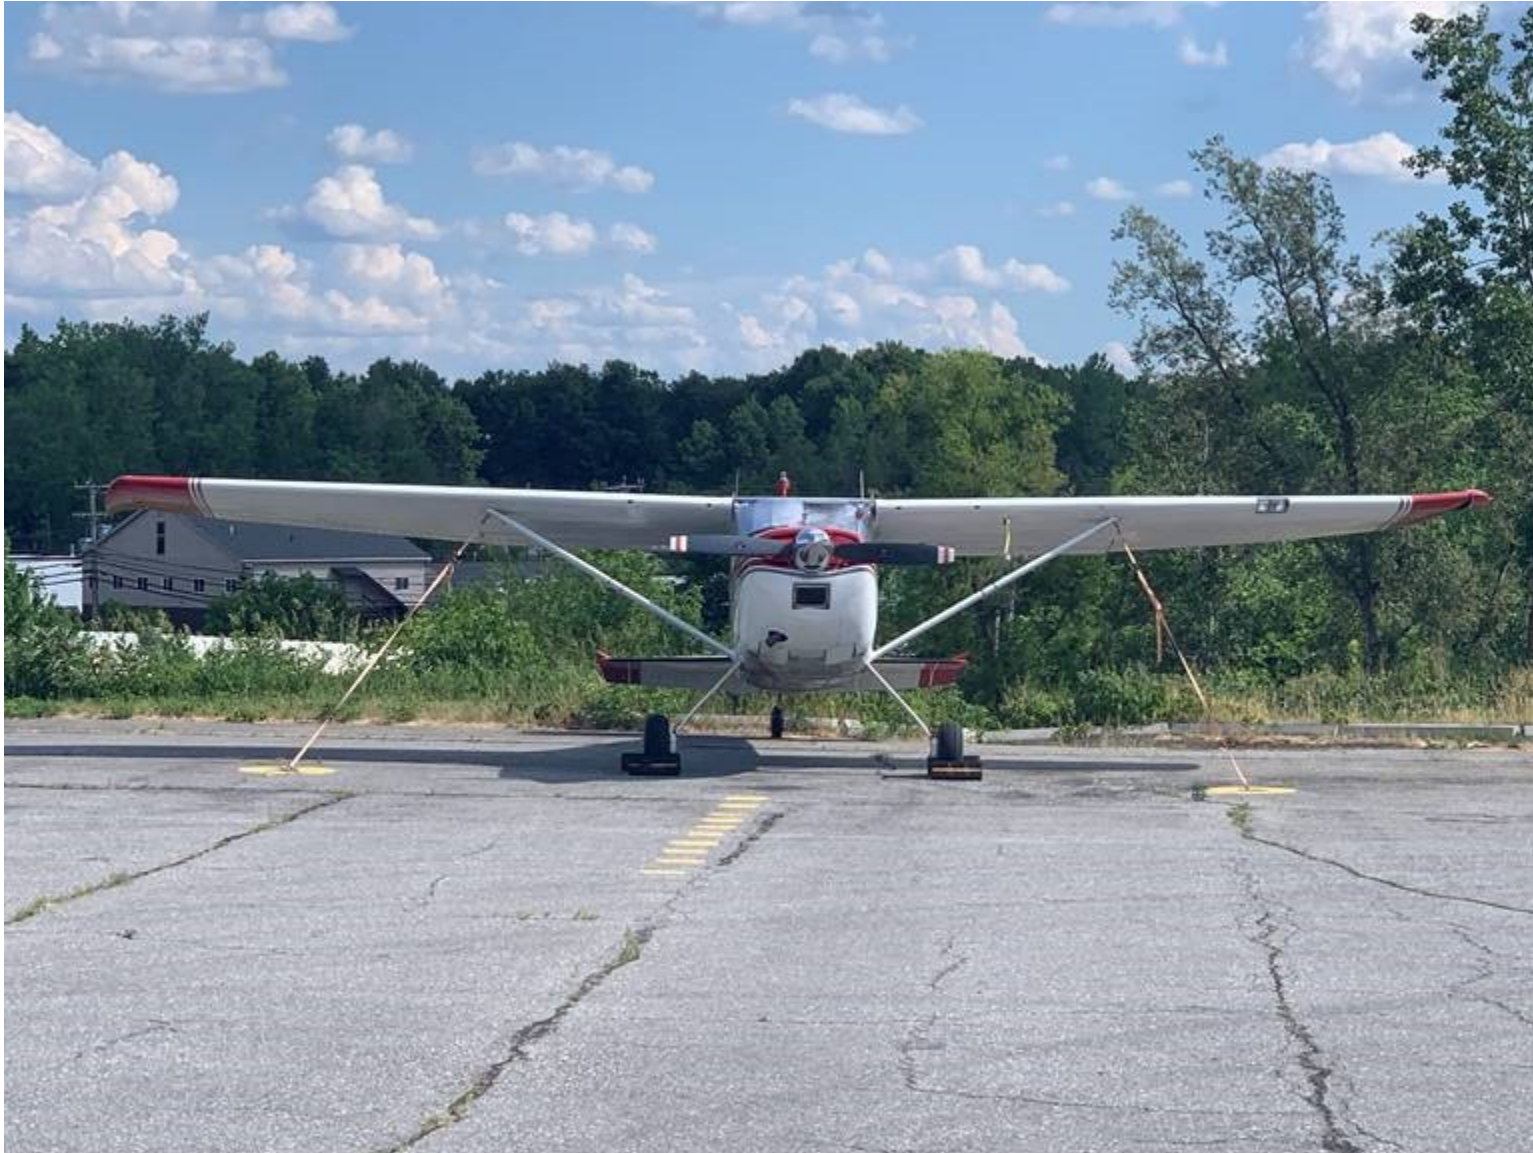
Photo 1 – front view, left wing spar bent (Owner)

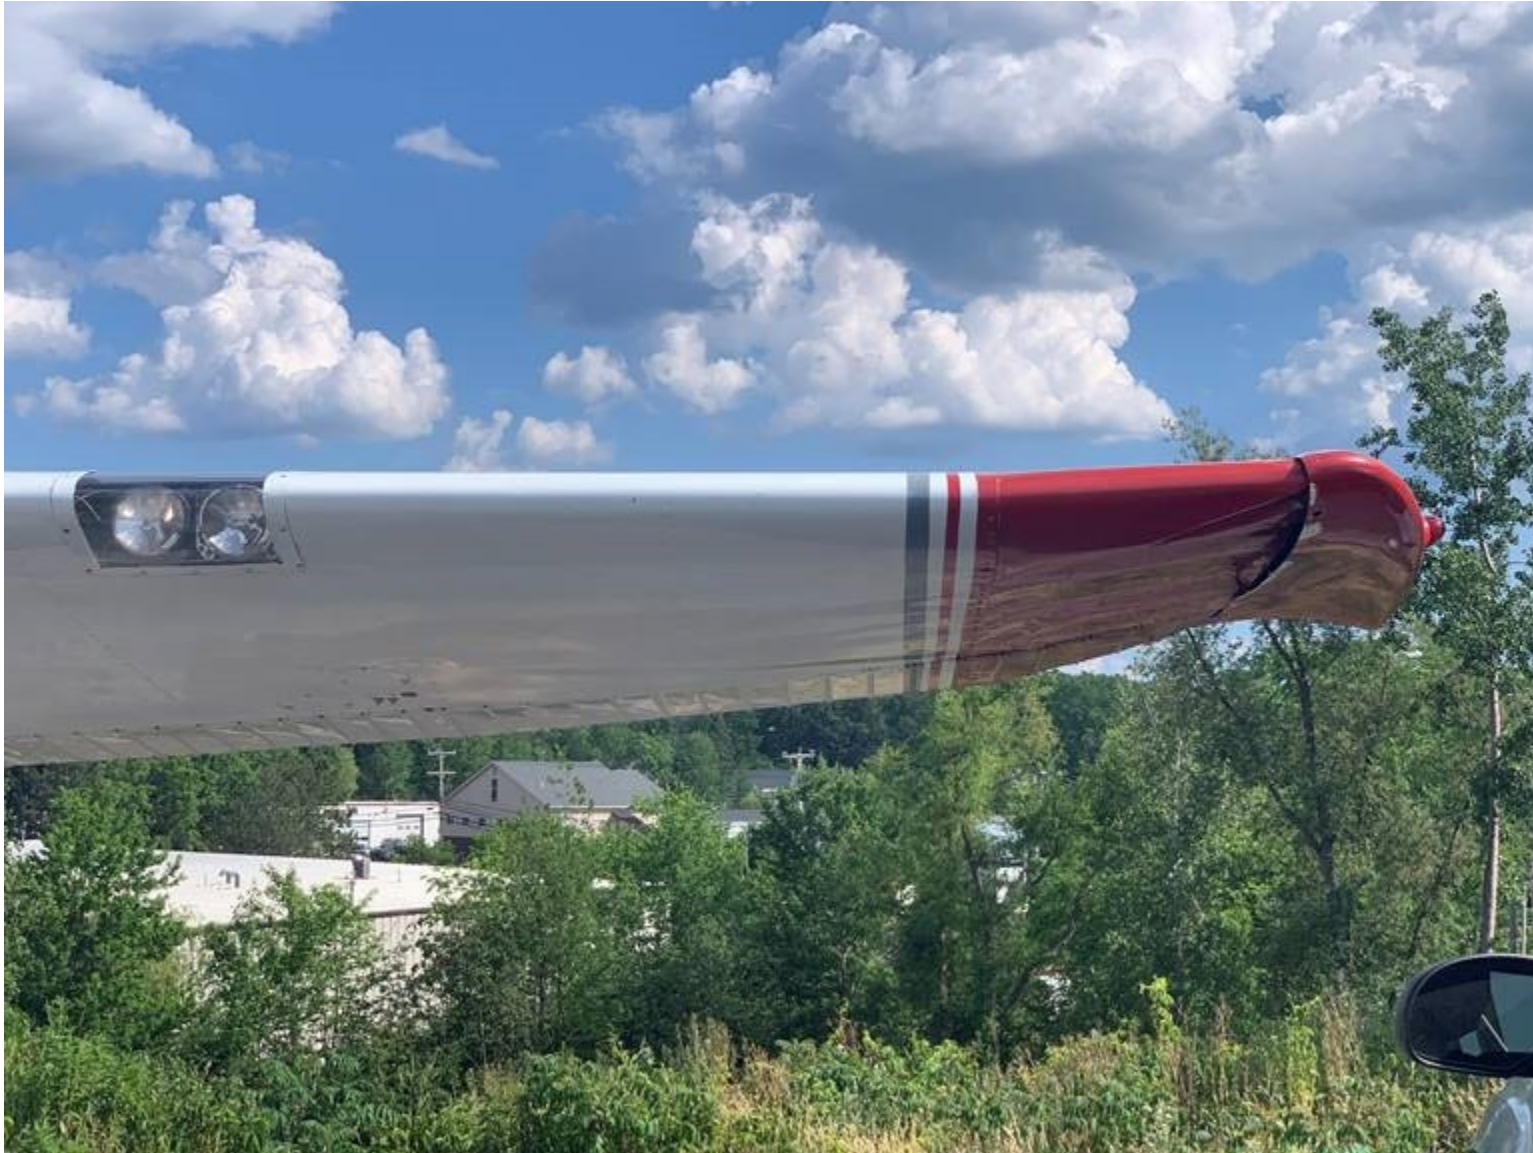
Photo 2 – Left wing tip, bent spar (Owner)
