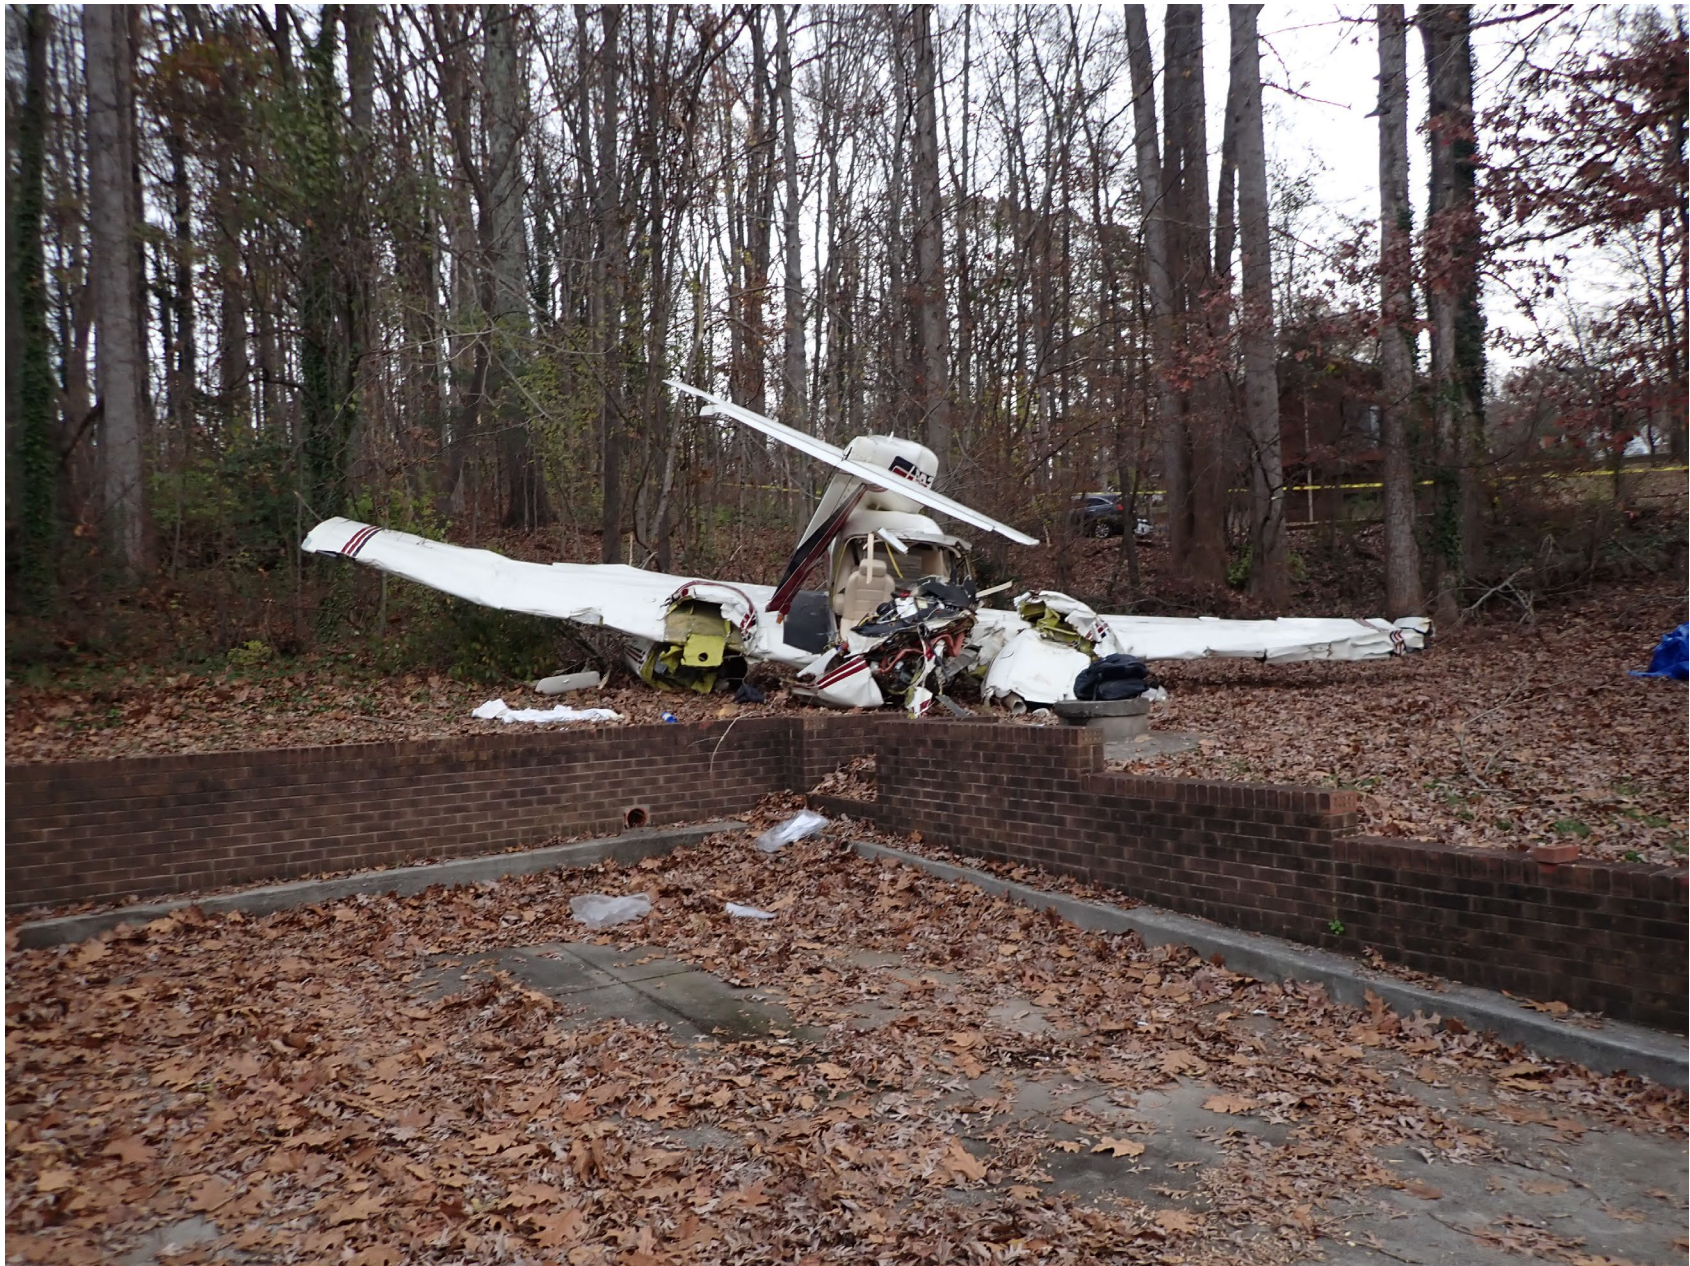
Photo 1 – NTSB Digital Photograph. Front View of the Wreckage at the Accident Site.

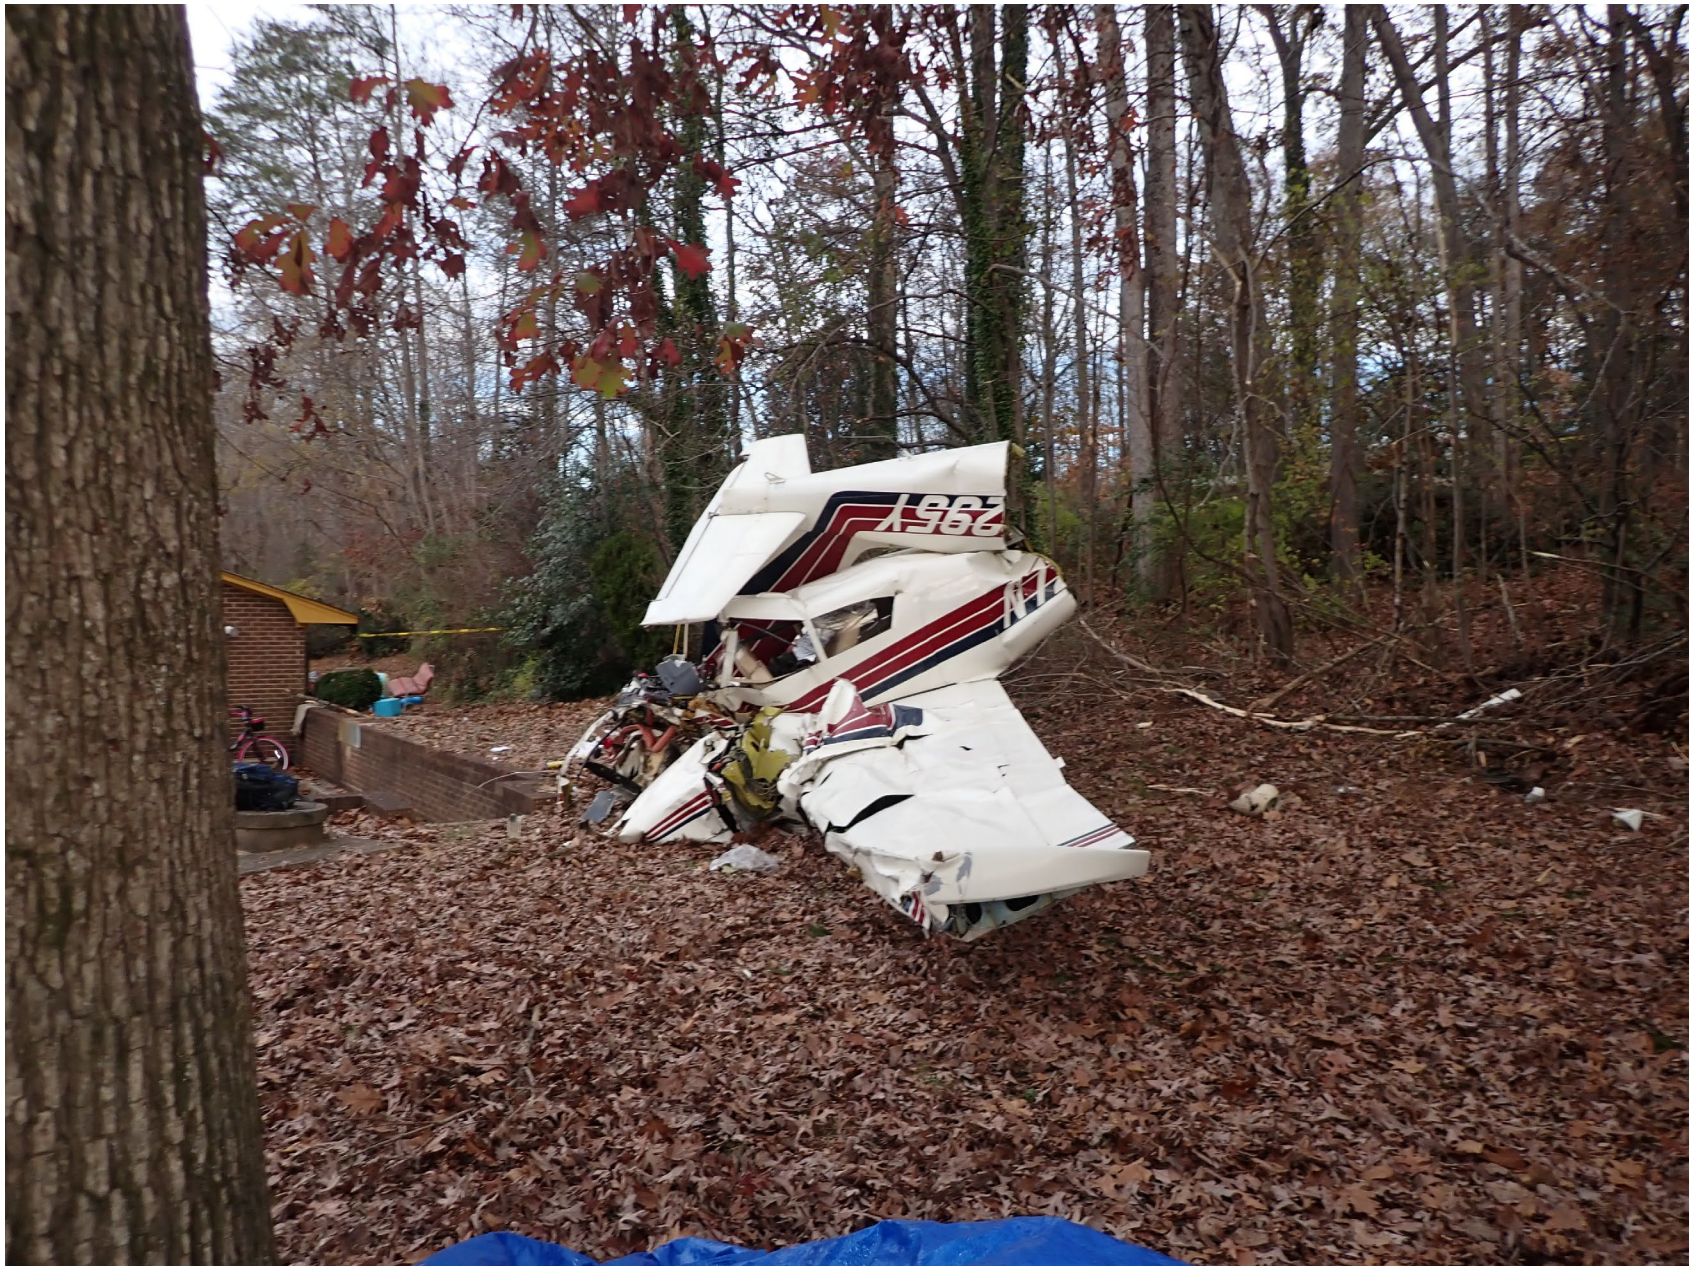
Photo 2 - NTSB Digital Photograph. Left Side View of the Wreckage at the Accident Site. Note the Aft Empennage Resting on Top of the Fuselage and Also Displaced to the Right.

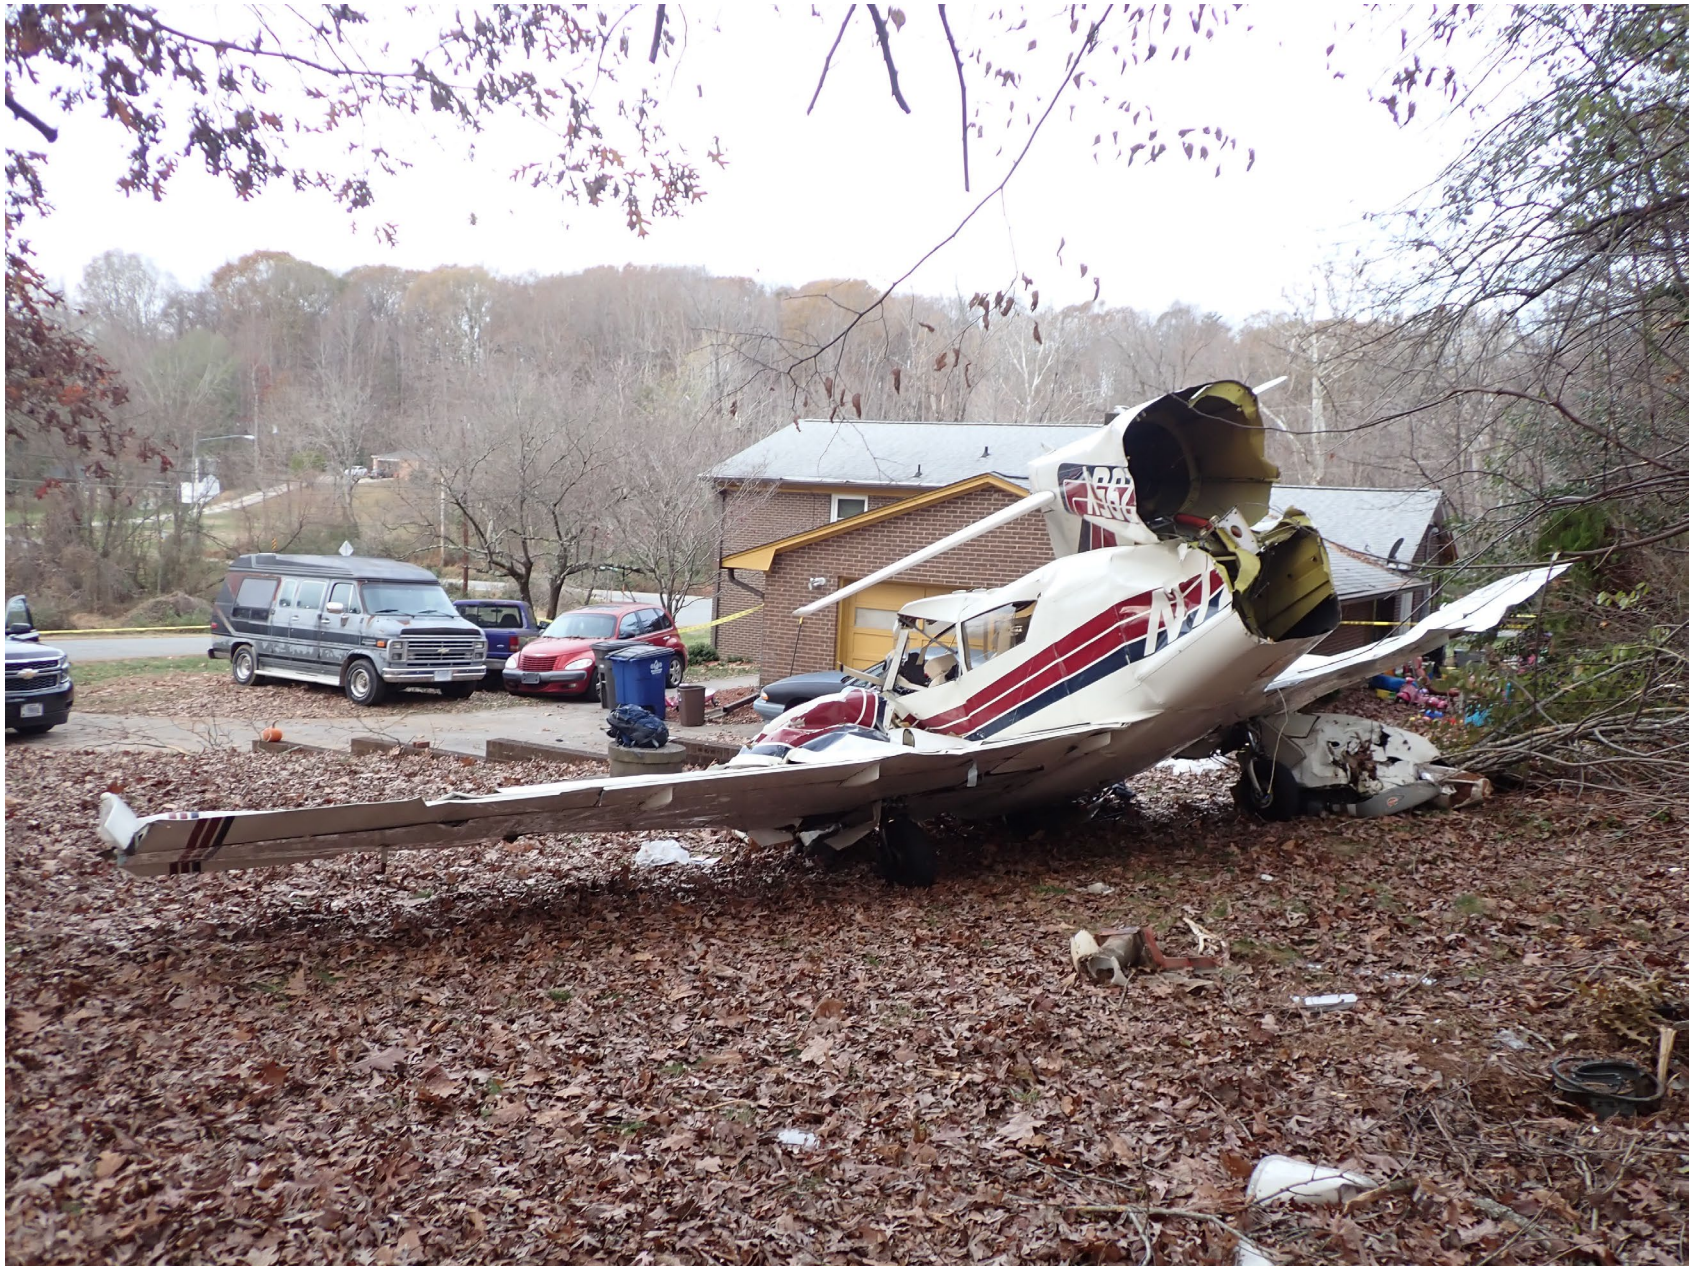
Photo 3 - NTSB Digital Photograph. Left Rear Quartering View of the Wreckage at the Accident Site. Note the Aft Empennage Resting on Top of the Fuselage and Also Displaced to the Right.

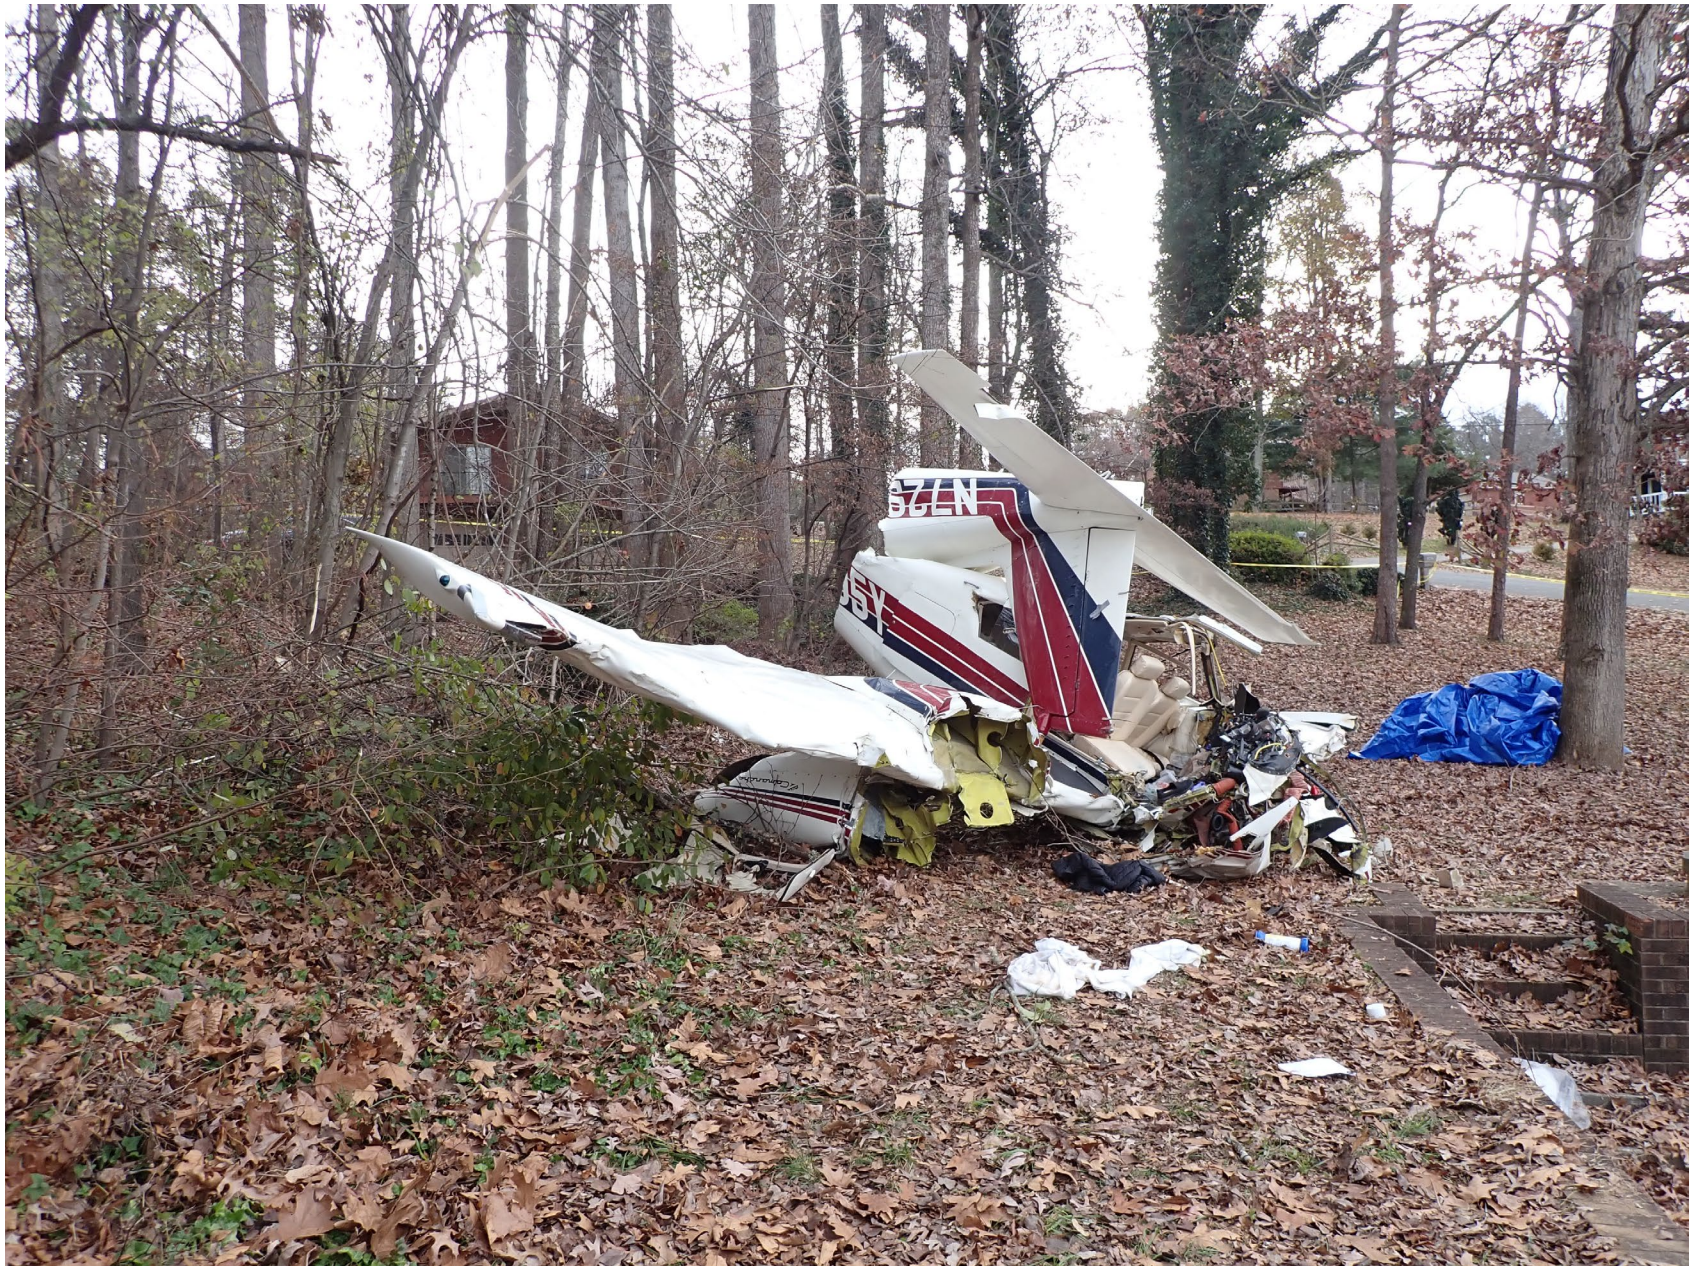
Photo 4 - NTSB Digital Photograph. Right Forward Quartering View of the Wreckage at the Accident Site. Note the Aft Empennage Resting on Top of the Fuselage and Also Displaced to the Right.

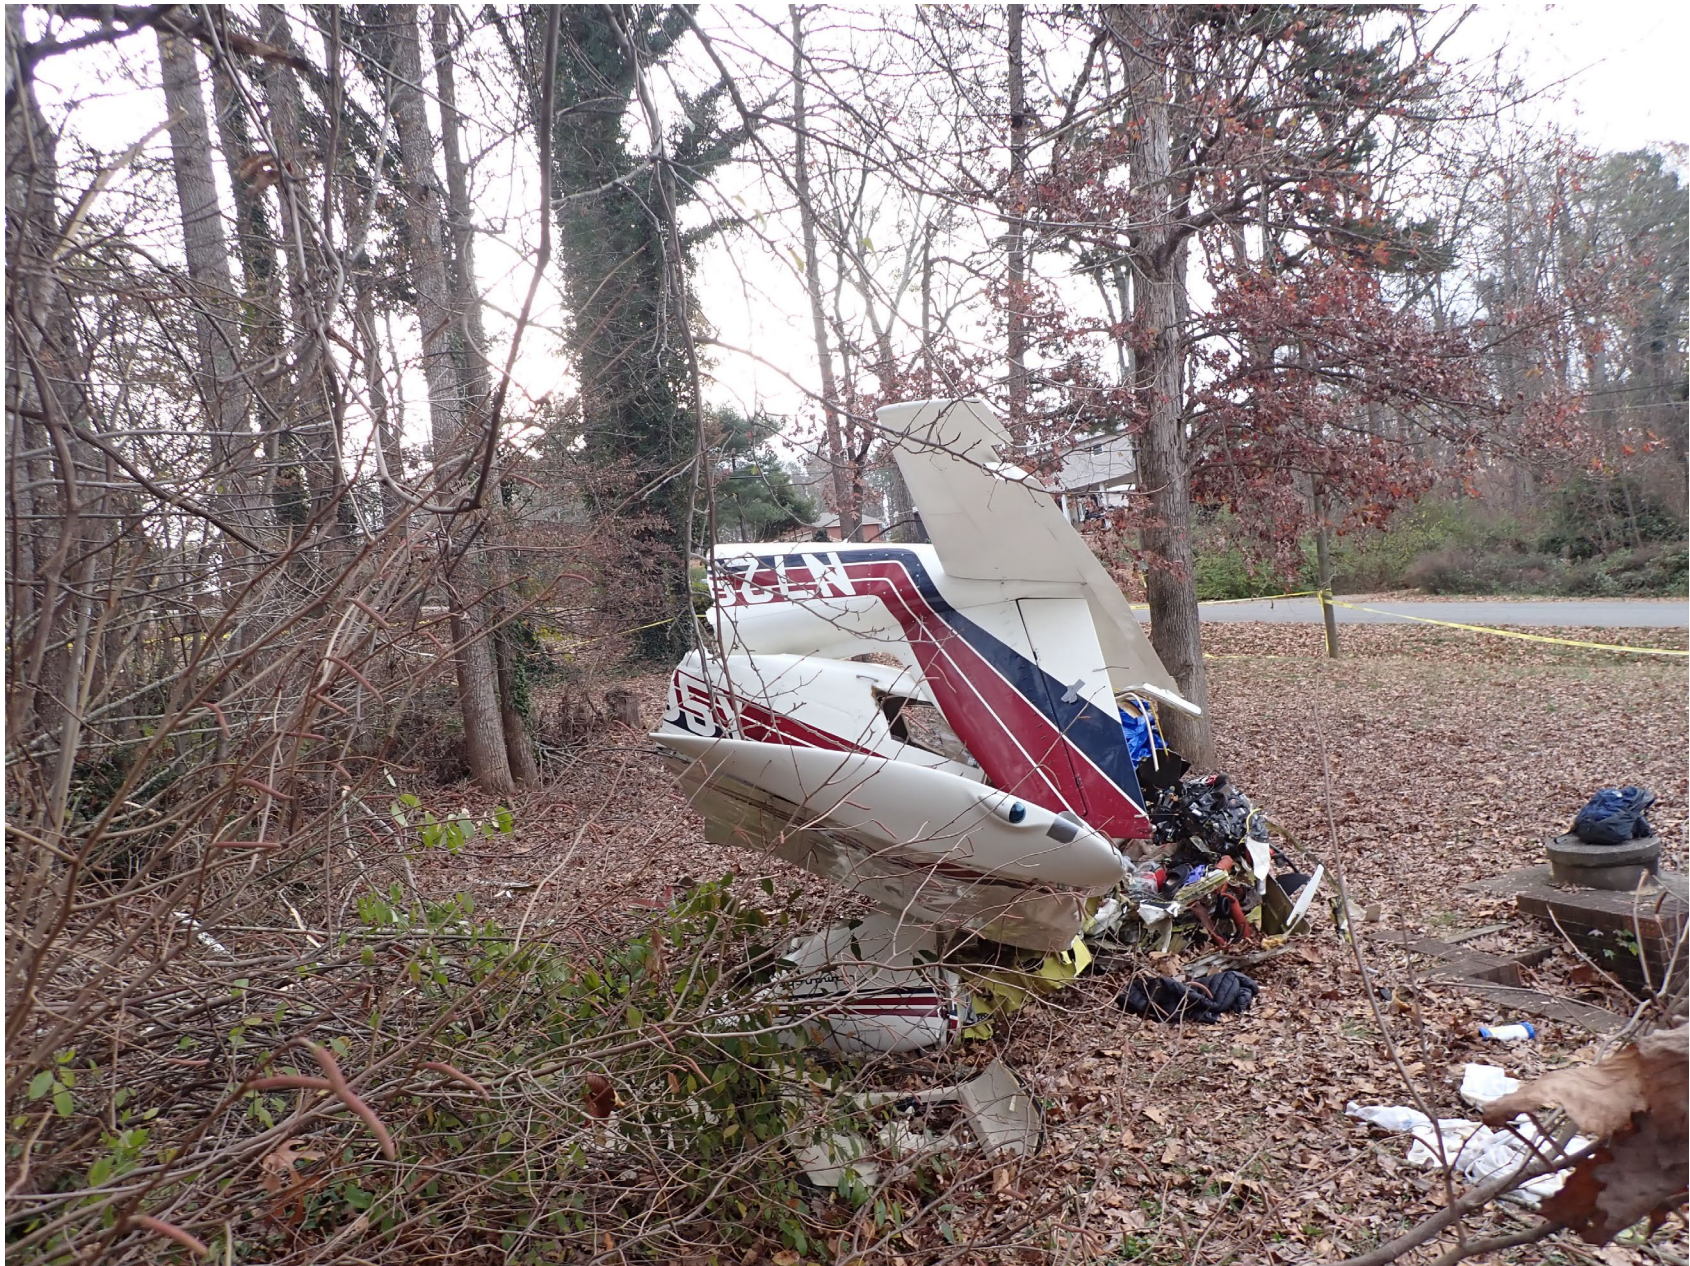
Photo 5 - NTSB Digital Photograph. Right Side View of the Wreckage at the Accident Site. Note the Aft Empennage Resting on Top of the Fuselage and Also Displaced to the Right.

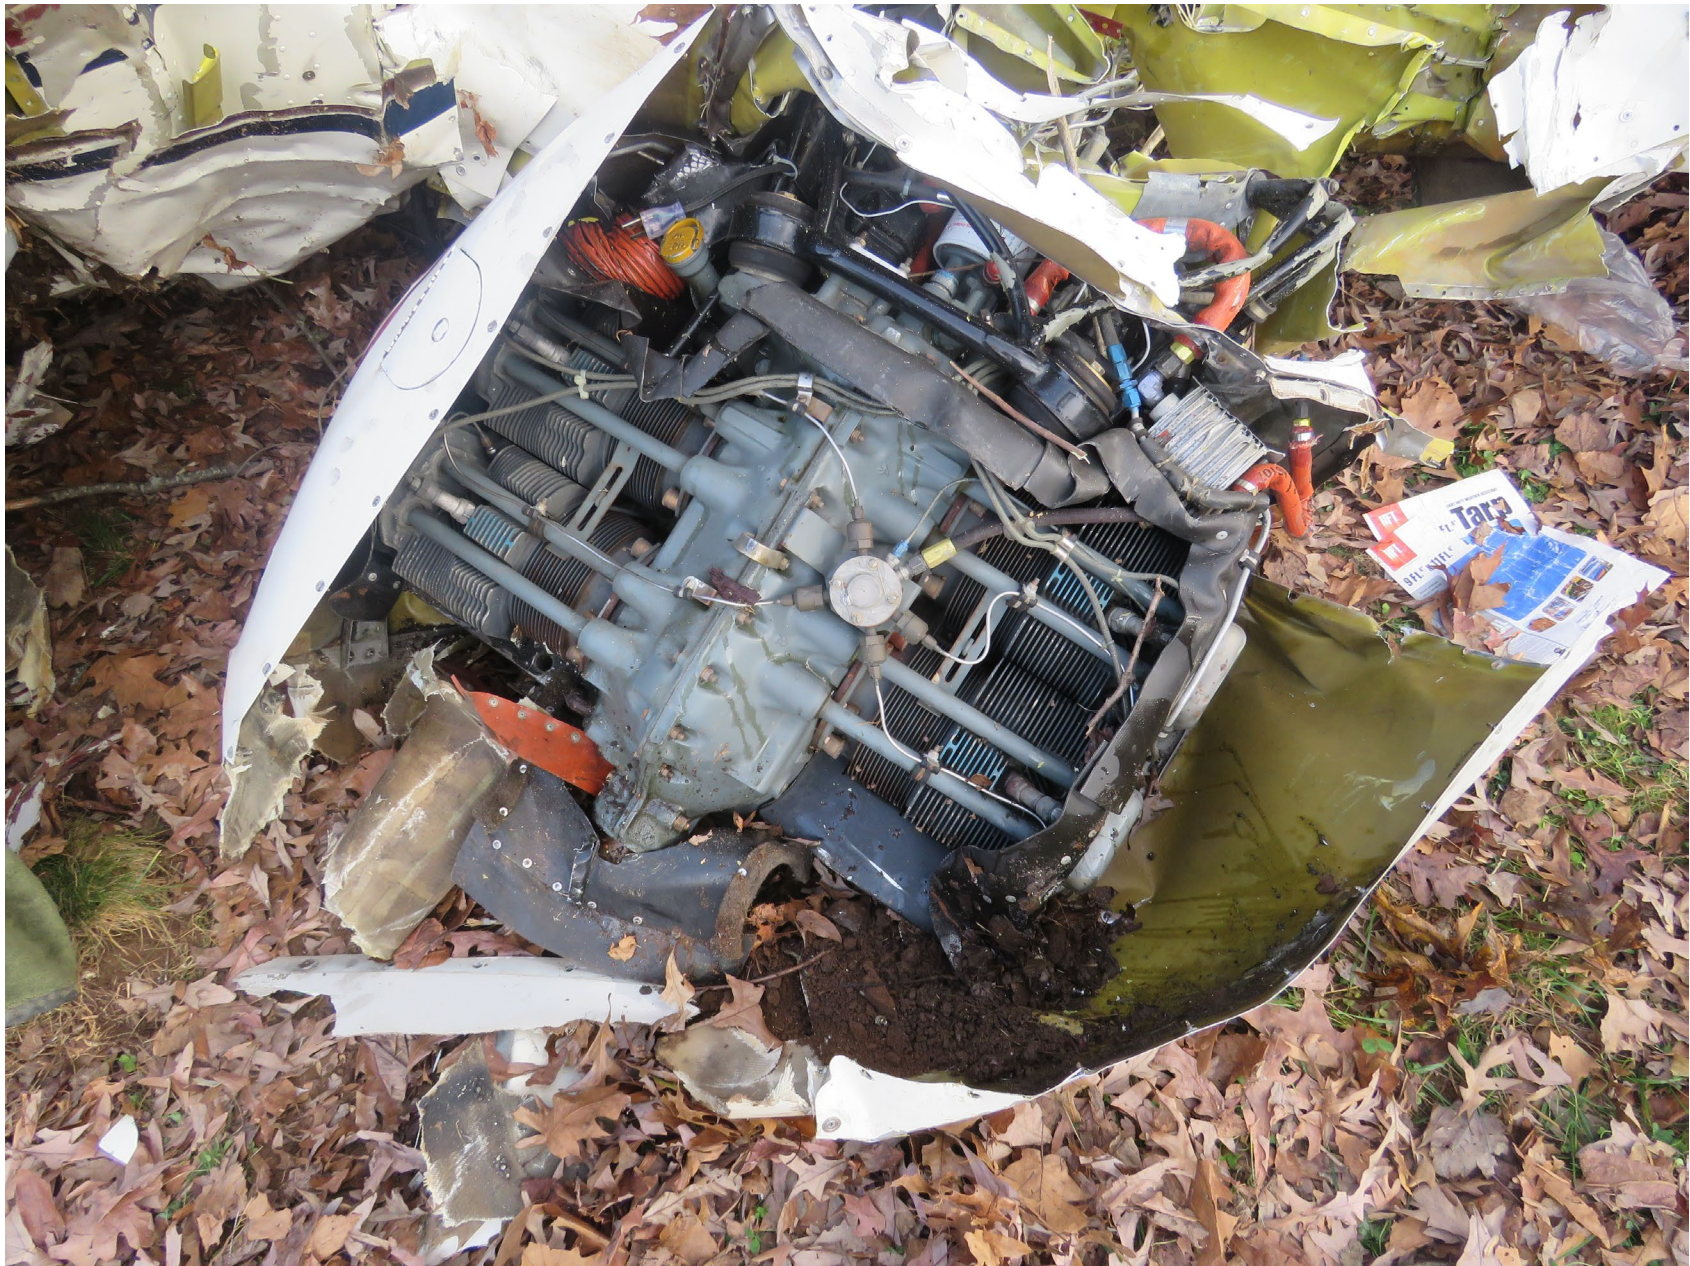
Photo 6 – Lycoming Digital Photograph. View of the Partially Uncowled Left Engine Assembly Before Removal for Examination.

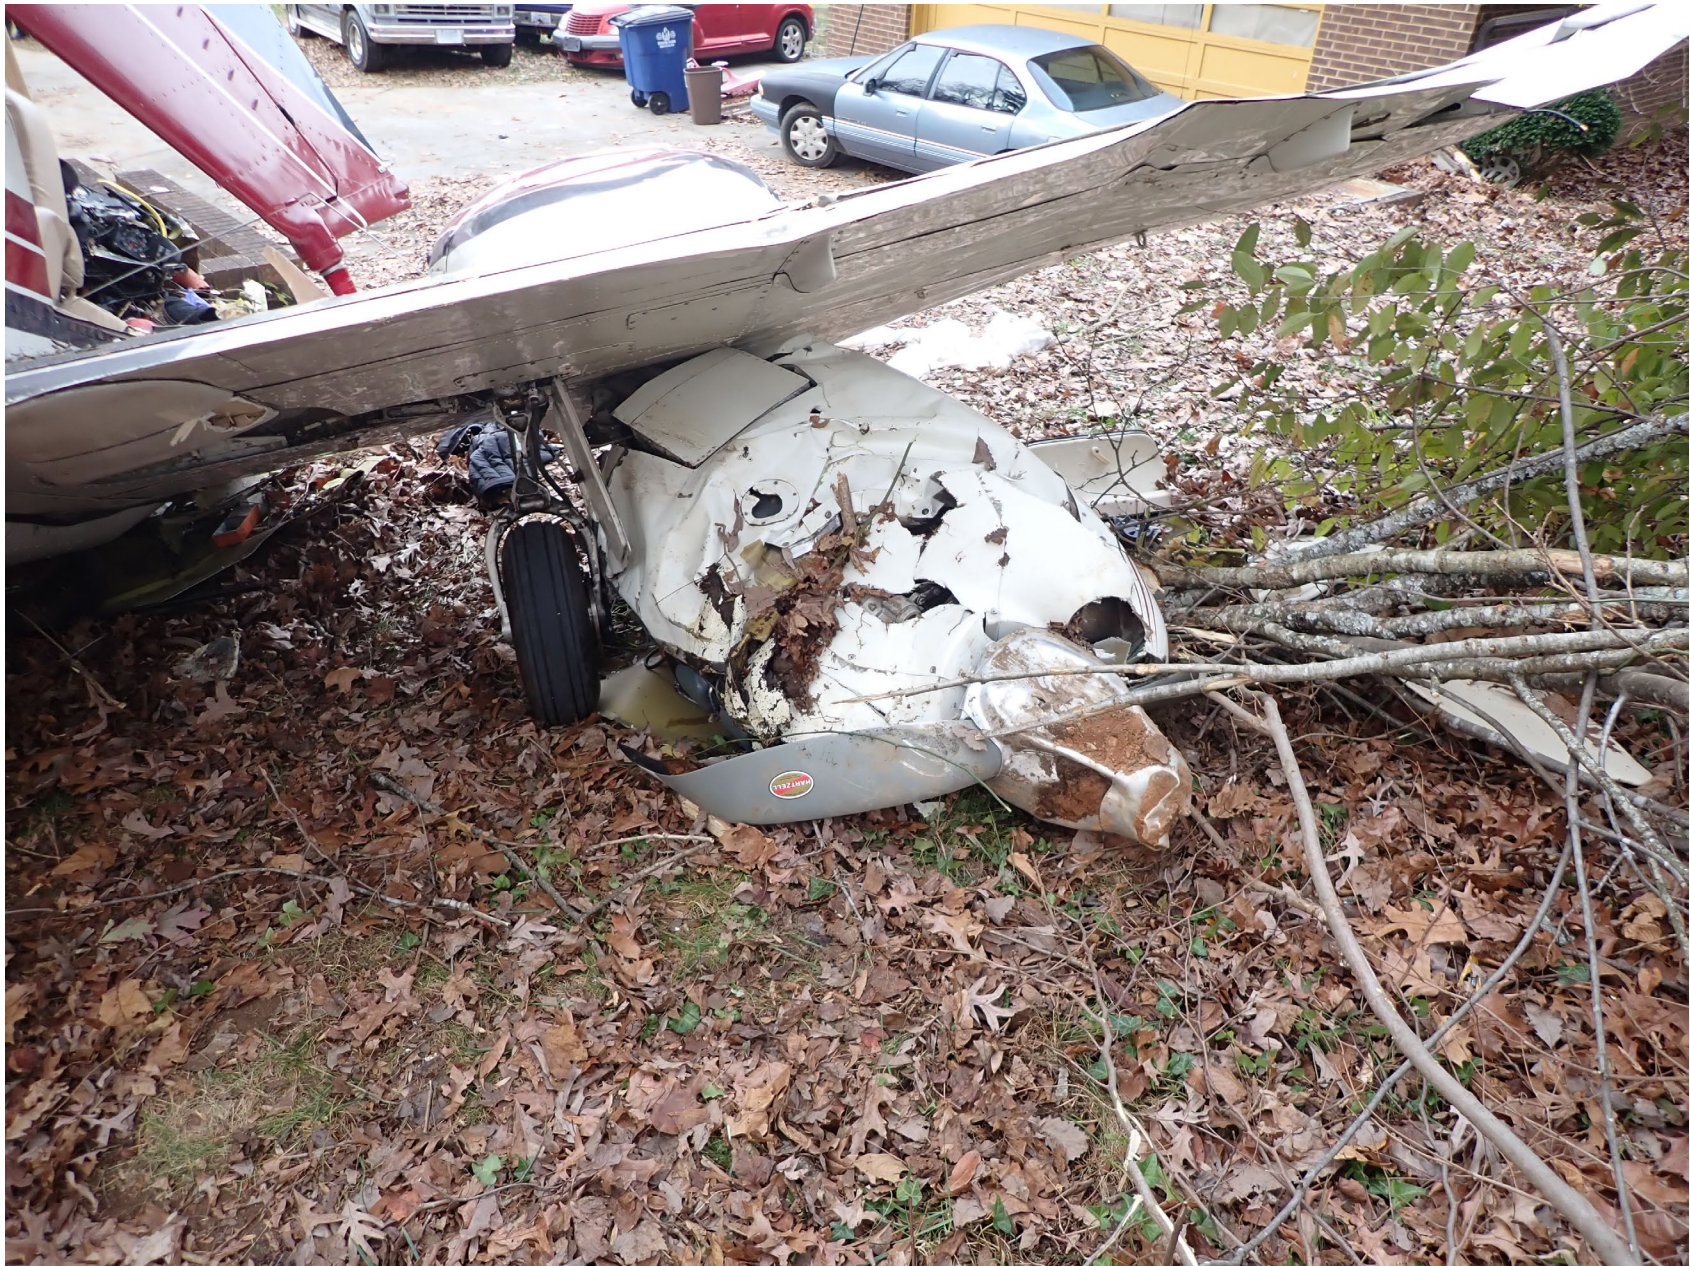
Photo 7 – NTSB Digital Photograph. View of the Resting Position of the Right Engine Assembly with Attached Propeller Assembly.

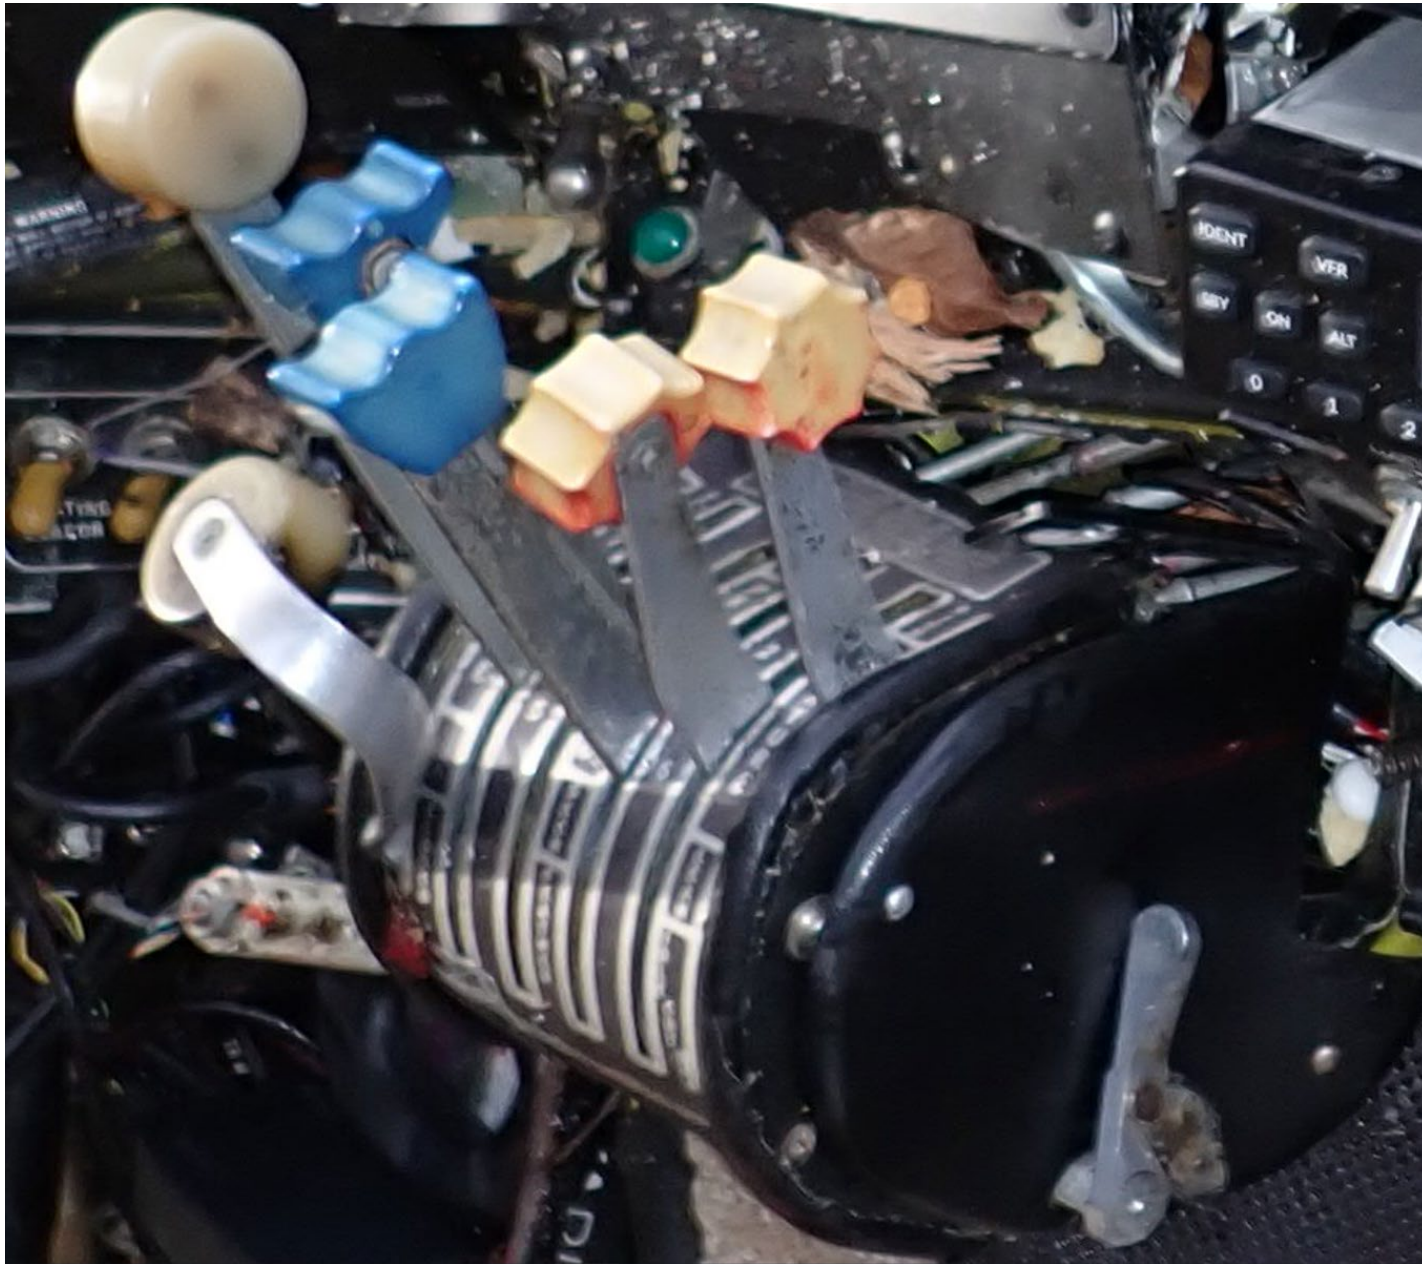
Photo 8 – NTSB Digital Photograph. Close-Up Right Side View of the Throttle Quadrant.

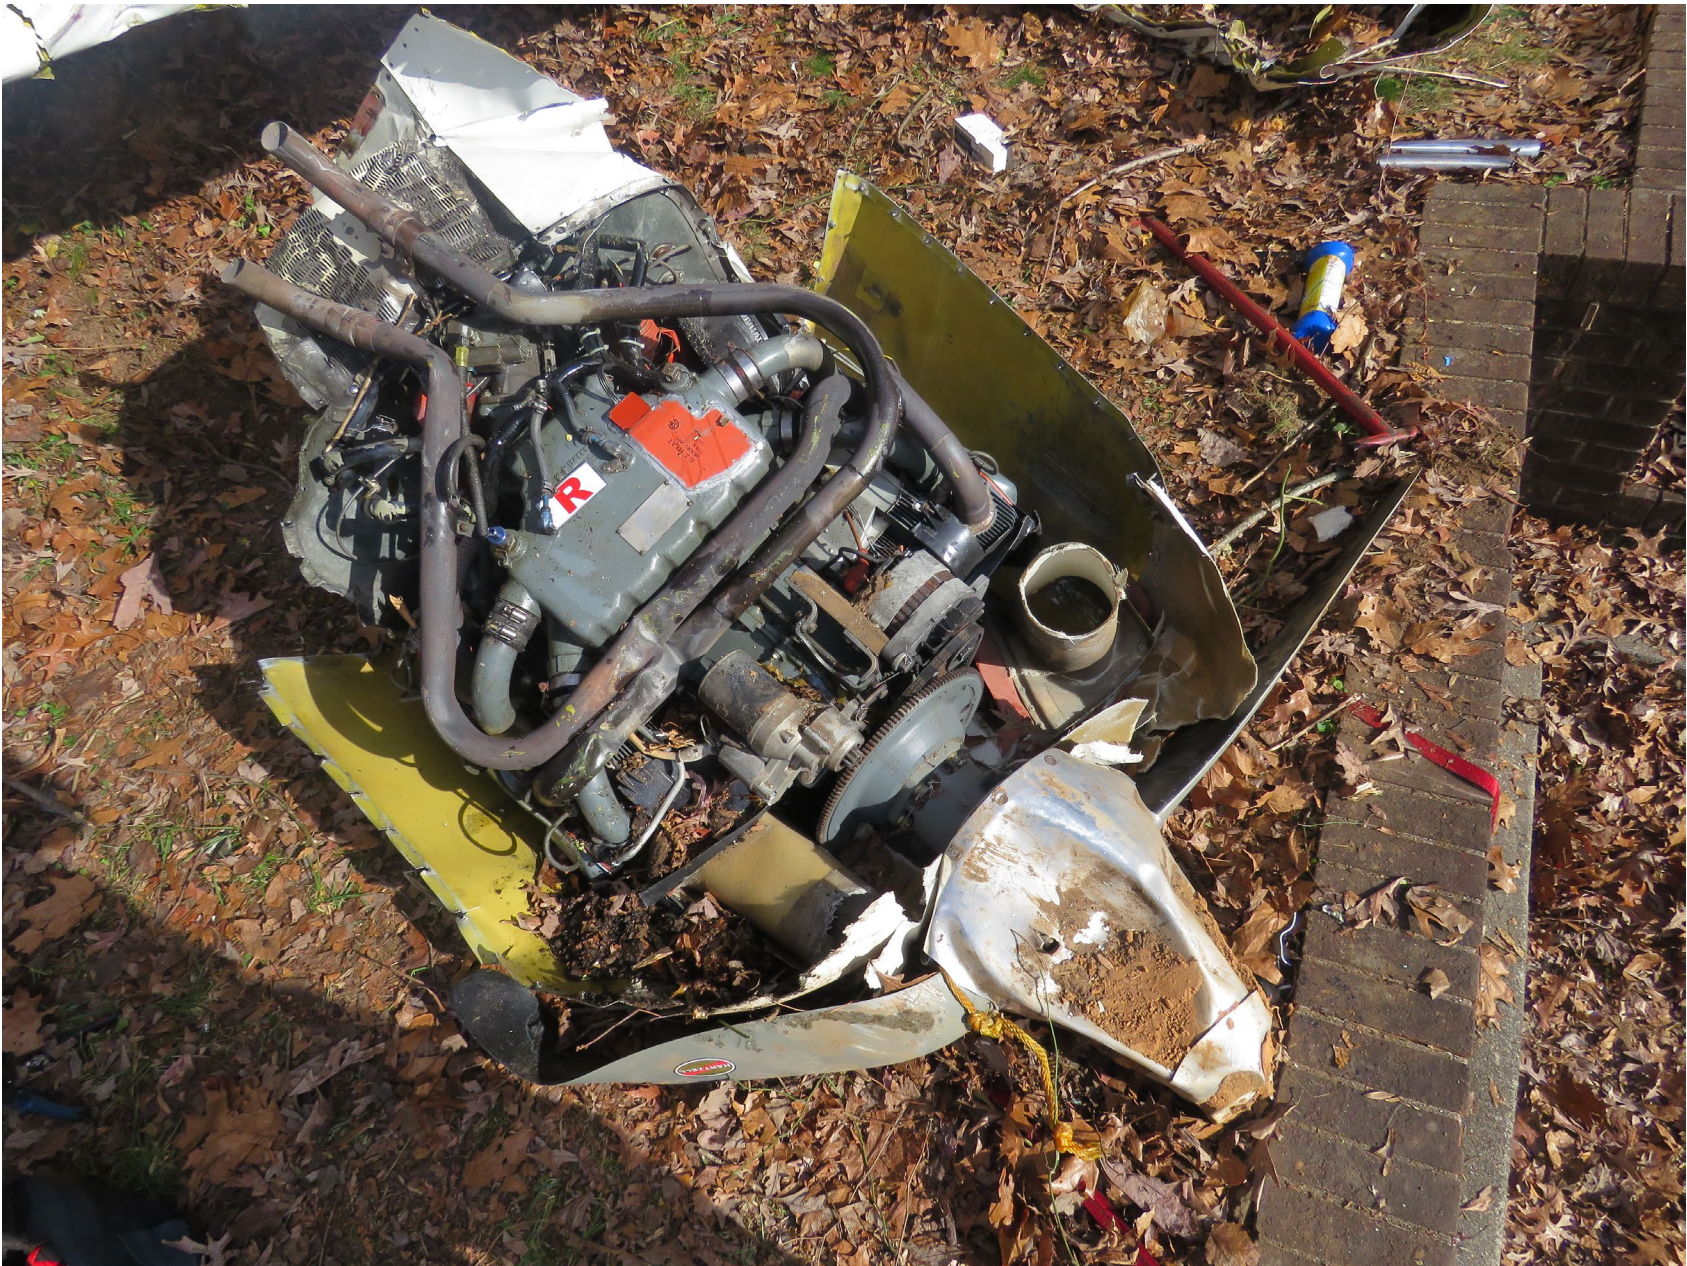
Photo 9 – Lycoming Digital Photograph. View of the Partially Uncowled Right Engine Assembly with Attached Right Propeller Assembly.

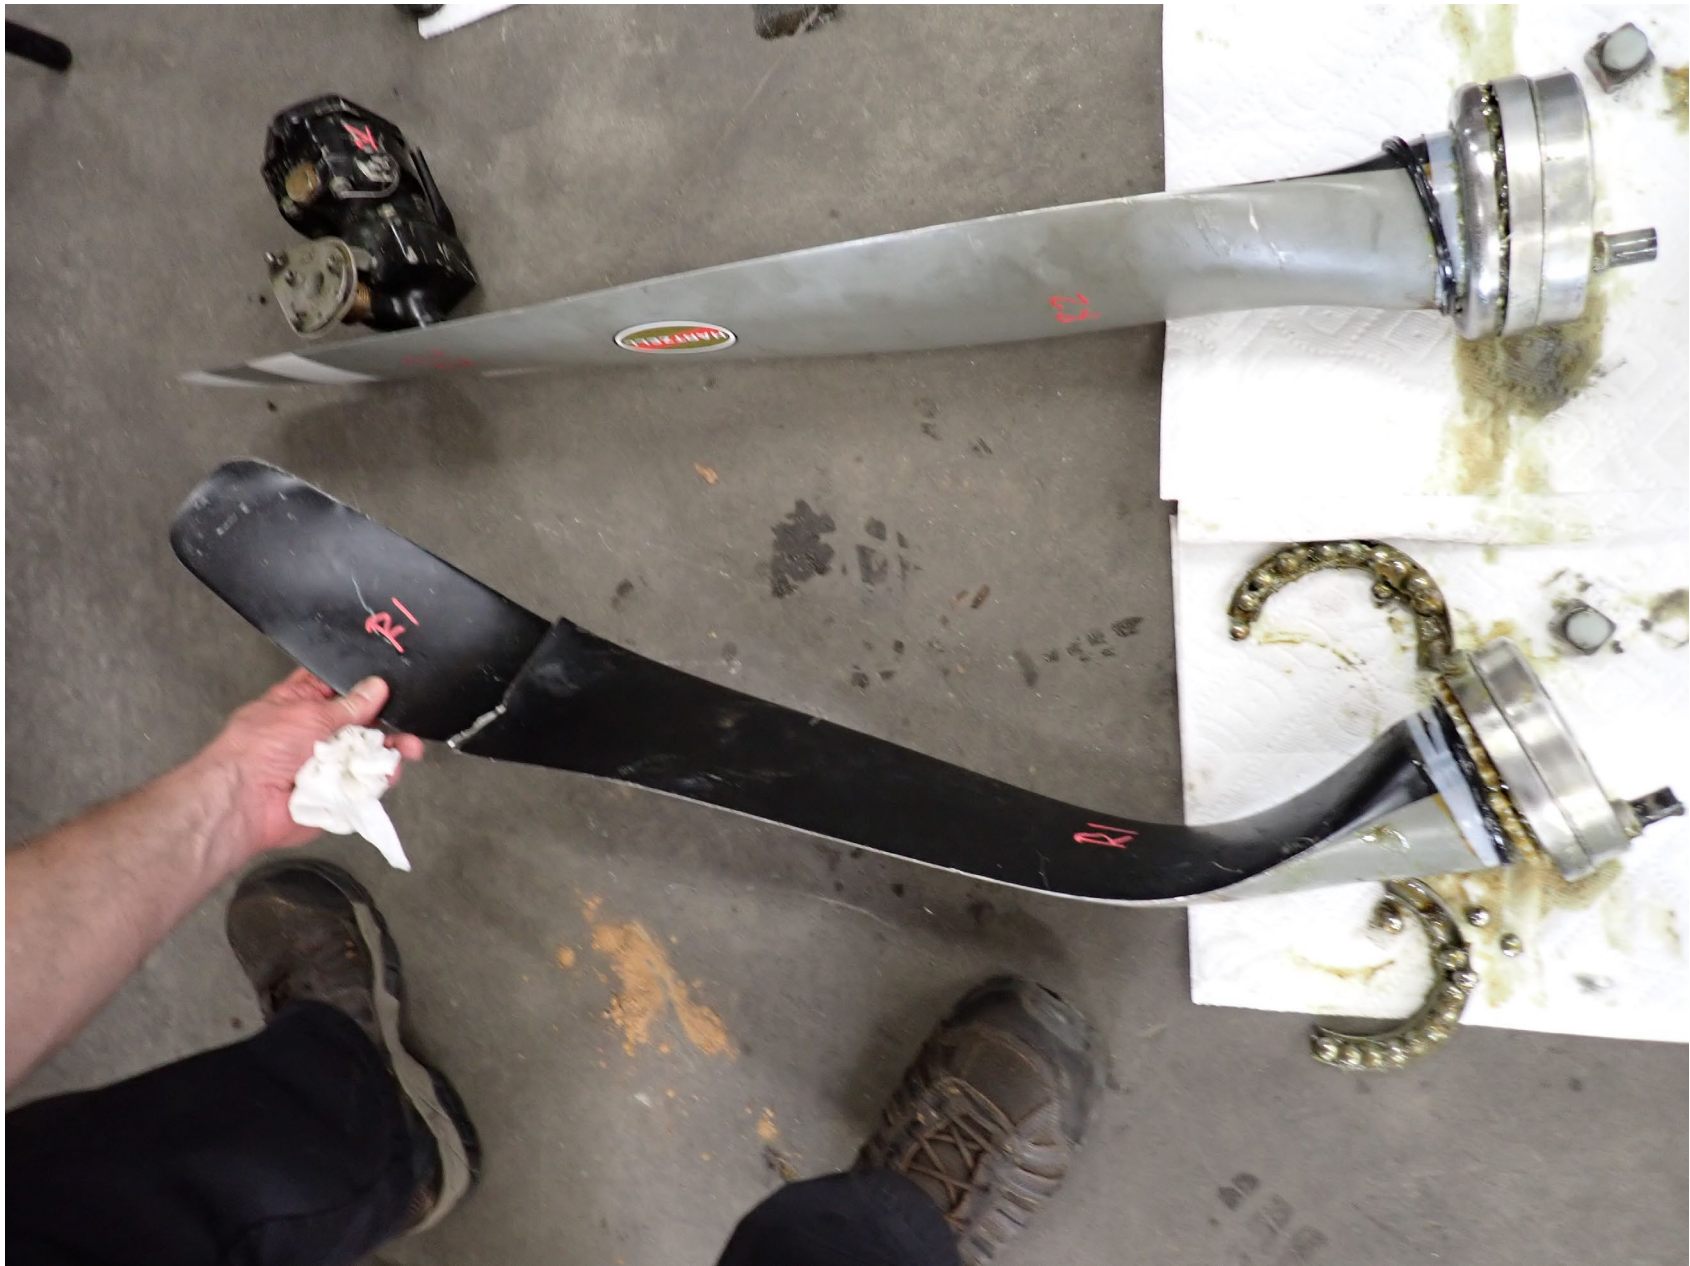
Photo 10 – Hartzell Digital Photograph. View of Both Right Propeller Blades Following Removal from the Hub and Also Right Propeller Governor. Note the R1 Blade Cut near the Tip For Recovery.
