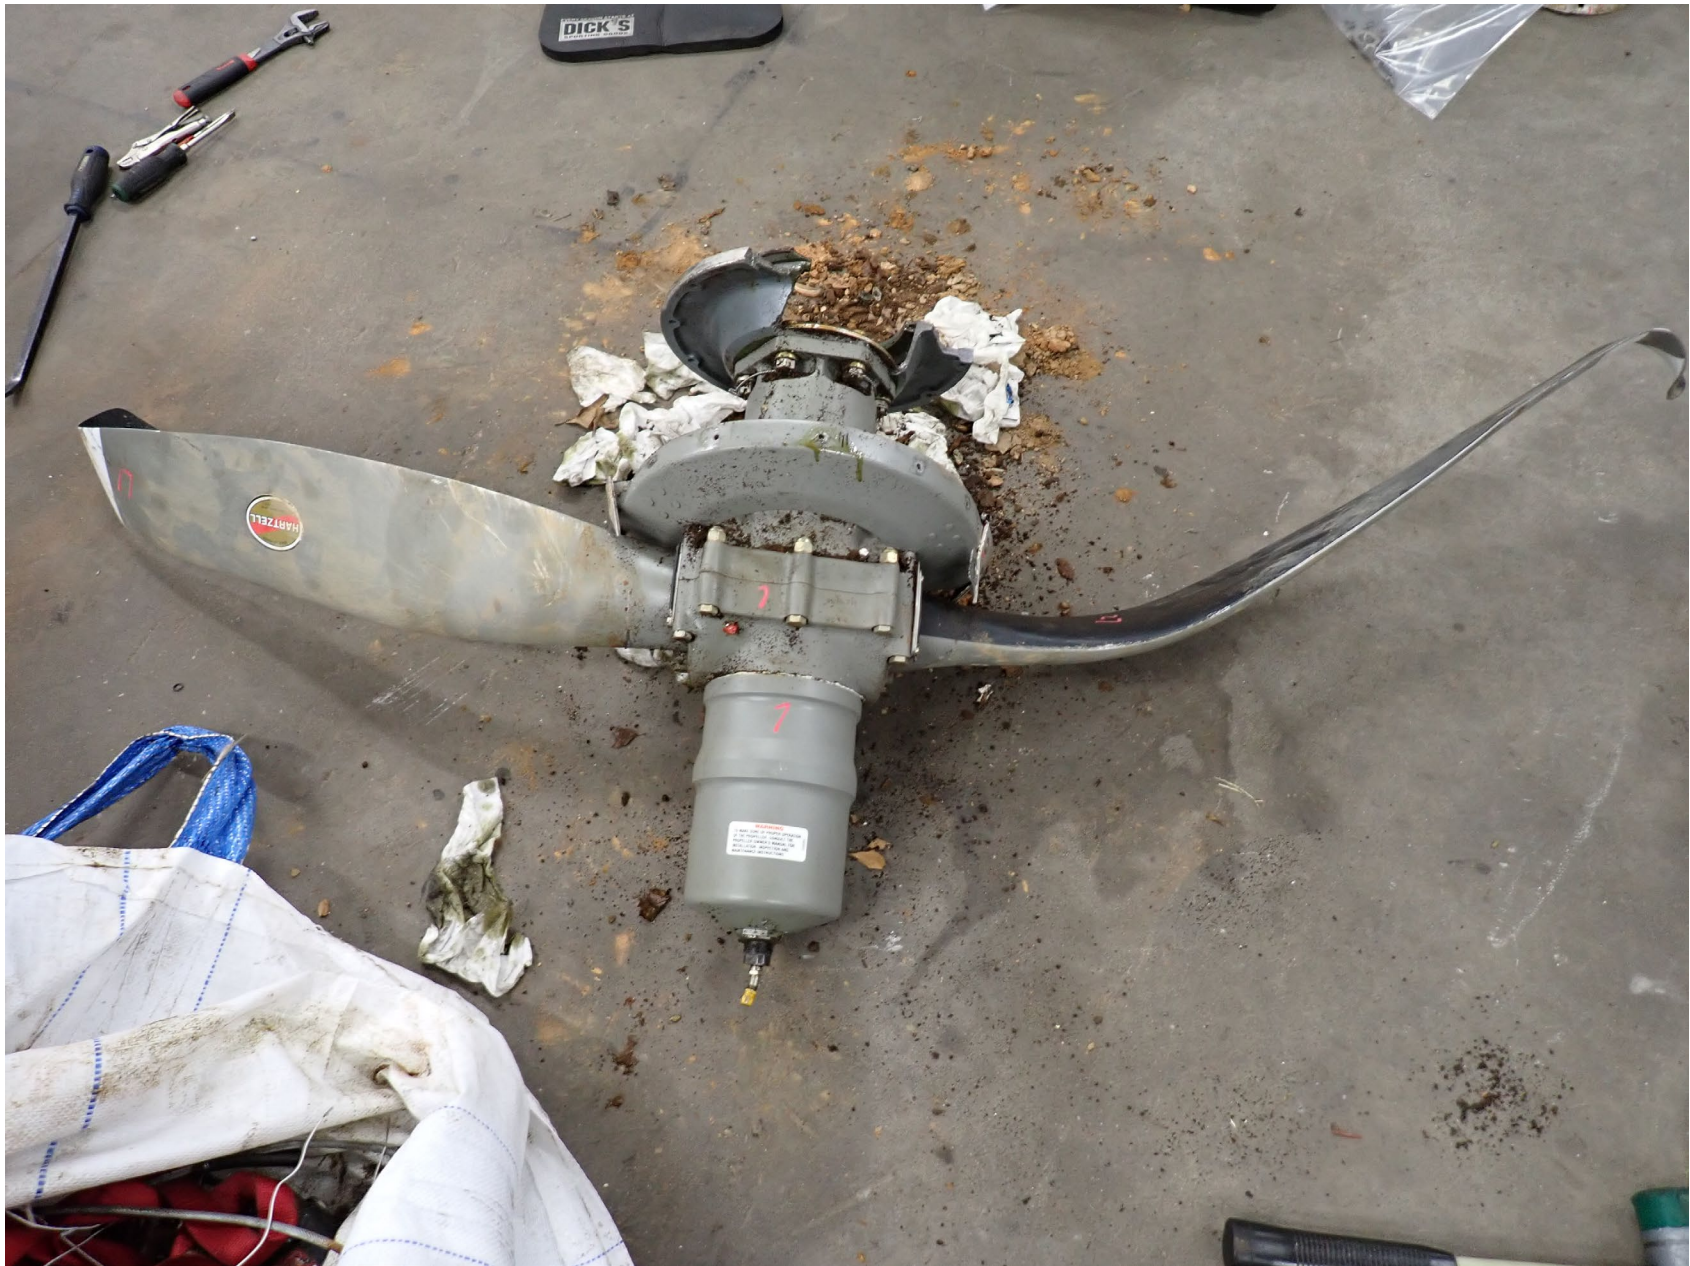
Photo 11 – Hartzell Digital Photograph. Frontal View of the Left Propeller Assembly.

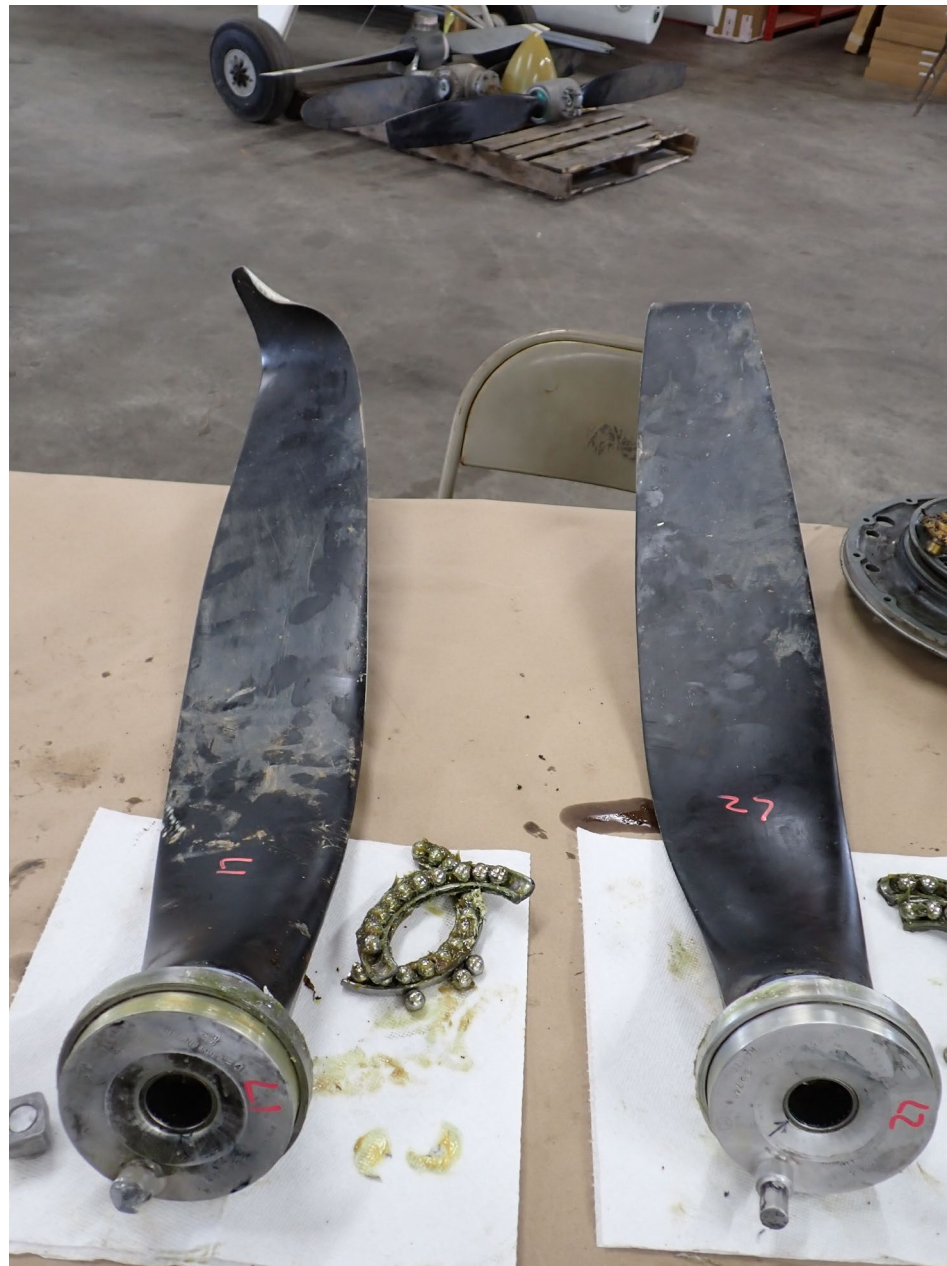
Photo 12 – Hartzell Digital Photograph. View of the Back Side of Both Left Propeller Blades Following Removal From the Propeller Hub.

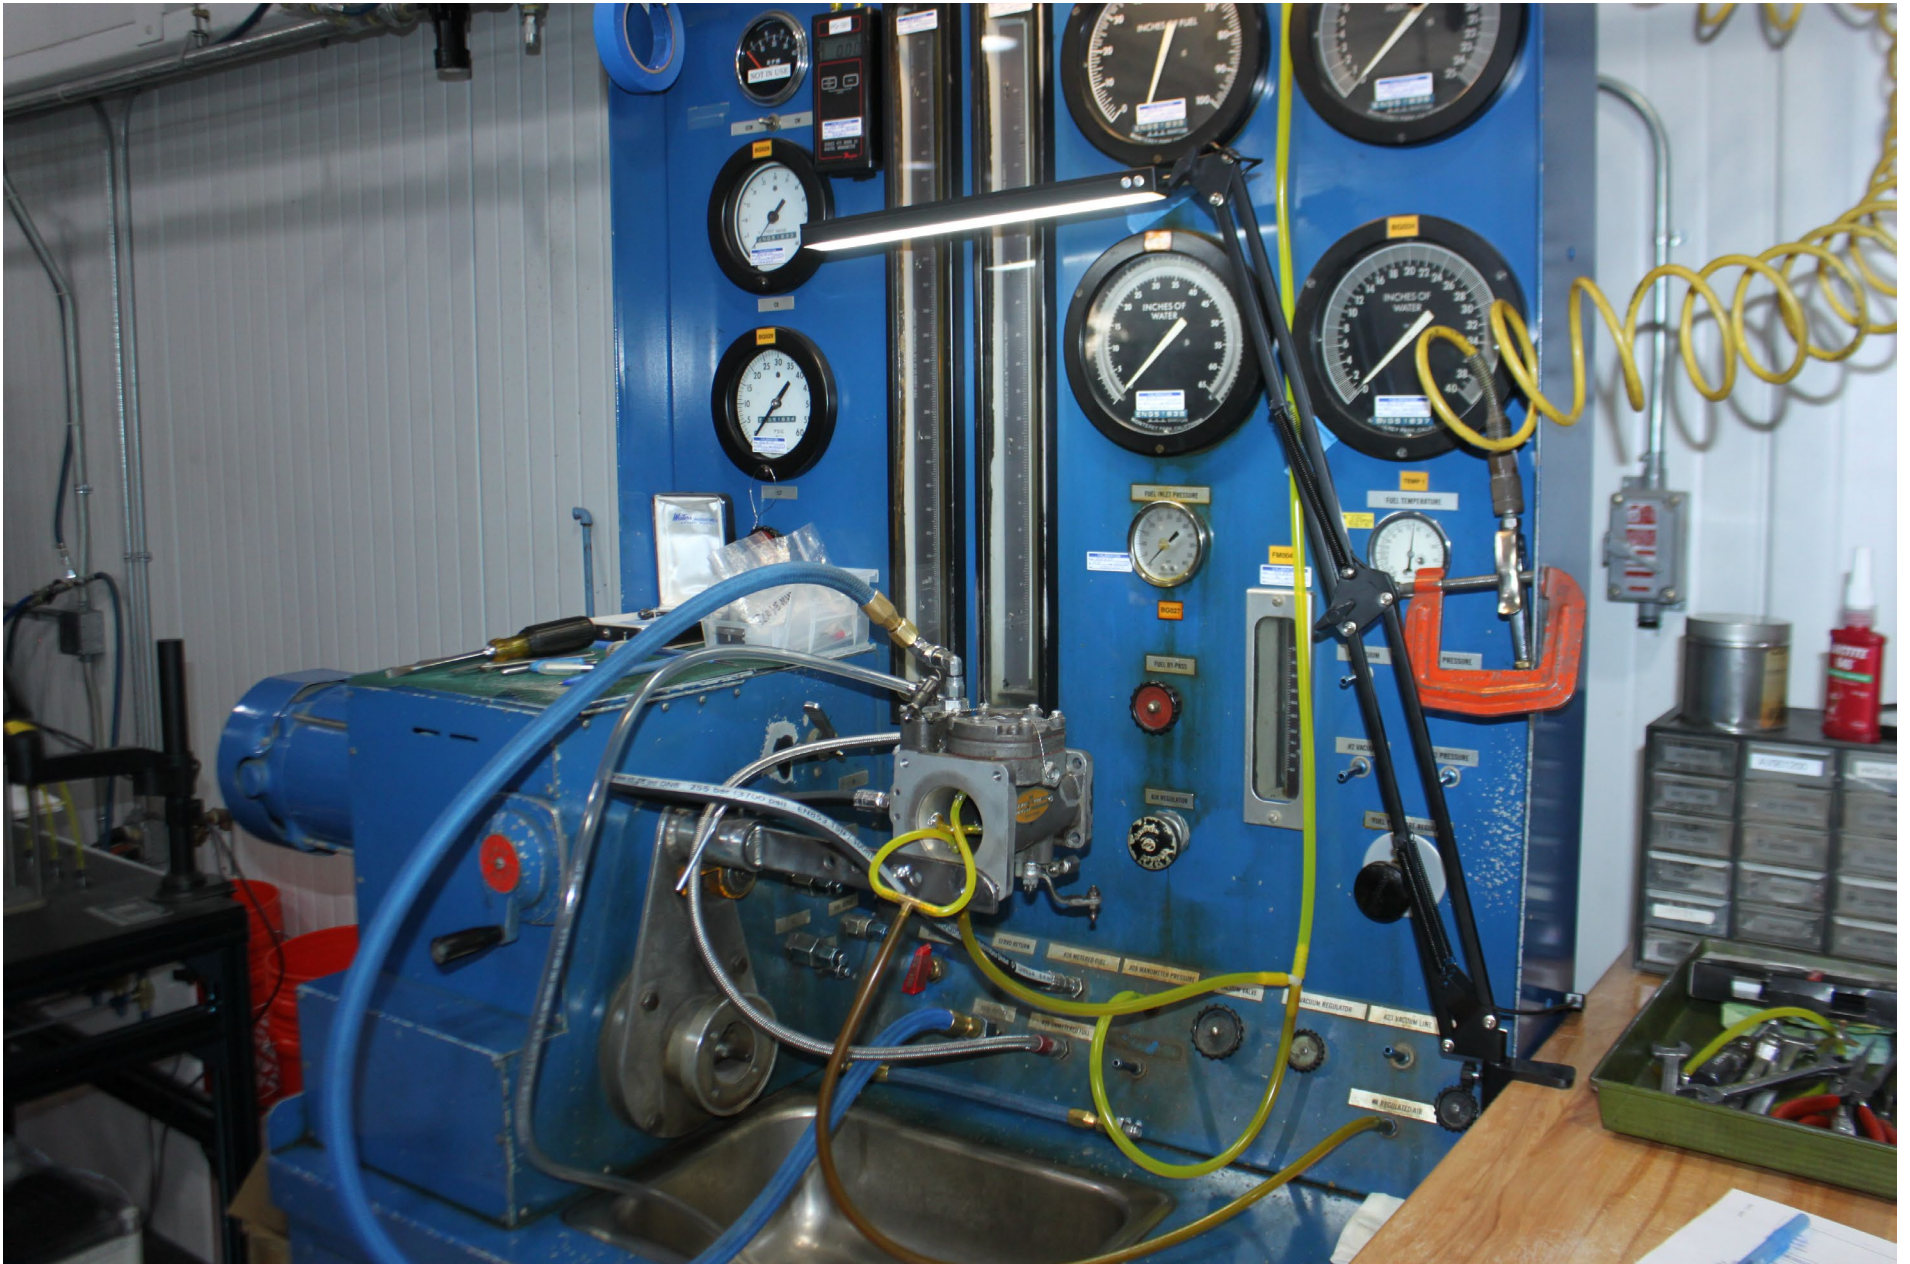
Photo 13 – NTSB Digital Photograph. View of the Right Fuel Injection Servo on the Test Bench Before Operational Testing.

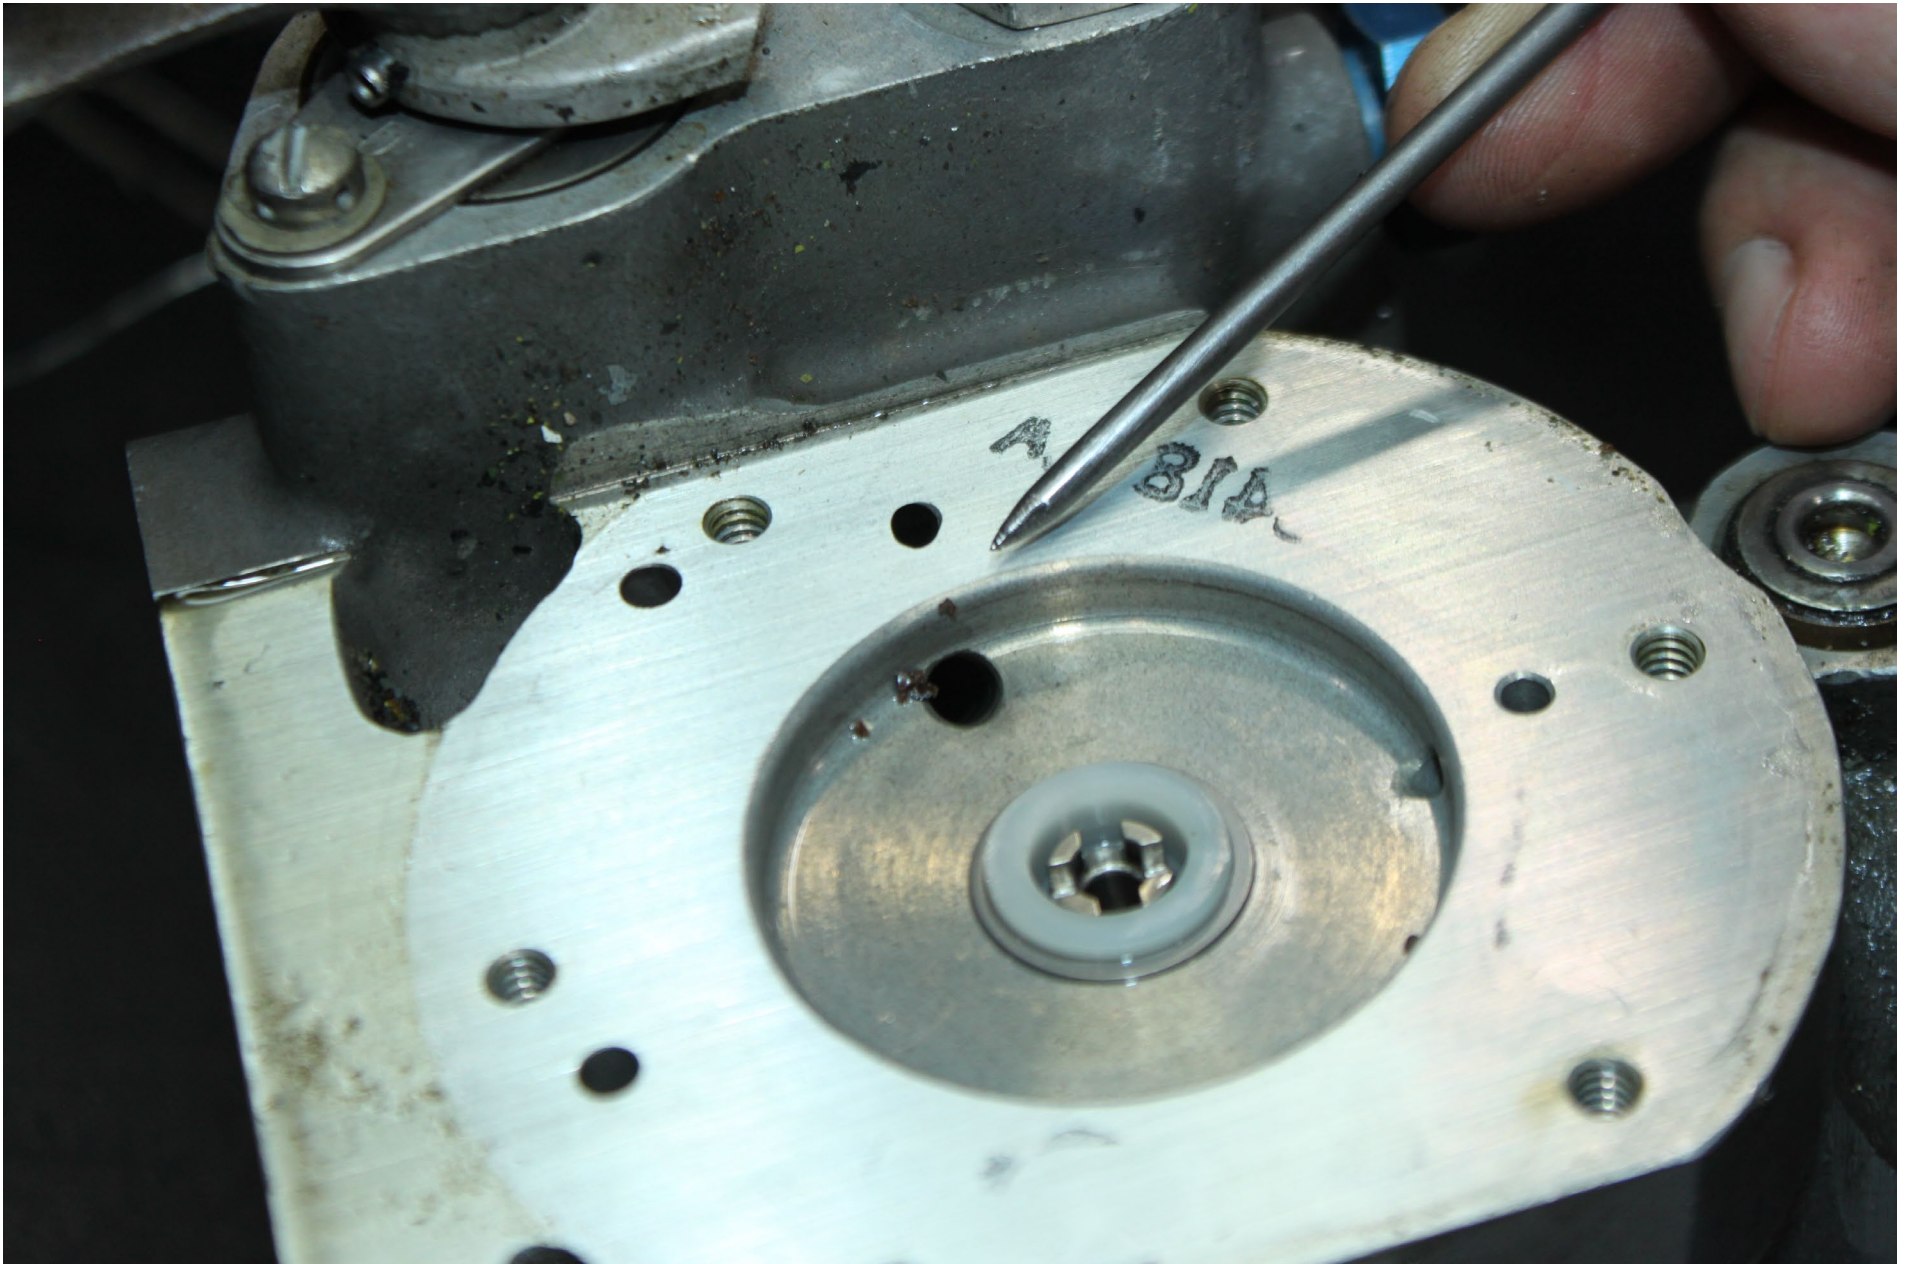
Photo 14 – NTSB Digital Photograph. View Showing the Contamination Inside the Fuel Section of the Regulator of the Right Fuel Injection Servo.

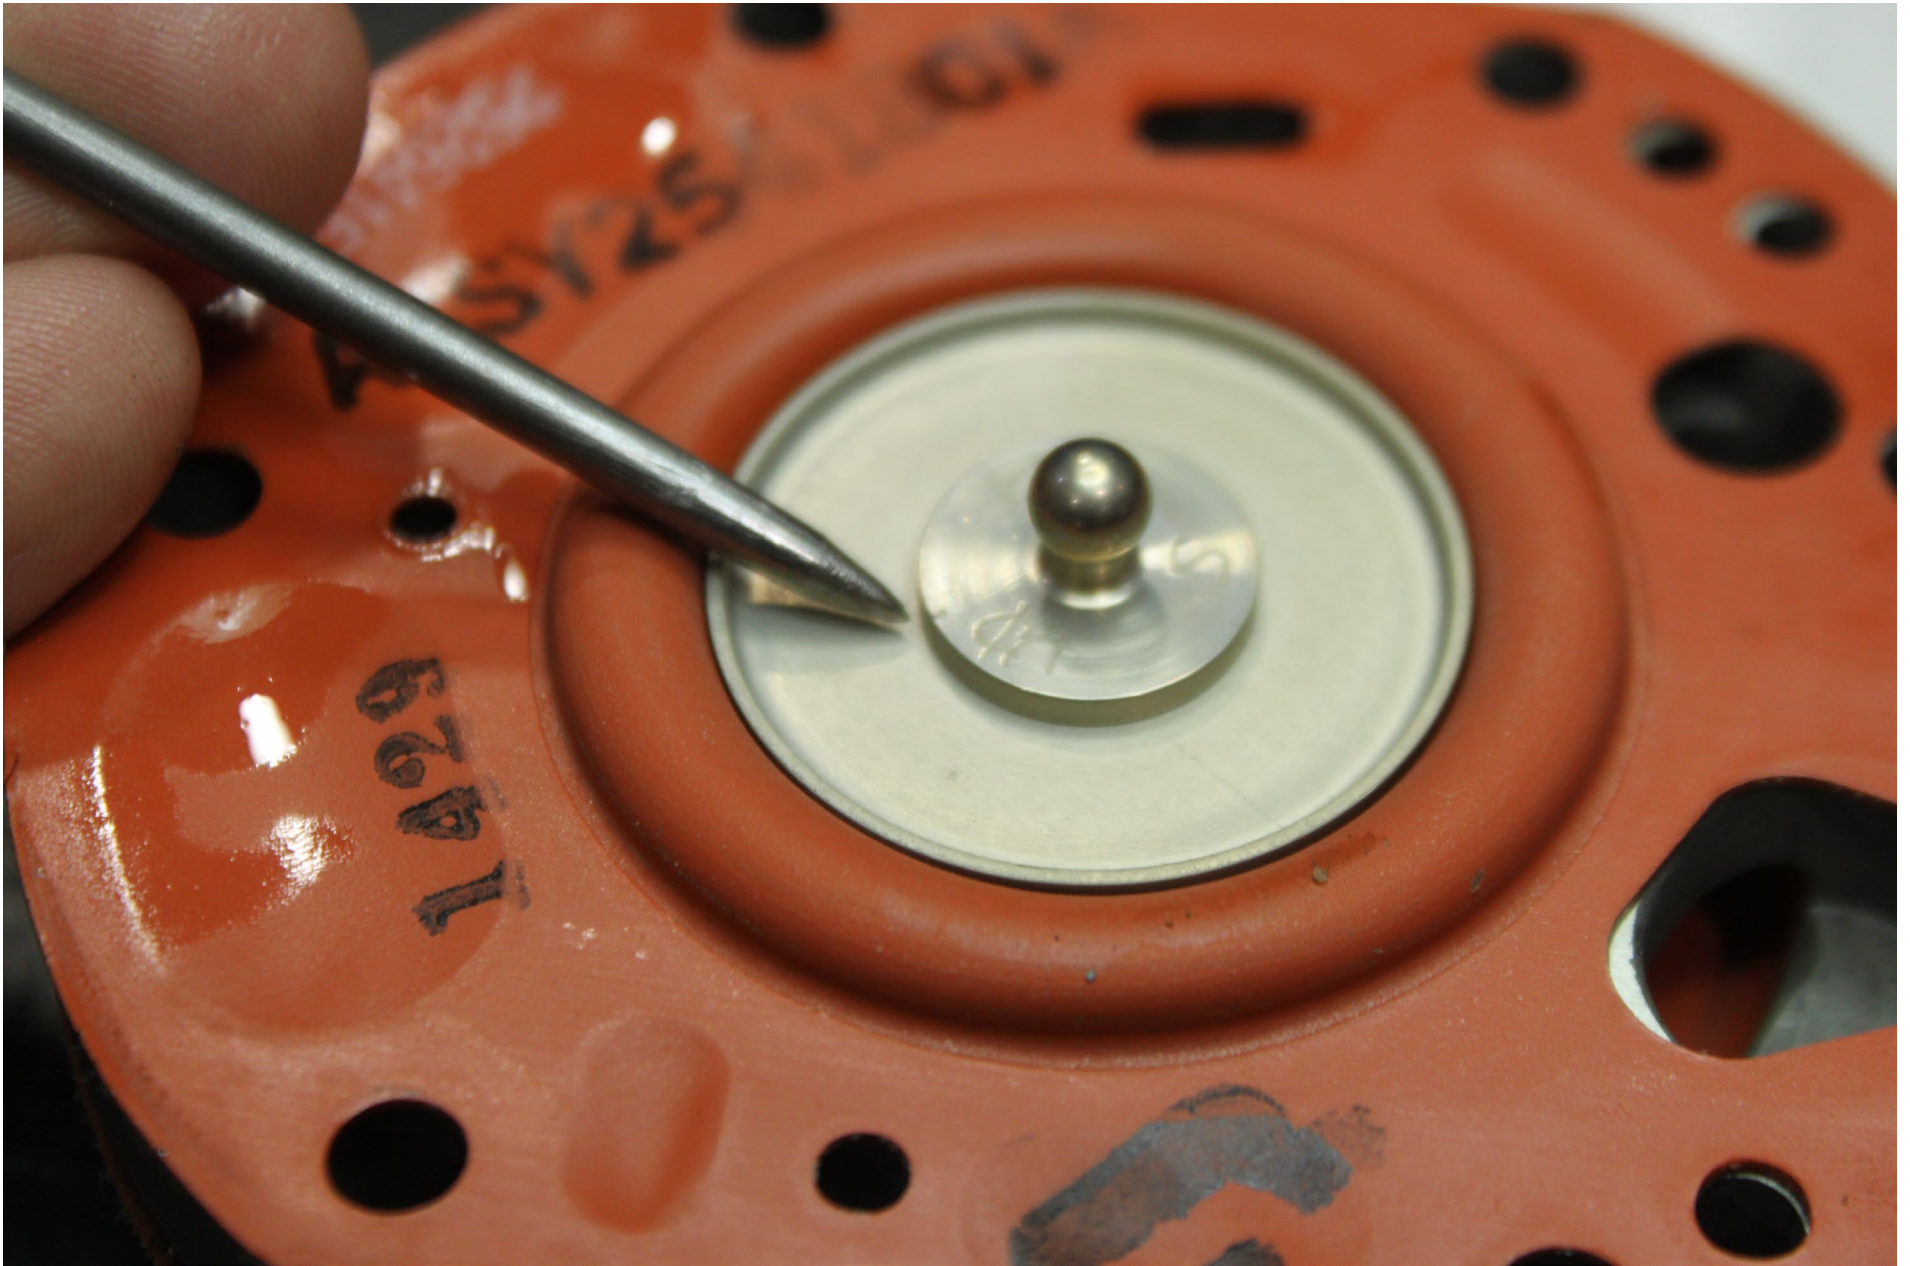
Photo 15 – NTSB Digital Photograph. Pointer is Pointing to Spec of Material on the Fuel Diaphragm of the Right Fuel Injection Servo.
