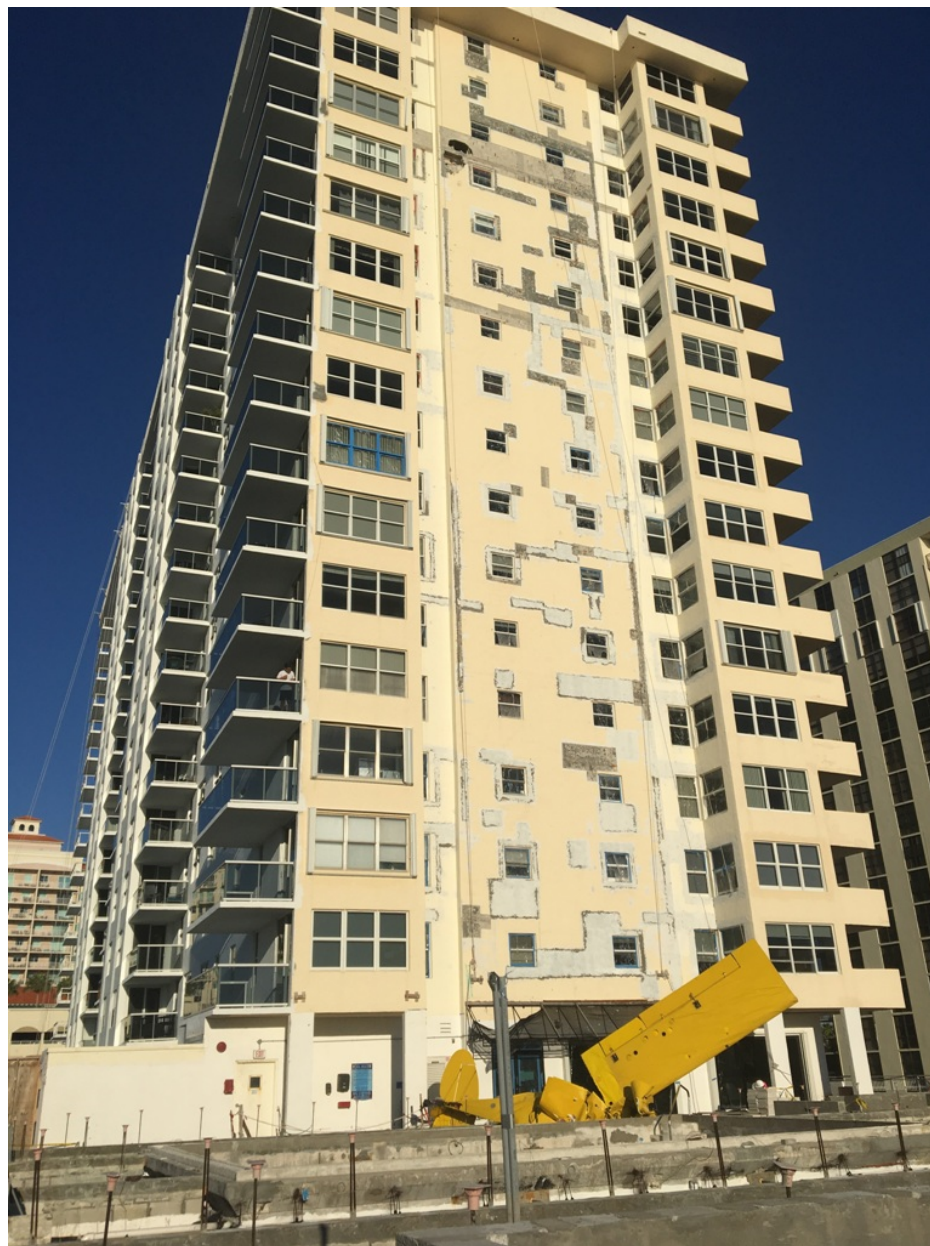
Photo 1 – NTSB Digital Photograph. View of the As-Found Position of the Airplane Adjacent to the Impacted Building.

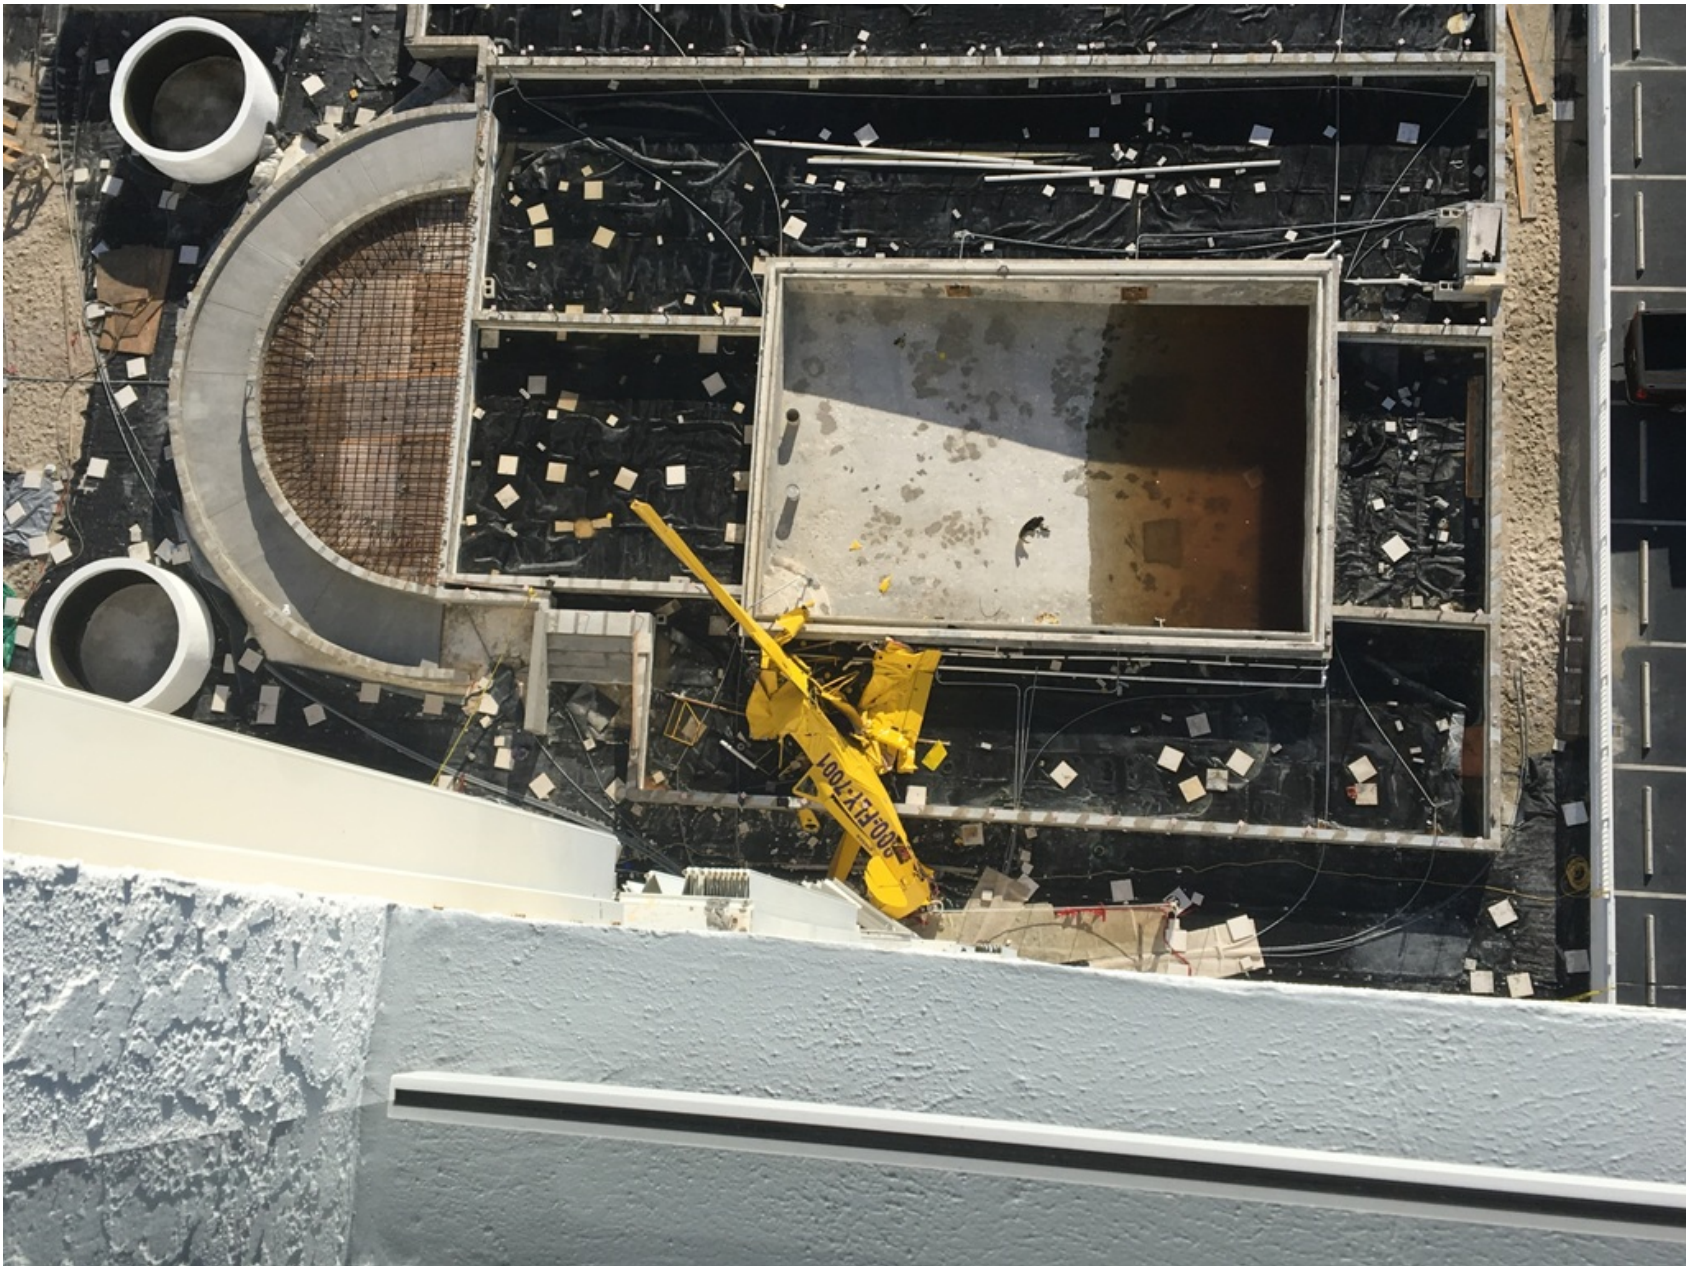
Photo 2 - NTSB Digital Photograph. View of the Airplane From One of the Impacted Units.

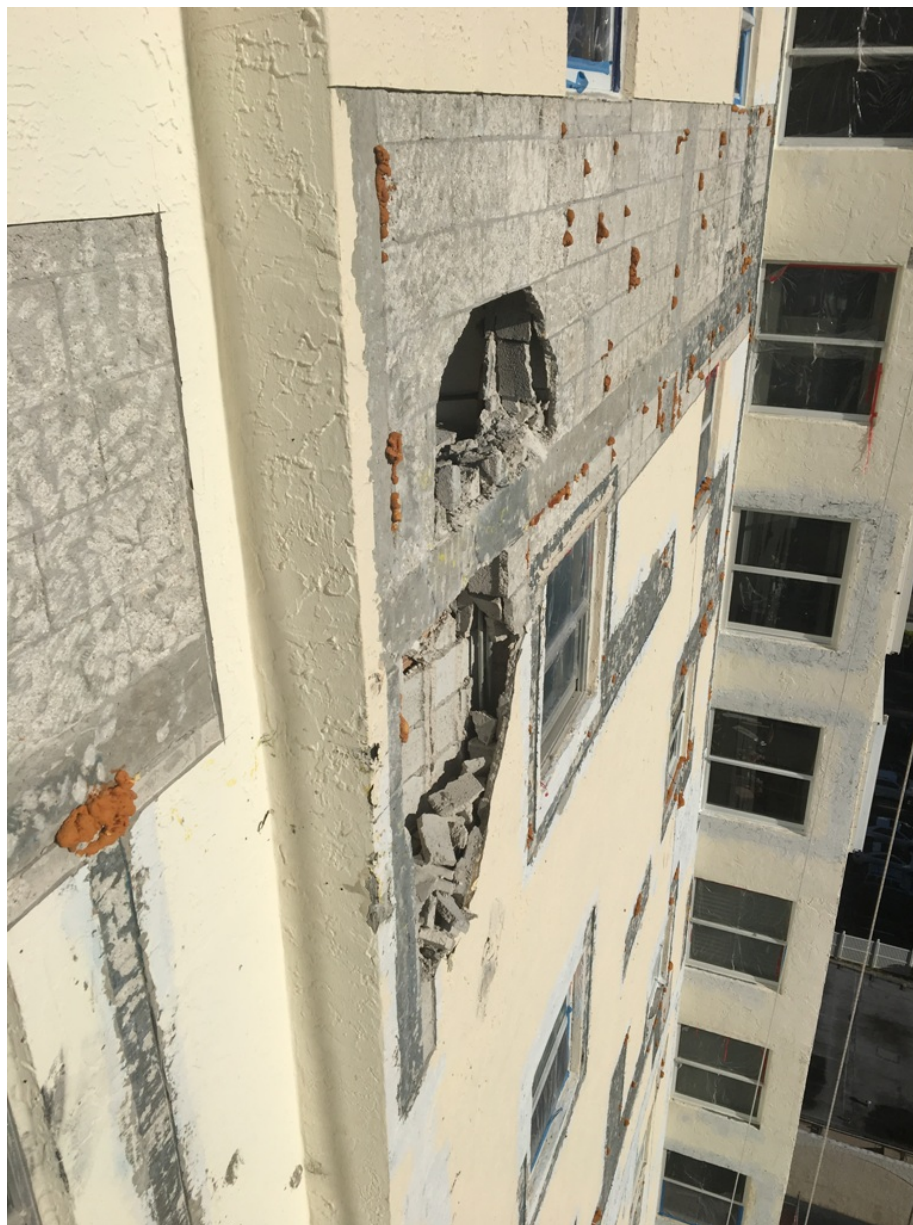
Photo 3 - NTSB Digital Photograph. View of the Damage to the East Face of the Impacted Building.

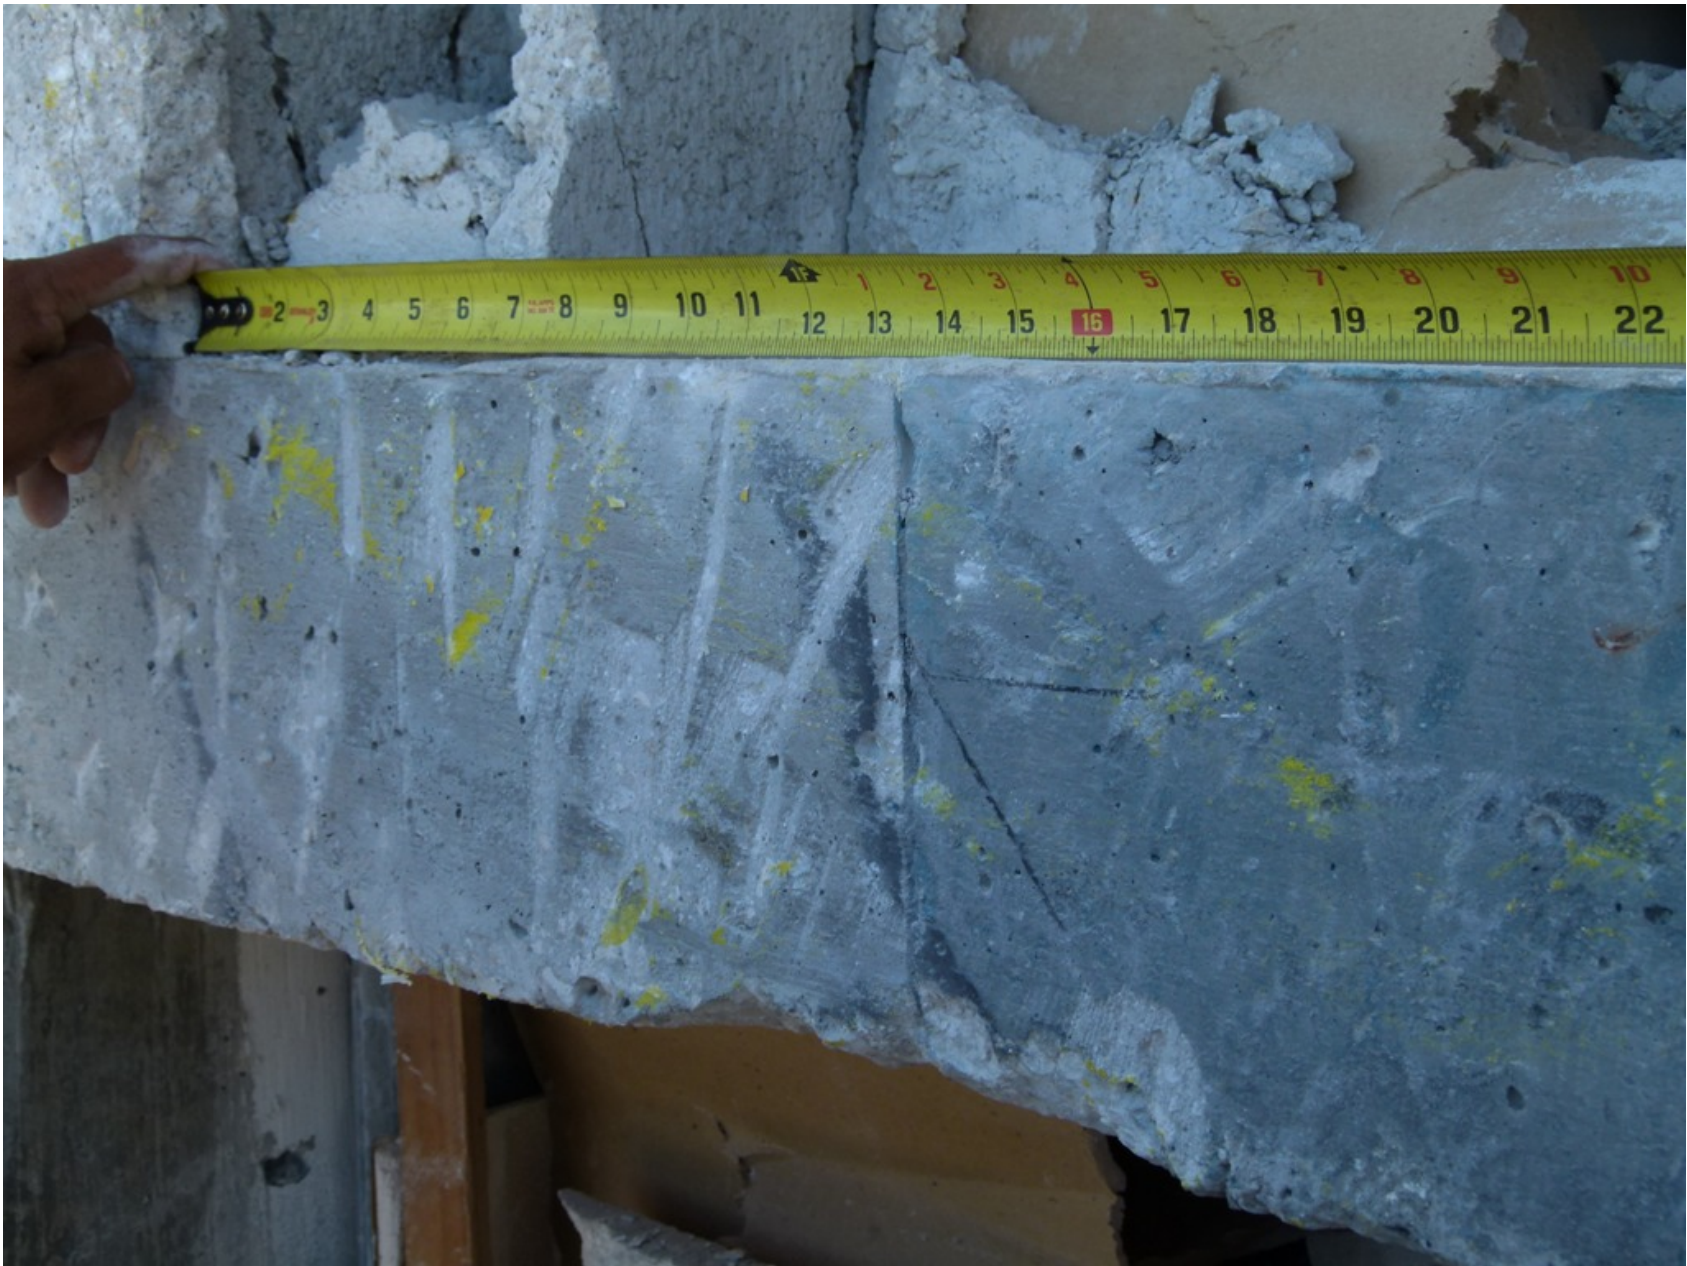
Photo 4 – Digital Photograph From SRI Consultants, Inc. View Depicting Gouges on the East Face of the Impacted Building.

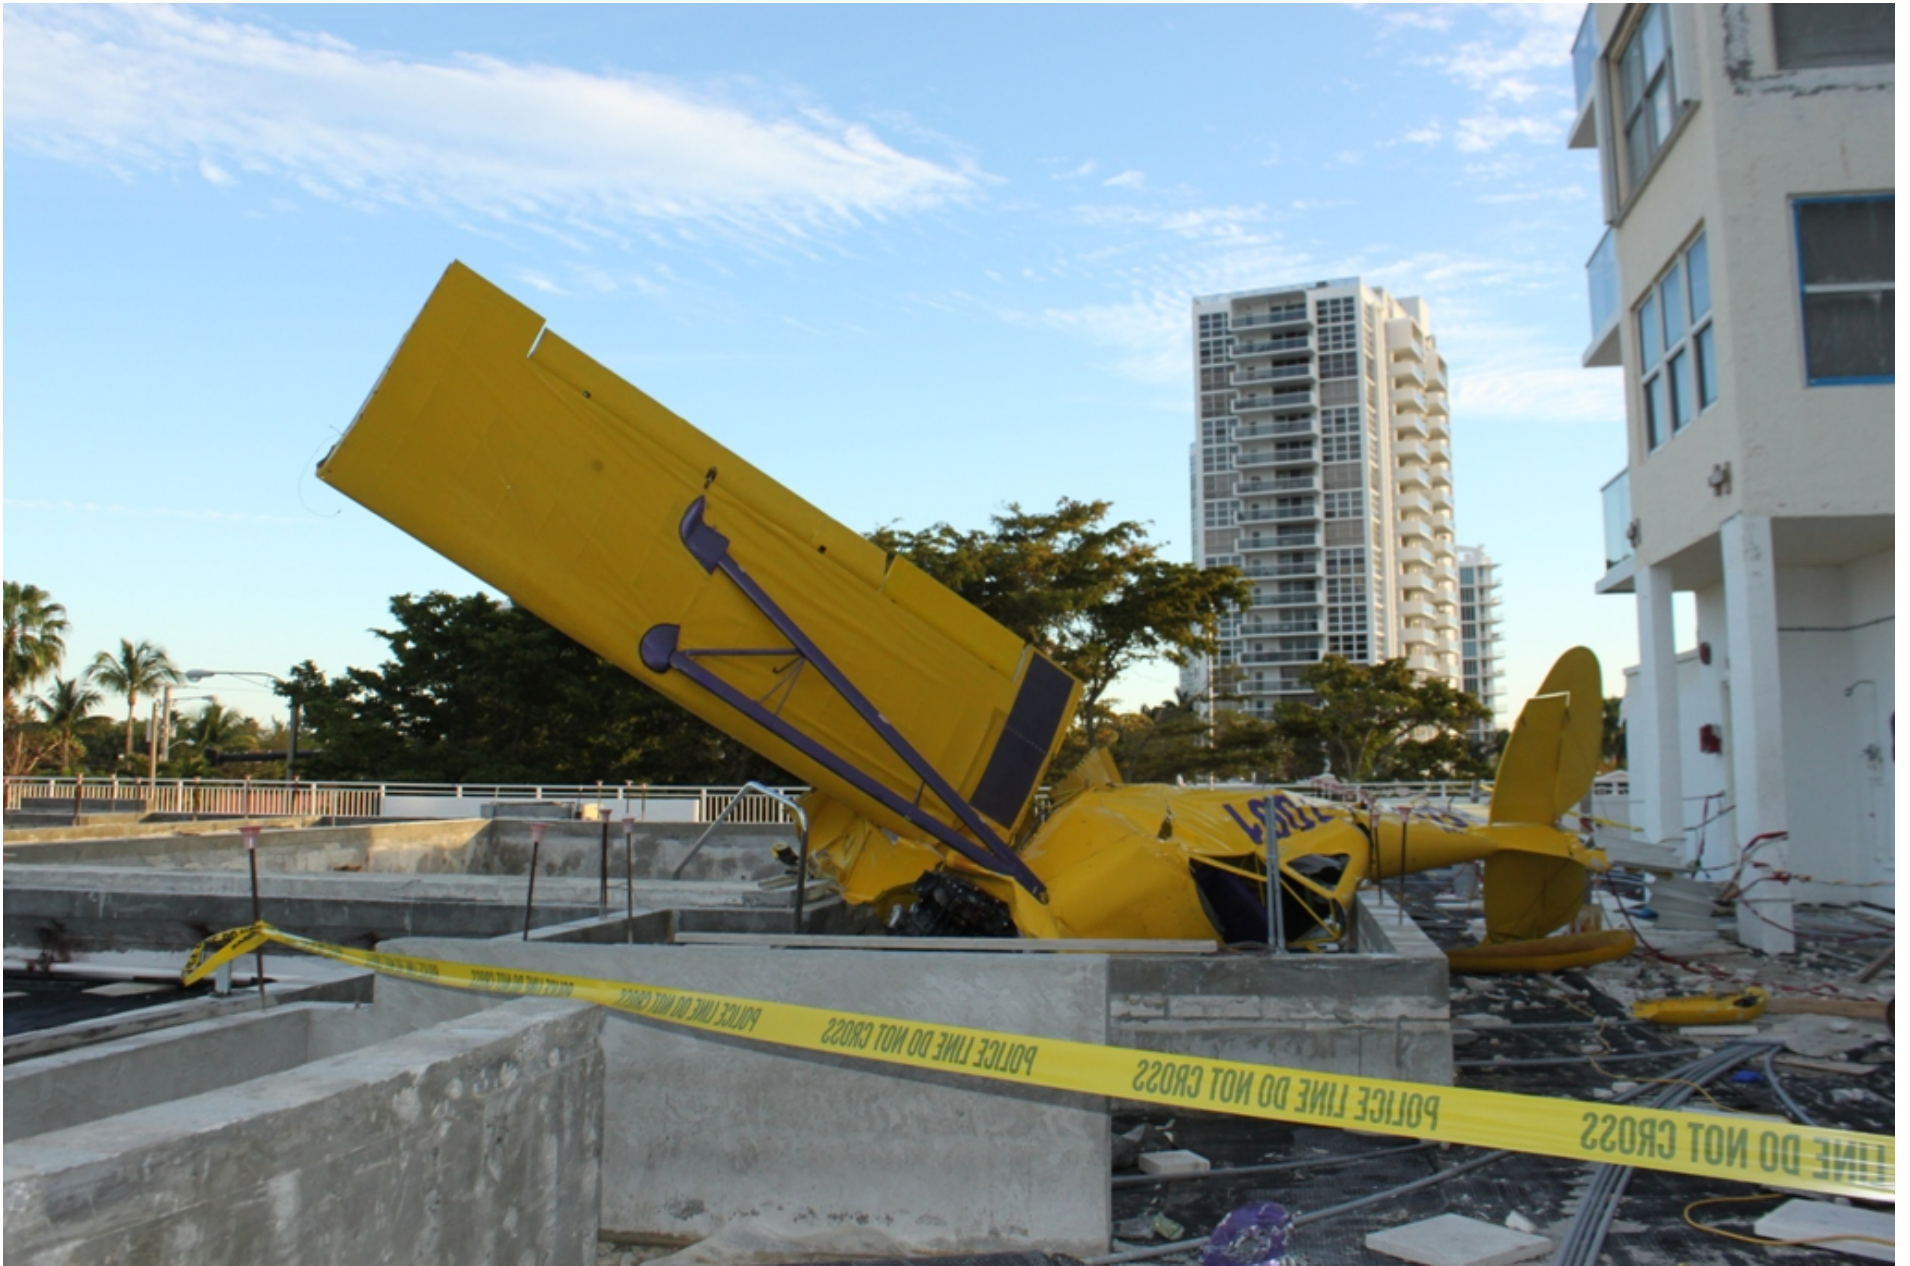
Photo 5 - NTSB Digital Photograph. View of the Resting Position of the Airplane Where it Came to Rest.

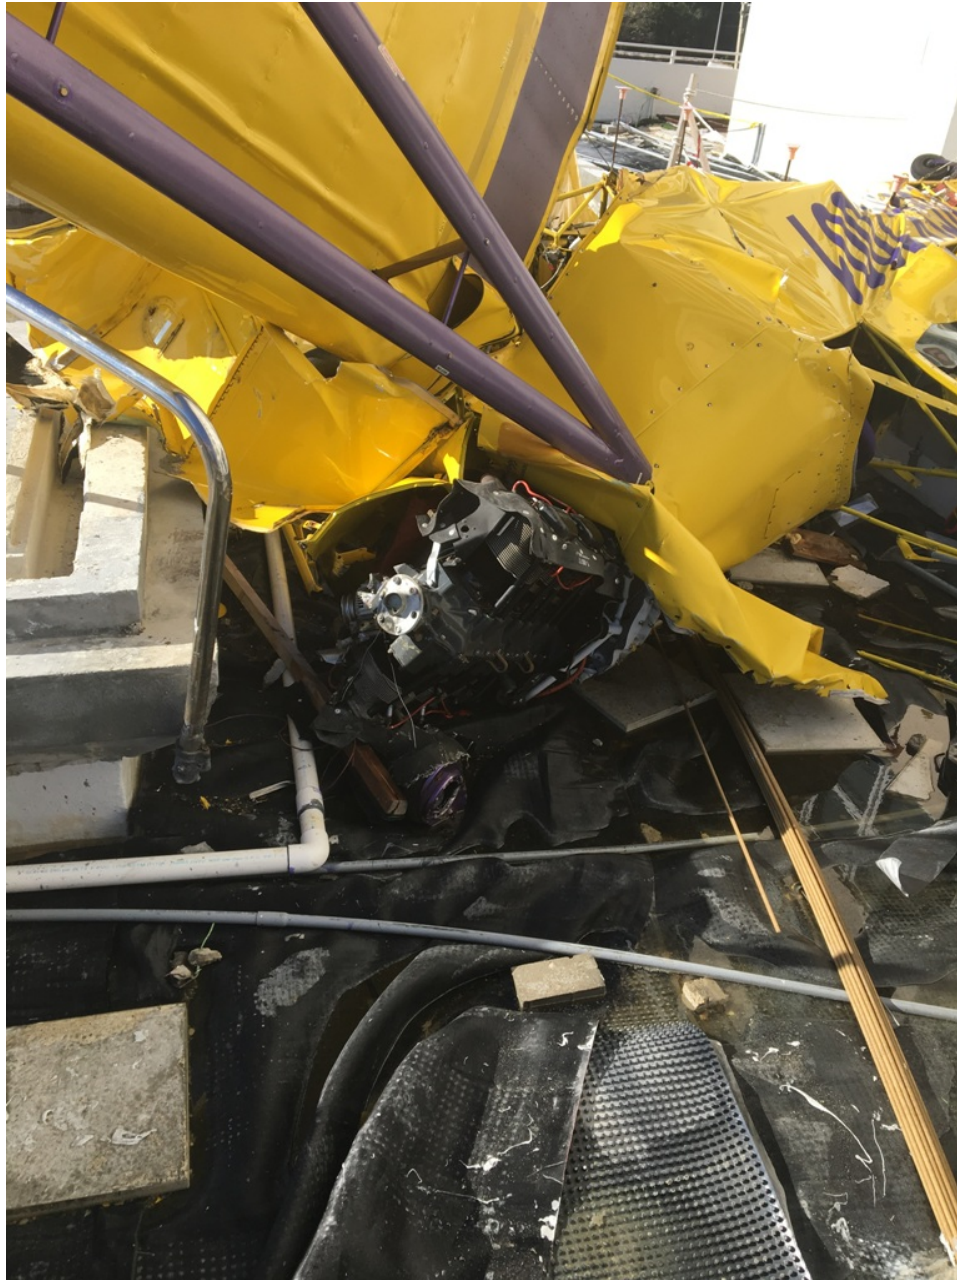
Photo 6 - NTSB Digital Photograph. View of the Engine Assembly At the Resting Position of the Airplane. Note the Separated Propeller.

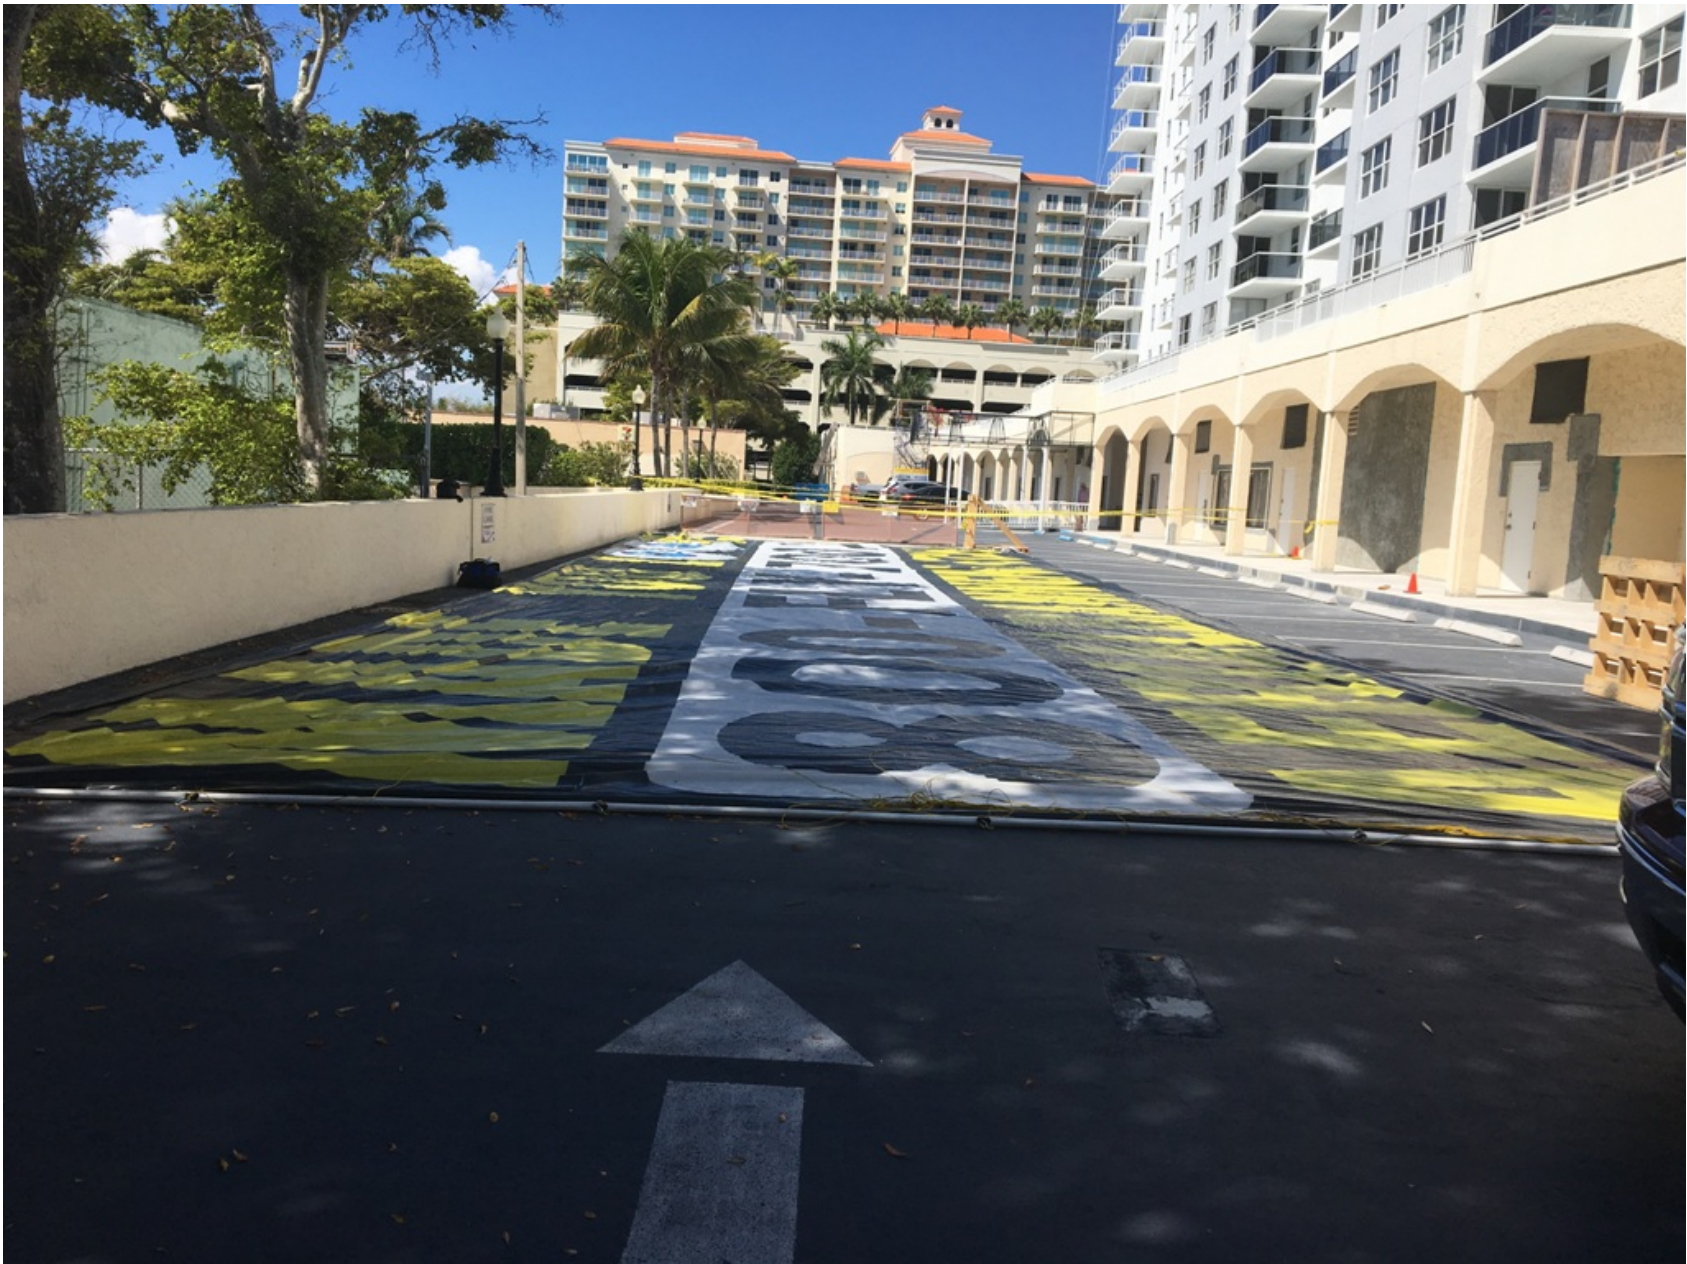
Photo 7 - NTSB Digital Photograph. View of the Banner Assembly.

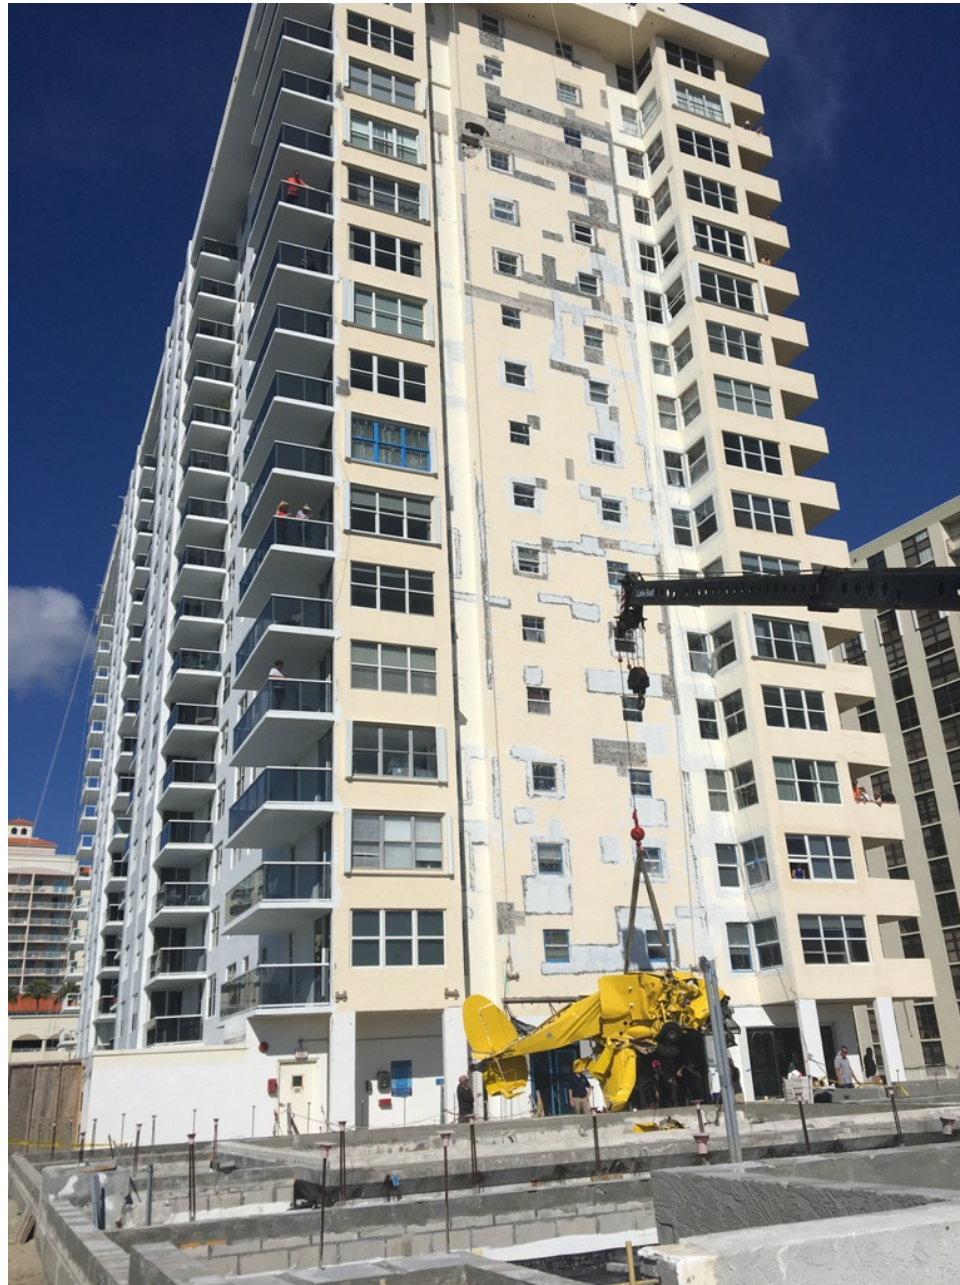
Photo 8 - NTSB Digital Photograph. View of the Airplane During Recovery.

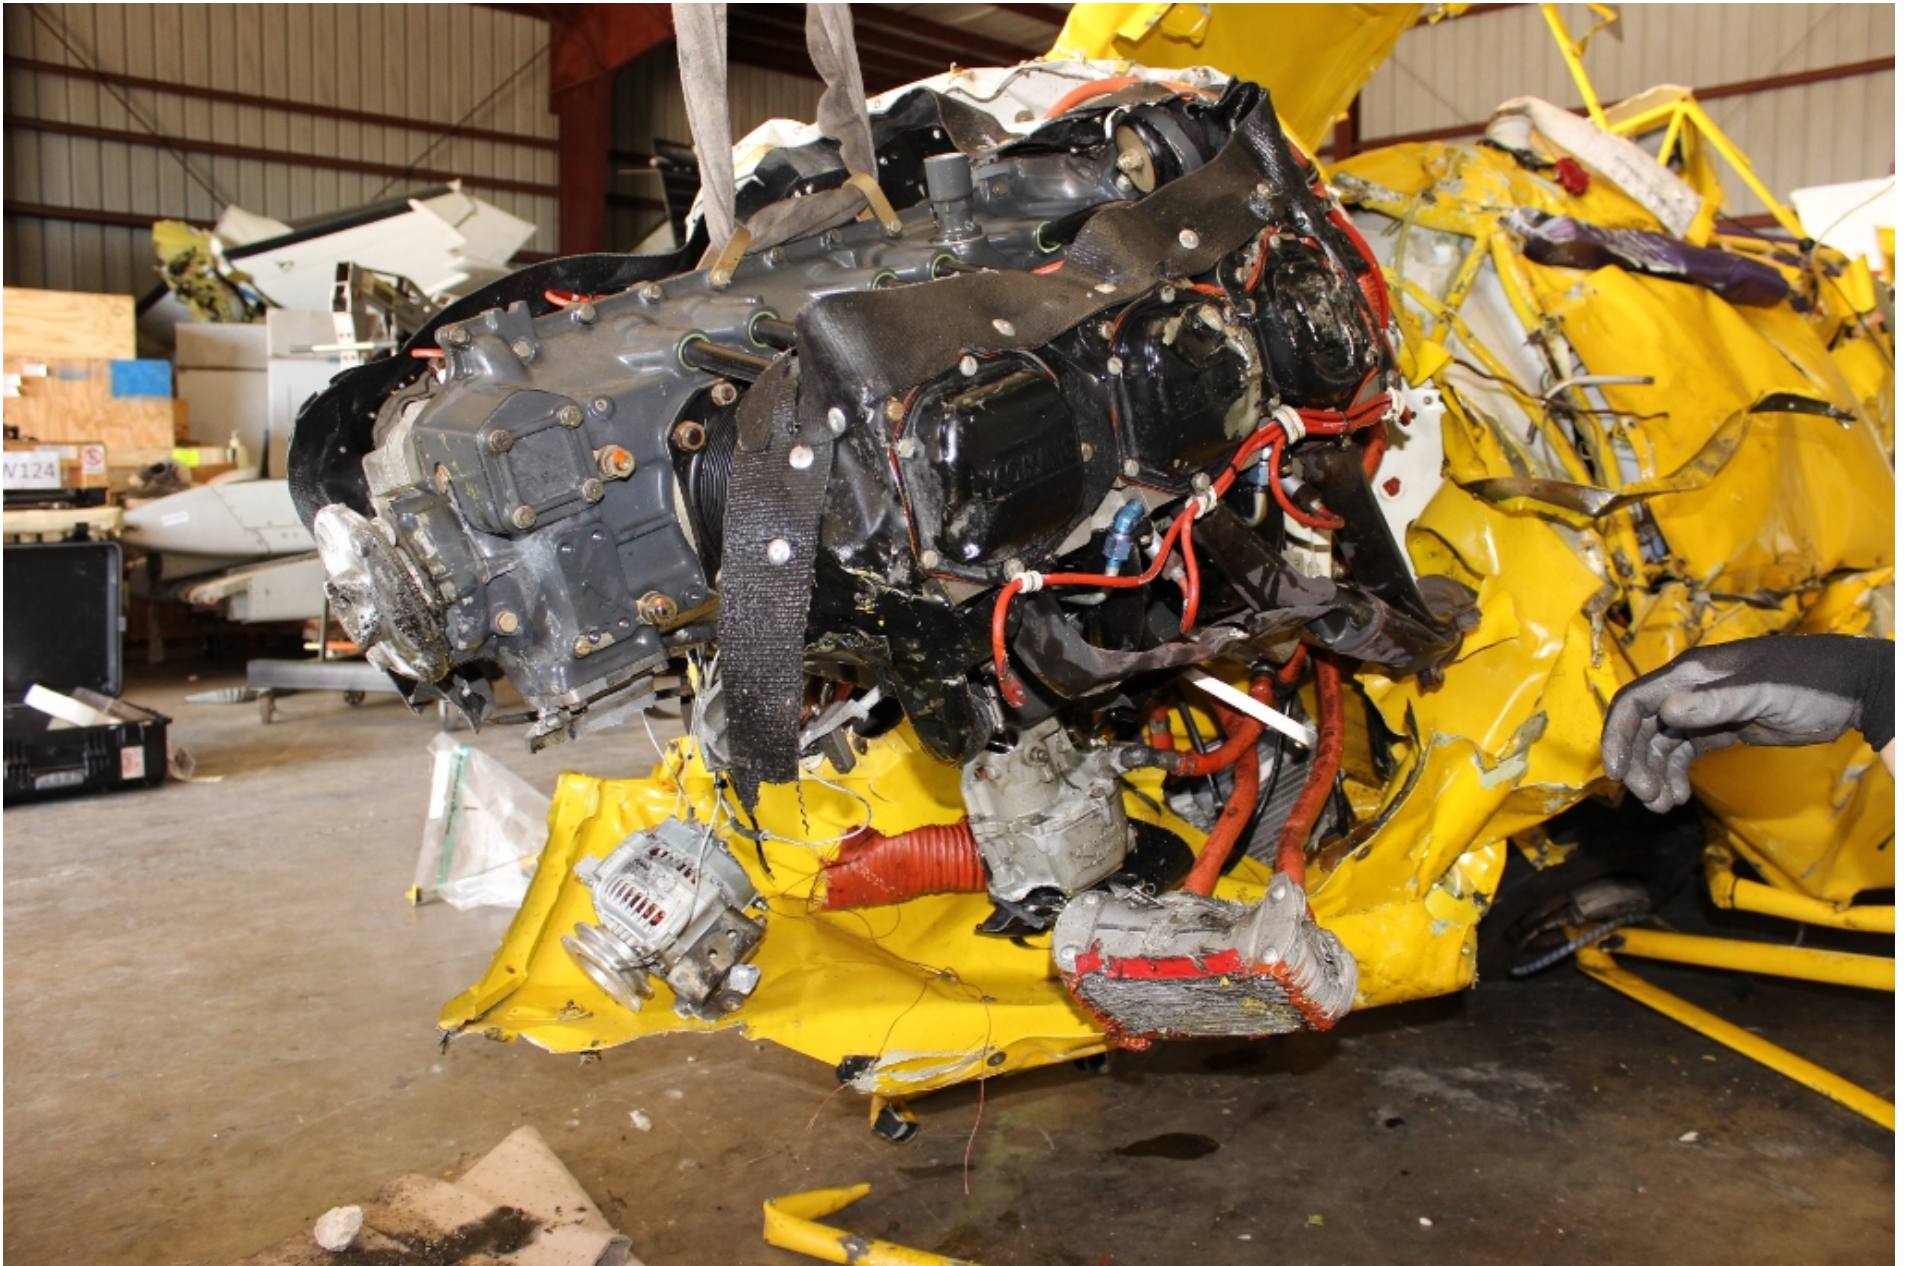
Photo 9 - NTSB Digital Photograph. View of the Left Side of the Engine Assembly.

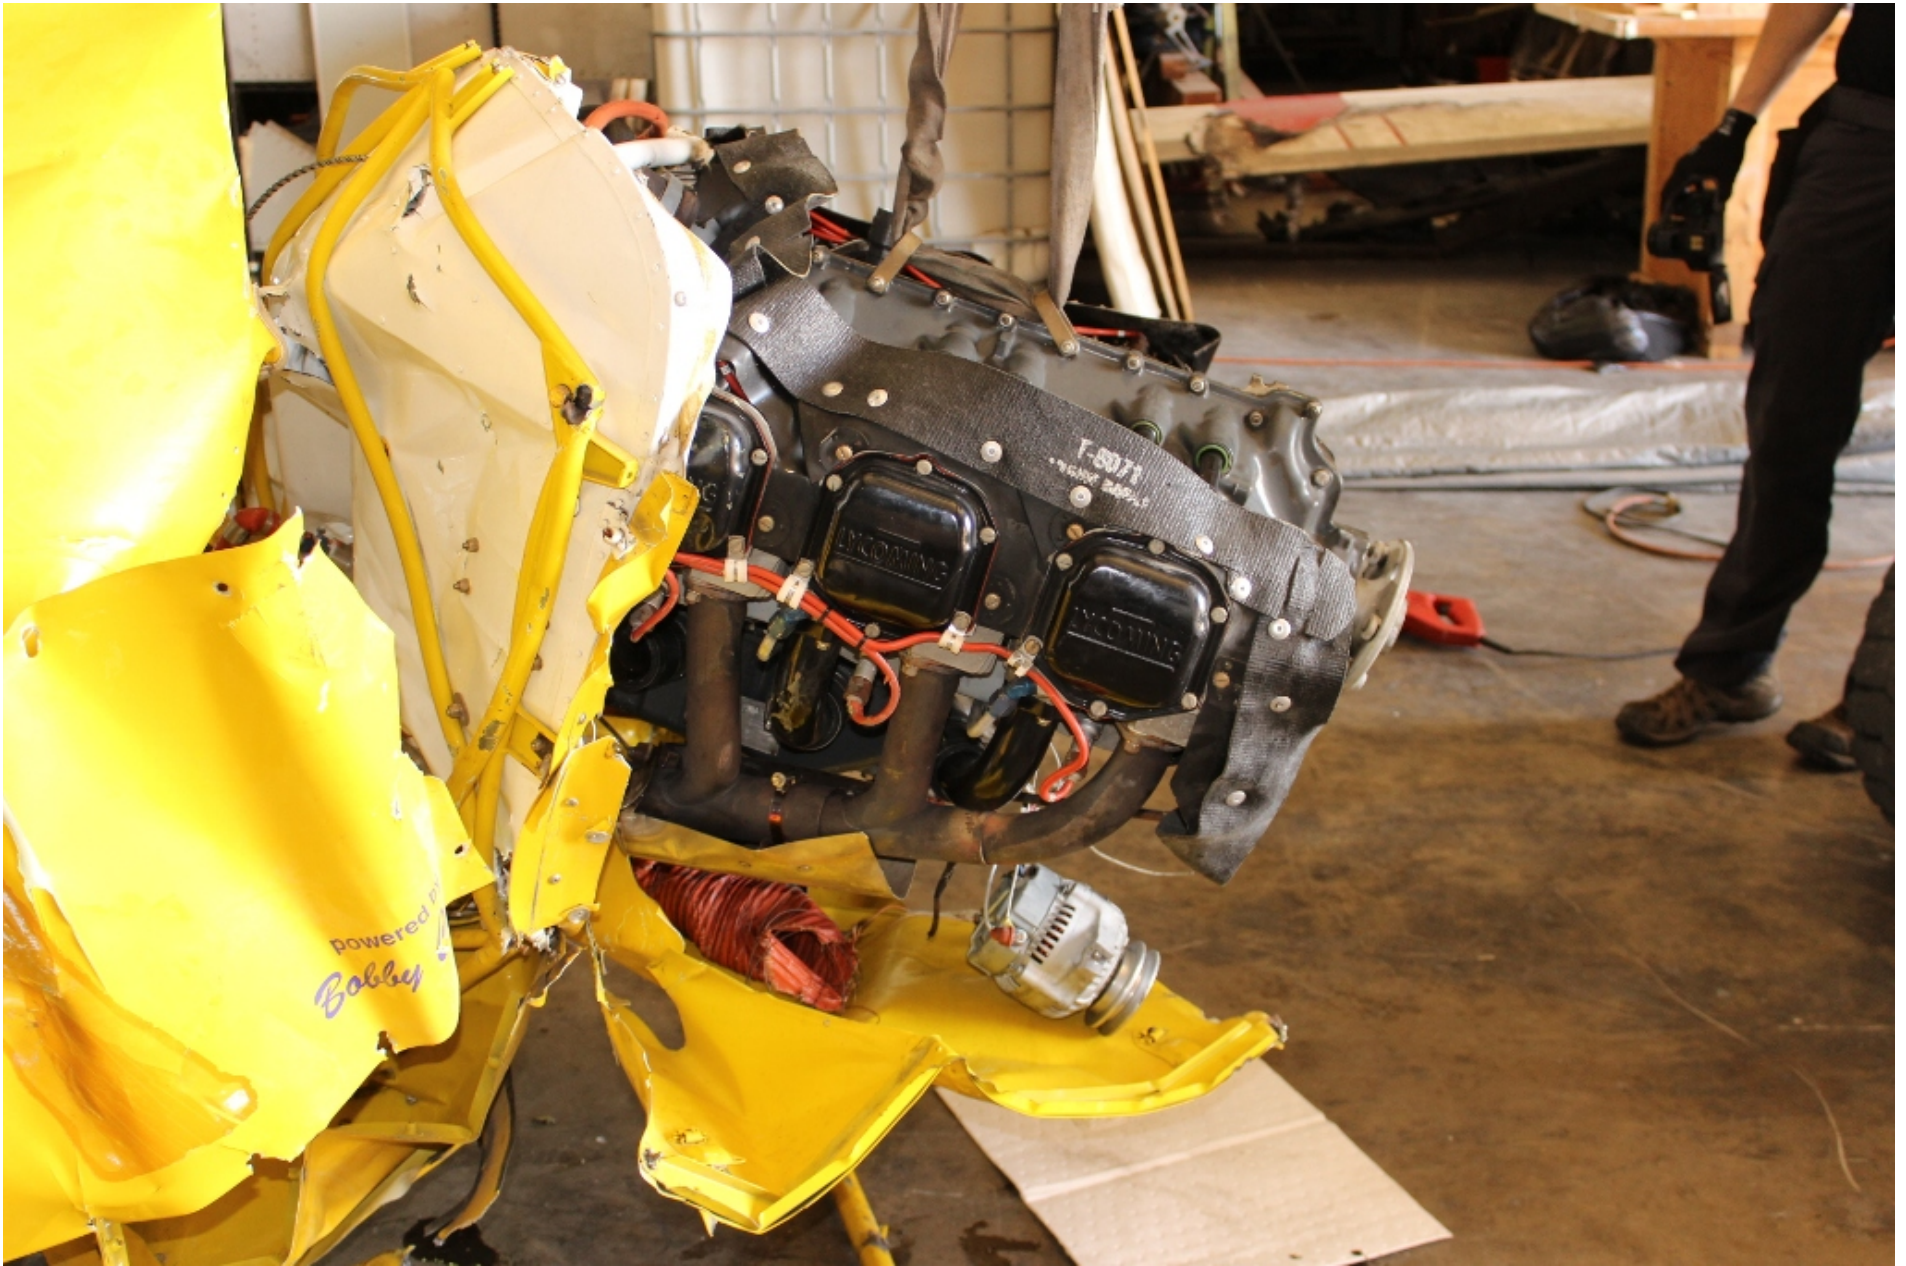
Photo 10 - NTSB Digital Photograph. View of the Right Side of the Engine Assembly.

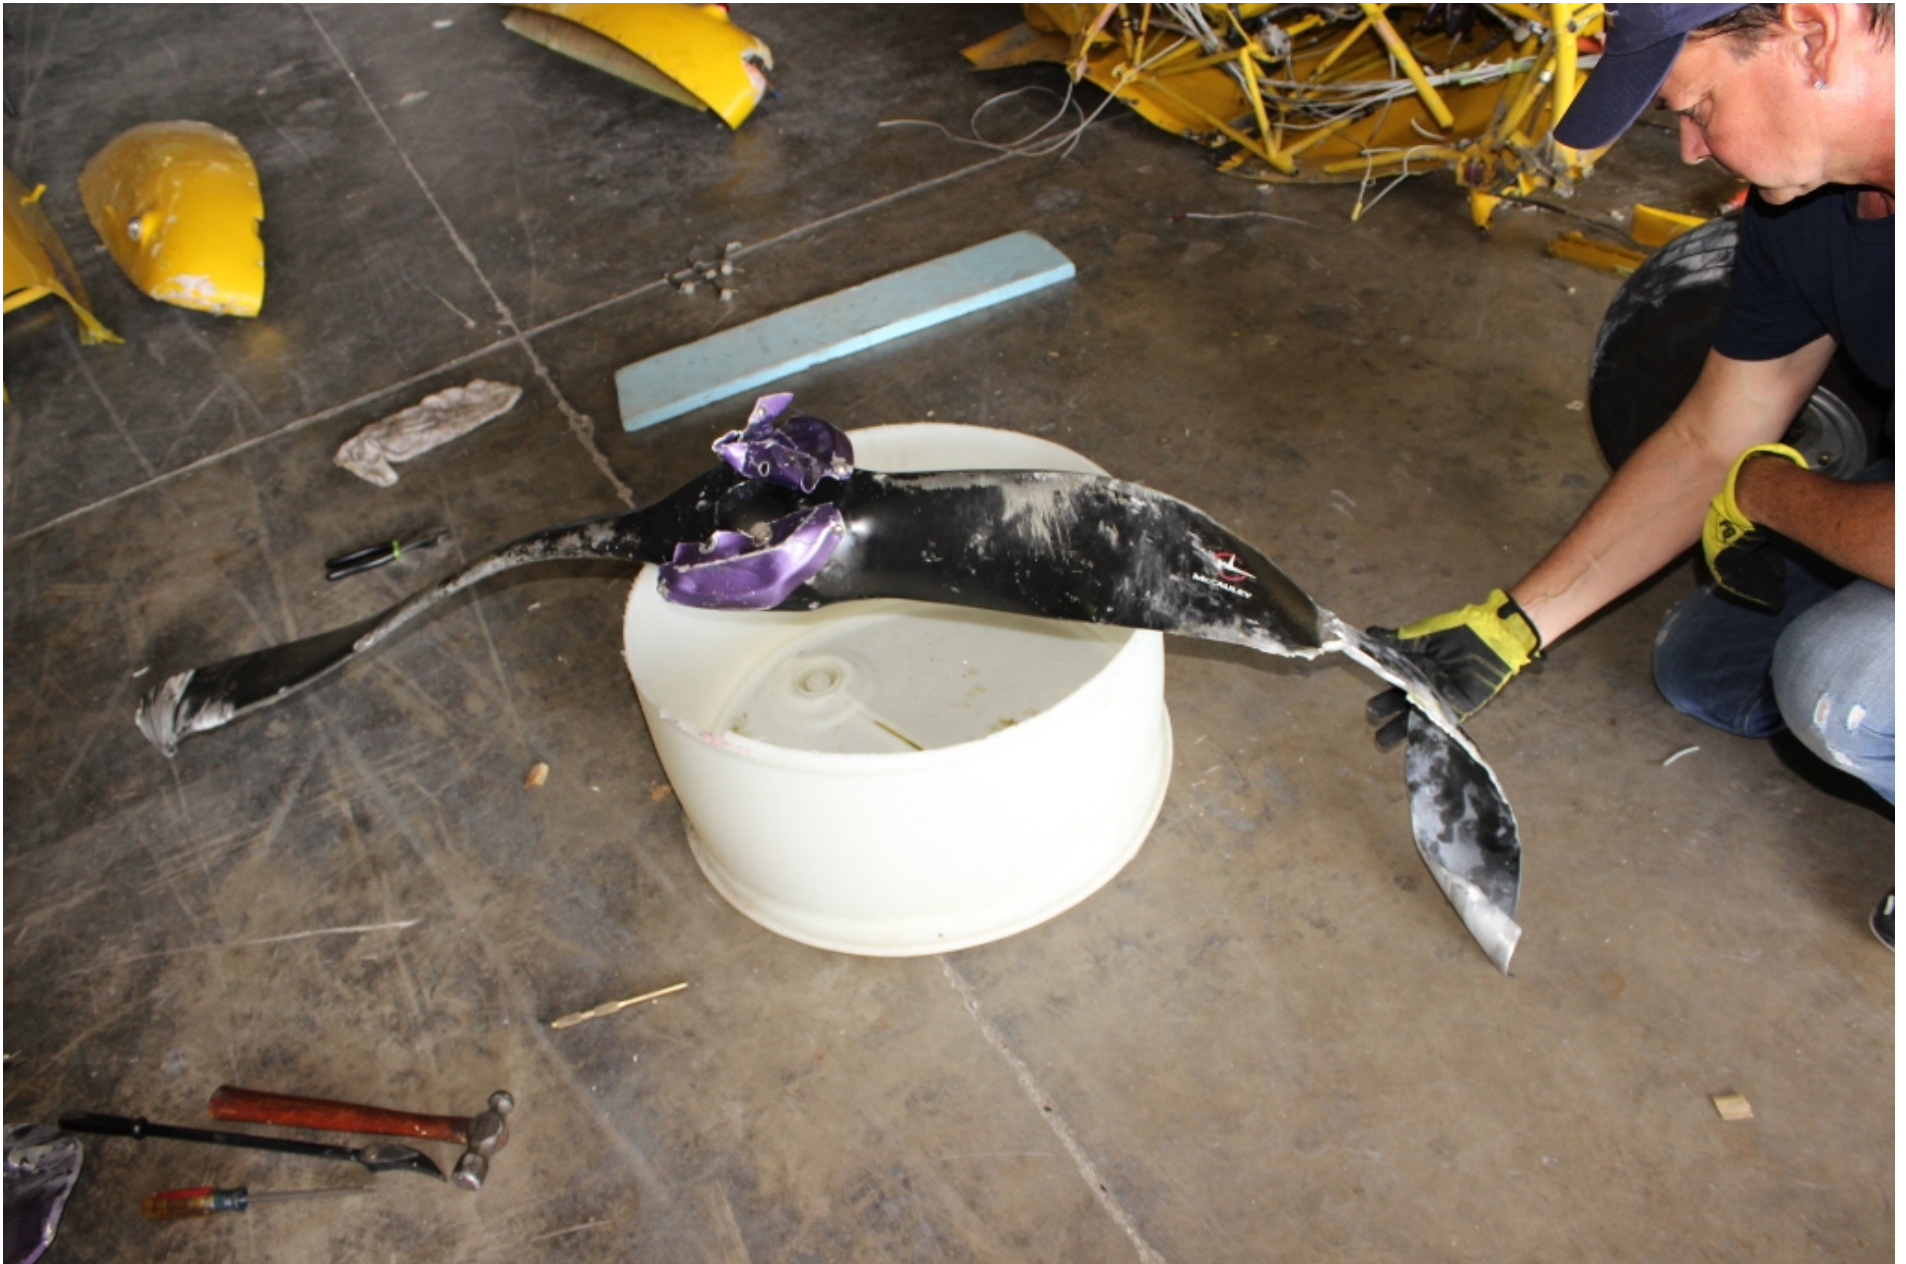
Photo 11 - NTSB Digital Photograph. View of the Propeller Assembly. Note the Placement of the Fractured Propeller Blade.
