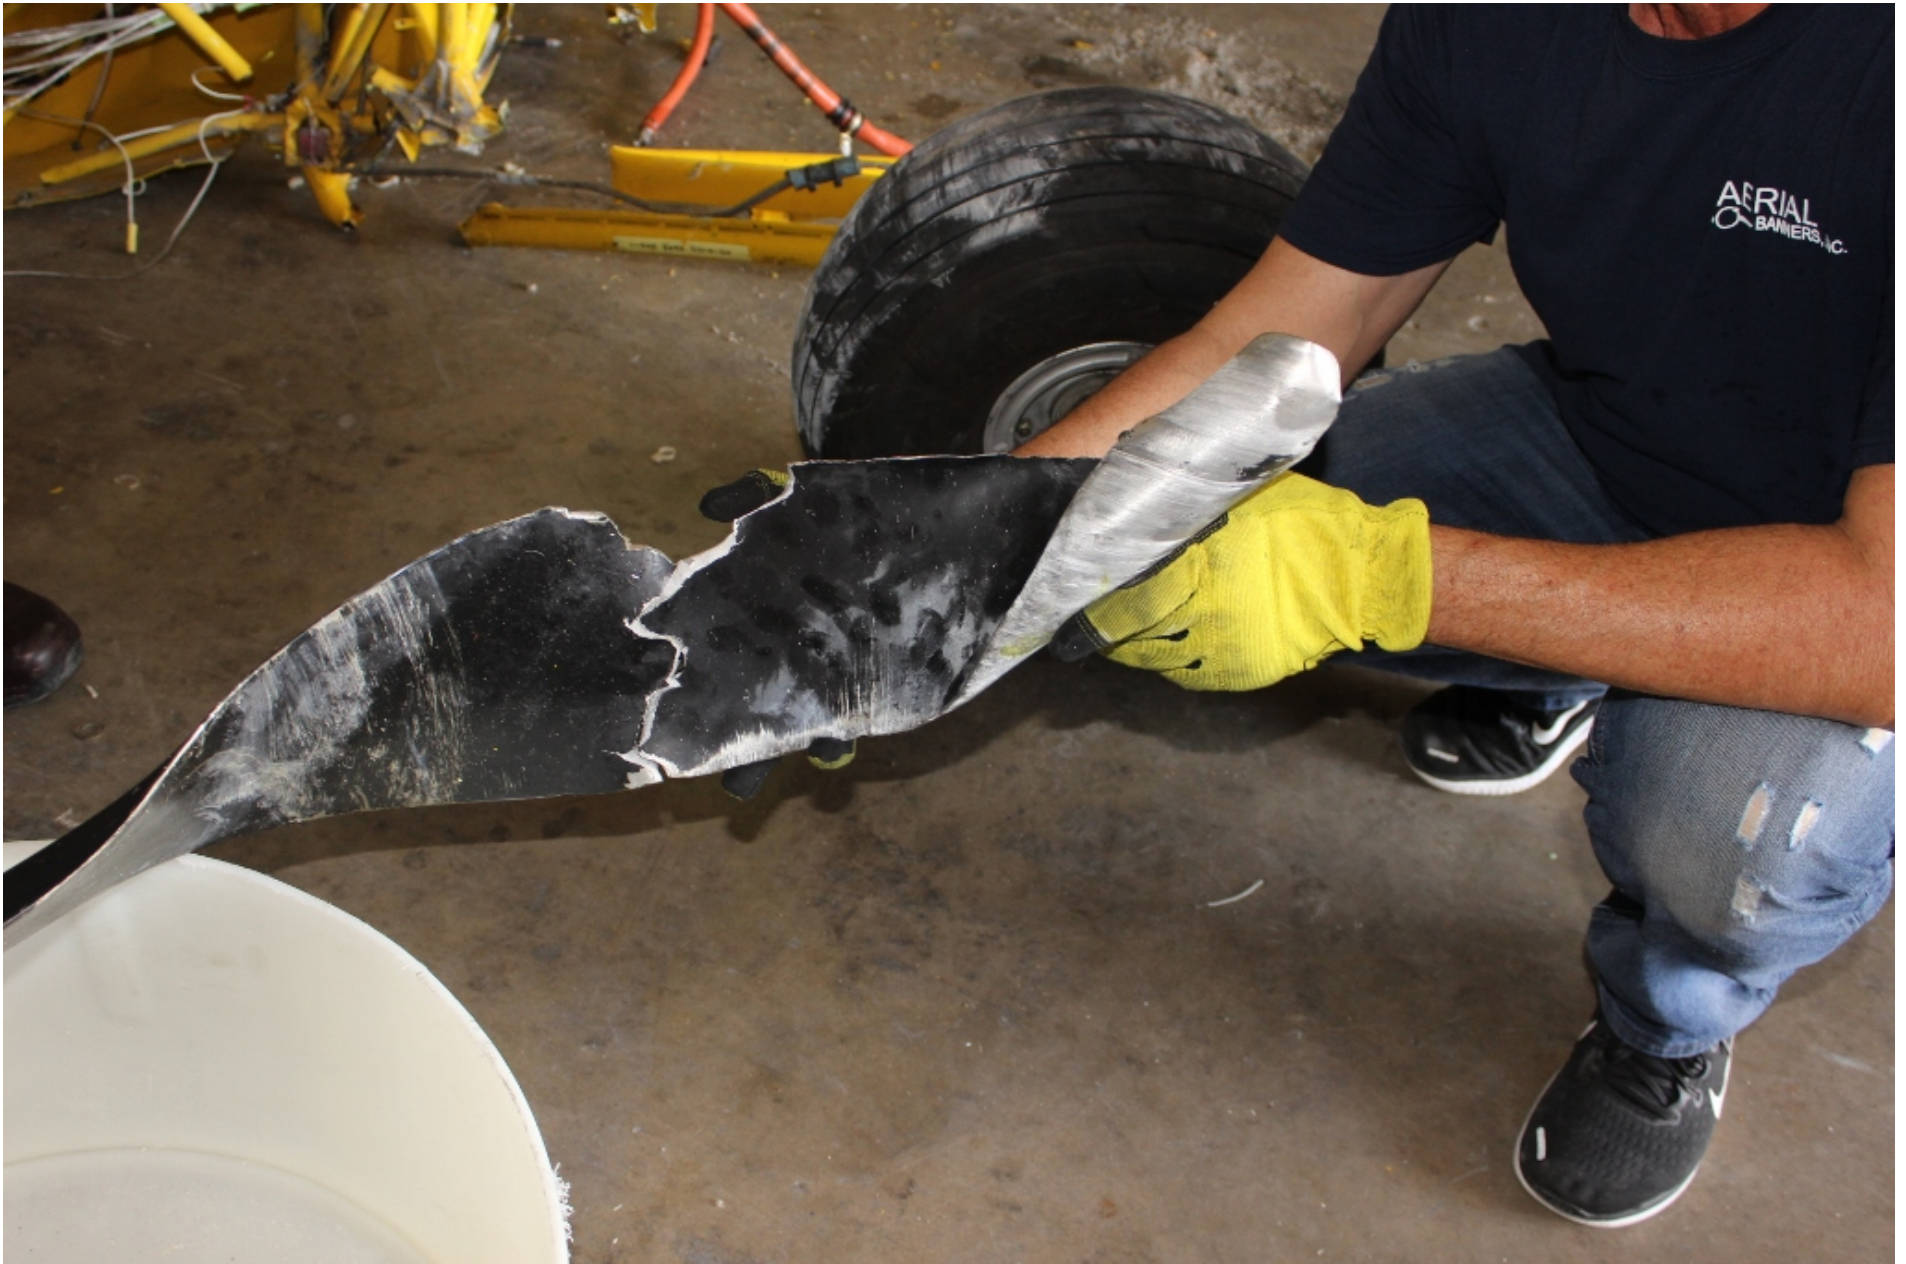
Photo 12 - NTSB Digital Photograph. View of the Fractured Propeller Blade. Note the Heavy, Course Chordwise Scratches and Curling.
