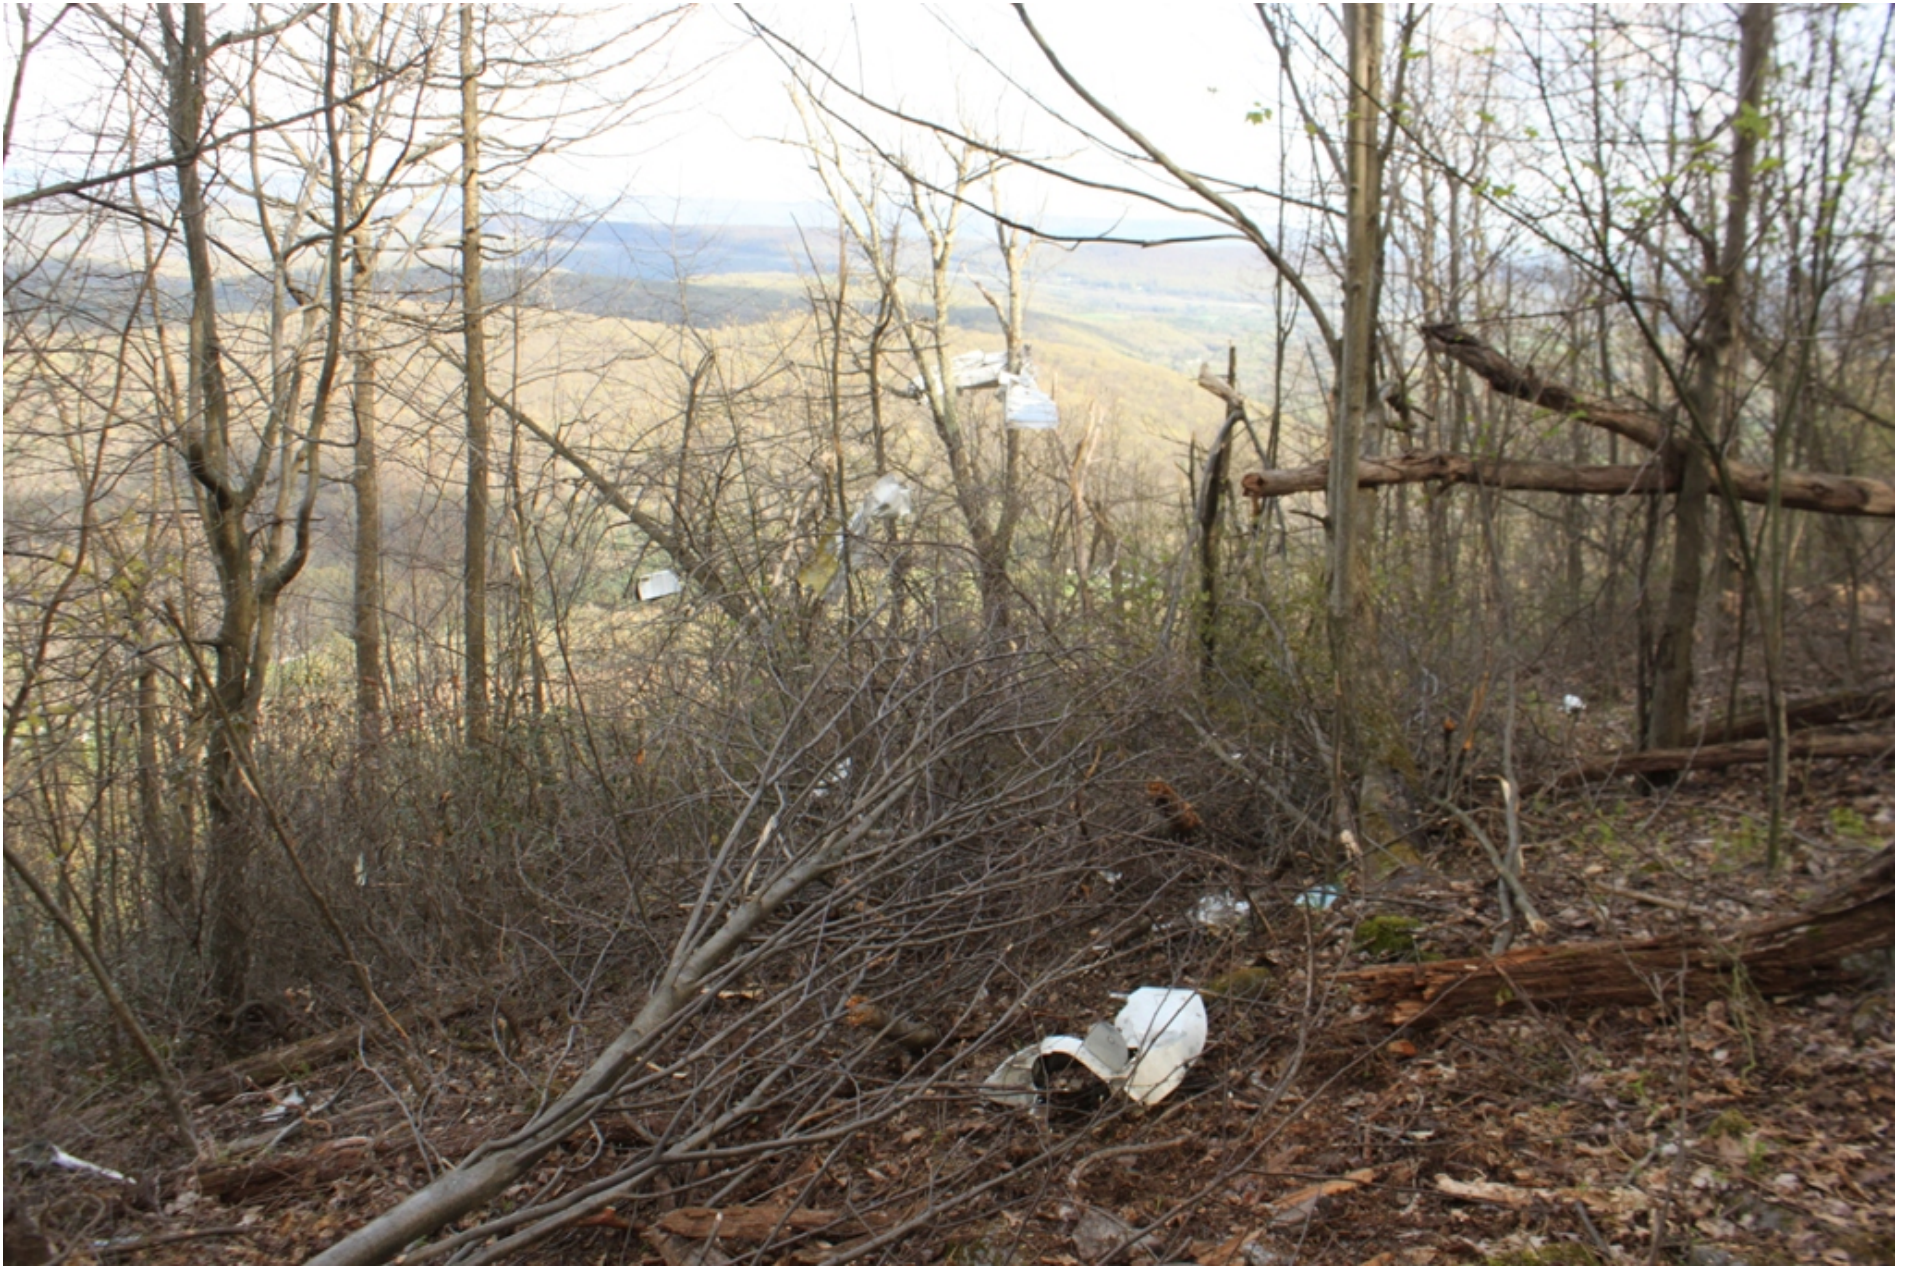
Photo 3 – NTSB Digital Photograph. View Depicting Wreckage on the Ground and Among Trees.

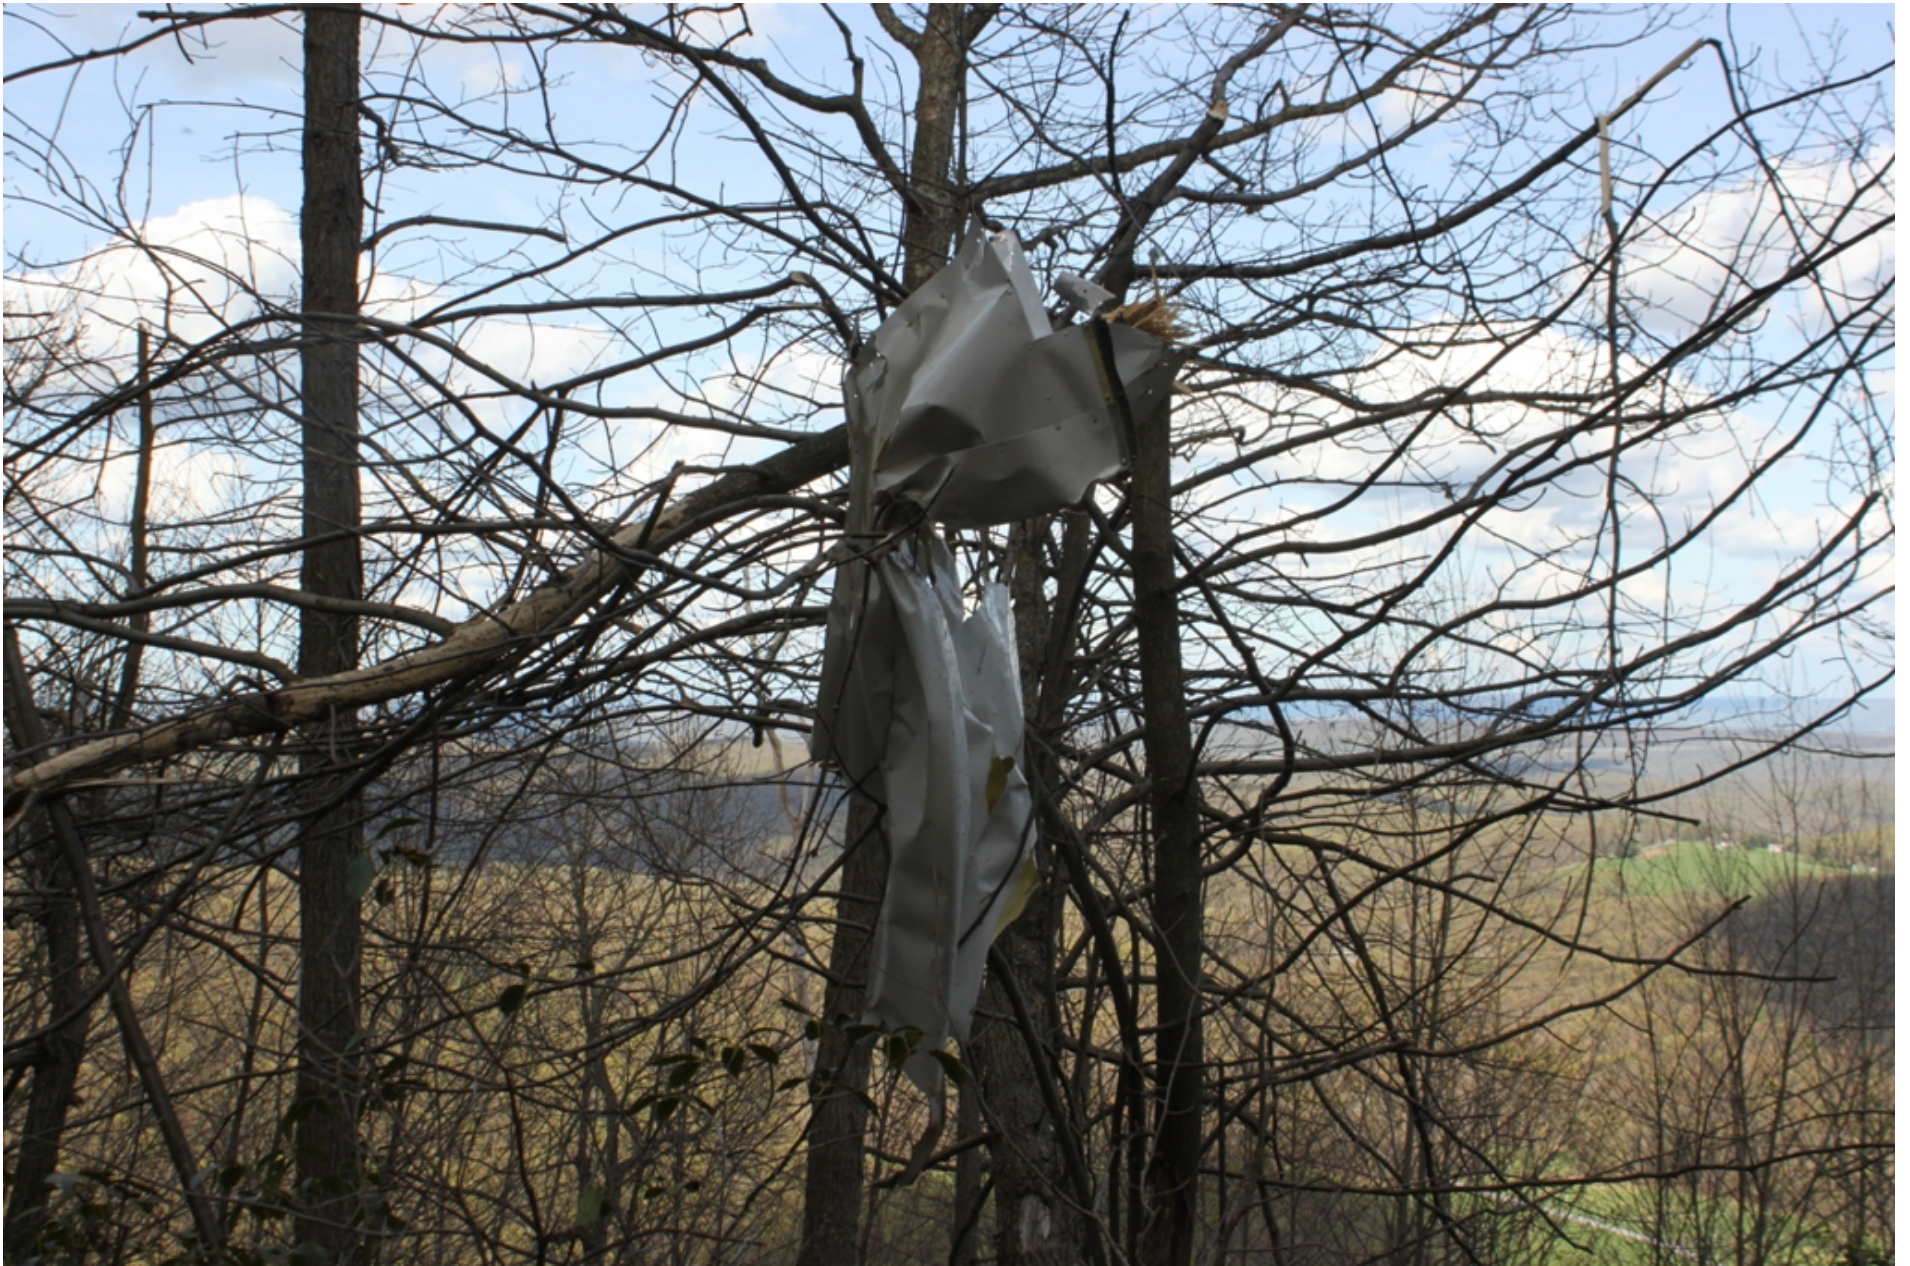
Photo 4 - NTSB Digital Photograph. View Depicting Right Wing Section Suspended in Tree.

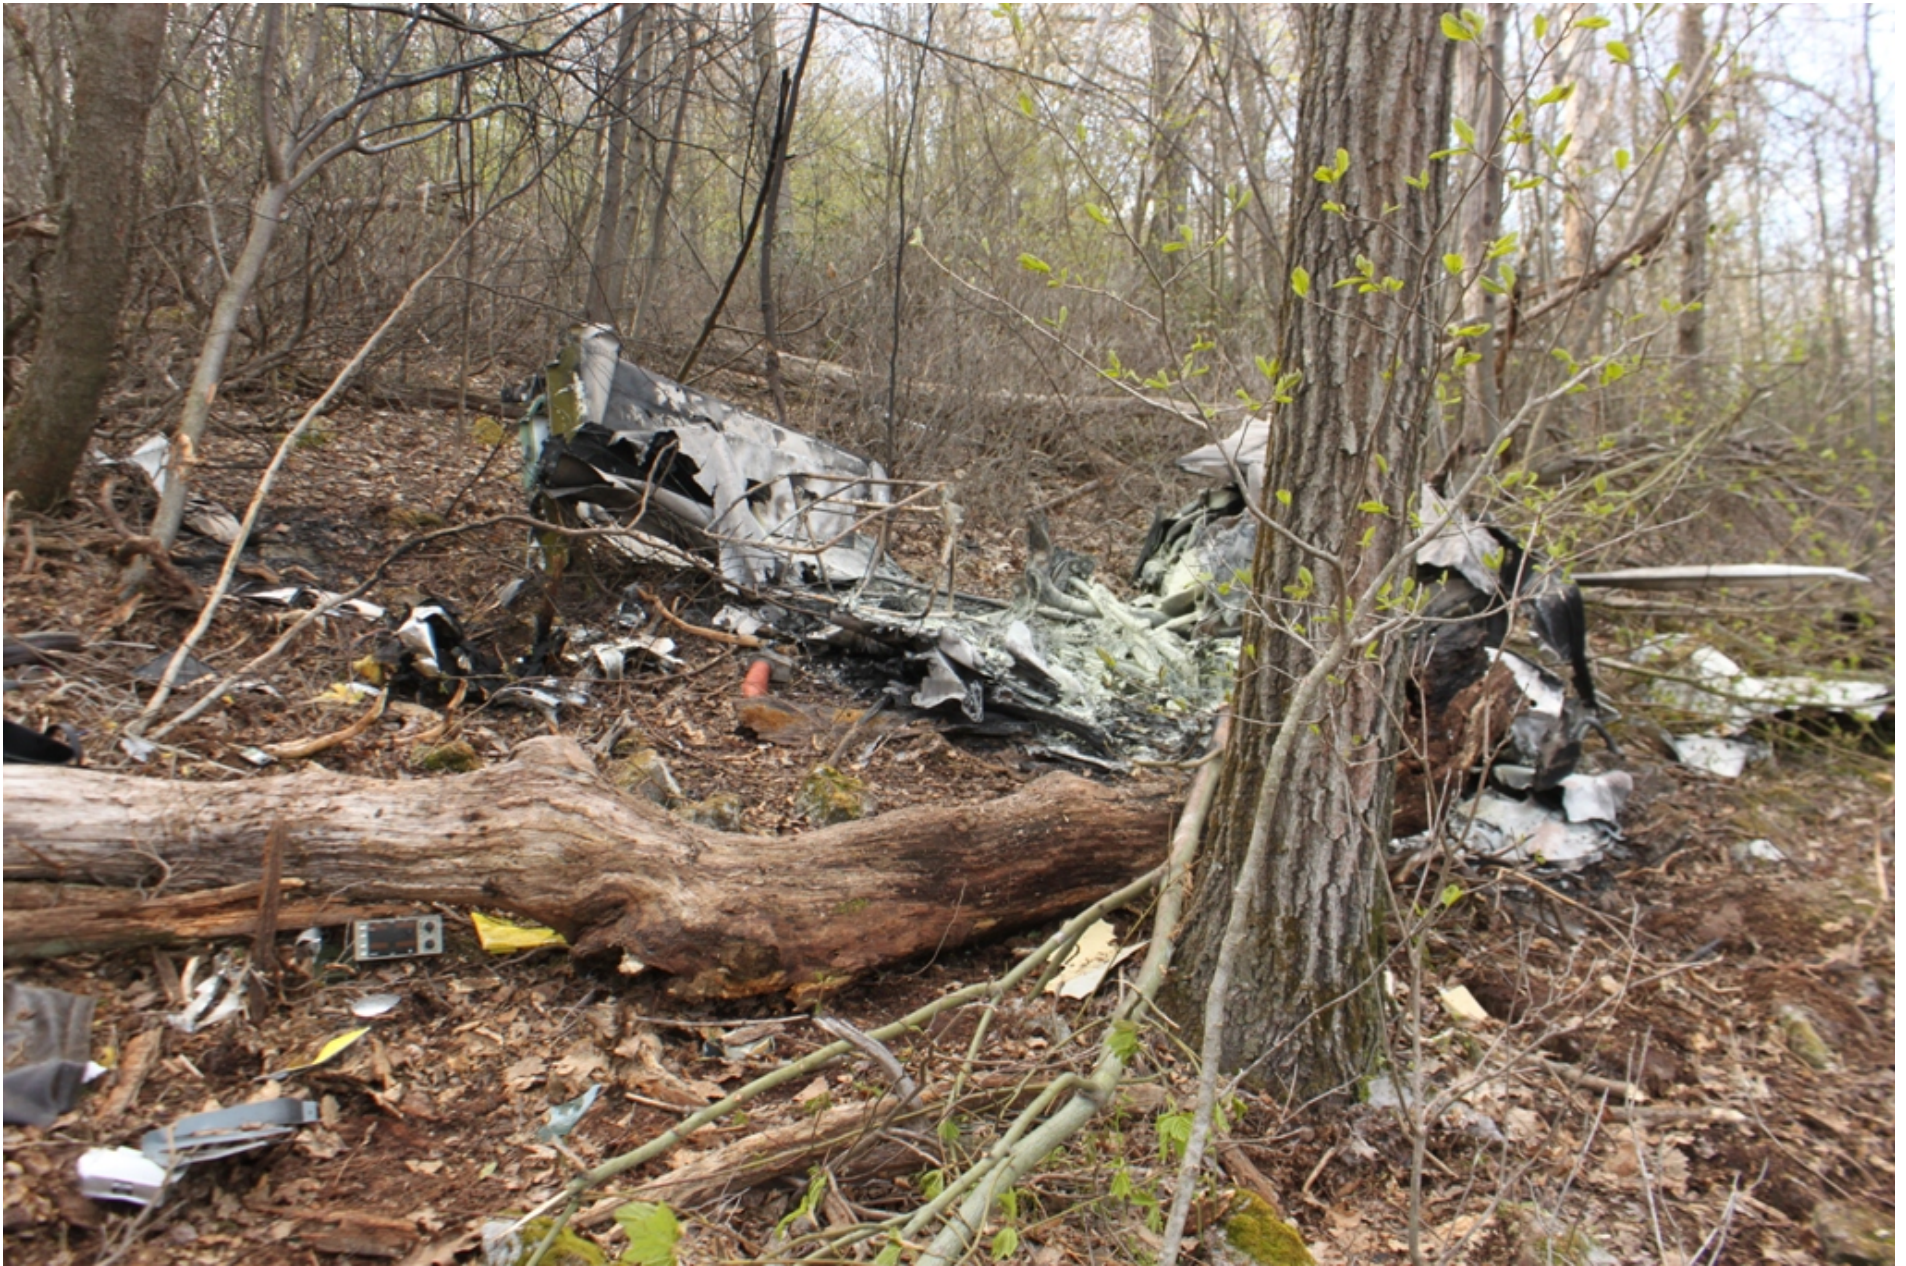
Photo 5 - NTSB Digital Photograph. View Depicting the Resting Position of the Main Wreckage Including the Cockpit Section, Engine Assembly.

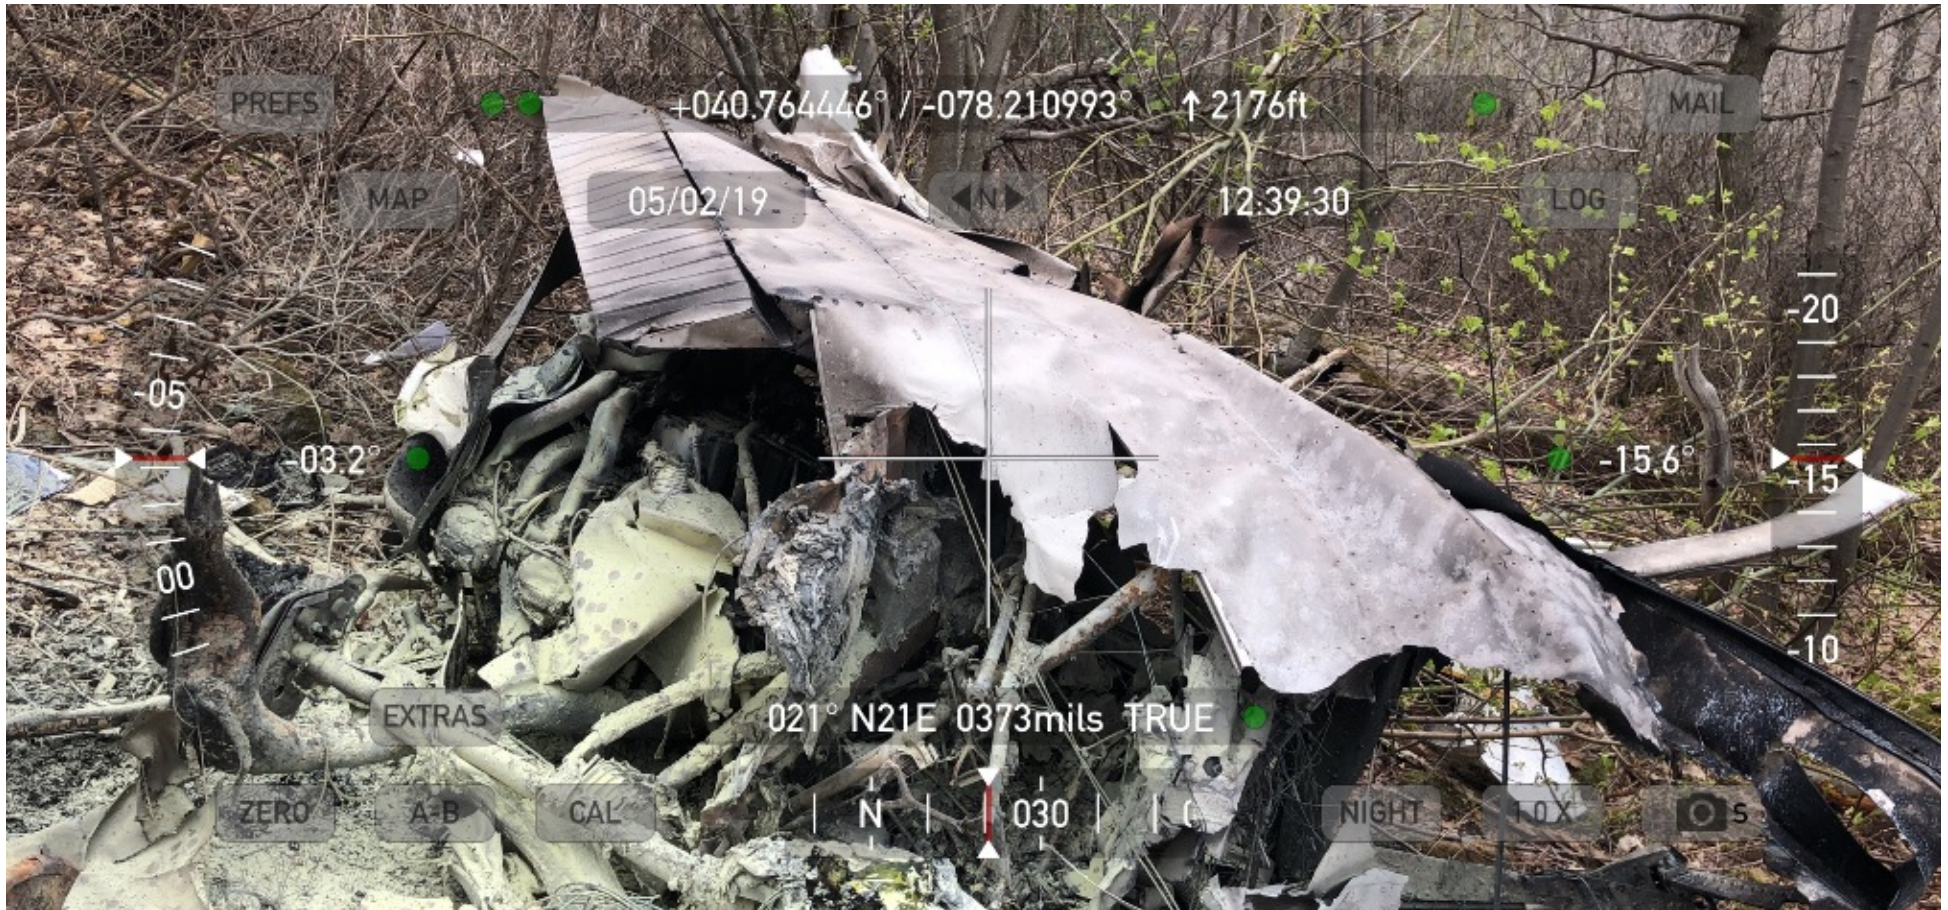
Photo 6 - NTSB Digital Photograph. Close-Up View of the Engine Assembly at the Resting Position. Note the Extensive Fire Damage.

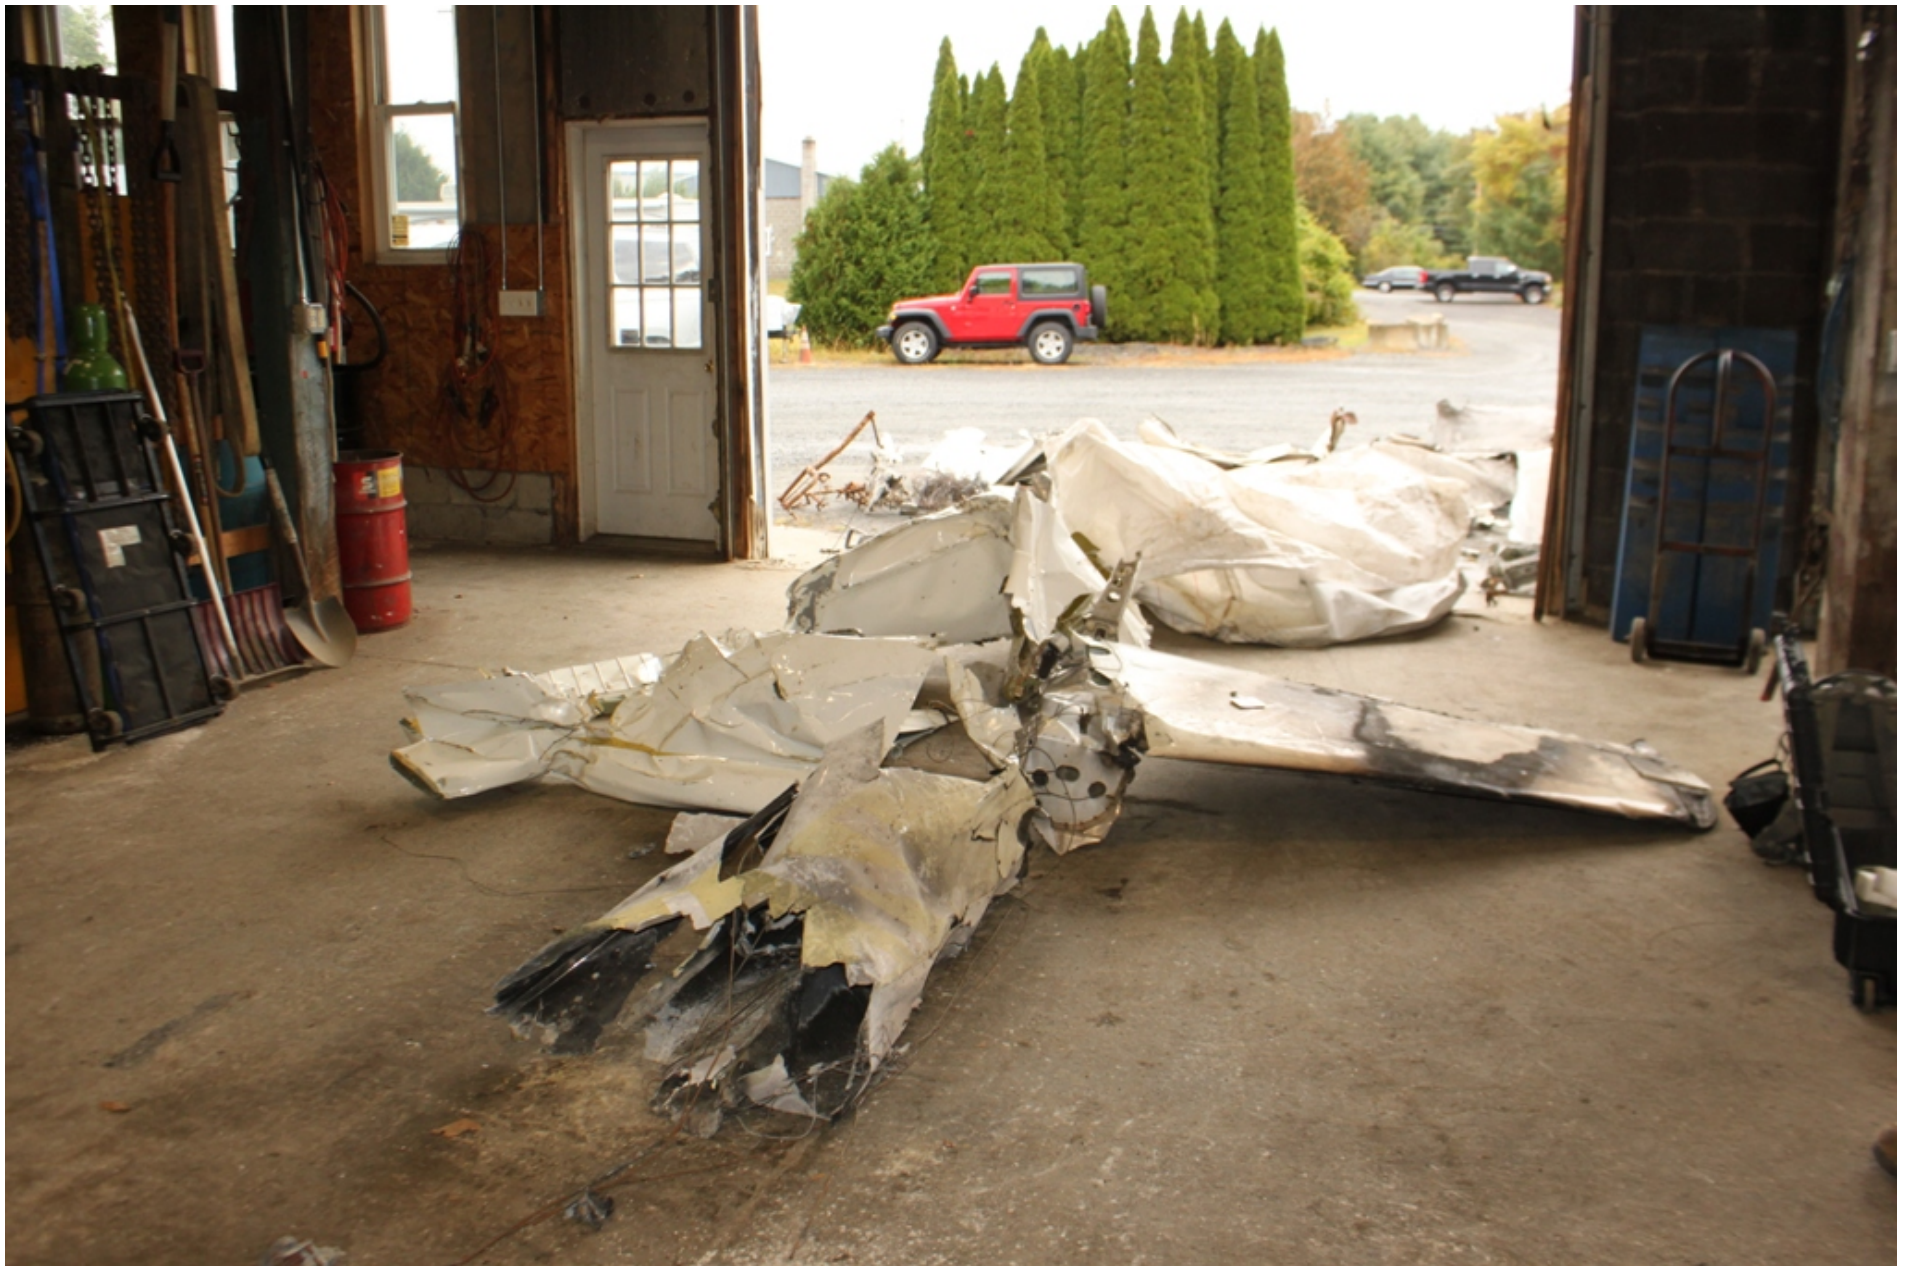
Photo 9 - NTSB Digital Photograph. View of the Aft Empennage Taken During Follow-Up Examination. Note the Extensive Fire Damage to the Fuselage Forward of the Attached Left Horizontal Stabilizer.

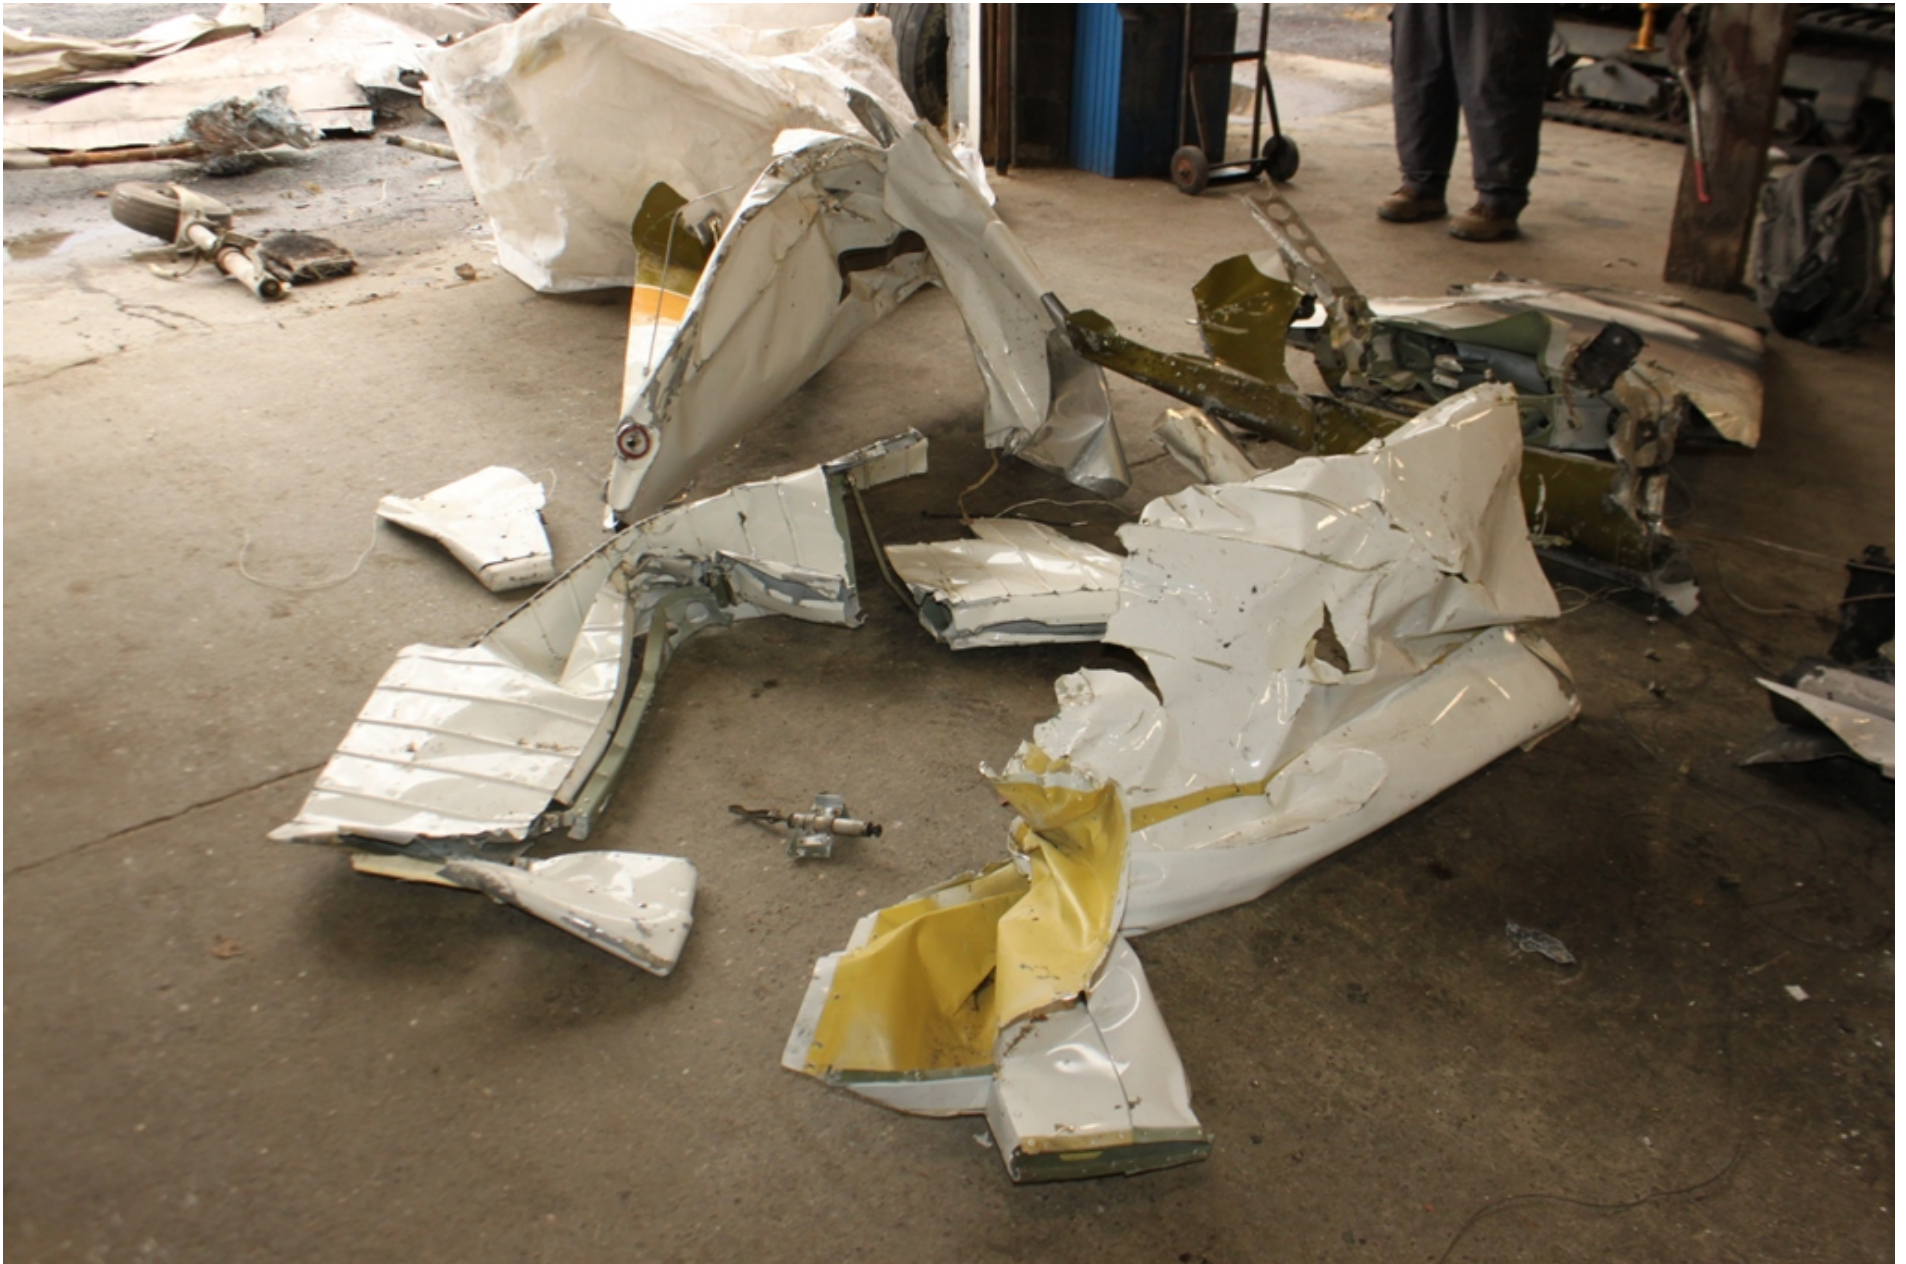
Photo 10 - NTSB Digital Photograph. View of the Separated Right Horizontal Stabilizer and Elevator Taken During Follow-Up Examination.

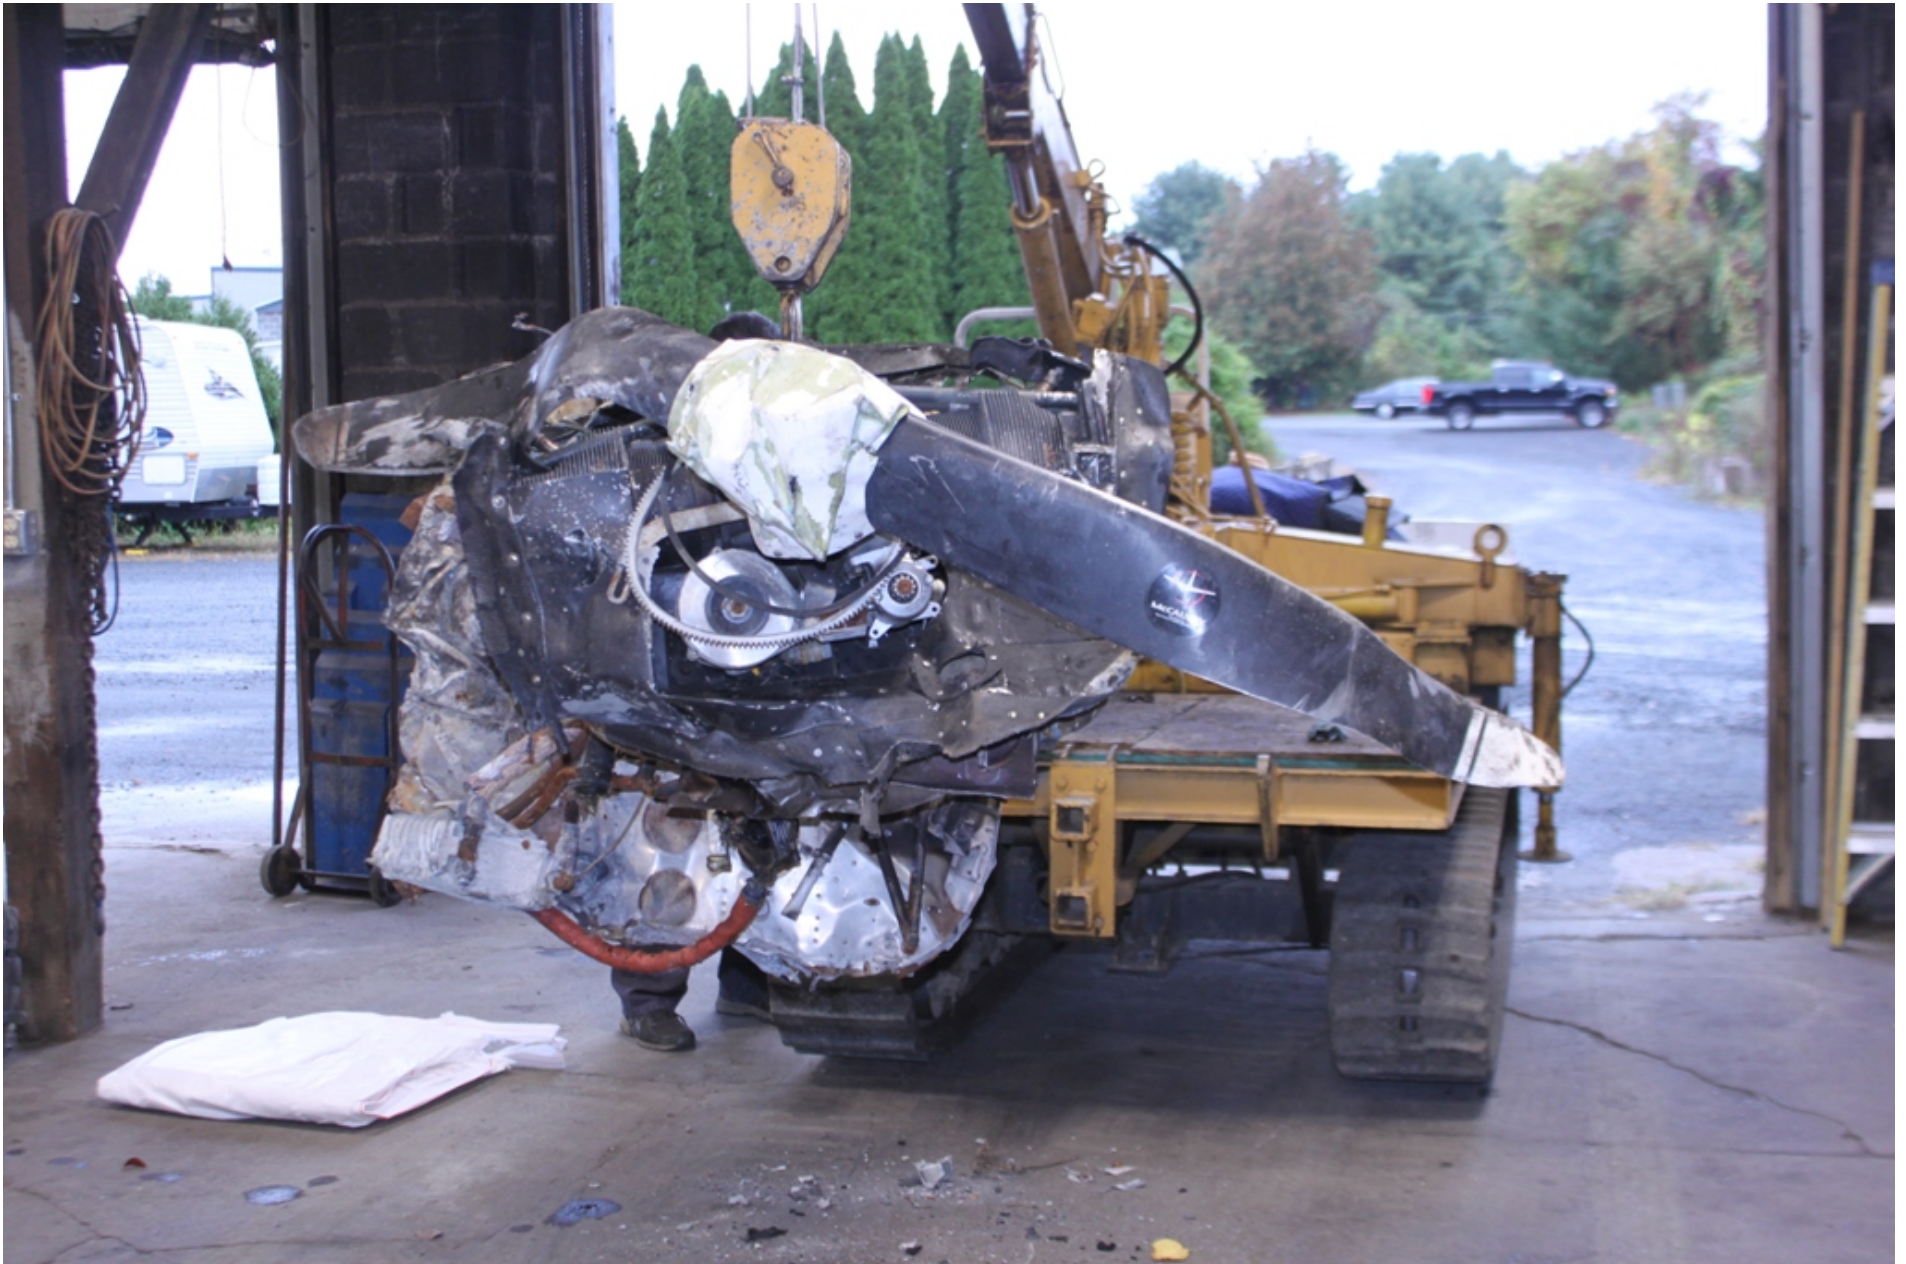
Photo 11 - NTSB Digital Photograph. Frontal View of the Engine Assembly with Attached Propeller During Follow-Up Examination. Note the Propeller Blade Bending.

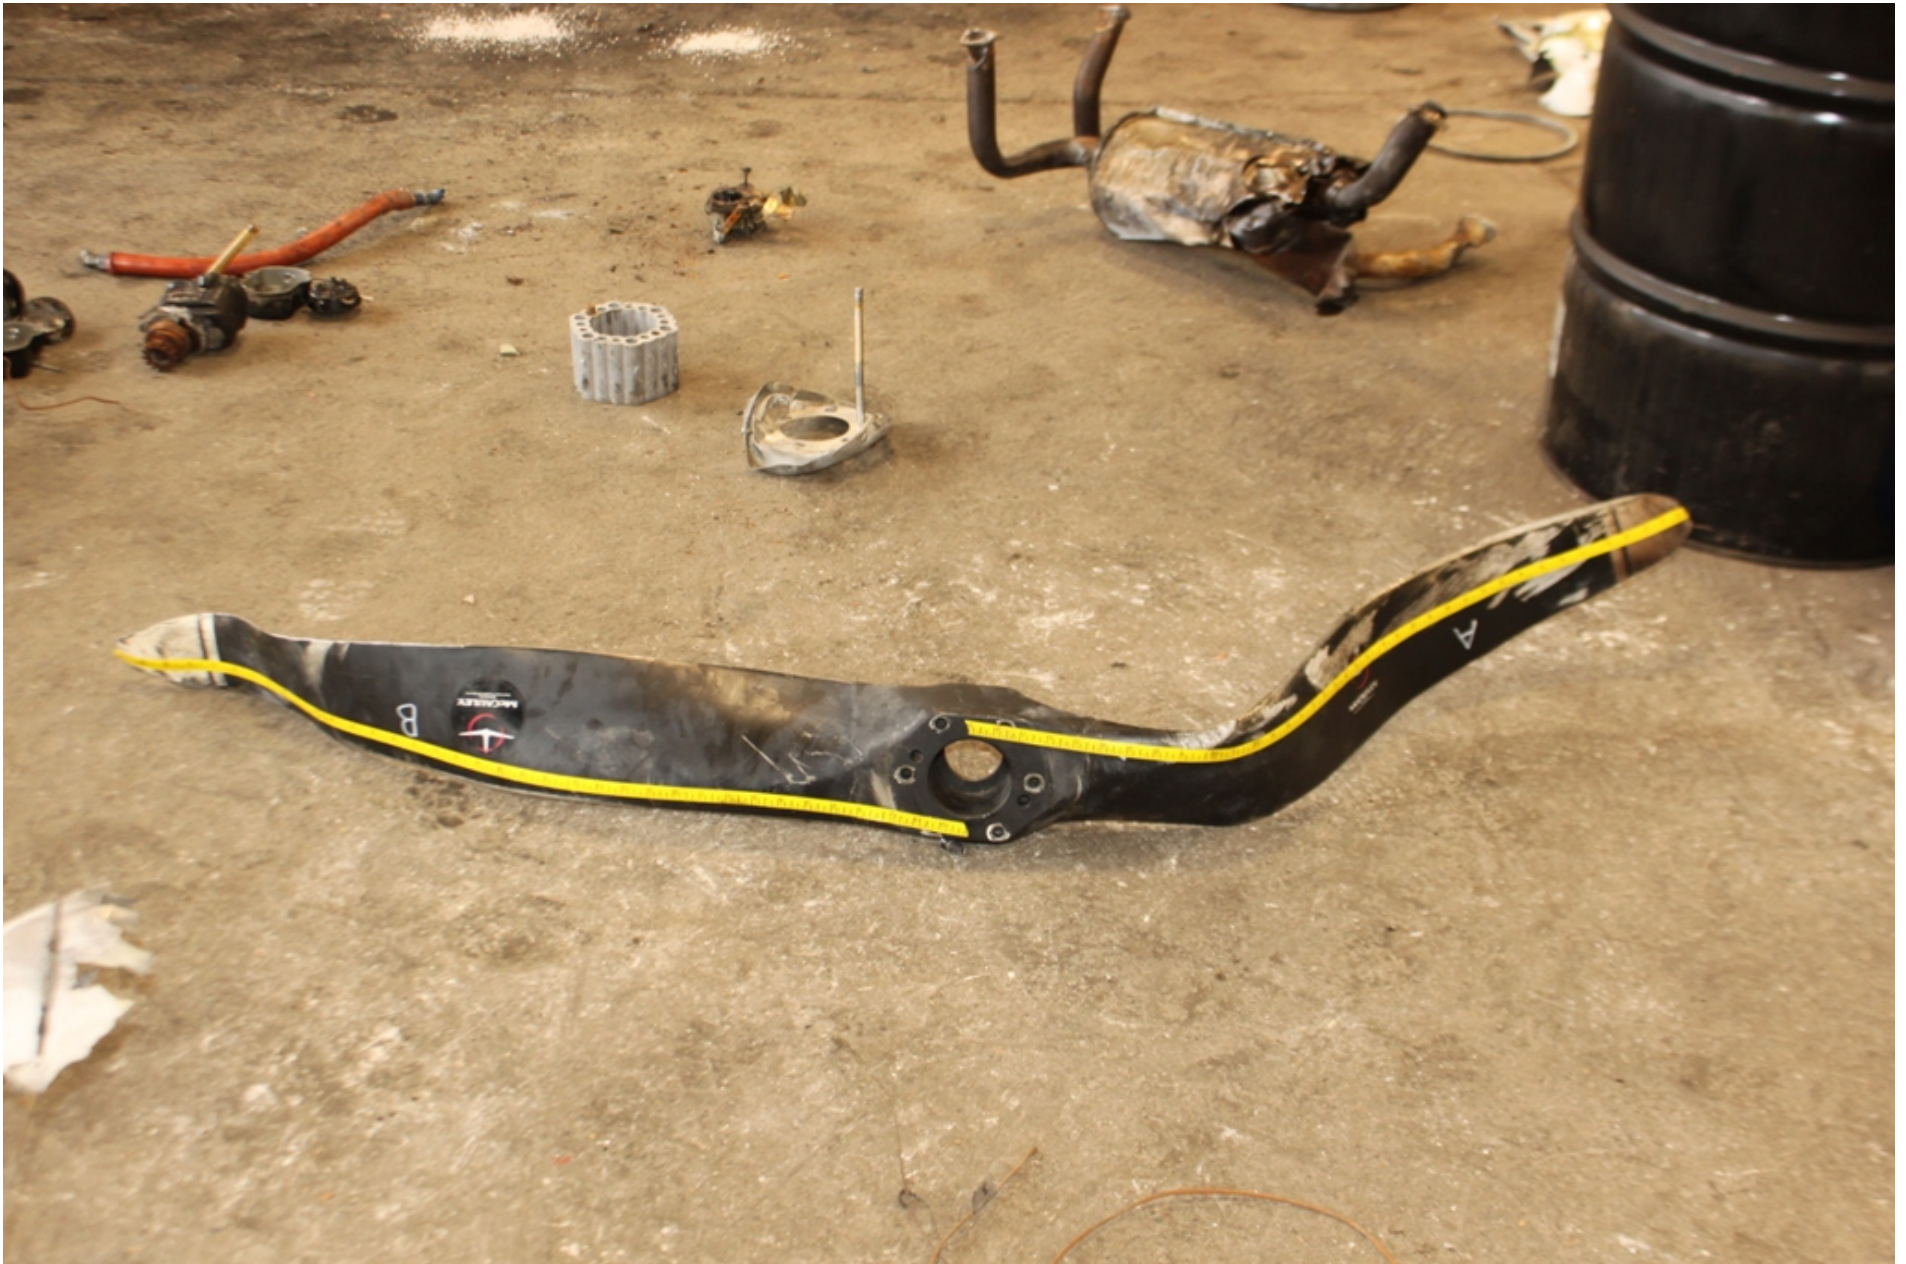
Photo 12 - NTSB Digital Photograph. View of the Propeller Following Separation From the Engine During Follow-Up Examination. Note the “S” Type Blade Bending of Both Blades.
