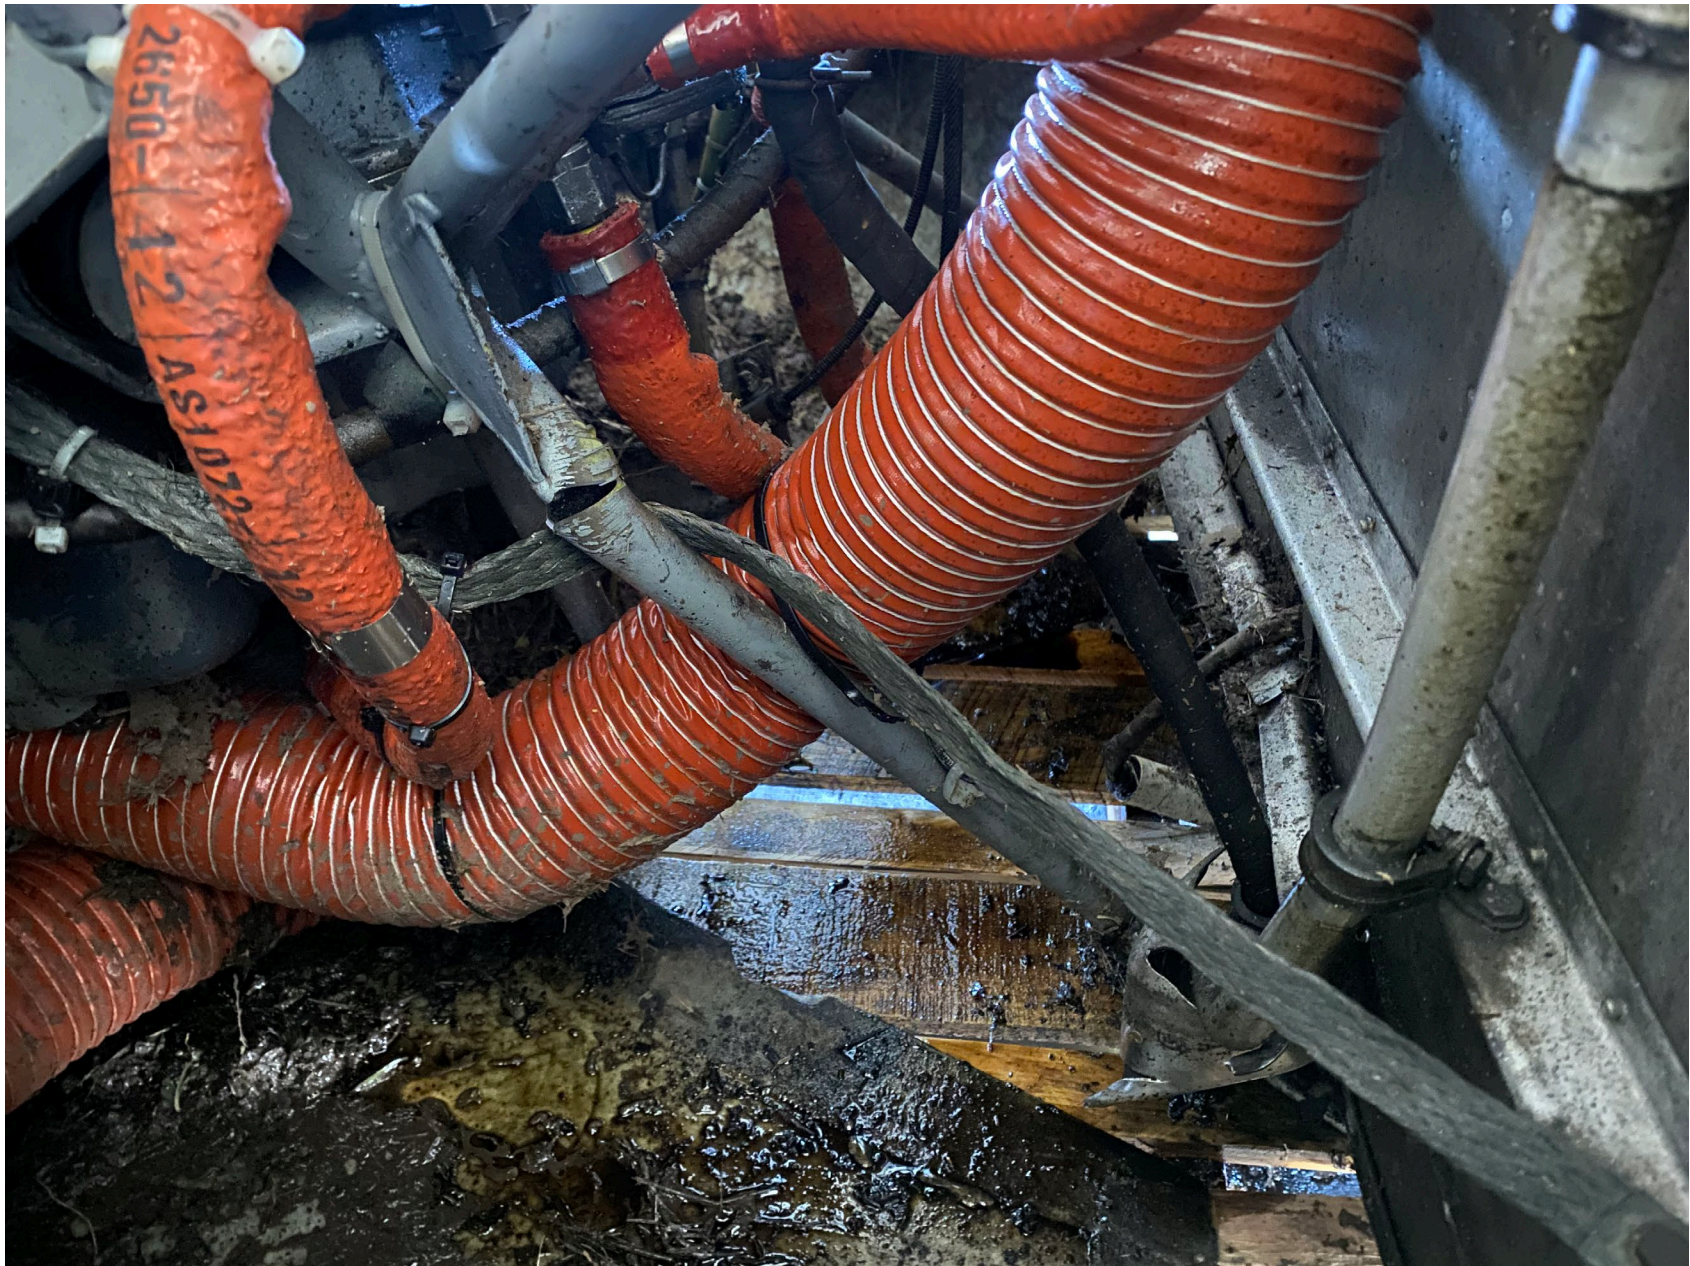
**Photo 1 – FAA Digital Photograph. View of a fractured Engine Mount Tube.**

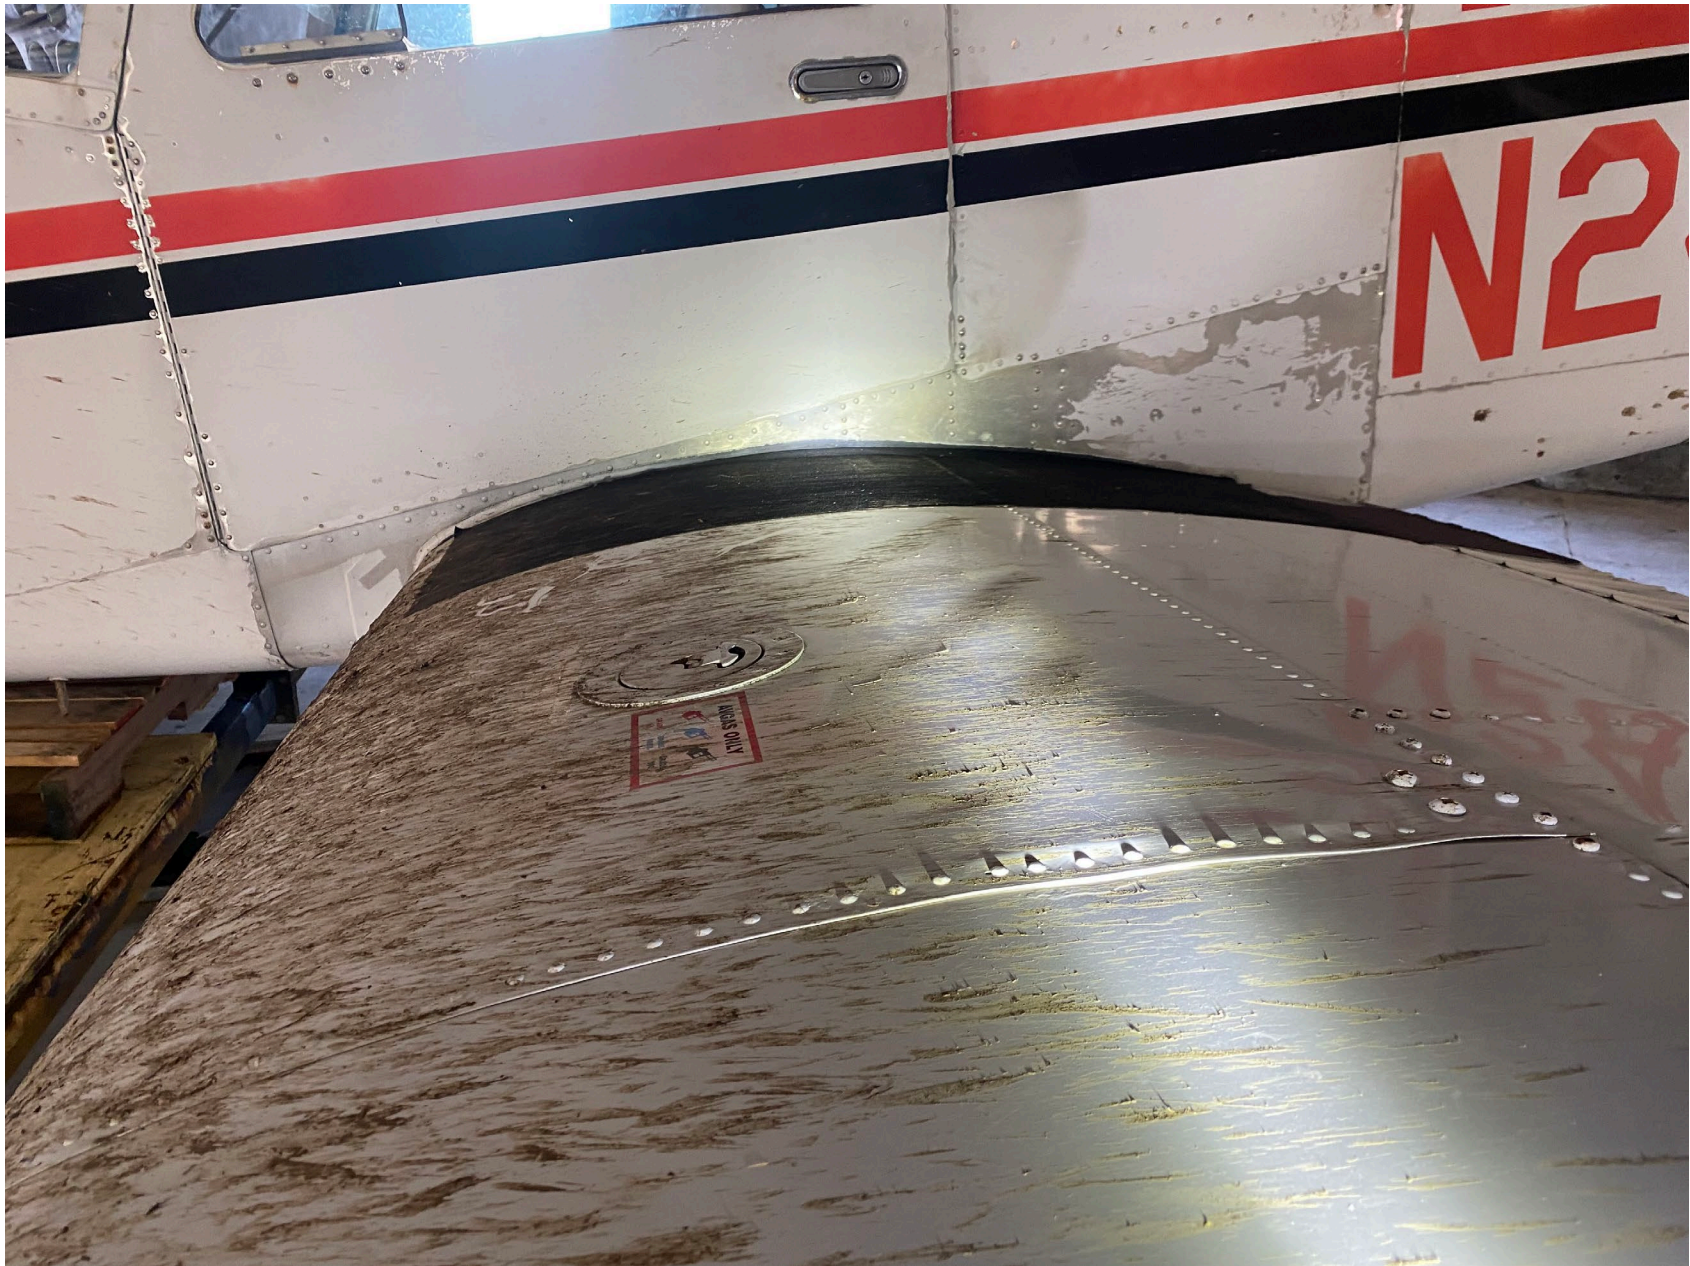
**Photo 2 - FAA Digital Photograph. View Depicting the Wrinkles in the Upper Skin of the Left Wing.**

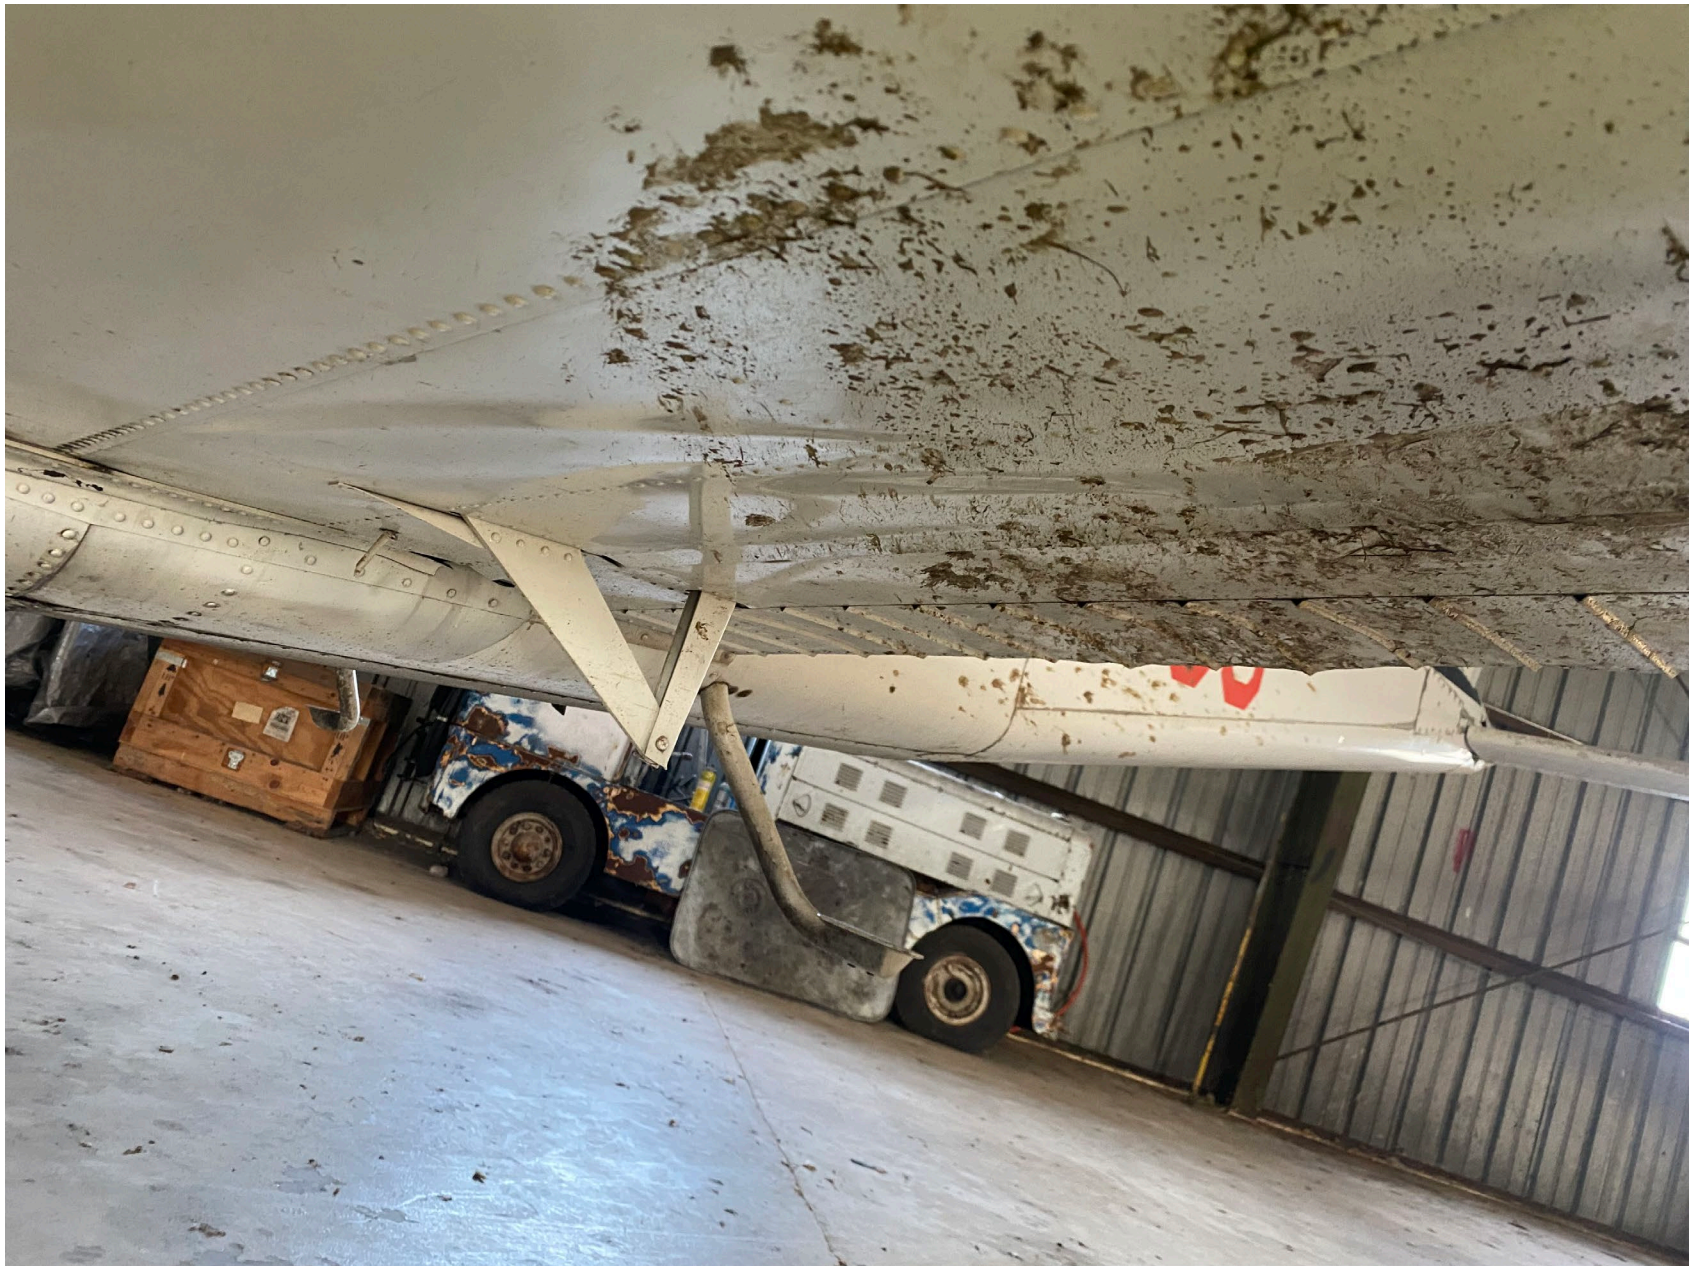
**Photo 3 - FAA Digital Photograph. View Depicting the Wrinkles in the Lower Skin of the Left Wing.**
